RE: Sewer over flow at 534 South 7th Street

AFIN: 07-00017

NPDES Permit No.: AR0021873

NPDES Compliance Inspection Report

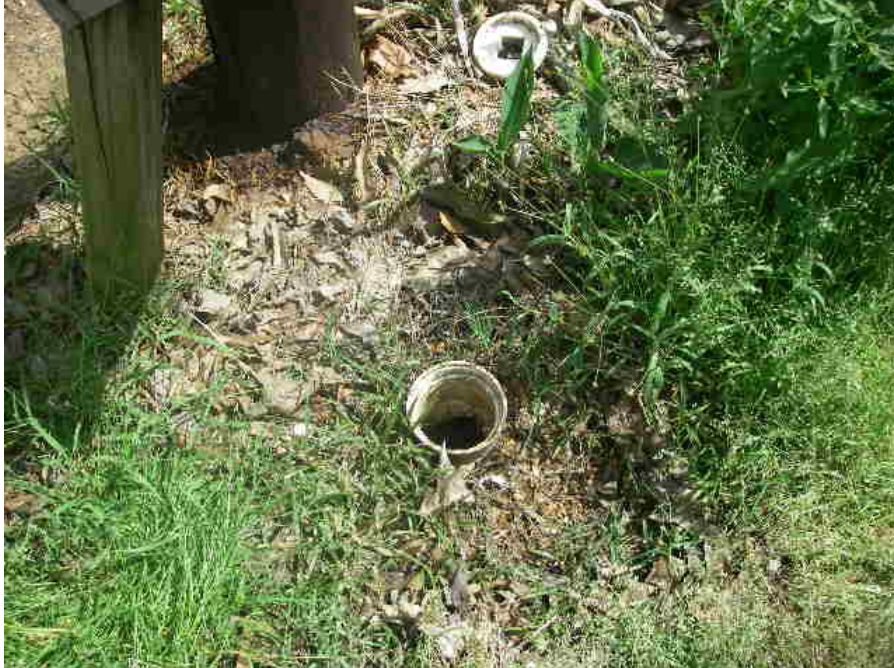
This inspection was performed in response to a complaint that alleged that the City of Hampton Sewer Collection System had overflowed into the home and yard located at 534 South 7th Street. The home is owned by Mr. Gilbert Watkins. On the date of the inspection, I viewed the sewer collection system located in this area. I opened two manholes and observed that the sewer in the manholes was flowing free, with no apparent obstructions. I next traveled to 534 South 7th Street. No one was present and according to Mr. Watkins, the house was not in condition to be lived in due to the raw sewage in the house. Since the house was locked, I could not verify the sewage in the house, but I did observe the service line located in the front yard. There was a small evidence of raw sewage overflow around the clean out.

Location:	534 South 7 th Street, Hampton, Arkansas						
Photographer:	John W. Lamb			Witness:	None		
Photo #	1	Of	1	Date:	4/21/08	Time:	15:20
Description:	House sewer clean out in yard of 534 South 7 th Street, Clean out had small evidence of raw sewage solids on ground

This was reported to the city's engineer. We are planning a smoke test of our collection system in this area to try and determine where the infiltration problems are and fix them. A backflow was installed by the city for Mr. Watkins and this should prevent any future problems at his home on 7th street, until we are able to locate and fix the possible infiltration to our system.
