ARKANSAS
Department of Environmental Quality

October 15, 2012

RE: AFIN: 04-00175

NO DISCHARGE INDUSTRIAL PERMIT INSPECTION FORM

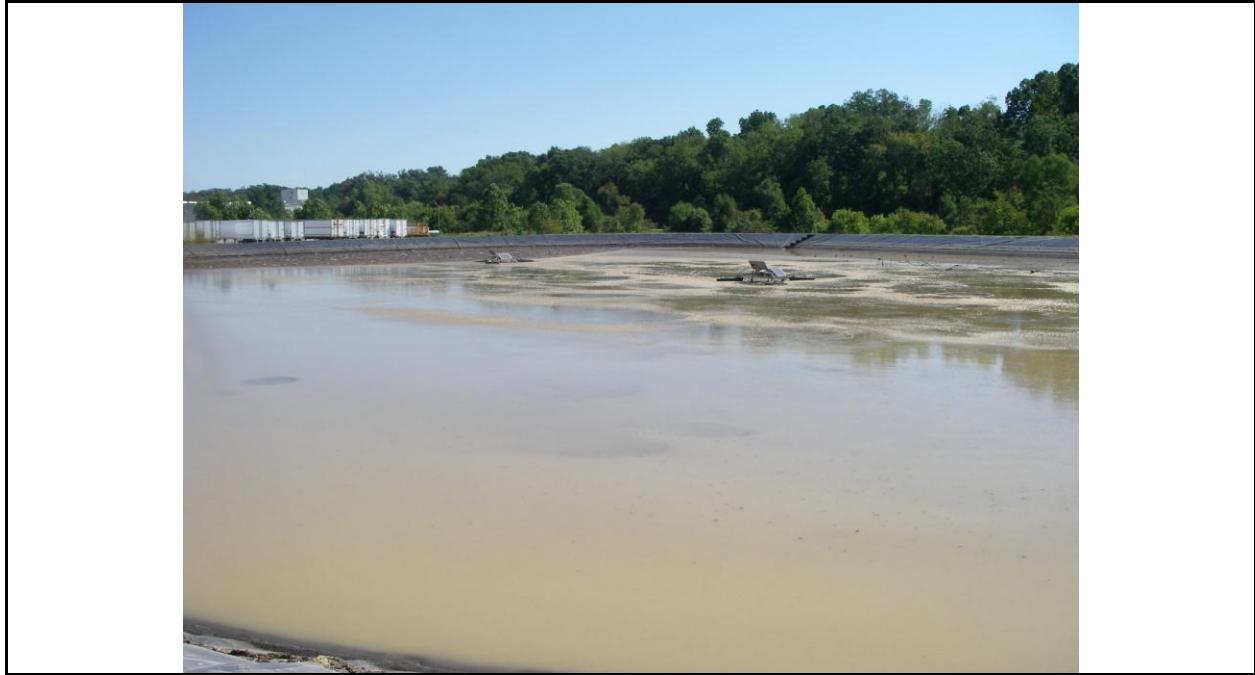
Photo #	1	Of	4	Date:	09/12/12	Time:	1133
----------------	---	-----------	---	--------------	----------	--------------	------

Description:	High density polyethylene heat-fused lined lagoon.
---------------------	--

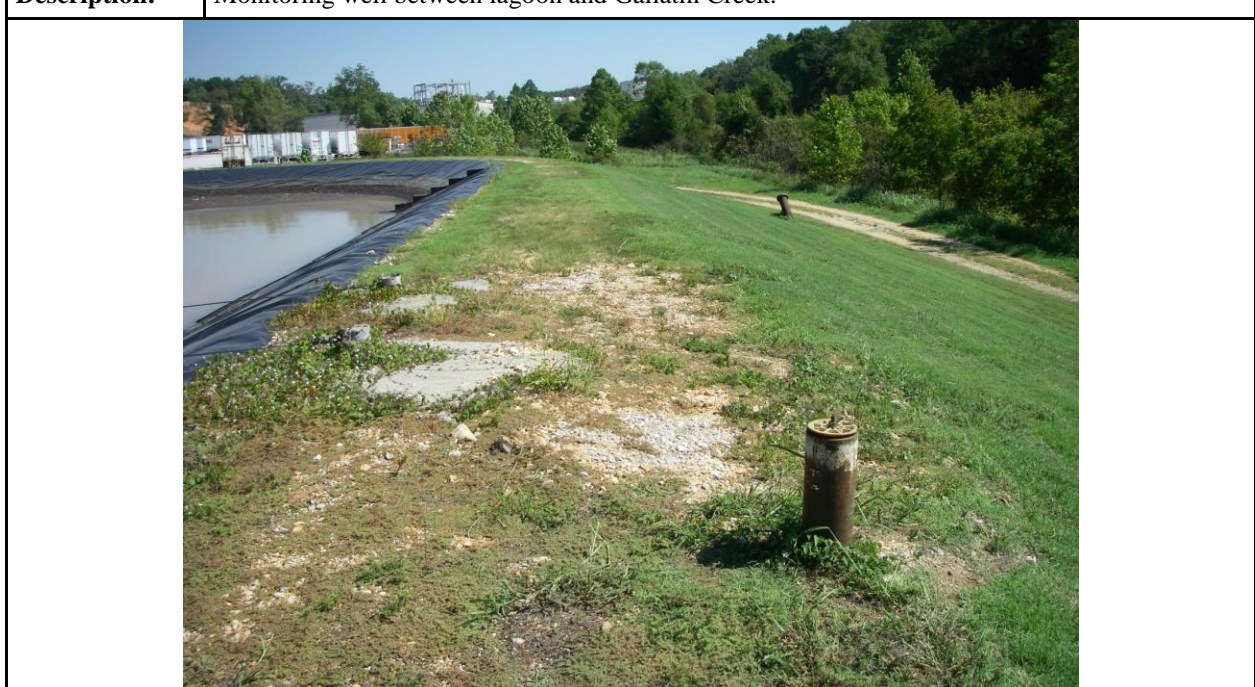
Photo #	2	Of	4	Date:	09/12/12	Time:	1146
----------------	---	-----------	---	--------------	----------	--------------	------

Description:	Monitoring well between lagoon and Gallatin Creek.
---------------------	--

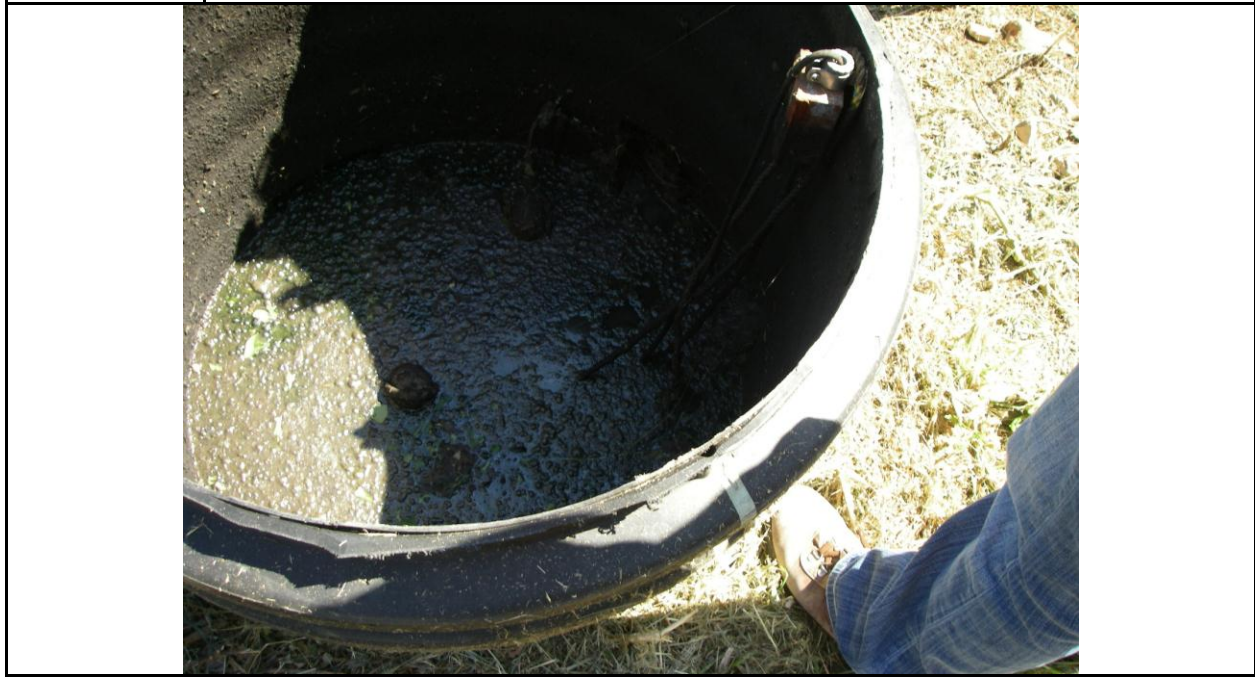
Photo #	3	Of	4	Date:	09/12/12	Time:	1154
----------------	---	-----------	---	--------------	----------	--------------	------

Description:	Out-of-use irrigation pump seal sump. Floats and high-level alarm not maintained. Cleaned out the following day.
---------------------	--

During the inspection, ADEQ staff questioned why a sump had not been pumped down and why it was not covered. This sump is intended to collect the irrigation pump seal water and return it to the wastewater system. However, these irrigation pumps were not currently in use at the time of the inspection since it was necessary to bring in an alternative pump because of issues with plugging the inlet screen on the irrigation pumps. As Sathi indicated when he spoke to Mr. Fazio, Allens is completing plans for a different type of inlet screening system that will address the concerns that we have had with the irrigation pumps. Since the sump (and the irrigation pumps related to it) had not been in use, the sump pump and high level alarm were not being maintained. Nonetheless, the sump was cleaned out, pumped down, and temporary cover has been placed over this sump. (See the following photos.) This sump will not be part of the new inlet screening system.

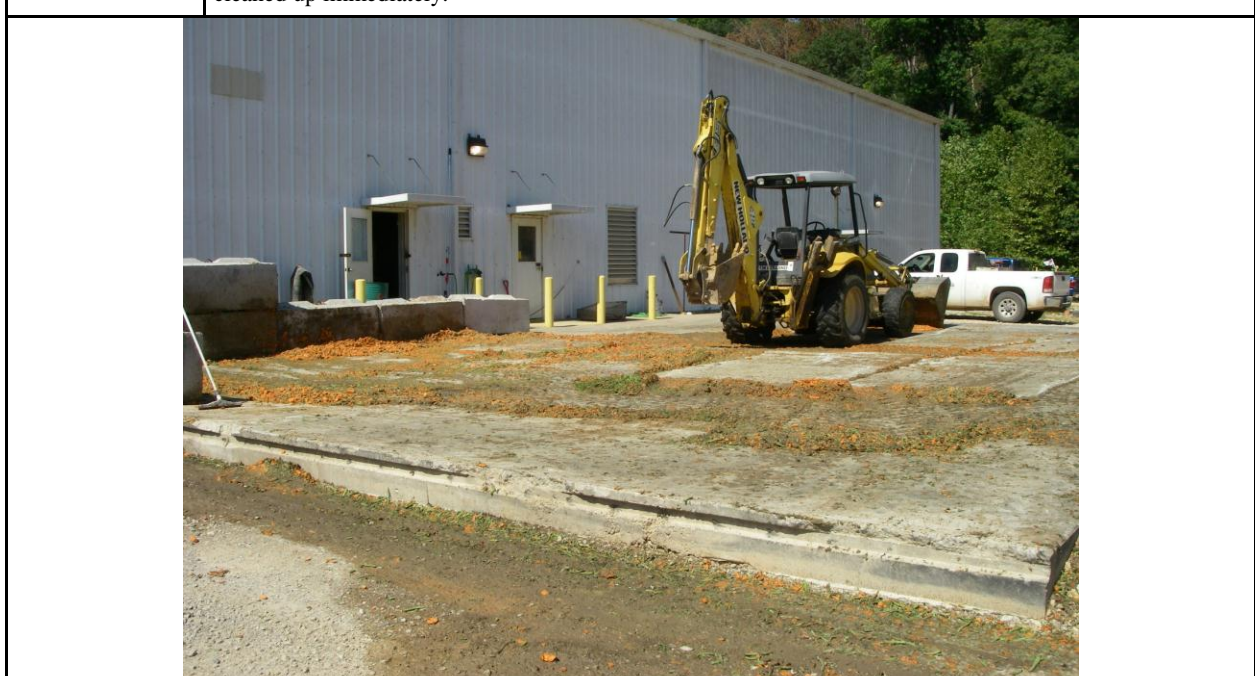
Photo #	4	Of	4	Date:	09/12/12	Time:	1156
----------------	---	-----------	---	--------------	----------	--------------	------

Description:	Carrot waste and wastewater that had escaped the staging pad. Drains cleared immediately and area cleaned up immediately.
---------------------	---

Also during the inspection, the ADEQ noted some liquid from the screened vegetable waste had escaped the concrete pad and gotten into the gravel drive. Allens believes this occurred because a drain (back to the wastewater system) on the concrete pad had become plugged. The drain has been cleared and the area has been cleaned up as shown in the following photo. Staff was reminded of the importance to contain all drainage from vegetable waste.

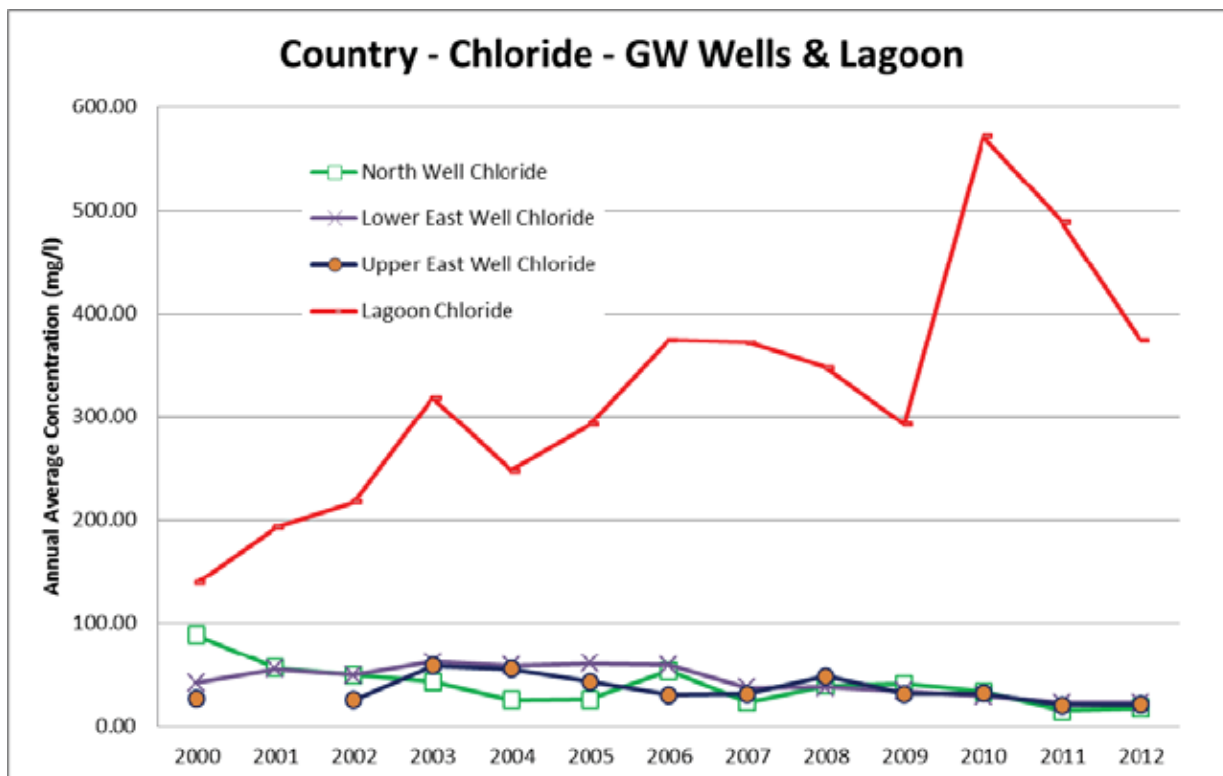
Upon learning that one of the plugs dislodged a few months ago, Allens environmental staff reviewed the groundwater monitoring data from around the wastewater lagoon to see if there were any disturbing trends. Although the current permit no longer requires it, Allens has continued to monitor the groundwater around the wastewater lagoon with three groundwater monitoring wells that are sampled and analyzed monthly. Two of these monitoring wells are located on the outside berm of the lagoon on the side nearest the stream, so Allens would anticipate minimal elapsed time between any lagoon leakage concerns and evidence in the monitoring wells. Allens believes the most indicative parameter of potential lagoon leakage to be chloride since it is not treated in the lagoon system and the wastewater has a fairly high concentration of chloride from the salt used in canning. A graph on chloride concentrations in the monitoring wells versus the wastewater concentrations is provided below.

During the most recent months of July, August, and September, the ranges in concentrations for all three of groundwater monitoring wells were as follows:

- Biochemical Oxygen Demand (BOD) <2 to 6 mg/l
- Total Dissolved Solids (TDS) 198 to 383 mg/l

In contrast, typical wastewater concentrations range from 500 to 4500 mg/l for BOD and 900 to 3500 mg/l for TDS. If you would like all the groundwater monitoring data, please let us know and we will provide it.

Based on the on-going groundwater monitoring results, Allens does not believe there is an immediate and significant concern about lagoon leakage. Because of the concerns raised in the alleged complaint, it is now recognized that there must have been much speculation amongst hourly staff about the potential source of the PVC pipes with caps found in the lagoon, and in contrast, the results of the groundwater monitoring were not really discussed with all employees. In any event, Allens plans on again emptying the lagoon with the new inlet screening project and inspecting the liner to confirm this and will make any corrective measures if necessary.
