RE: Reconnaissance Inspection AFIN: 72-00629 Permit No.: 4630-WR-3

Inspection Report: Valley View Golf Course, L.L.C, AFIN: 72-00629, Permit #: 4640-WR-3

Overflow Incident Report for WCPO #5 Farmington, AR

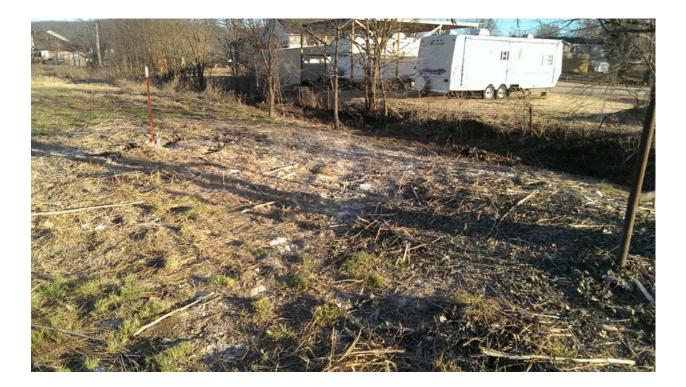
On *December 19, 2013*, WCPO had overflow from manhole spill safe area below lift station. This was immediately taken care of and proper cleanup was done.

Area around overflow cleaned and Agriculture Lime was applied. Debris was discovered inside manhole causing clog in second spill safe manhole. This was main reason overflow occurred. This system is designed to have two (spill safe) man holes to keep any overflow from occurring before maintenance crew can repair.

Overflow area was sanded as well as cleared with mower and lime was applied shortly after incident. We continue to monitor and clean up as necessary.
