**RE: Reconnaissance Inspection (Conway Co)**  
**AFIN: 15-00034**

**Permit No.: 3509-WR-5**

**NO DISCHARGE INDUSTRIAL PERMIT INSPECTION FORM**

<b>Water Division No Discharge Industrial Photographic Evidence Sheet</b>
---

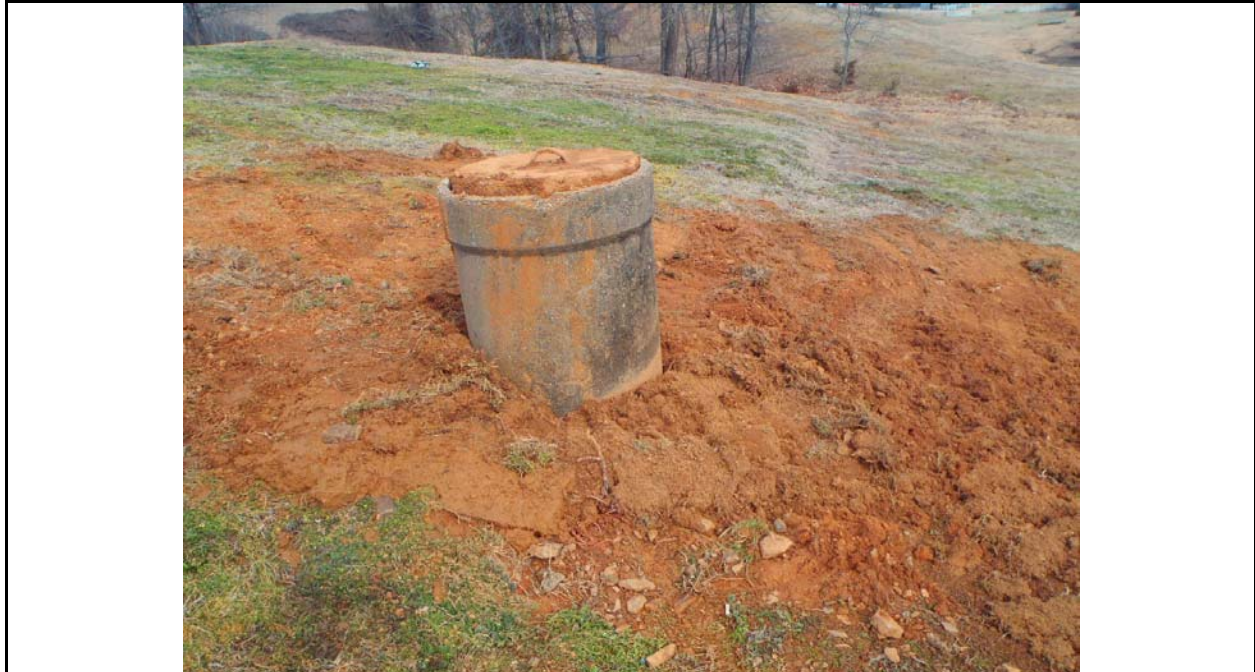
<b>Photo #</b>	1	<b>Of</b>	8	<b>Date:</b>	2/18/14	<b>Time:</b>	1441
----------------	---	-----------	---	--------------	---------	--------------	------

A sewer spill (discharge) occurred at a pressure vent. **This is a violation of Part II.10 of the permit.** The spill had been repaired prior to the inspection. The facility should submit a spill report to the Enforcement Branch per Part III.13 of the permit. Submittal of the spill report satisfies a response to this inspection.

<b>Description:</b>	View of pressure vent where sewer discharge occurred. Repair made prior to inspection.
---------------------	--

The Morrilton Wastewater Department has corrected the sewer leak east of I-40. It appears that the leak was caused by contractors hitting the line while they were working in the area. The contractor tried to repair the line, but did not repair it correctly, causing it to leak again. The Morrilton Wastewater Department repaired the line and the problem is corrected.

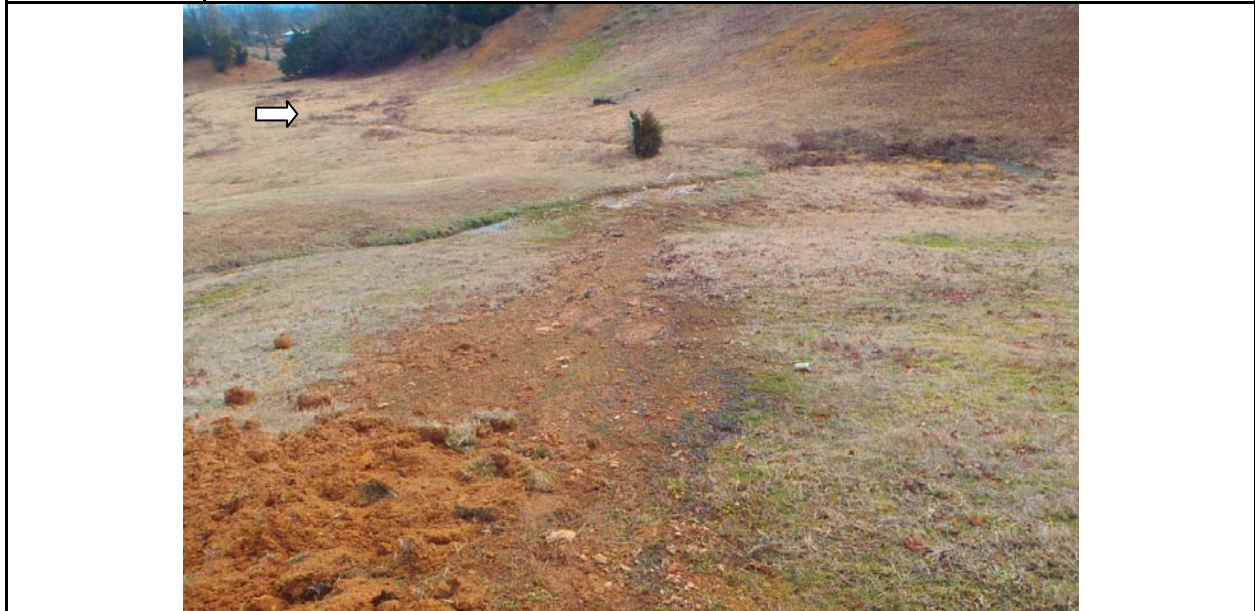
<b>Photo #</b>	2	<b>Of</b>	8	<b>Date:</b>	2/18/14	<b>Time:</b>	1441
----------------	---	-----------	---	--------------	---------	--------------	------

<b>Description:</b>	View down-hill from pressure vent. I could detect sewer odor in the low spot extending left of the shooting target visible next to cedar. I did not see any visible solids/sludge in this area. Sludge is visible immediately next to the pressure vent. Arrow represents approximate extent of area with sewer odor.
---------------------	---

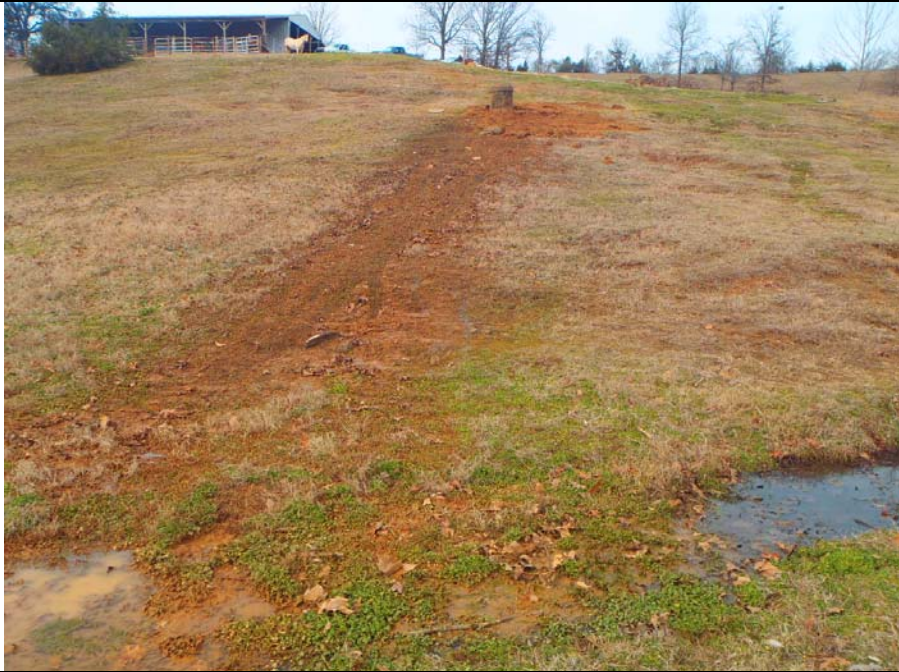
<b>Photo #</b>	3	<b>Of</b>	8	<b>Date:</b>	2/18/14	<b>Time:</b>	1444
----------------	---	-----------	---	--------------	---------	--------------	------

<b>Description:</b>	View up-hill towards pressure vent.						
---------------------	-------------------------------------	--	--	--	--	--	--

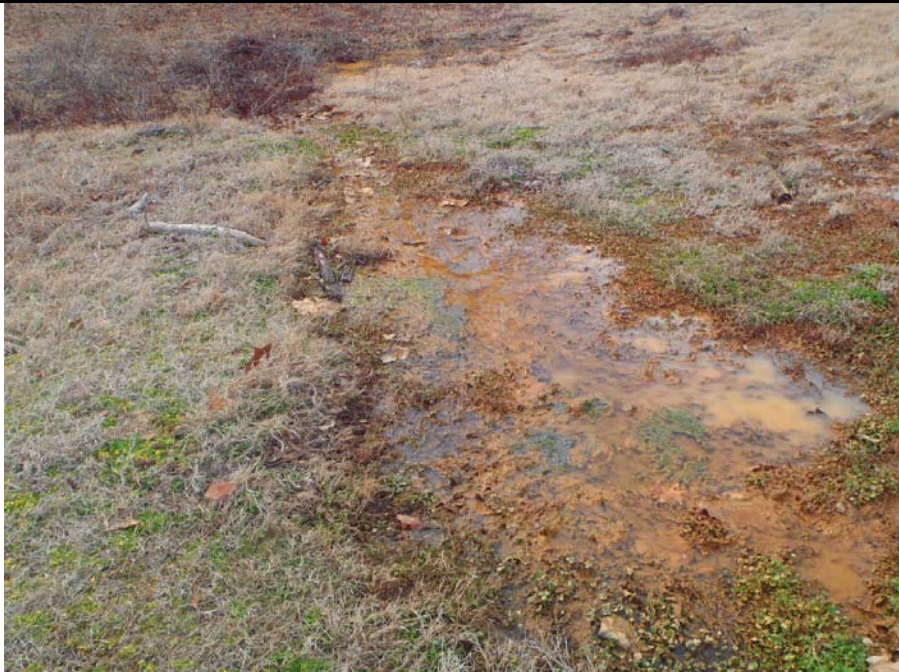
<b>Photo #</b>	4	<b>Of</b>	8	<b>Date:</b>	2/18/14	<b>Time:</b>	1444
----------------	---	-----------	---	--------------	---------	--------------	------

<b>Description:</b>	View of accumulated puddle down-hill from pressure vent.						
---------------------	--	--	--	--	--	--	--

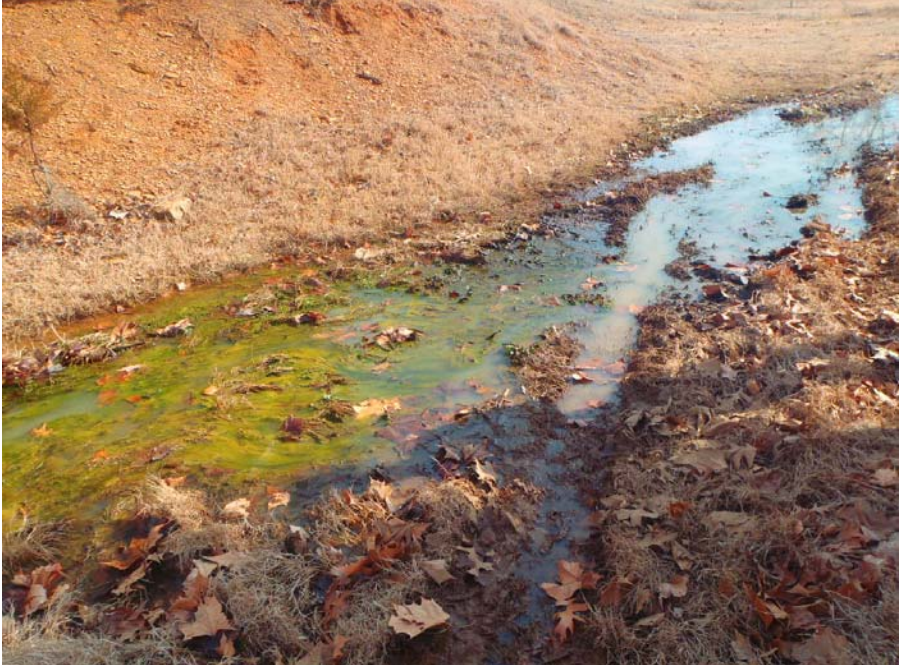
Water Division No Discharge Industrial Photographic Evidence Sheet							
<b>Location:</b>	Sewer discharge on private land (35.143791, -92.750175), Morrilton.						
<b>Photographer:</b>	Travis Harmon			<b>Witness:</b>	David York		
<b>Photo #</b>	5	<b>Of</b>	8	<b>Date:</b>	2/18/14	<b>Time:</b>	1453
<b>Description:</b>	View drinking water discharge due to broken line. Flowing form east of the affected sewer discharge area. Algal growth indicates flow over a period of time.

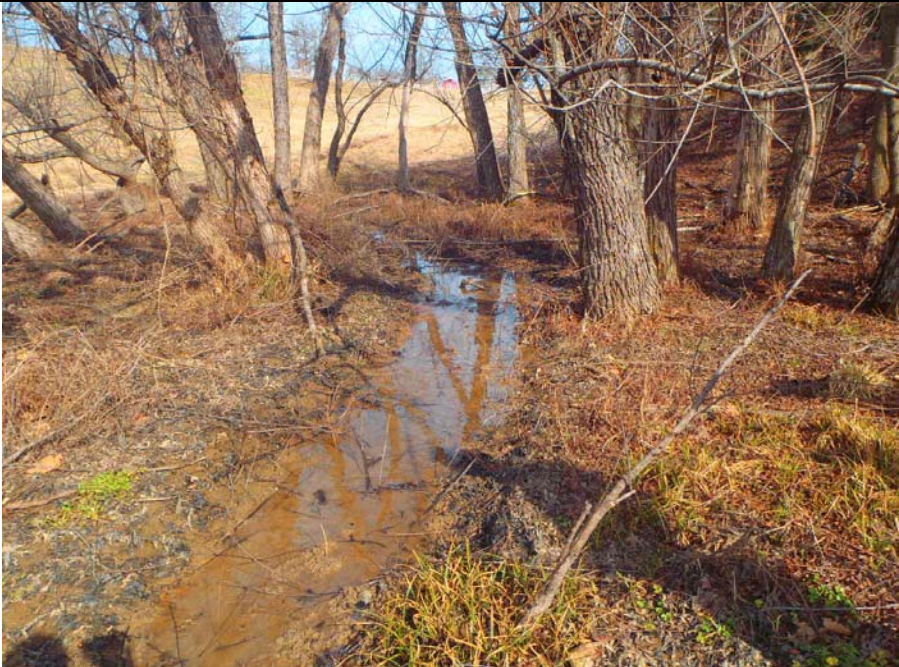
<b>Photographer:</b>	Travis Harmon			<b>Witness:</b>	David York		
<b>Photo #</b>	6	<b>Of</b>	8	<b>Date:</b>	2/18/14	<b>Time:</b>	1455
<b>Description:</b>	Looking east and upstream towards source of drinking water discharge.

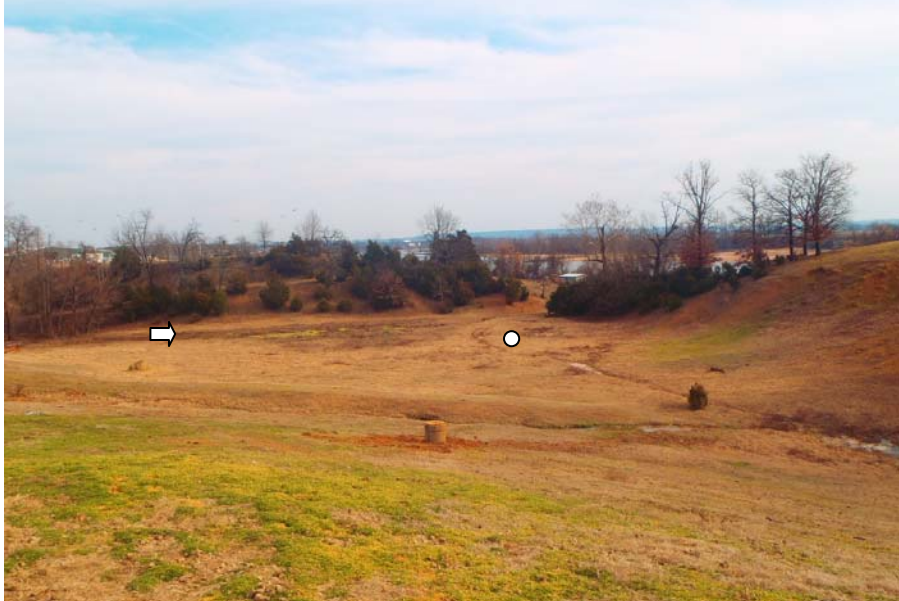
**Photo #** 7    **Of** 8      **Date:** 2/18/14    **Time:** 1516

**Description:** Overview of low spot (affected area). Circle shows the approximate location down-hill from pressure vent where sewer odor was noticeable. I suspect that some sewer liquid has seeped into the soil in this area. Arrow shows the location and direction of flow form the broken drinking water line.

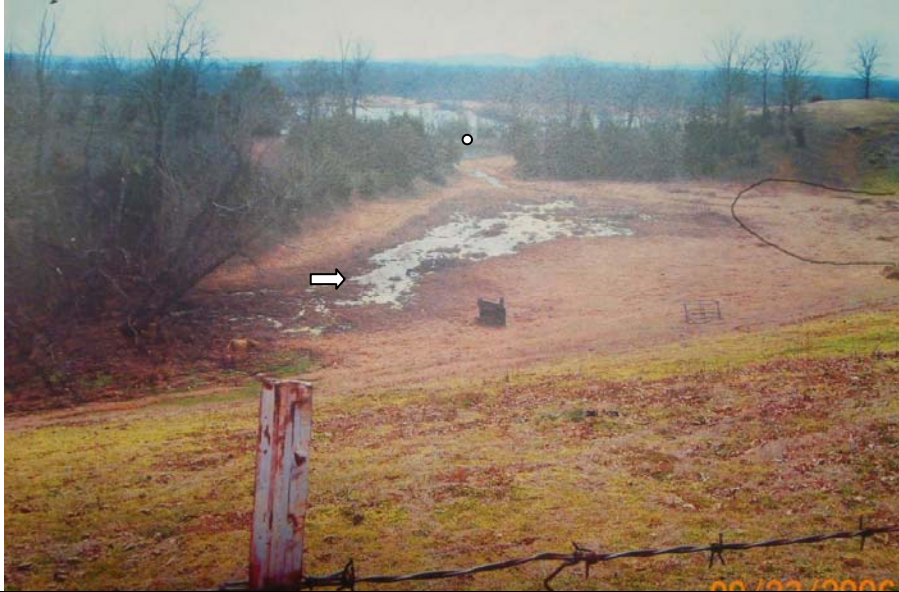
**Photo #** 8    **Of** 8      **Date:** 2/19/14    **Time:** 0926

**Description:** Photo taken by Operator showing location of pond and affected area. Circle shows the location of the pond. Arrow shows location and direction of drinking water flow. Black line shows area where sewer odor was present.

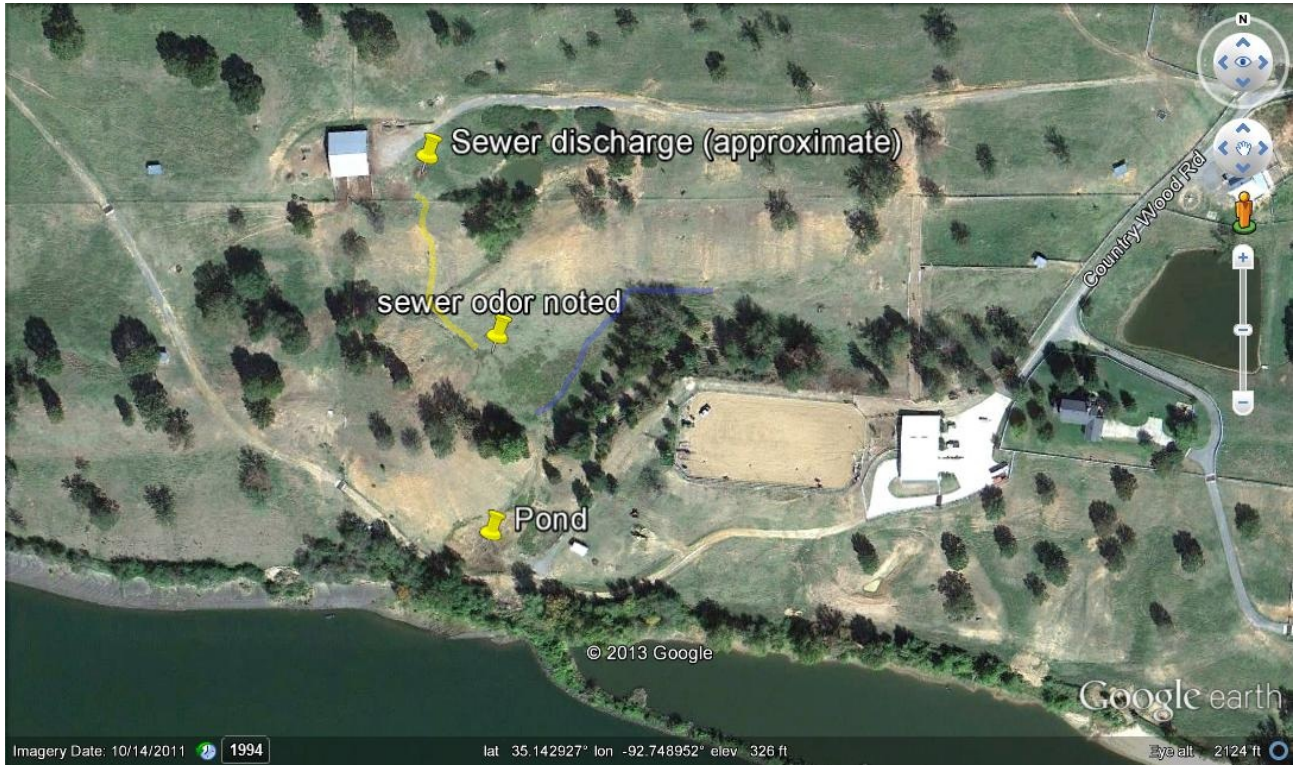
Google Earth Image showing area and locations (yellow line shows approximated flow pattern of sewer spill and extent of noticeable odor; blue line shows flow path of drinking water leak).
