RE: AFIN: 70-00037 Permit No.: No Permit-South Plant
Great Lakes South Plant Brine Management and Disposal System

On January 30, 2009, I performed an inspection of the Great Lakes South Plant Brine Management and Disposal System in accordance with the provisions of the Arkansas Water and Air Pollution Control Act and the regulations promulgated thereunder. This inspection revealed the following:

NO DISCHARGE INDUSTRIAL PERMIT INSPECTION FORM

Location:	GLCC South Plant Tail Brine Tank								
------------------	----------------------------------	--	--	--	--	--	--	--	--

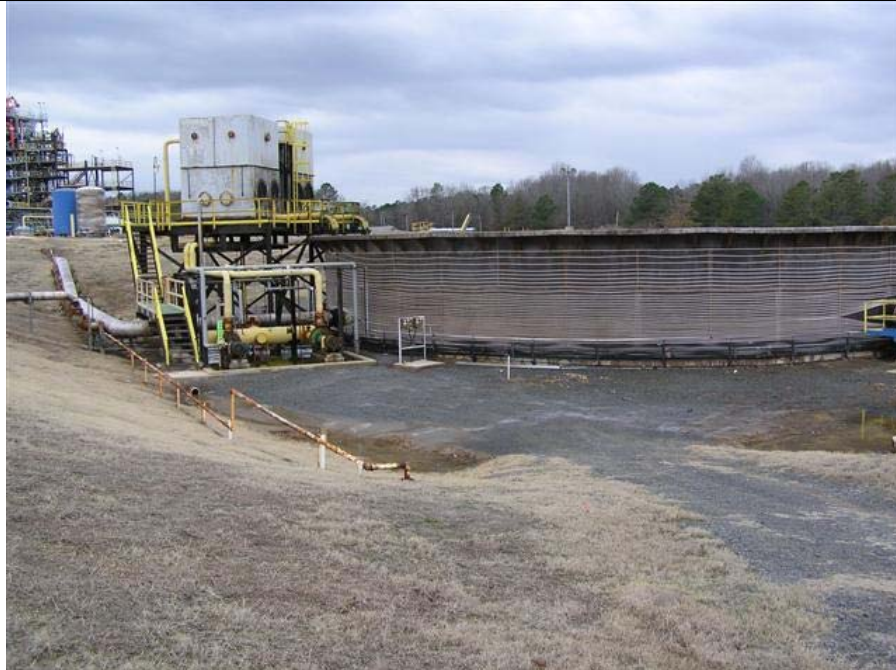
Photo #	1	Of	4	Date:	3 Feb 09	Time:	unknown		
----------------	---	-----------	---	--------------	----------	--------------	---------	--	--

Description:	Tail brine tank at South Plant								
---------------------	--------------------------------	--	--	--	--	--	--	--	--

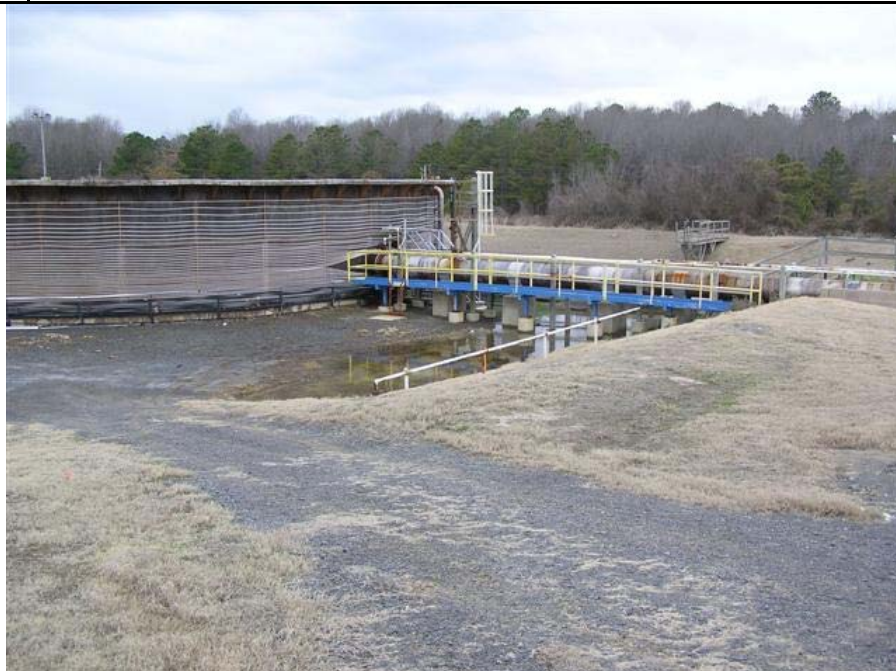
Photo #	2	Of		Date:	3 Feb 09	Time:	unknown		
----------------	---	-----------	--	--------------	----------	--------------	---------	--	--

Description:	Tail brine tank, showing discharge of tank to tail brine disposal system								
---------------------	--	--	--	--	--	--	--	--	--

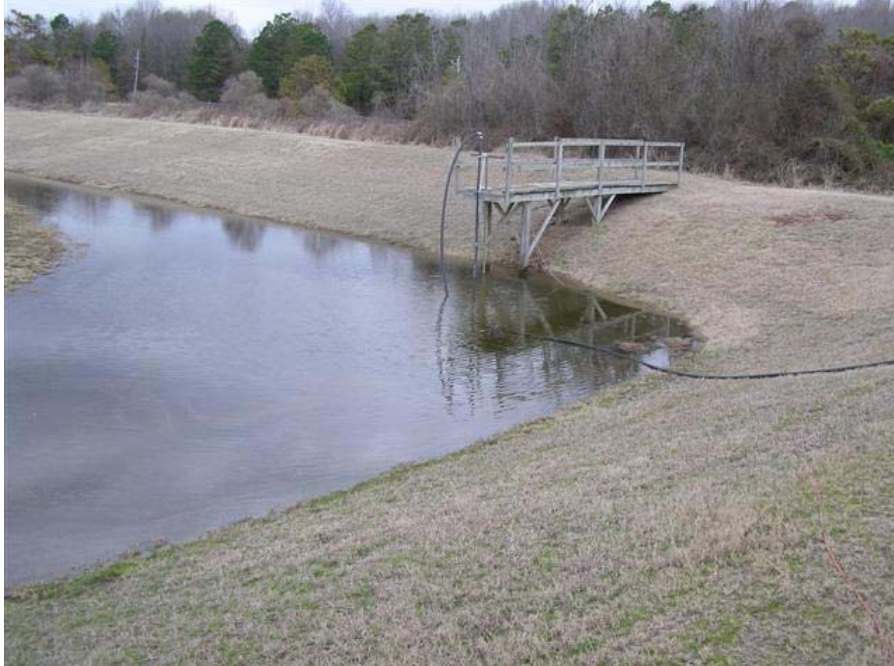
During a normal environmental round, GLCC Environmental personnel discovered that the water in the containment and in the ditch outside the containment. No rain had been recorded recently. The water was traced back to the tail brine tank and it was assumed it was leaking. The valve that drains the tail brine French drain was leaking as was the valve that drains the containment area. GLCC capped off both the pipes.

Location:	GLCC South Plant, Tail Brine tank							
Photographer:	Tom Hammons				Witness:	N/A		
Photo #	3	Of	4		Date:	03 Feb 2009	Time:	unknown
Description:	Containment area, showing water leaked from tank

The tank in question was temporarily taken out of service for a Br2 tower shutdown. After cooling, we noted that the secondary containment had began to fill with water (water seen inside of the dike of the attached pictures). This tank is designed to have a working capacity of approximately 800,000 gallons. When isolated, this tank contained approximately 360,000 gallons, minus the significant volume of solids that have accumulated in the tank over an extended period of time. We estimate the volume of solids contained in the tank to be approximately 160,000 gallons. While evaluating the tank prior to putting it back into service, we observed that the level in the tank had dropped a small amount. We estimate that this decrease may roughly equate to 10,000 to 14,000 gallons per day. The secondary containment does not appear to have this volume of water inside of it.

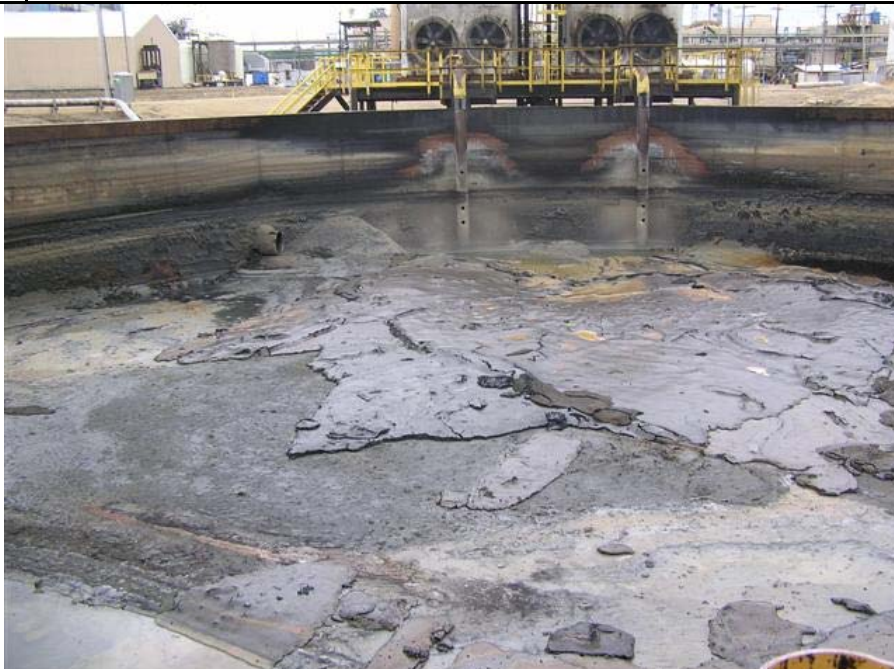
One the date of the inspection, I met with Mr. Tom Hammons, GLCC Environmental Engineer and we went to inspect the tank. The tank had been drained into the tail brine system except for a volume of sludge in the tank, approximately 160,000 gallons. The sludge was not totally dewatered so that the sludge would not harden and could be removed easier. Mr. Hammons told me that that they did not know where the volume of missing water was. It is possible that the missing volume is in the sand layer but Mr. Hammons could not rule out the possibility that some of the brine had made it through the clay liner so they wanted to be sure we were notified.

Photographer:	Tom Hammons				Witness:	N/A		
Photo #	4	Of	4		Date:	03 Feb 09	Time:	unknown
Description:	Inside of tail brine tank, showing it empty with sludge remaining

We are currently gathering the resources required to remove all of the accumulated solids from the bottom of the tank in order to allow us to perform a thorough inspection of the bottom of the tank and to determine if the tank requires any repairs. We will promptly carry out any repairs necessary to restore the integrity of the tank prior to putting back into service.
