RE: AFIN: 73-01031

Permit No.: 5024-W

On November 5, 2009, I performed a routine compliance inspection of the waste treatment and disposal facility in accordance with the provisions of the Arkansas Water and Air Pollution Control Act and the regulations promulgated thereunder. This inspection revealed the following violations:

Water Division No Discharge Industrial Photographic Evidence Sheet									
--	--	--	--	--	--	--	--	--	--

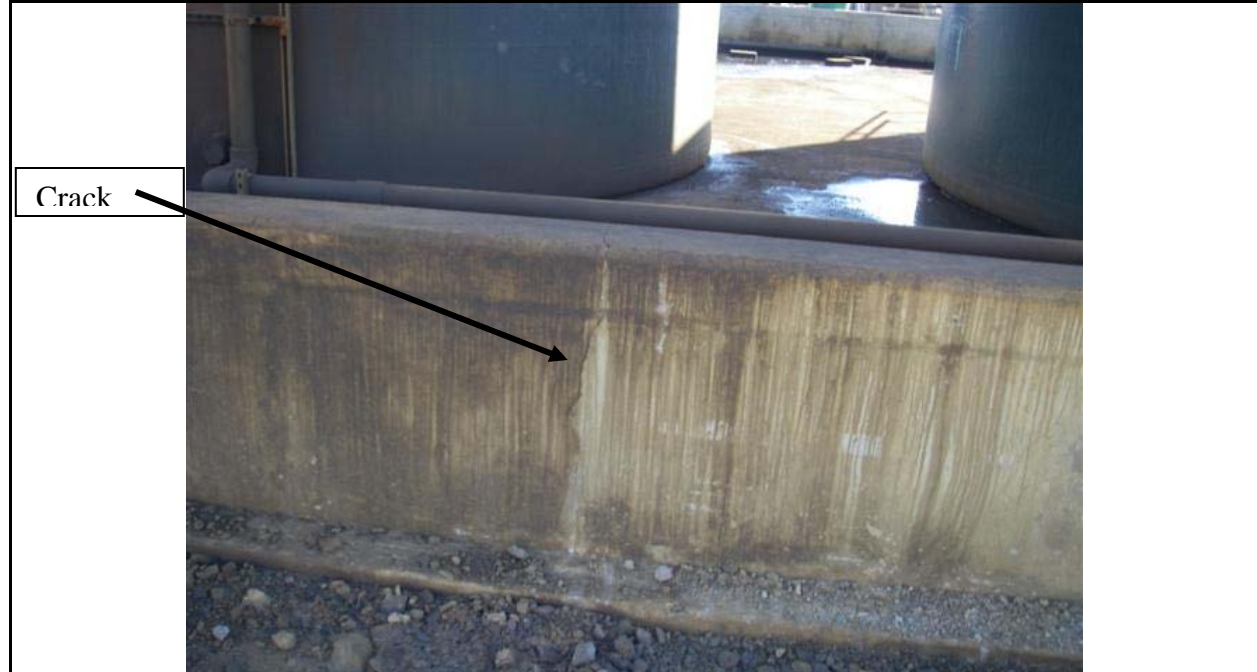
Photo #	1	Of	7	Date:	11/5/09	Time:	2:48 pm		
----------------	---	-----------	---	--------------	---------	--------------	---------	--	--

1. Several cracks were observed in the secondary containment wall; one of which was leaking fluids resulting in an unpermitted discharge. Lack of an impermeable dike is a violation of Part I. 8. and the discharge of fluids as a result of the crack in the dike is a violation of Part I. 2.
2. Erosion of the hillside behind the facility has resulted in accumulation of sediment, which in rain events could be washed into the waters of the state. Stabilizing the hillsides will prevent further erosion from taking place. This is a violation of A.C.A. § 8-4-217(a)(2).
3. Septic sewage was pooled on the ground above the septic holding tank. This sewage had been diverted to a ditch and could potentially reach the waters of the State. This is a violation of A.C.A. § 8-4-217(a)(2).

Description:	One of multiple cracks in Secondary Containment wall								
---------------------	--	--	--	--	--	--	--	--	--

1. We have sealed the cracks in the containment wall and will re-seal them in the next few days as we have dry weather.
2. We will stabilize the hillsides with planted ground cover and netting. We are more than willing to do whatever ADEQ suggest to help remedy this problem.
3. We are working with the local waste water officials, whom we have asked to come out to our site to give us options for the placement of subsurface septic system.

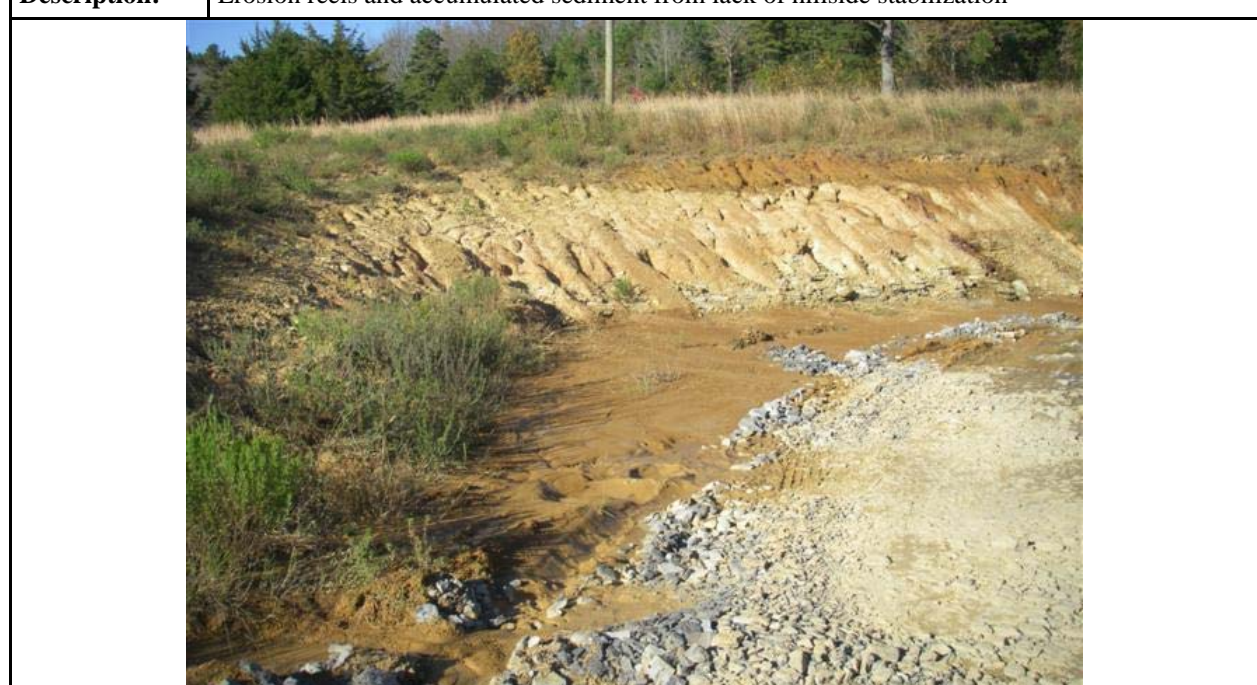
Photo #	2	Of	7	Date:	11/5/09	Time:	2:53 pm		
----------------	---	-----------	---	--------------	---------	--------------	---------	--	--

Description:	Erosion reels and accumulated sediment from lack of hillside stabilization								
---------------------	--	--	--	--	--	--	--	--	--

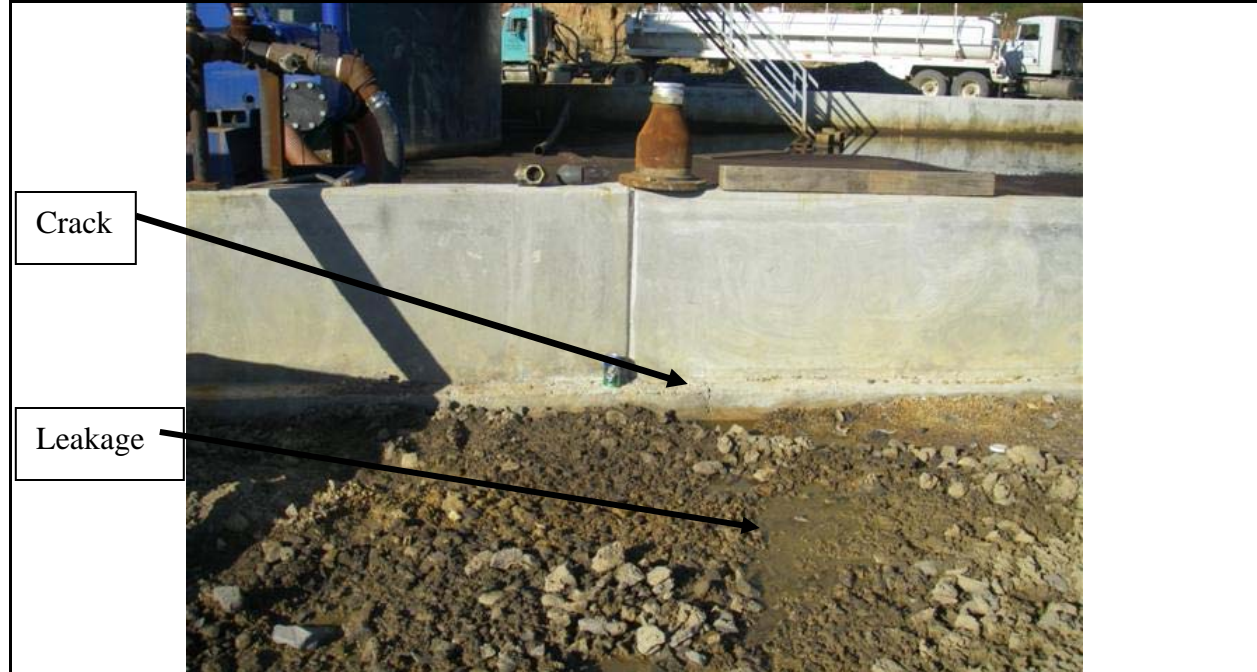
Photo #	3	Of	7	Date:	11/5/09	Time:	3:00 pm		
----------------	---	-----------	---	--------------	---------	--------------	---------	--	--

4C. Is the treatment system being properly operated and maintained as required by permit?
☐ Yes ☒ No ☐ N/A
Cracks were located in the secondary containment wall and were
 If no, explain **leaking.** _____

Description:	Crack in Secondary containment wall and leak								
---------------------	--	--	--	--	--	--	--	--	--

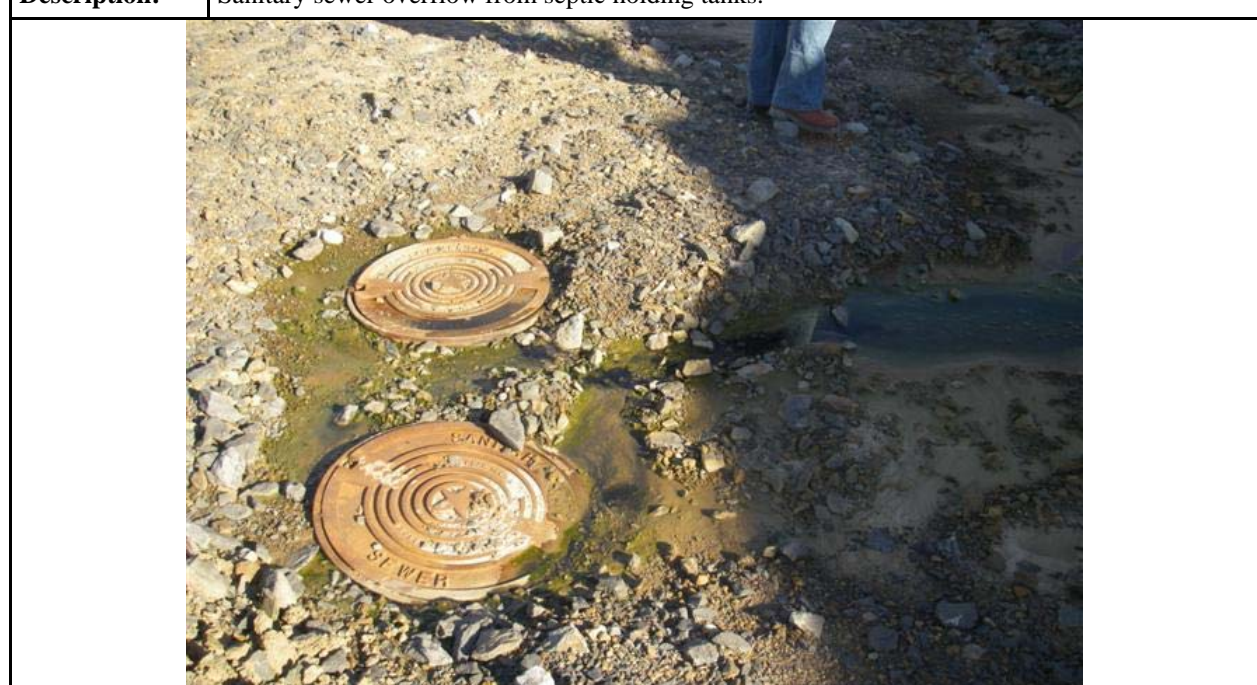
Photo #	4	Of	7	Date:	11/5/09	Time:	3:02 pm		
----------------	---	-----------	---	--------------	---------	--------------	---------	--	--

Description:	Sanitary sewer overflow from septic holding tanks.								
---------------------	--	--	--	--	--	--	--	--	--

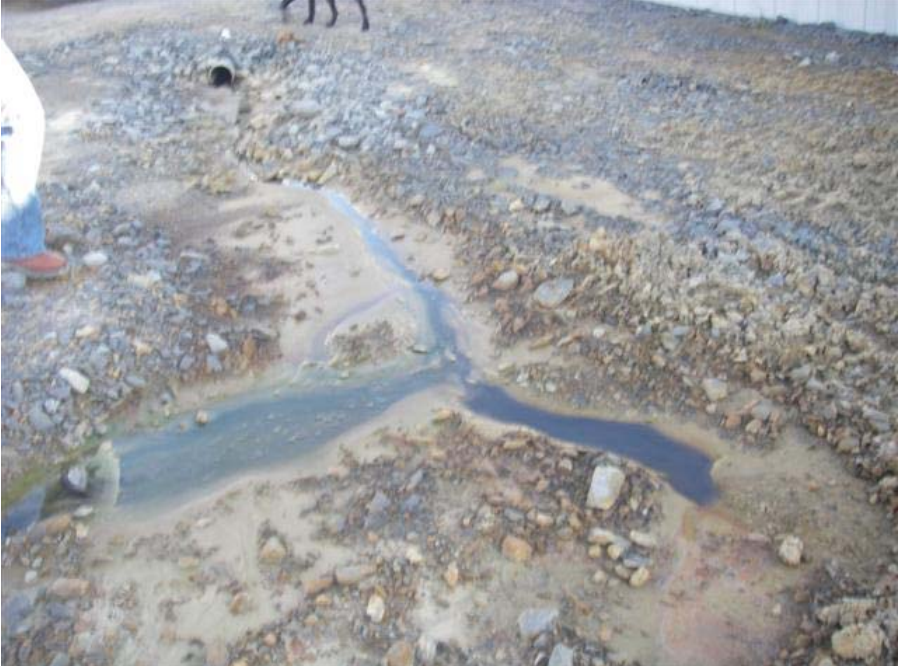
Water Division No Discharge Industrial Photographic Evidence Sheet									
Location:		Poseidon Energy Services							
Photographer:		Lindsay Stoker				Witness:		Dawn Keller	
Photo #	5	Of	7		Date:	11/5/09	Time:	3:02 pm	
Description:		Septic Sewage diversion.

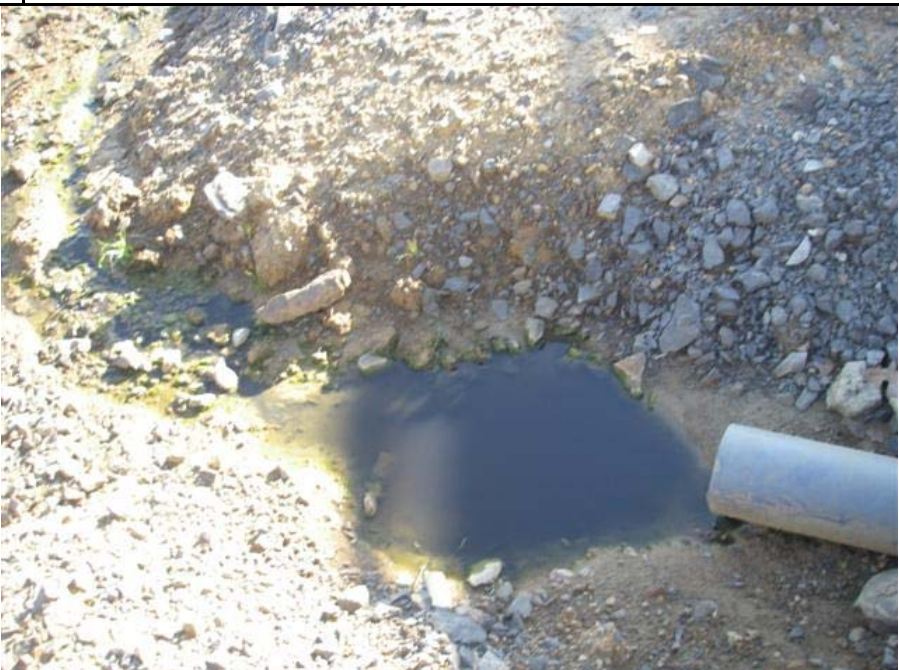
Water Division No Discharge Industrial Photographic Evidence Sheet									
Location:		Poseidon Energy Services							
Photographer:		Lindsay Stoker				Witness:		Dawn Keller	
Photo #	6	Of	7		Date:	11/5/09	Time:	3:03 pm	
Description:		Septic sewage being released into a ditch.

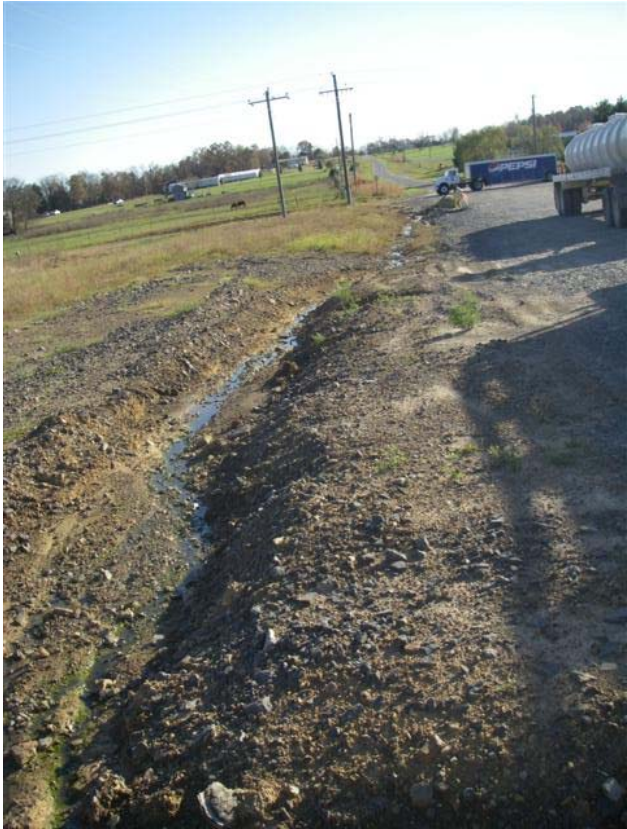
Water Division No Discharge Industrial Photographic Evidence Sheet								
Location:		Poseidon Energy Services						
Photographer:		Lindsay Stoker			Witness:		Dawn Keller	
Photo #	7	Of	7	Date:		11/5/09	Time:	3:03 pm
Description:		Septic Sewage runs length of ditch potentially headed for the Waters of the State.
