Appendix B

Sediment and Soil Photo Logs

MAYFLOWER PIPELINE INCIDENT RESPONSE

EXXONMOBIL ENVIRONMENTAL SERVICES COMPANY DOWNSTREAM AREAS DATA ASSESSMENT REPORT

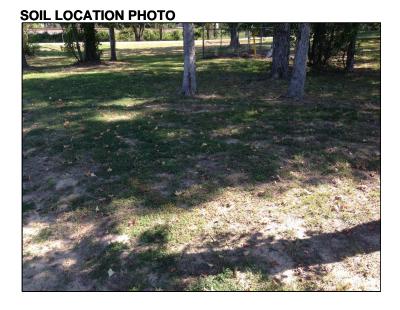
SOIL SAMPLE FIELD PHOTOS: SO-DA-001

0 – 0.5 ft CLAYEY SILT (ML), some clay, no plasticity, soft, dry, red, no odor

0.5 – 1.0 ft CLAYEY SILT (ML), some clay, no plasticity, soft, dry, red, no odor

1.0 – 1.5 ft CLAYEY SILT (ML), some clay, no plasticity, soft, dry, red, no odor

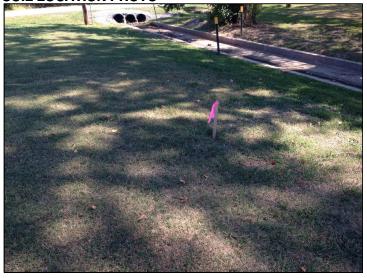
SOIL SAMPLE FIELD PHOTOS: SO-DA-002

0 – 0.5 ft CLAY (CL), some silt, soft, medium plasticity, moist, trace organics, no odor

0.5 – 1.0 ft CLAY (CL), some silt, soft, medium plasticity, moist, trace organics, no odor

1.0 – 1.5 ft CLAY (CL), soft, medium plasticity, wet, brown, no odor

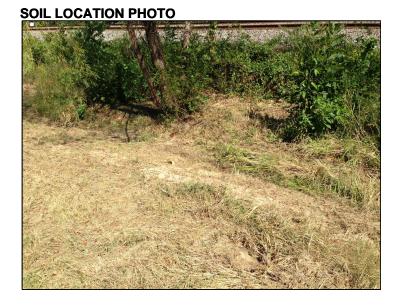
SOIL SAMPLE FIELD PHOTOS: SO-DA-003

0 – 0.5 ft CLAY (CL), trace silt, soft, trace gravel, medium to high plasticity, moist, trace organics, no odor, brown

0.5 – 1.0 ft CLAY (CL), trace silt, soft, trace gravel, medium to high plasticity, moist, trace organics, no odor, brown

1.0 – 1.5 ft CLAY (CL), stiff, low plasticity, dry–moist, no odor, red

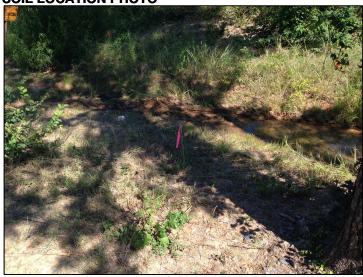
SOIL SAMPLE FIELD PHOTOS: SO-DA-005

0 – 0.5 ft CLAY (CL), stiff, low to medium plasticity, moist, red, no odor

0.5 – 1.0 ft CLAY (CL), stiff, low to medium plasticity, moist, red, no odor

1.0 – 1.5 ft CLAY (CL), stiff, low to medium plasticity, moist, red, no odor

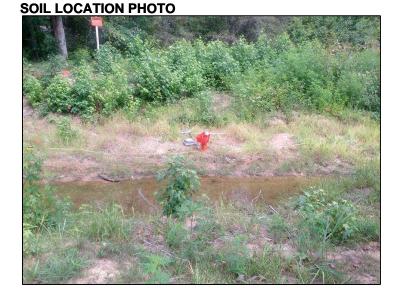
SOIL SAMPLE FIELD PHOTOS: SO-DA-007

0 – 0.5 ft CLAY (CL), some silt, medium plasticity, dry, very soft, gray/light brown, no odor

0.5 – 1.0 ft CLAY (CL), some silt, medium plasticity, dry, very soft, gray/light brown, no odor

1.0 – 1.5 ft CLAY (CL), some silt, medium plasticity, dry, very soft, gray/light brown/reddish, no odor

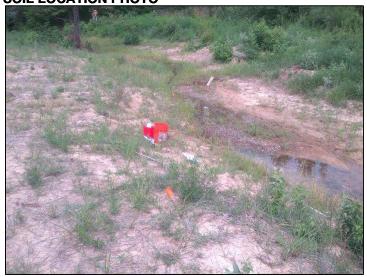
SOIL SAMPLE FIELD PHOTOS: SO-DA-008

0 – 0.5 ft SILT (ML), some clay, low plasticity when wet, dry, beige, no odor, trace organics

0.5 – 1.0 ft CLAY (CL), some silt, low to medium plasticity, dry, gray/brownish, no odor

1.0 – 1.5 ft CLAY (CL), some silt, low to medium plasticity, dry, gray/brownish, no odor

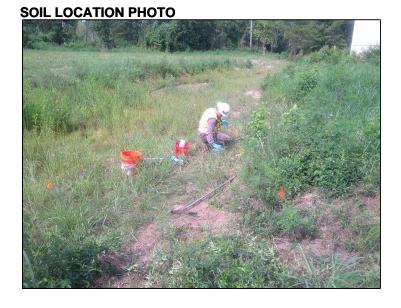
SOIL SAMPLE FIELD PHOTOS: SO-DA-009

0 – **0.5** ft CLAY (CL), some silt, high plasticity, slightly damp, brown, no odor, some organics

0.5 – 1.0 ft CLAY (CL), some silt, medium plasticity, dry, brown/reddish, no odor, trace organics

1.0 – 1.5 ft CLAY (CL), some silt, medium plasticity, soft, gray/reddish brown, no odor

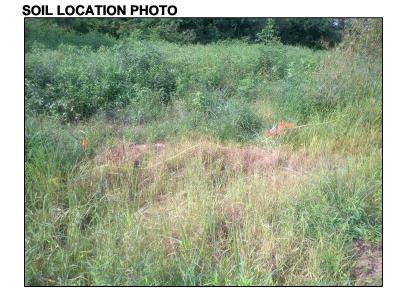
0 – 0.5 ft CLAYEY SILT (ML), no plasticity, dry, soft, light– red brown, no odor, some organics

0.5 – 1.0 ft SILT (ML), some clay, no plasticity, dry, light brown/beige, no odor, no organics

1.0 – 1.5 ft SILT (ML), little clay, no plasticity, dry, soft, beige, no odor, no organics

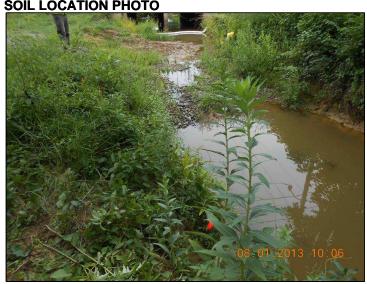
SOIL SAMPLE FIELD PHOTOS: SO-DA-012

0.5 – 1.0 ft SANDY CLAY (CL), reddish brown, no odor, trace SANDY CLAY (CL), reddish brown, low plasticity, no odor, trace organics

1.0 – 1.5 ft SANDY CLAY (CL), reddish brown, low plasticity, no odor. Bottom half: clay, gray, high plasticity, very soft, dry-slightly moist

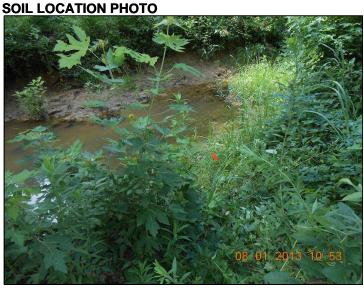
0 – 0.5 ft SILTY CLAY (CL), trace fine grain sand, reddish brown, gray, no plasticity, no odor, no sheen, trace organics

0.5 – 1.0 ft SILTY CLAY (CL), some sand, fine grain, reddish gray, low plasticity, soft, no sheen, no odor, organics

1.0 – 1.5 ft SILTY CLAY (CL), trace fine sands, reddish gray, low to medium plasticity, soft, no odor, no sheen, trace organics

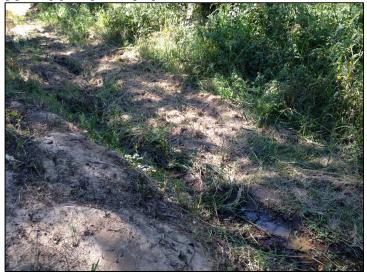
0 – 0.5 ft SILTY CLAY (CL), light brown, medium plasticity, very soft, no odor, organics

0.5 – 1.0 ft SILTY CLAY (CL), light brown, soft, medium to high plasticity, slightly moist, no odor

1.0 – 1.5 ft SILTY CLAY (CL), trace sand, light reddish brown, soft, medium to high plasticity, slightly moist, no odor

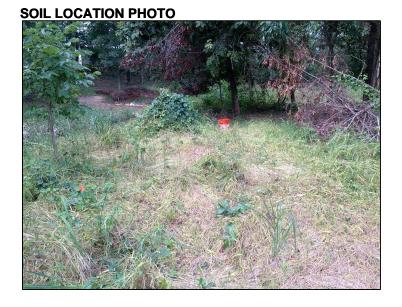
0 – 0.5 ft SILTY CLAY (CL), moist, low plasticity, medium stiff, some organics, no odor, reddish brown

0.5 – 1.0 ft SILTY CLAY (CL), moist, low plasticity, medium stiff, some organics, no odor, reddish brown

$$1.0-1.5\ ft$$ CLAY (CL), soft, medium plasticity, trace organics, no odor

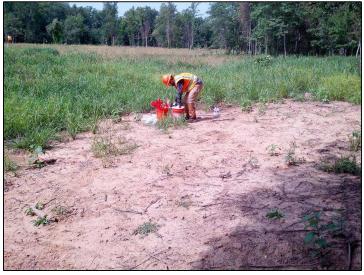
0 – 0.5 ft CLAY (CL), medium stiff, no plasticity, dry, red/rusty, no odor

0.5 – 1.0 ft CLAY (CL), medium stiff, no plasticity, dry, red/rusty, no odor

1.0 – 1.5 ft CLAY (CL), medium stiff, no plasticity, dry, red/rusty, no odor

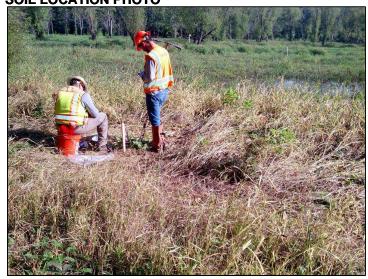
0 – 0.5 ft SILTY CLAY (CL), soft, moist, medium plasticity, gray/brown, no odor

0.5 – 1.0 ft CLAY (CL), trace silt, dry, moist, medium plasticity, reddish brown, no odor

1.0 – 1.5 ft CLAY (CL), trace silt, dry, moist, medium plasticity, reddish brown, no odor

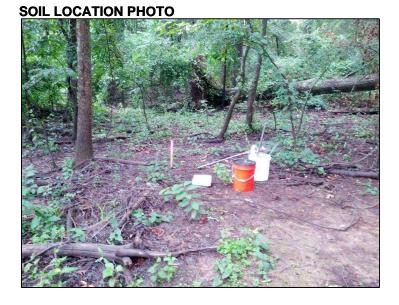
0 – 0.5 ft SILTY CLAY (CL), moist, soft, red, no odor, some organics

0.5 – 1.0 ft SILTY CLAY (CL), moist, soft, red, no odor, some organics

1.0 – 1.5 ft SILTY CLAY (CL), moist, soft, red, no odor, some organics

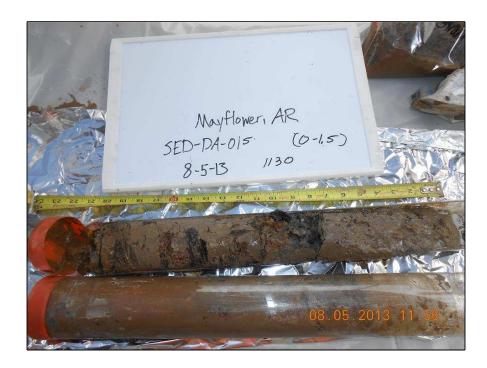
0 – 0.5	SANDY CLAY (CL), soft, wet, no plasticity, HCO
0.5 – 1.0	SANDY CLAY (CL), soft, wet, low plasticity, reddish brown, slight HCO
1.0 – 1.5	SANDY CLAY (CL), soft, wet, low plasticity, reddish brown, slight HCO

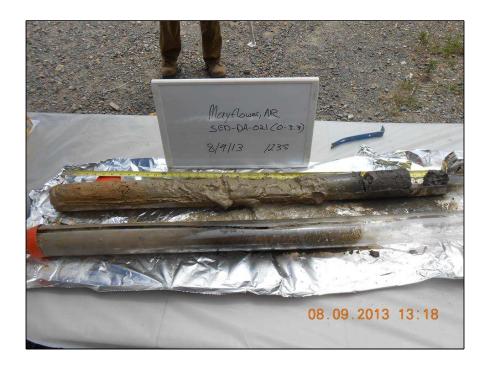
0 – 0.5	MUD/SILT (ML), some clay, soft, some organics, moist-wet, brown/black, some odor
0.5 – 1.0	CLAY (CL), trace silt, soft, wet, low-medium plasticity, gray, no odor
1.0 – 1.5	CLAY (CL), trace silt, soft, wet, low-medium plasticity, gray, no odor
1.5 – 2.0	CLAY (CL), trace silt, soft, wet, low-medium plasticity, gray, no odor
2.0 - 3.0	CLAY (CL), medium stiff, high plasticity, moist, gray/red, no odor
3.0 – 3.3	CLAY (CL), stiff, low plasticity, moist-dry, brown/grayish red, no odor
