Appendix C

Lake Conway Depositional Layer
Assessment Photographs

EXXONMOBIL ENVIRONMENTAL SERVICES COMPANY
MAYFLOWER PIPELINE INCIDENT RESPONSE, MAYFLOWER, ARKANSAS
DOWNSTREAM AREAS DATA ASSESSMENT REPORT

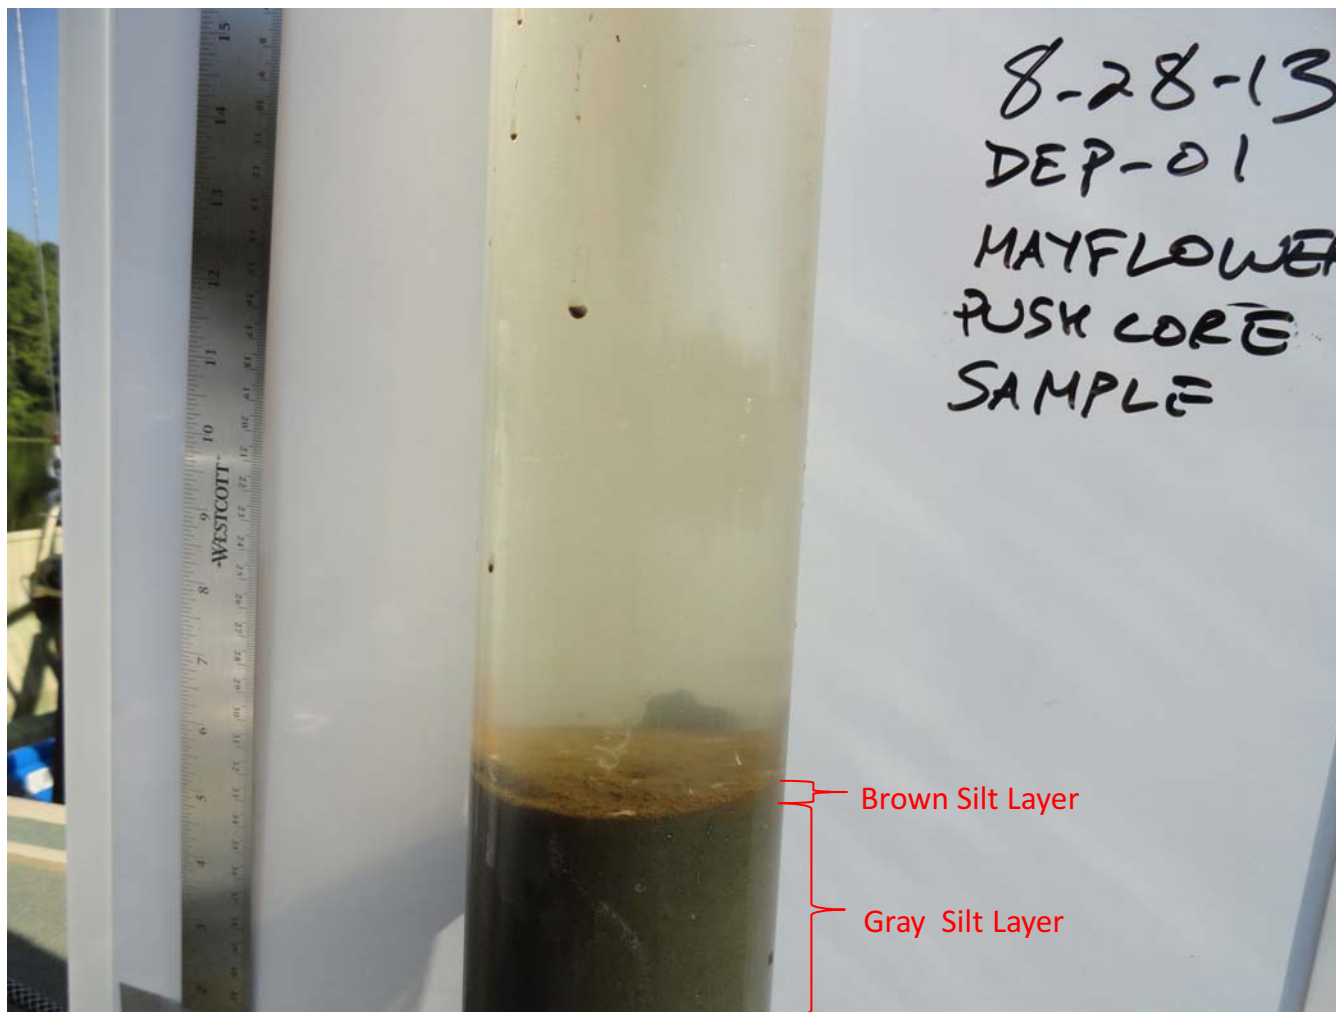
FIGURE
C-1

**DEPOSITIONAL LAYER ASSESSMENT
CORE: DEP-01**

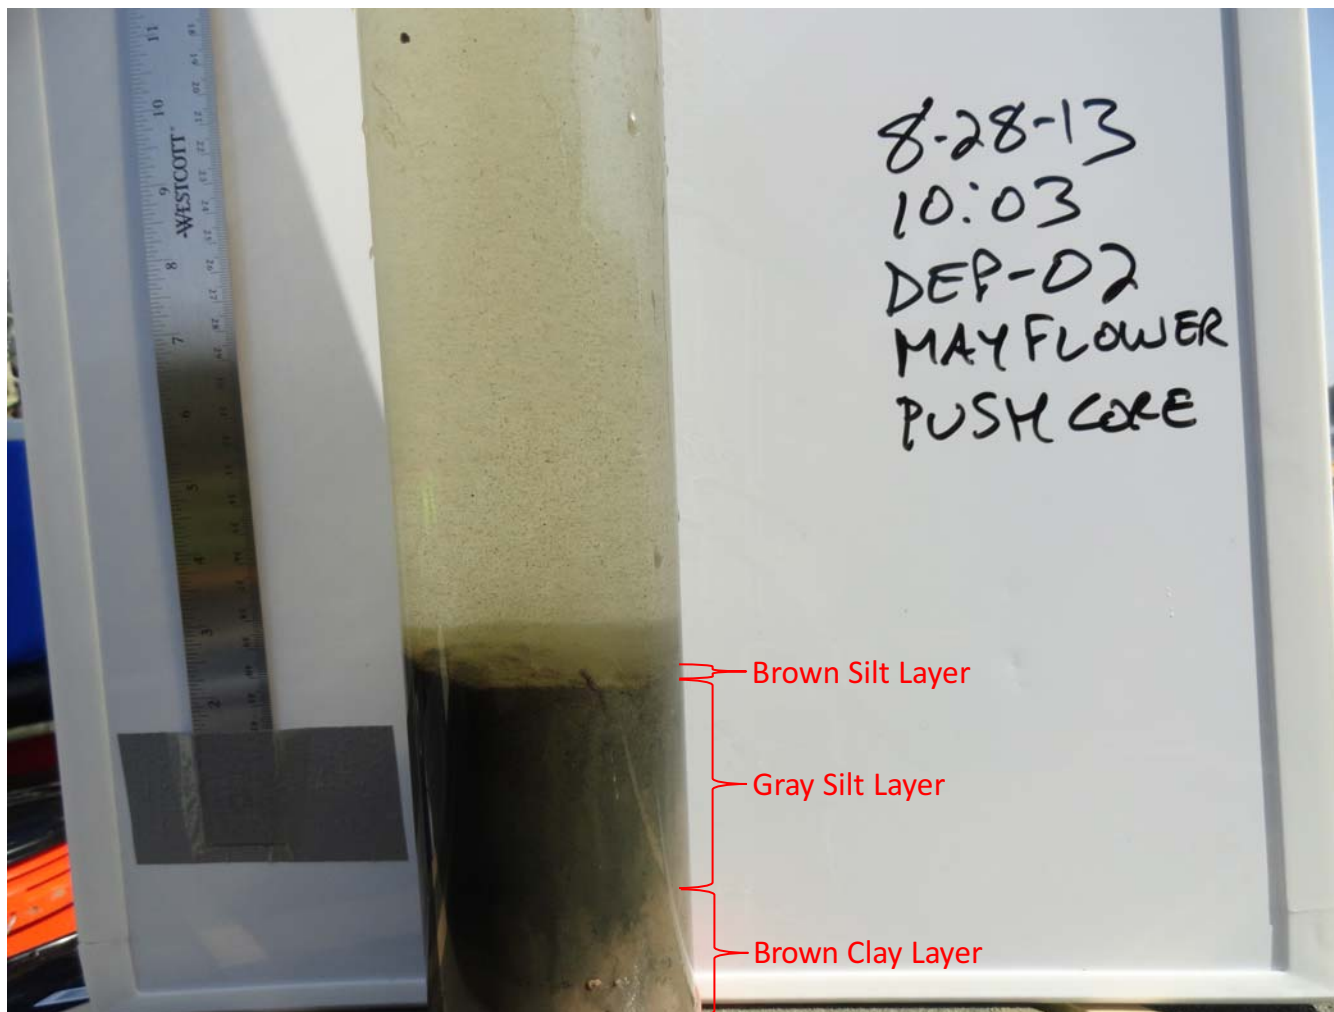
FIGURE
C-2

**DEPOSITIONAL LAYER ASSESSMENT
CORE: DEP-02**

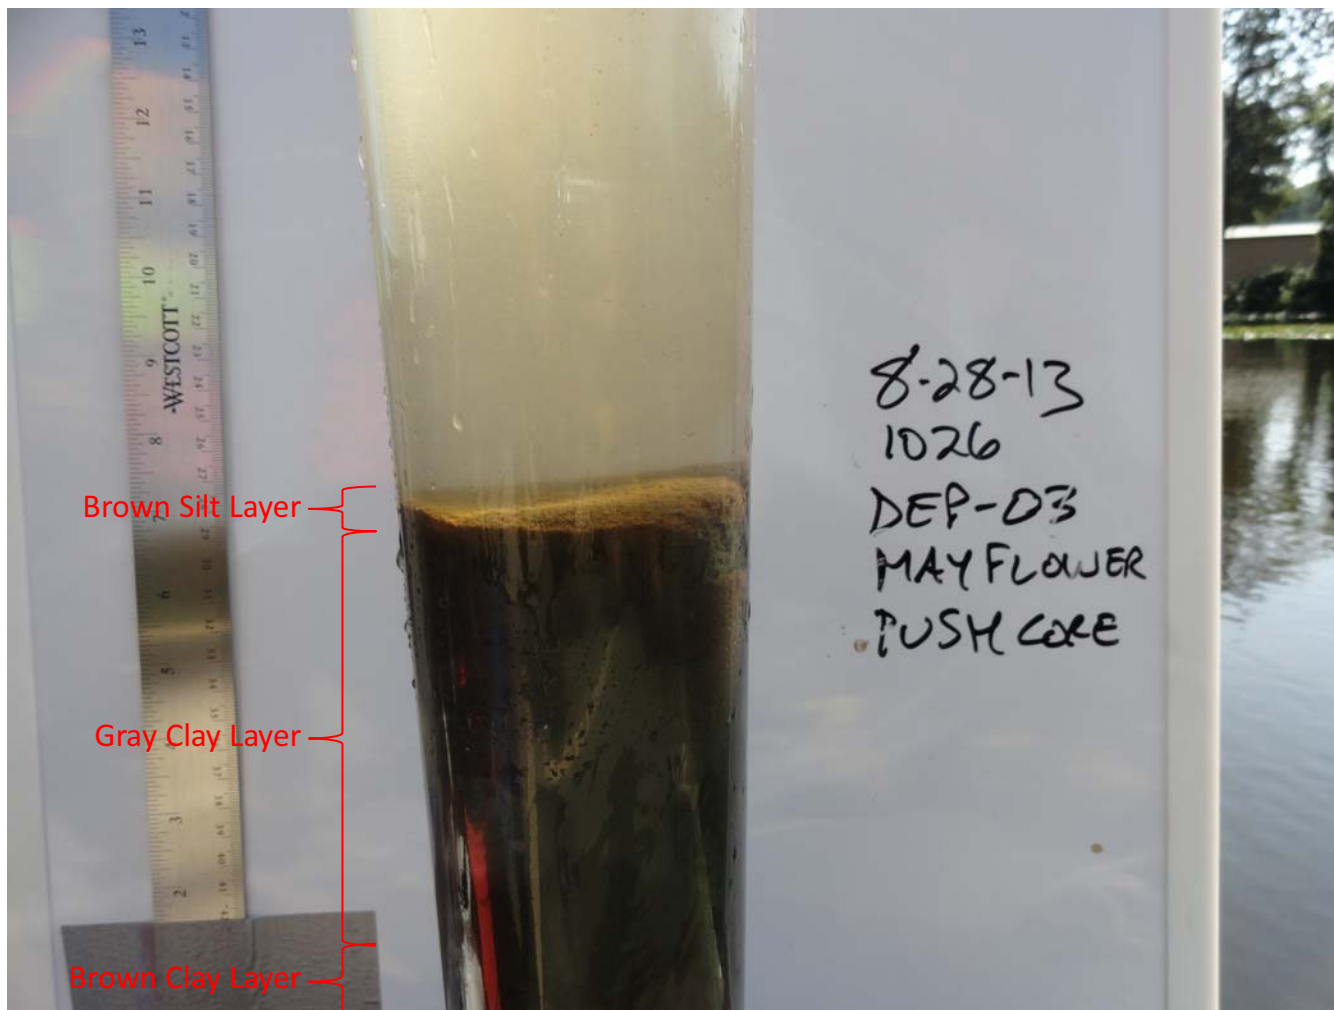
FIGURE
C-3

**DEPOSITIONAL LAYER ASSESSMENT
CORE: DEP-03**

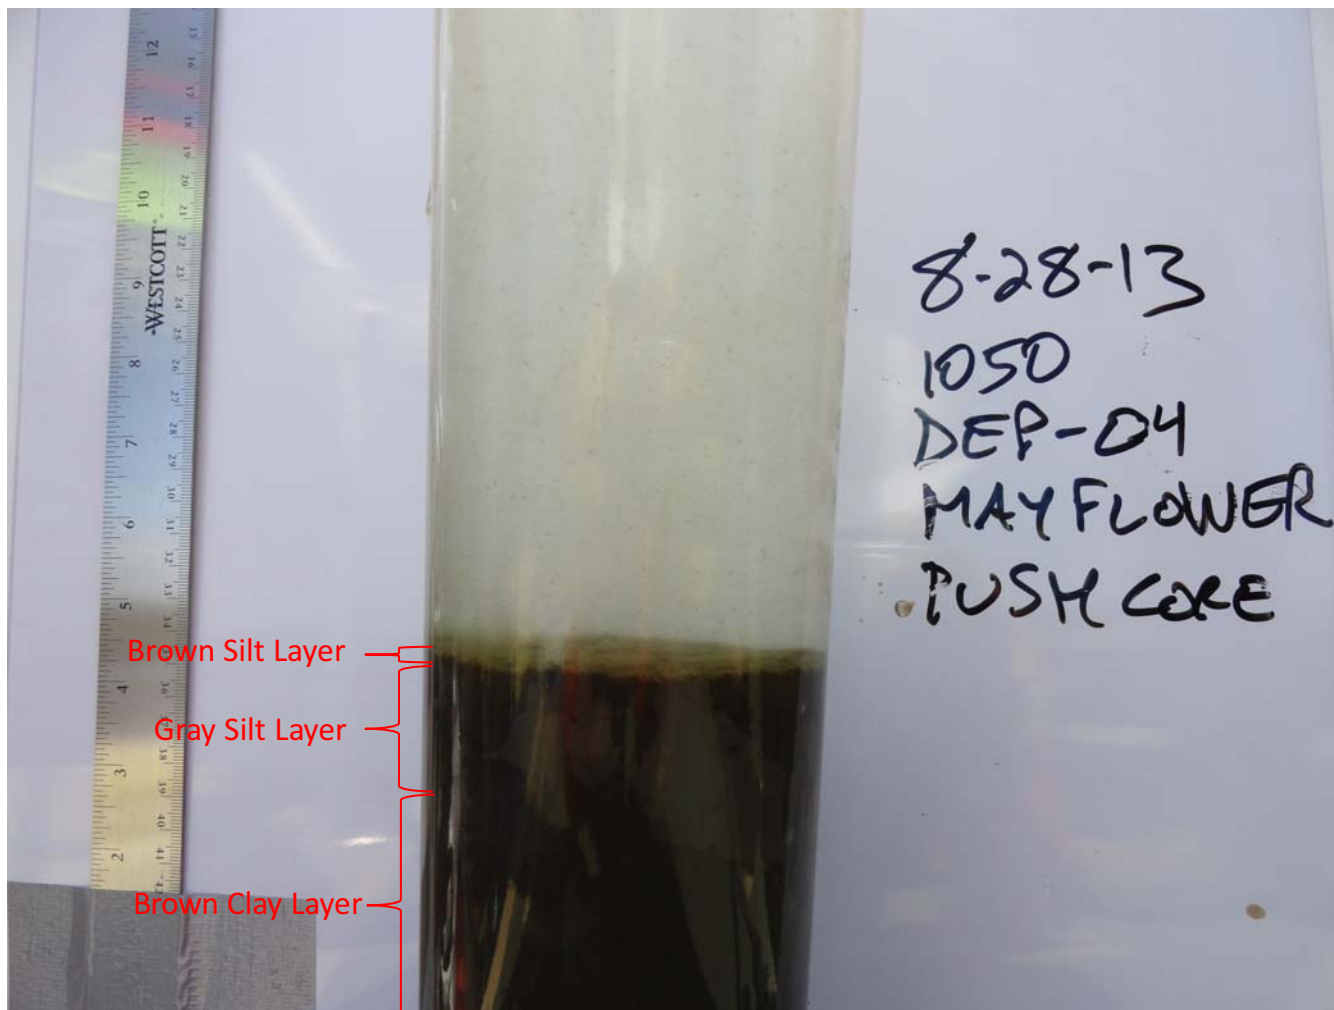
FIGURE
C-4

**DEPOSITIONAL LAYER ASSESSMENT
CORE: DEP-04**

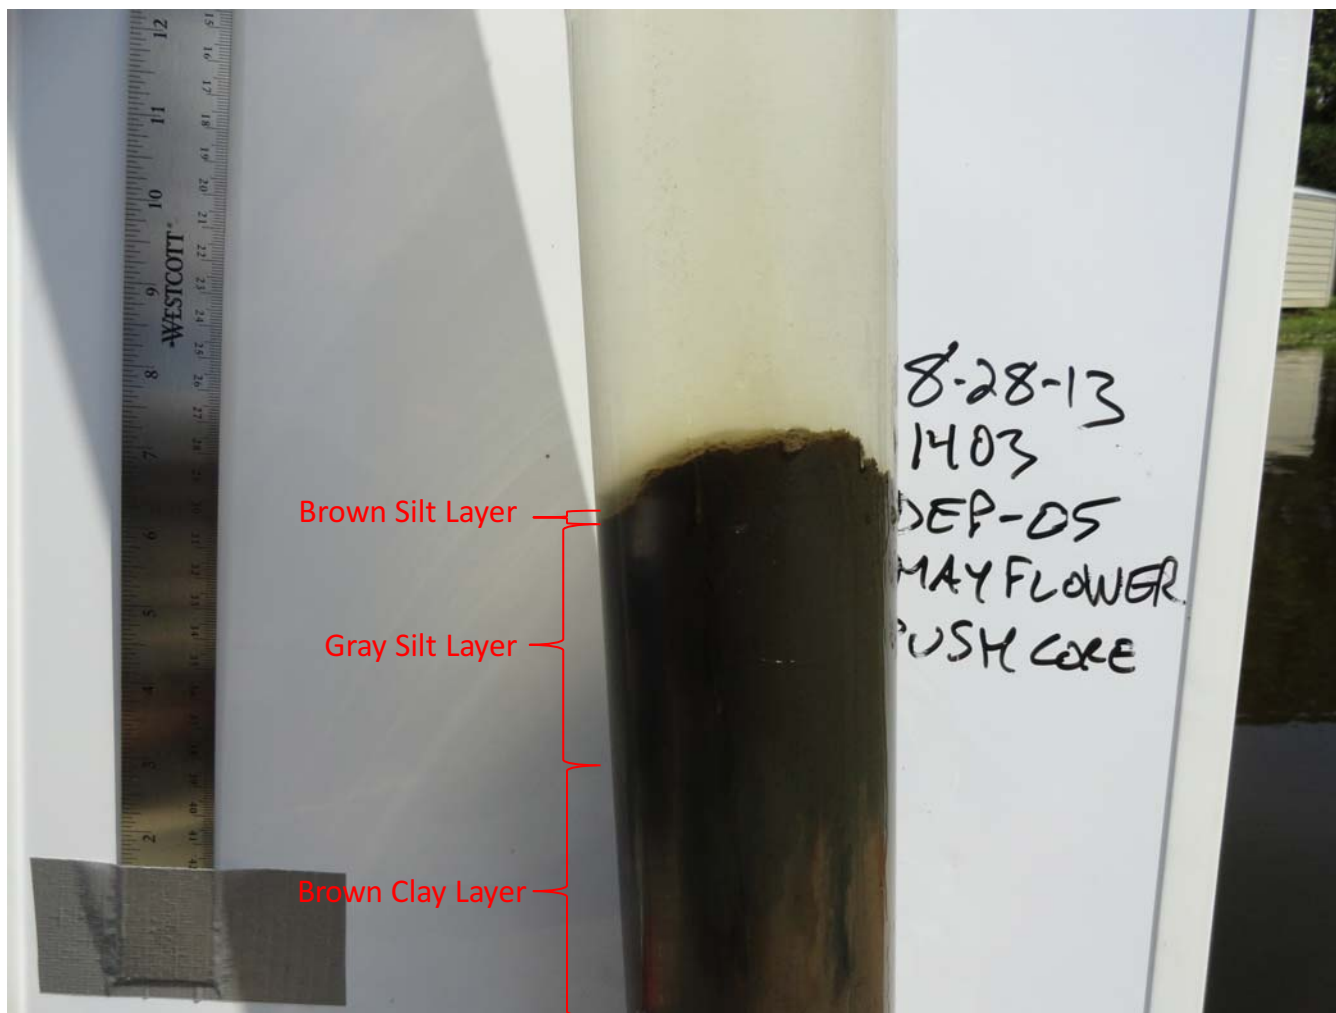
FIGURE
C-5

**DEPOSITIONAL LAYER ASSESSMENT
CORE: DEP-05**

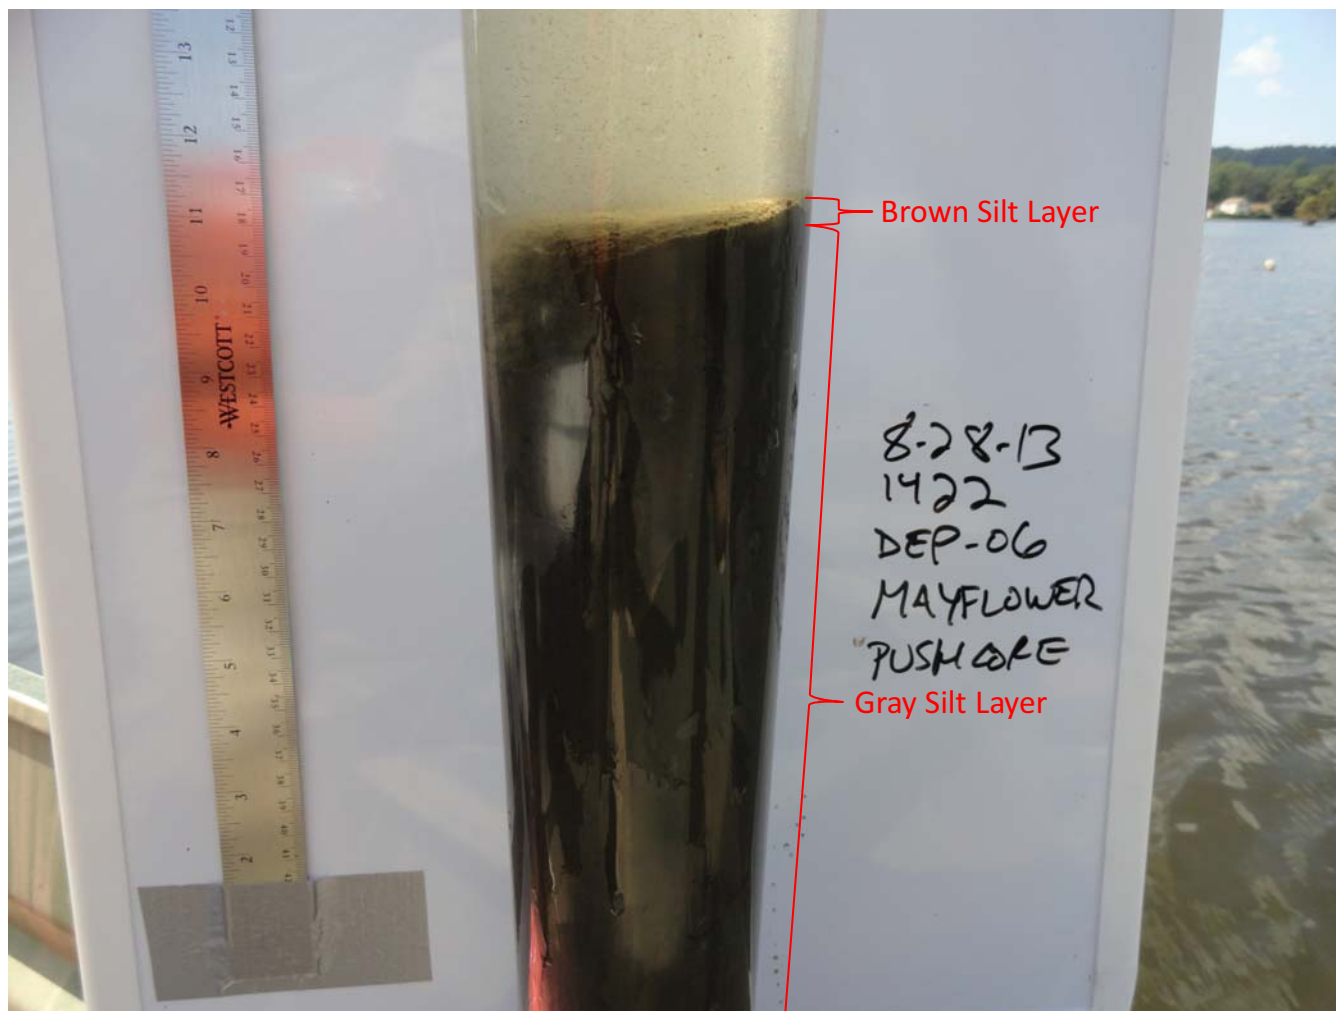
FIGURE
C-6

**DEPOSITIONAL LAYER ASSESSMENT
CORE: DEP-06**

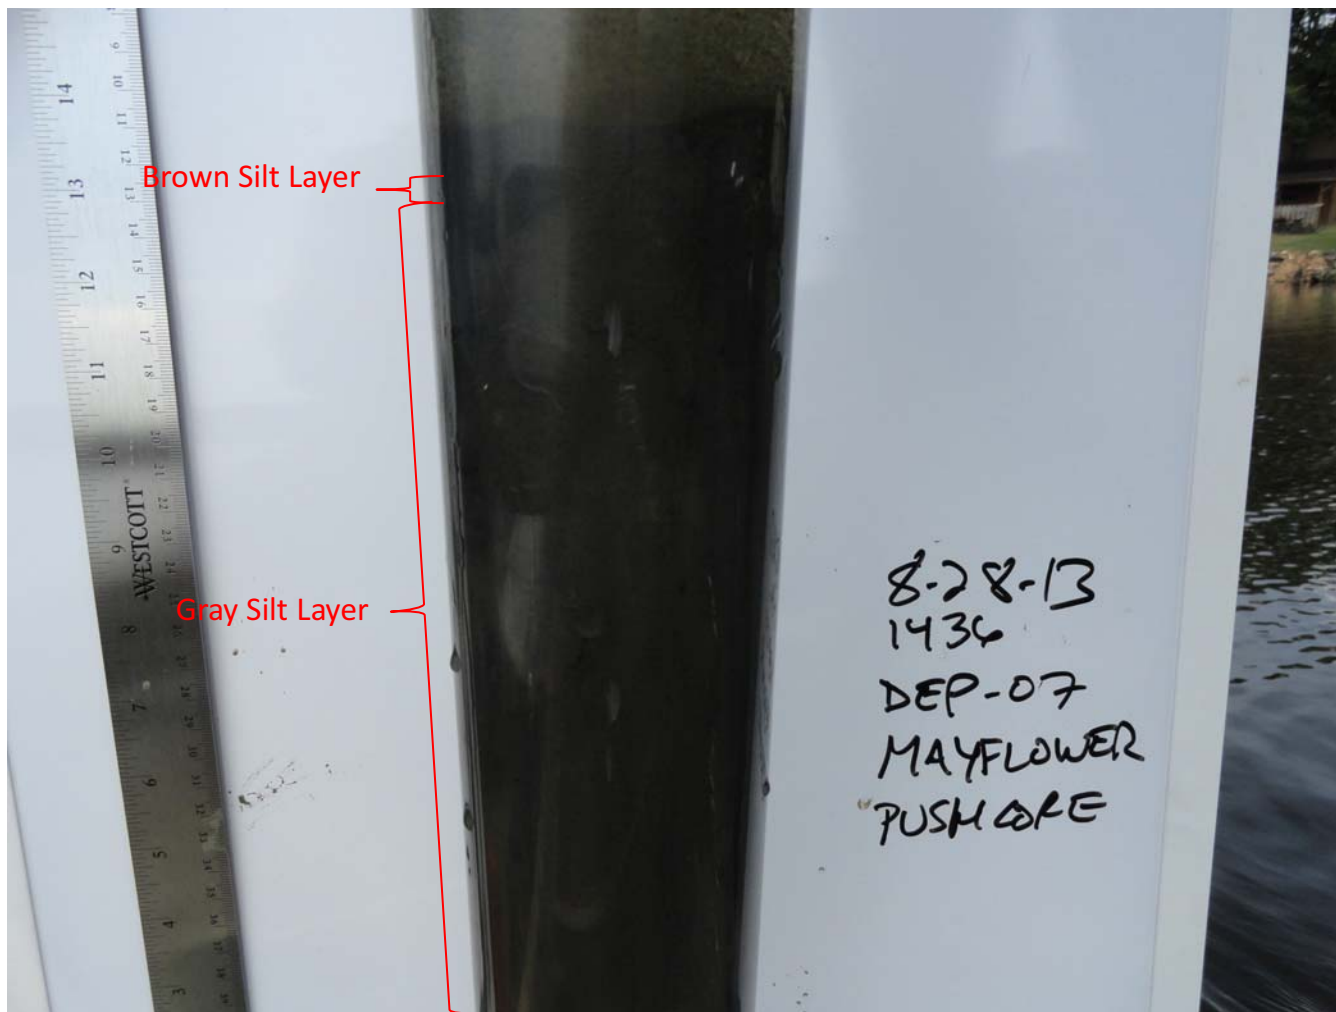
FIGURE
C-7

**DEPOSITIONAL LAYER ASSESSMENT
CORE: DEP-07**

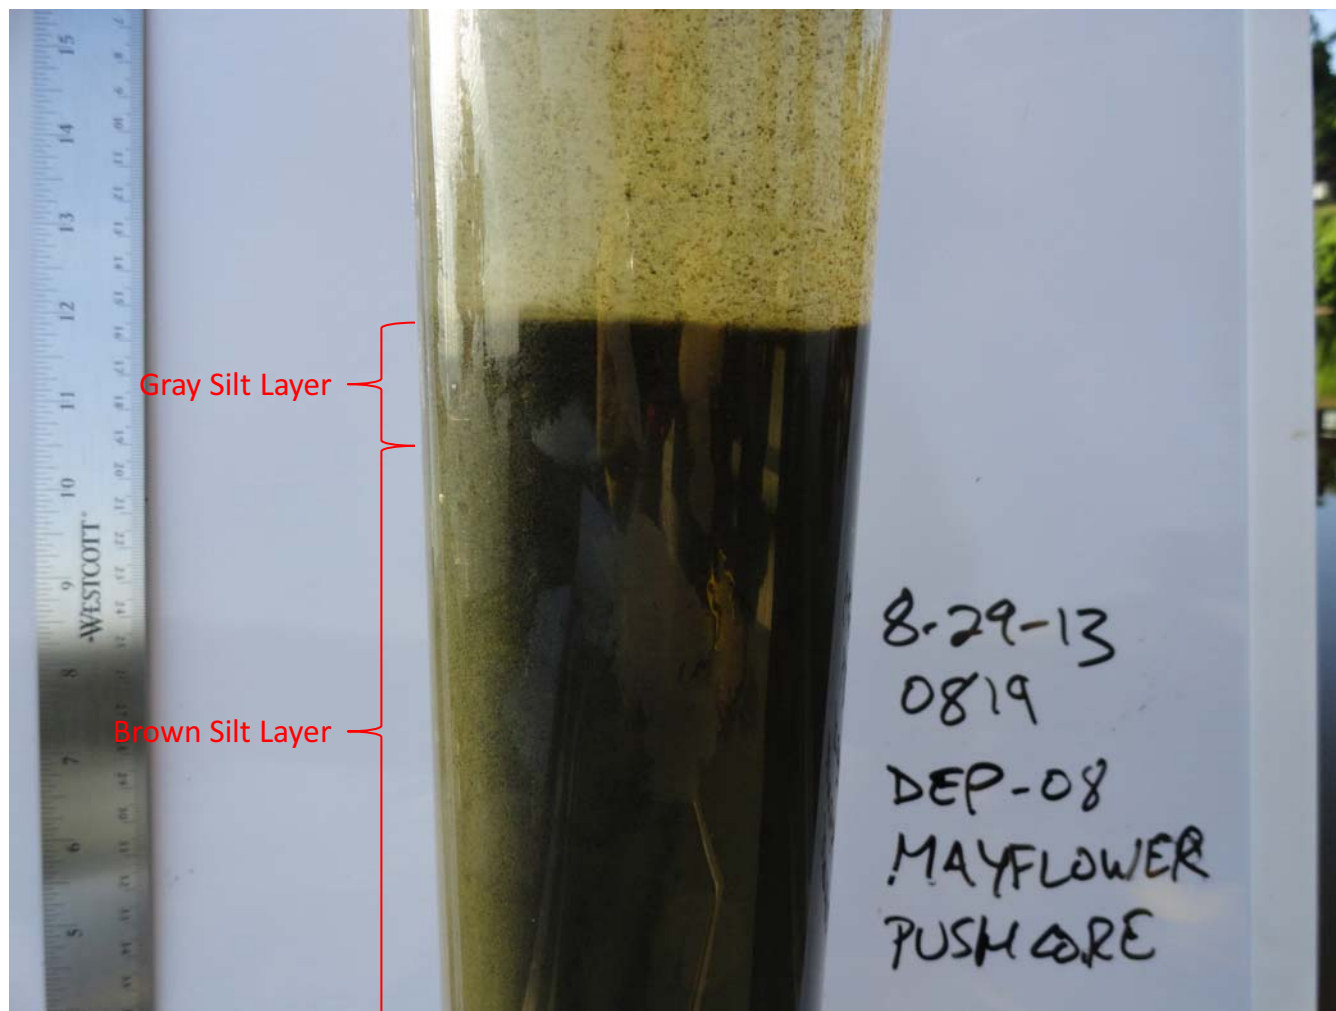
FIGURE
C-8

**DEPOSITIONAL LAYER ASSESSMENT
CORE: DEP-08**

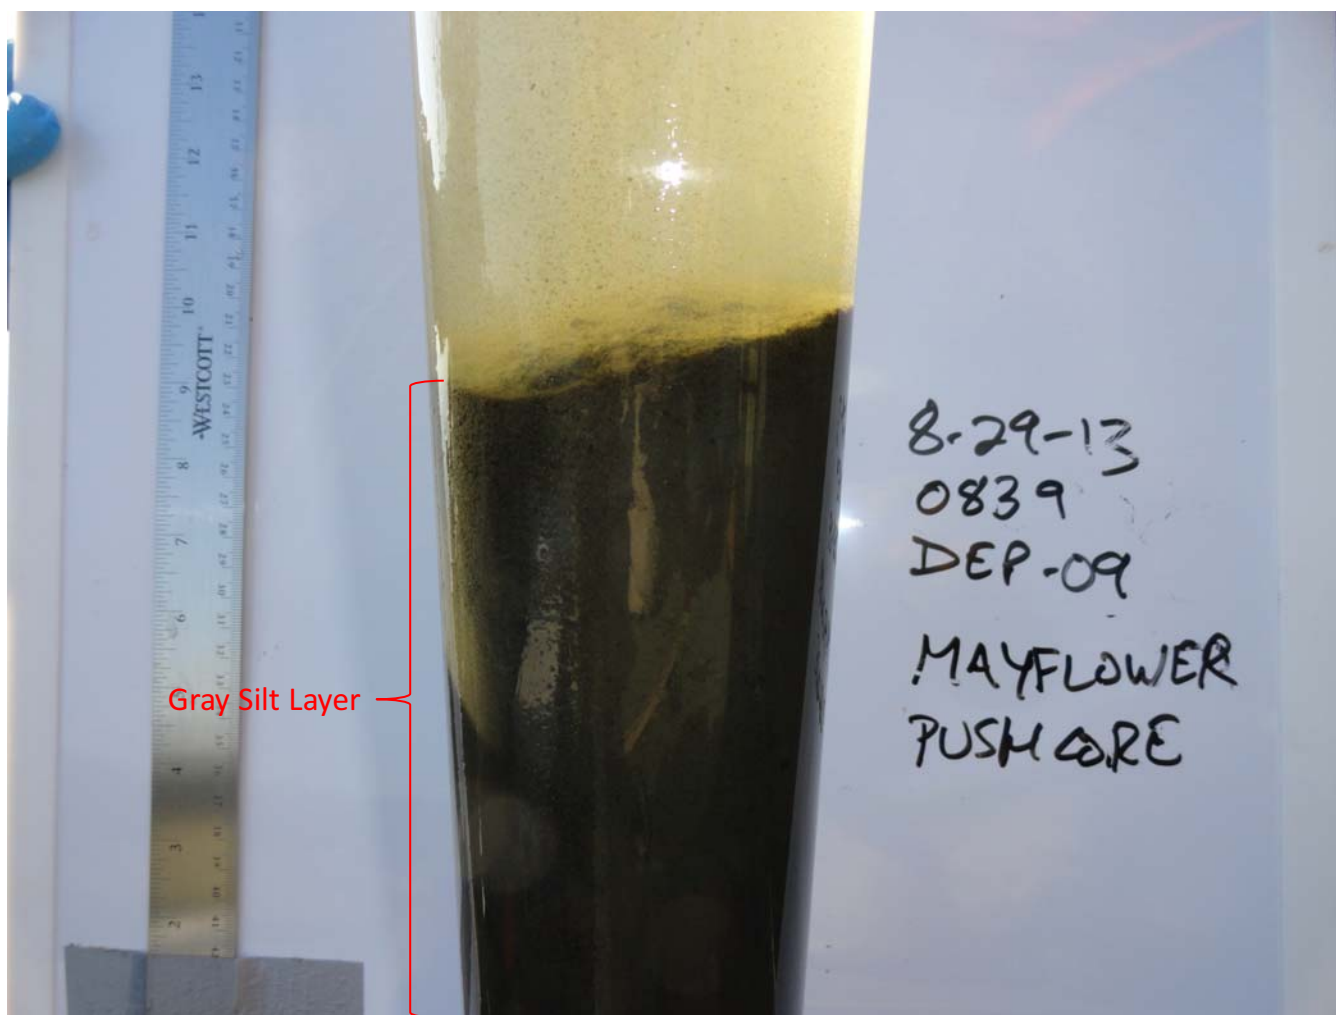
FIGURE
C-9

**DEPOSITIONAL LAYER ASSESSMENT
CORE: DEP-09**

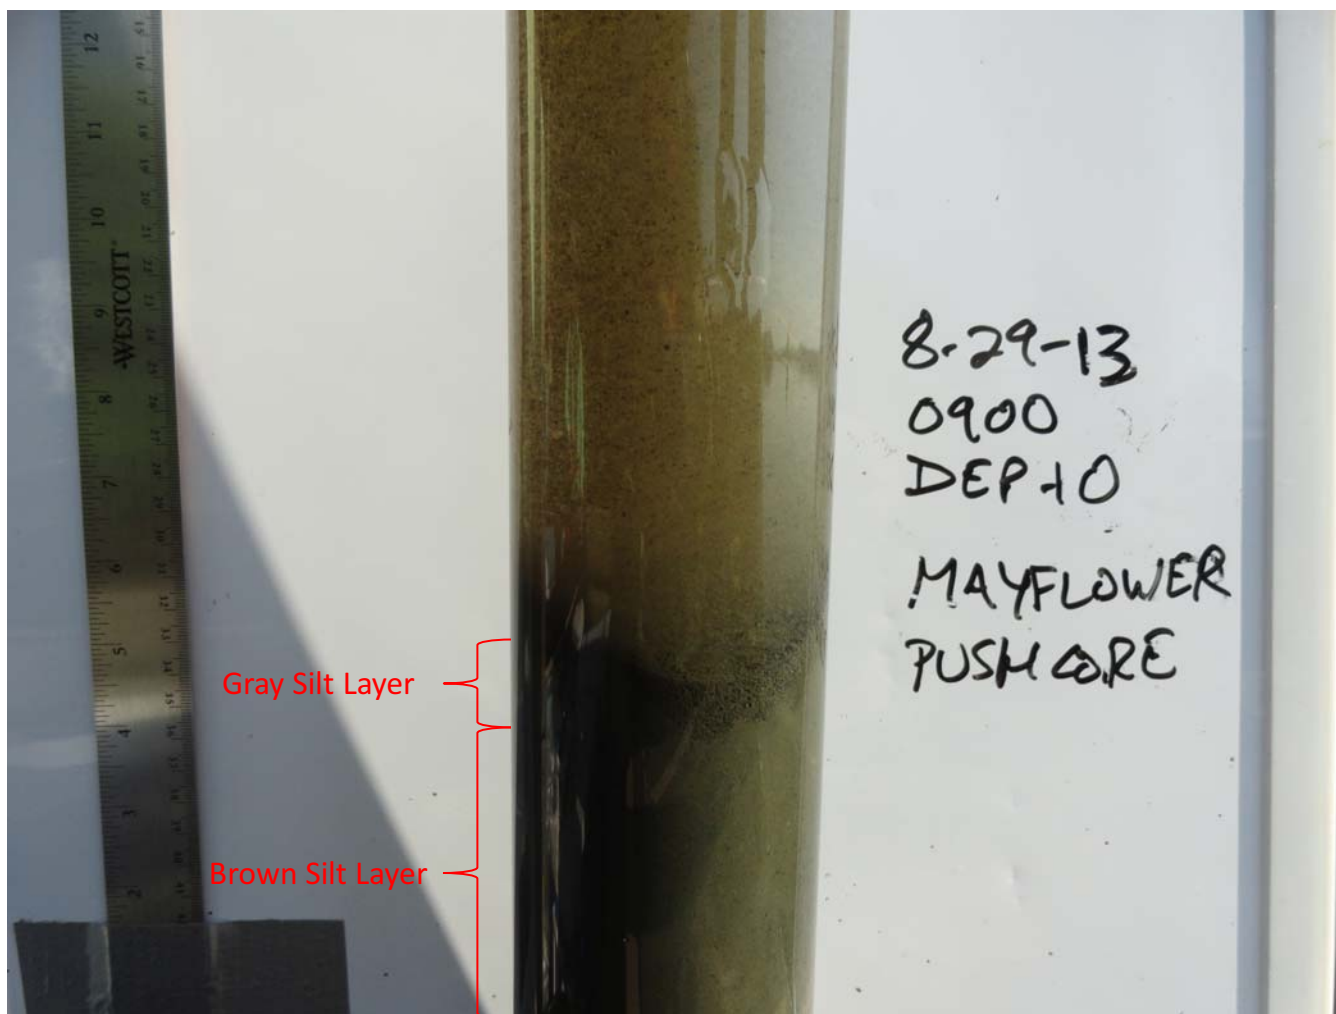
FIGURE
C-10

**DEPOSITIONAL LAYER ASSESSMENT
CORE: DEP-10**

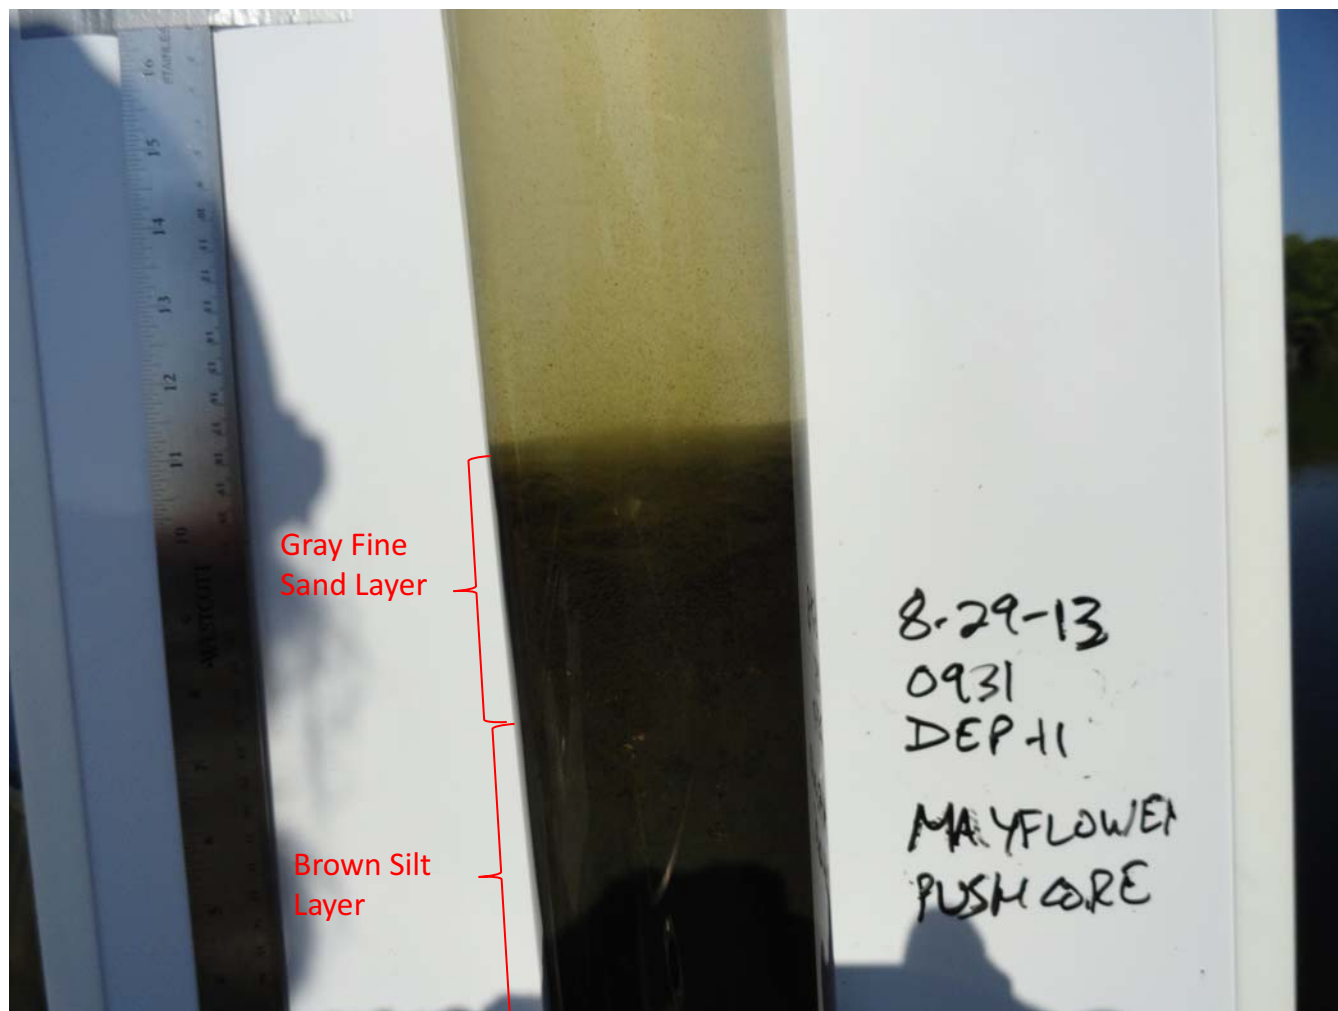
FIGURE
C-11

**DEPOSITIONAL LAYER ASSESSMENT
CORE: DEP-11**

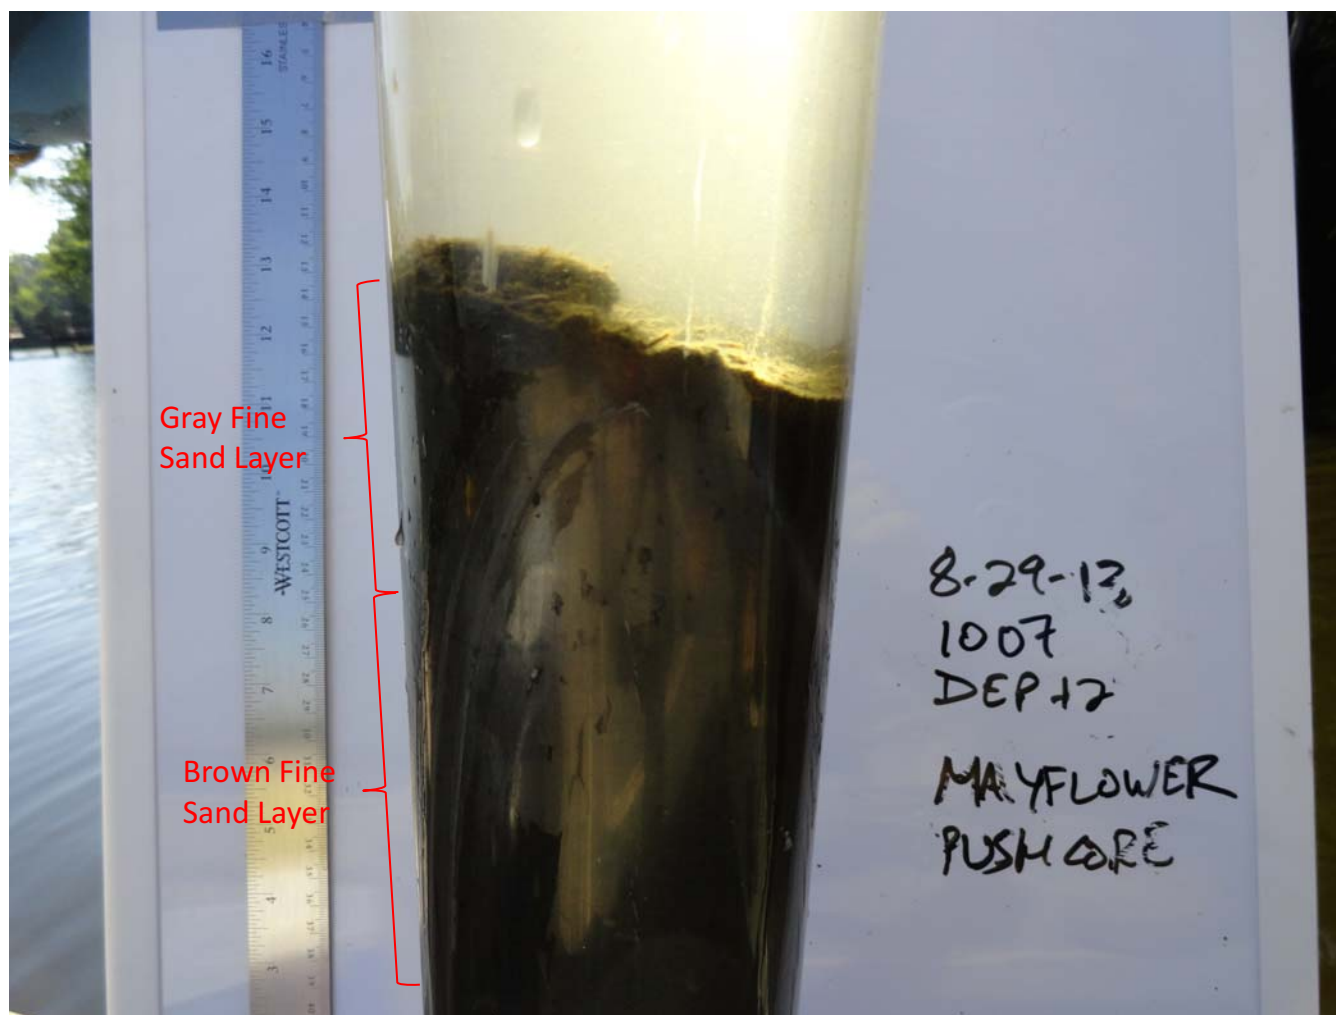
FIGURE
C-12

**DEPOSITIONAL LAYER ASSESSMENT
CORE: DEP-12**

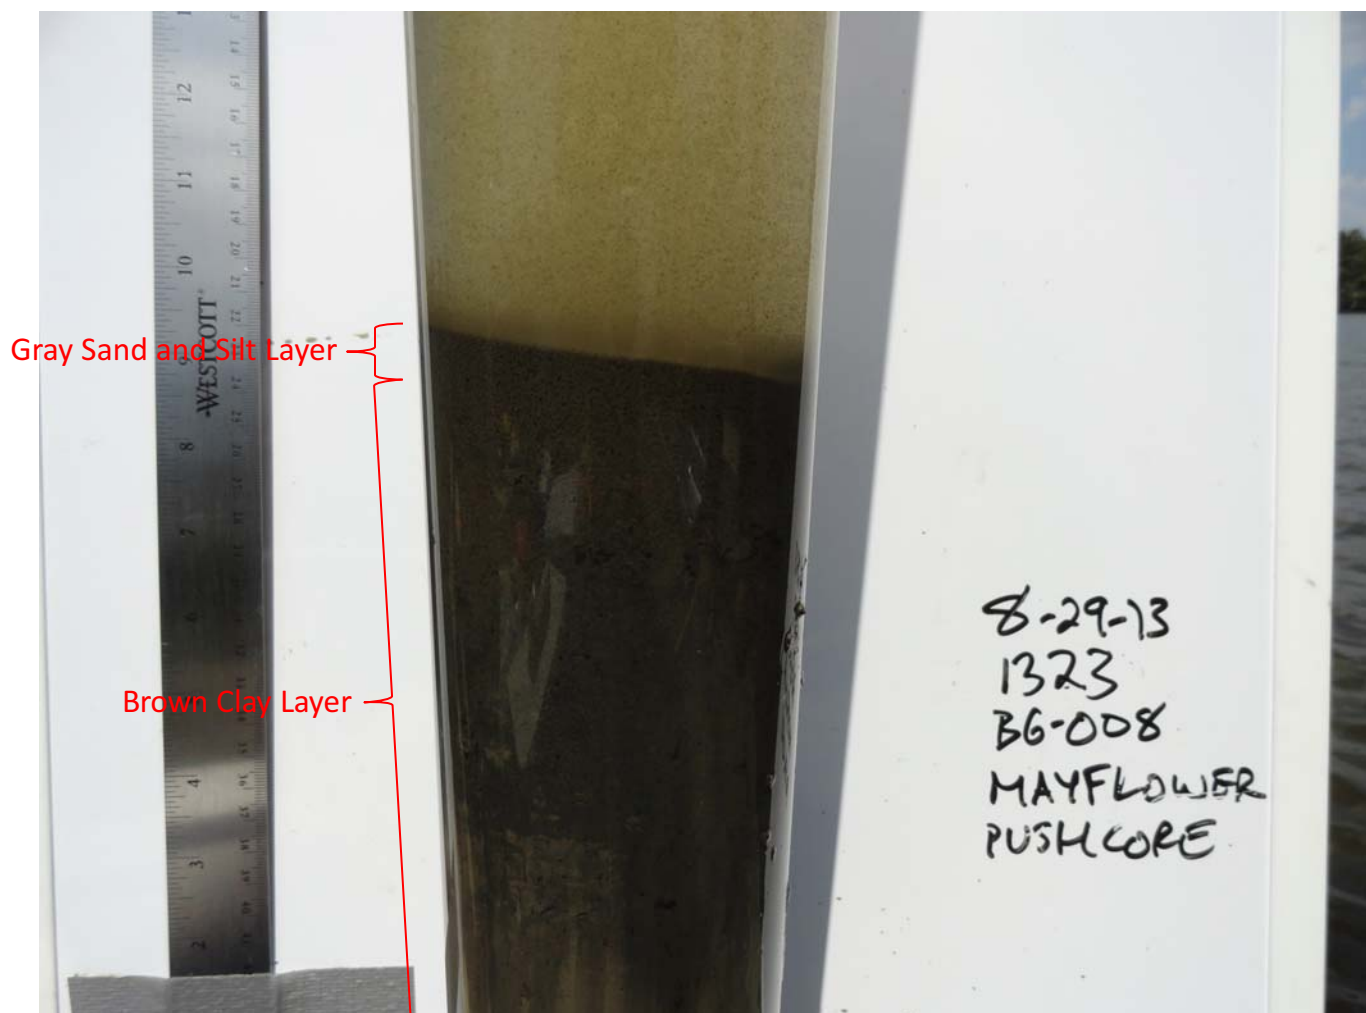
FIGURE
C-13

DEPOSITIONAL LAYER ASSESSMENT
CORE: DEP-BG-008

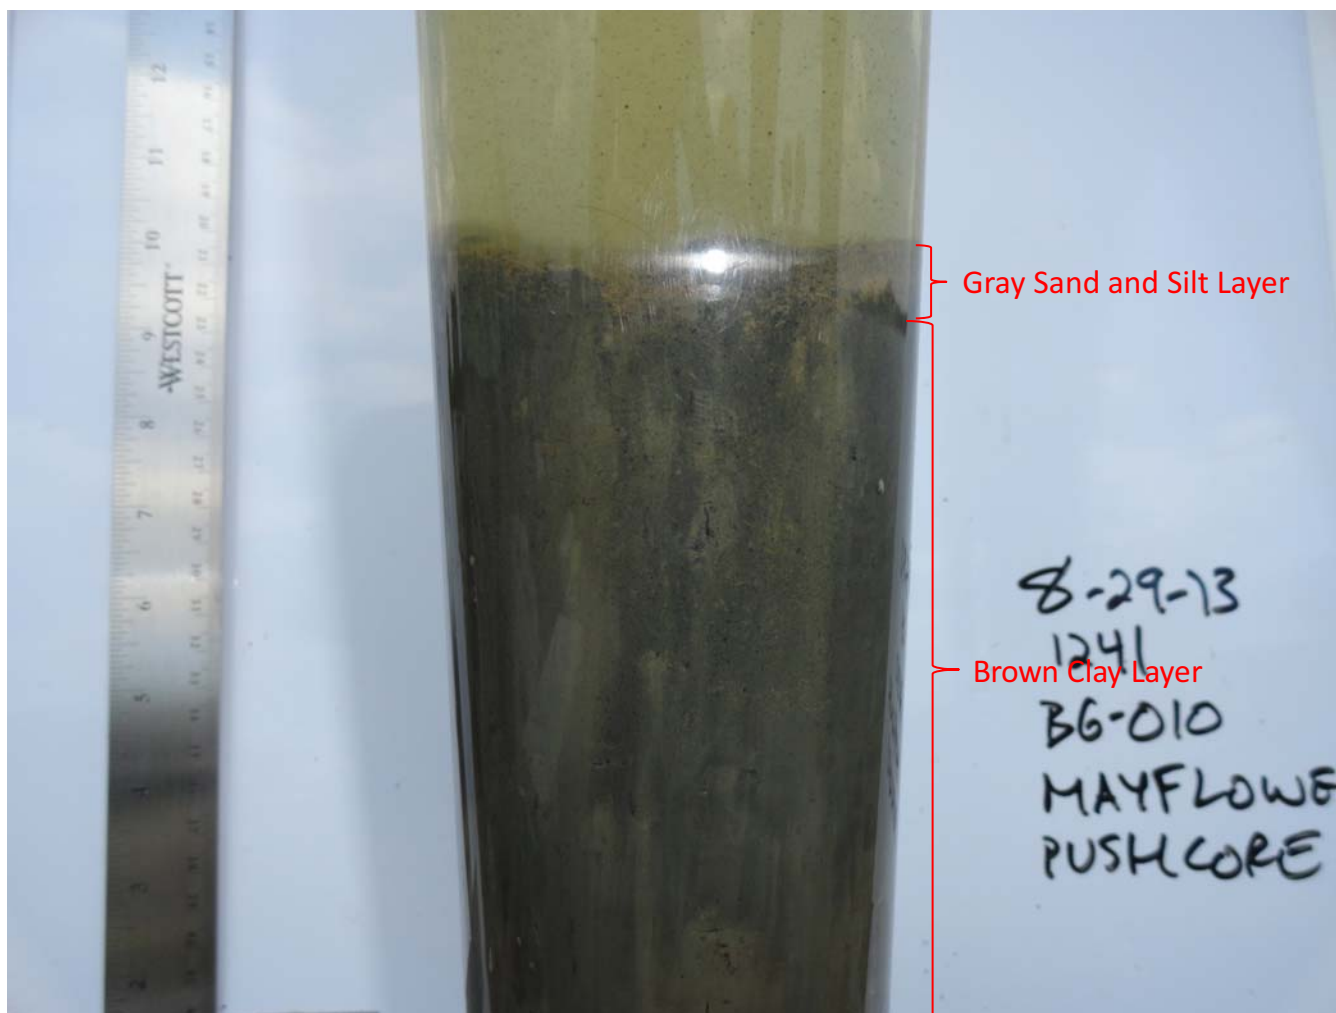
FIGURE
C-14

**DEPOSITIONAL LAYER ASSESSMENT
CORE: DEP-BG-010**

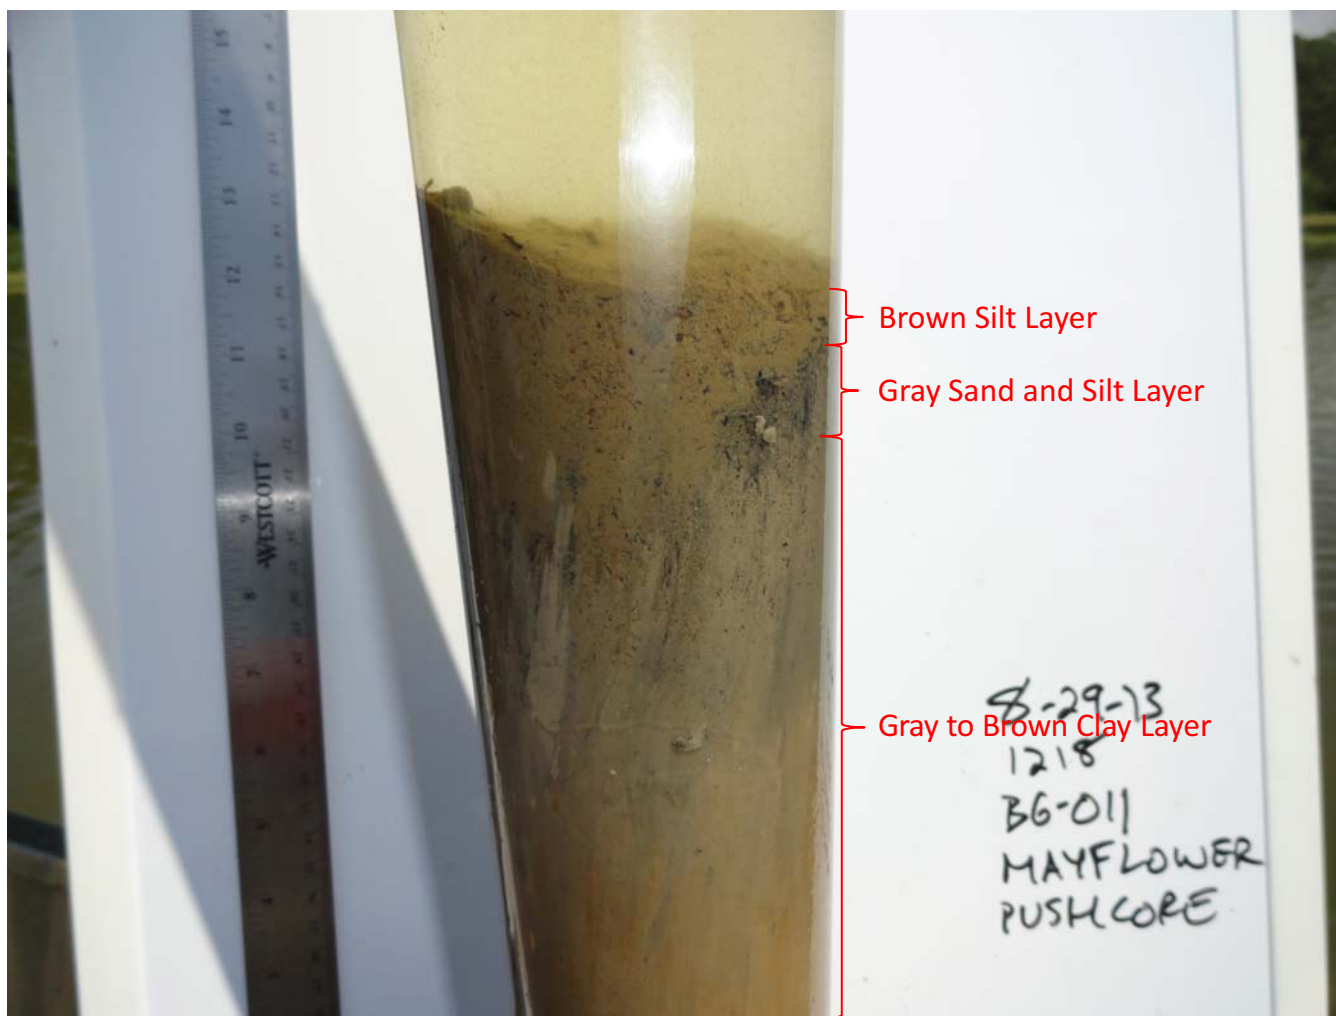
FIGURE
C-15

**DEPOSITIONAL LAYER ASSESSMENT
CORE: DEP-BG-011**

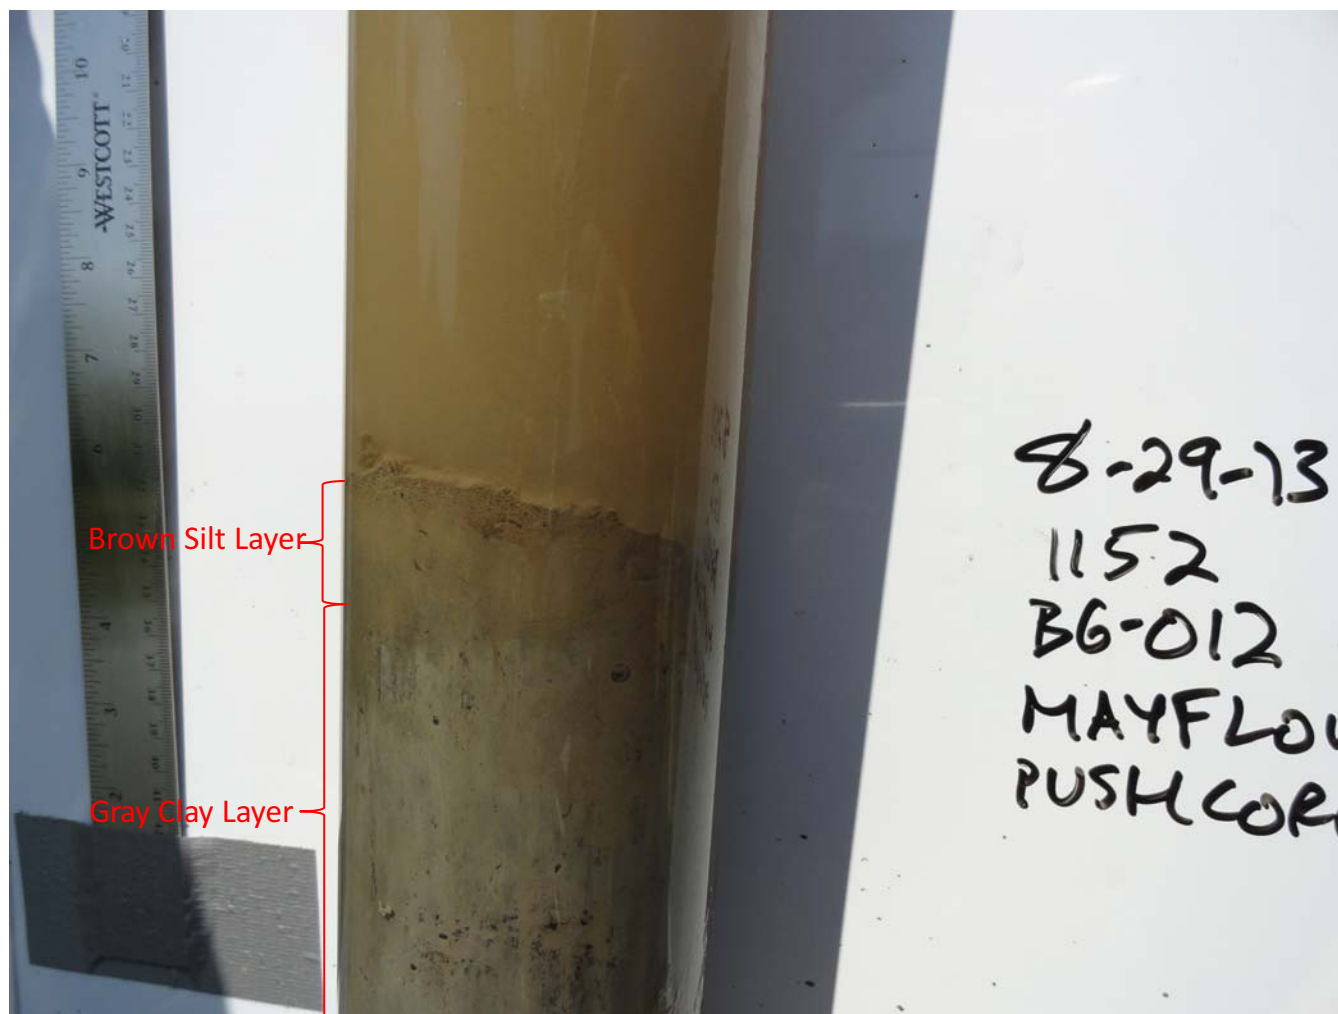
FIGURE
C-16

DEPOSITIONAL LAYER ASSESSMENT
CORE: DEP-BG-012
