## **Sheen Monitoring Report #12**

**Monitoring Period:** Daily\* from 01/06/2014 through 01/12/2014 \*Limited sheen monitoring due to icy (2-3 inches of snow/ice) and unsafe ground conditions.

# Mayflower Pipeline Incident Response

## **Mayflower, Arkansas**

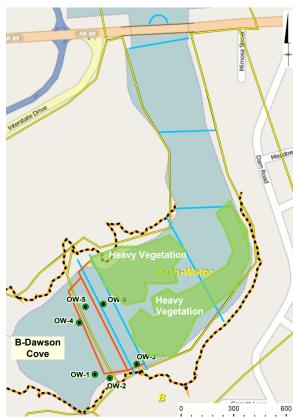
Dawson Cove (Summary of Observations from 01/06/2014 through 01/12/2014)

· No sheens observed.
