# **Sheen Monitoring Report #15**

# Mayflower Pipeline Incident Response

# **Mayflower, Arkansas**

Monitoring Period: Daily from 01/27/2014 through 02/02/2014

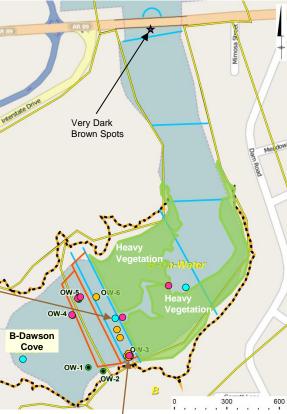
- One cover (no particular structure) of brittle<sup>1</sup> very dark brown sheens; one patch and one cover of brittle<sup>1</sup> metallic/silver gray sheens observed.
- One patch/streamer (with 0.5-inch wide oil spots) and one patch (with 0.25-inch wide oil spot) of non-brittle<sup>2</sup> silver gray sheens; one patch and one streamer (with 0.1- to 0.5-inch wide oil spots) of non-brittle<sup>2</sup> metallic/silver gray sheens; and seven patches/streamers (four with 0.1- to 0.25-inch wide oil spots) and three streamers (one with 0.1- to 0.5-inch wide oil spots) of non-brittle<sup>2</sup> metallic/rainbow sheens observed.
- On January 29, very dark brown spots observed near Highway 89 and reported to the field crew. When the field crew arrived at that location, the spots were not observed and thus, not characterized.

Dawson Cove (Summary of Observations from 01/27/2014 through 02/02/2014)
