Mayflower Pipeline Incident Response

Sheen Monitoring Report #20

Monitoring Period: Daily* from 03/03/2014 through 03/09/2014 *Limited sheen monitoring due to unsafe weather conditions.

Mayflower, Arkansas

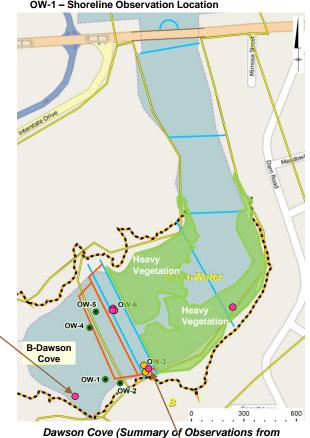
Silver Gray Sheen Streamer Observation on 03/08/2014
