Sheen Monitoring Report #21

Period: 03/10/2014 through 03/16/2014

Mayflower Pipeline Incident Response

Mayflower, Arkansas

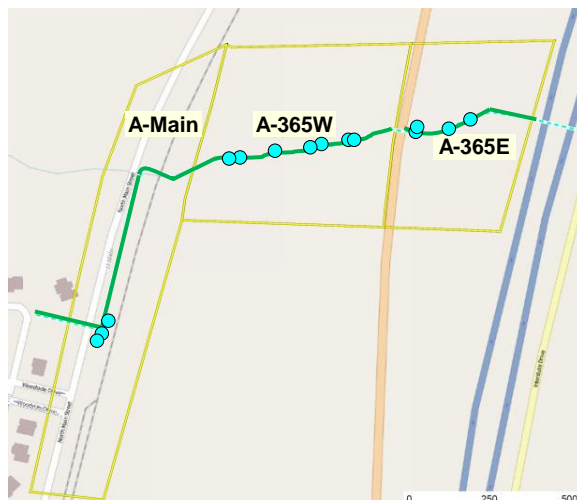
Drainage Ways (Summary of Observations from 03/10/2014 through 03/16/2014)

- A-Main
 - Three covers (no particular structure) of silver gray sheens observed. Sheens broke apart when disturbed ("brittle")¹.
- A-365W
 - Seven covers (no particular structure) of brittle¹ silver gray sheens observed.
- A-365E
 - Four covers (no particular structure) of brittle¹ silver gray sheens observed.

Mitigation: Suspected petrogenic sheens were removed using absorbent materials.

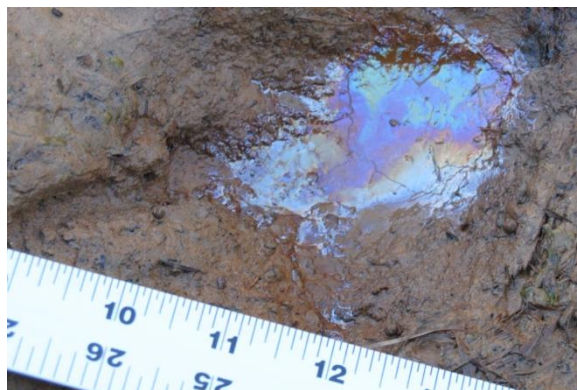
- Six covers (no particular structure) of brittle¹ silver gray sheens, one cover of brittle¹ metallic/rainbow sheens, and one cover of brittle¹ rainbow/silver gray sheens observed.

Metallic/Rainbow Sheen Cover Observation on 03/10/2014

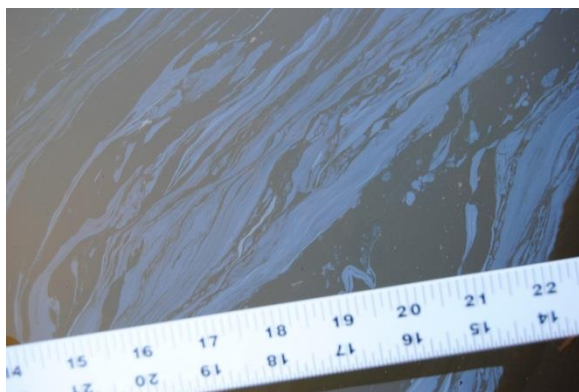
- Three streamers and five patches/streamers (one with 0.25-inch wide oil spots) of silver gray sheens, and one patch/streamer (with 0.1- to 0.5-inch wide oil spots) of rainbow/silver gray sheens observed. Sheens did not break when disturbed ("non-brittle")².

Silver Gray Sheen Streamer Observation on 03/10/2014

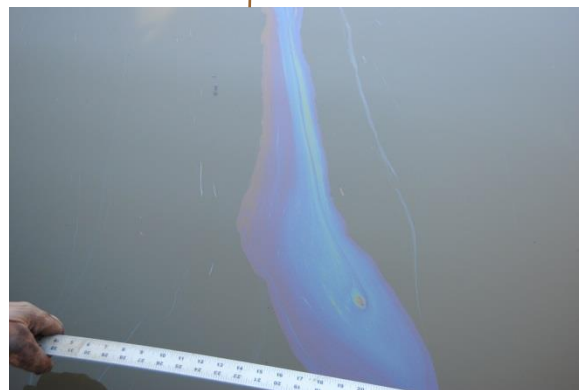
Rainbow/Silver Gray Sheen Patch/Streamer with Oil Spots (0.1- to 0.5-inch wide) Observation on 03/11/2014
