Sheen Monitoring Report #6

Monitoring Period: Daily from 11/25/2013 through 12/01/2013

Mayflower Pipeline Incident Response

Mayflower, Arkansas

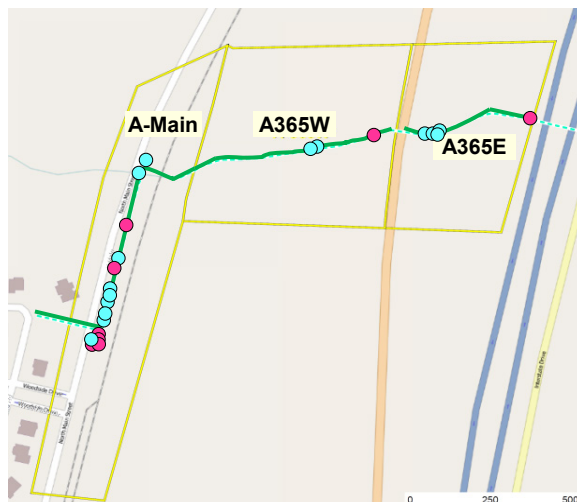
- A-Main
 - Six patches and three streamers of metallic sheens observed. Sheens broke apart when disturbed ("brittle")¹.
 - Two streamers and four patches of metallic sheens observed. Sheens did not break when disturbed ("non-brittle")².
- A365W
 - Two patches of brittle¹ metallic sheens observed.
 - One patch of non-brittle² metallic sheens observed.
- A365E
 - Four patches of brittle¹ metallic sheens observed.
 - One patch of non-brittle² metallic sheens observed.

Drainage Ways (Summary of Observations from 11/25/2013 to 12/01/2013)

Mitigation: Suspected petrogenic sheens were removed using absorbent materials.

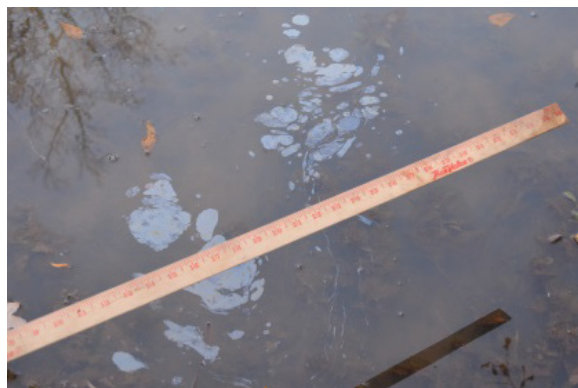
Metallic Sheen Patch Observation on 11/30/2013

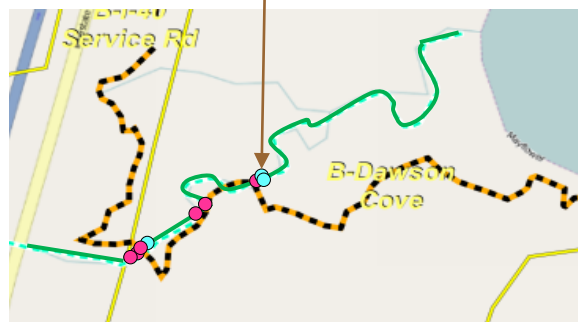
- One streamer and two patches of brittle¹ metallic sheens observed.
- Six patches of non-brittle² metallic sheens observed.

Dawson Cove Inlet Channel (Summary of Observations from 11/25/2013 to 12/01/2013)

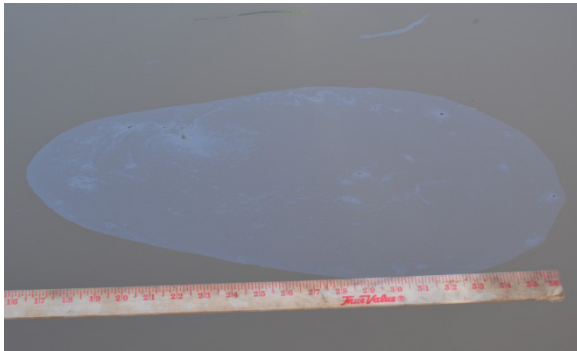
Metallic Sheen Patch with Small Oil Spots (0.1-inch Wide) Observation on 11/30/2013

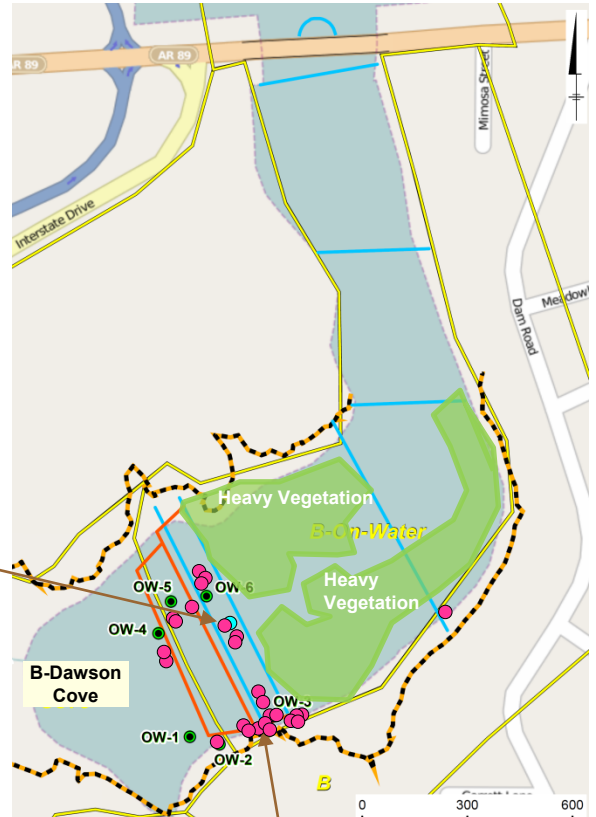
- One patch of brittle¹ rainbow sheens observed.
- One streamer (with 0.25-inch wide oil spots) and eight patches (four with small oil spots – 0.1-, 0.25-, and 0.5-inch wide) of non-brittle² rainbow sheens; seven patches (one with 0.1-inch wide oil spots) and two patches/streamers of non-brittle² metallic sheens; and seven patches and one patch/streamer of non-brittle² metallic/rainbow sheens with small oil spots (0.1- and 0.25-inch wide) observed.

Dawson Cove (Summary of Observations from 11/25/2013 to 12/01/2013)

- Continue sheen monitoring in all areas.

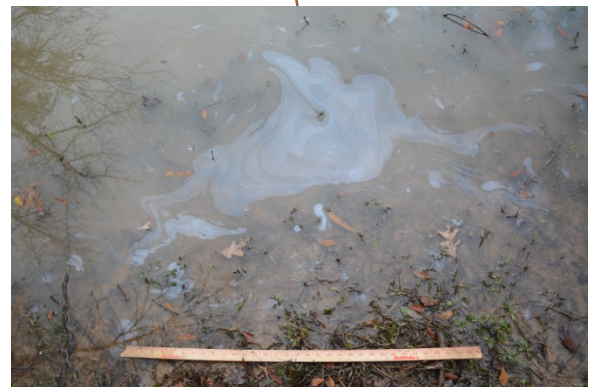
Metallic/Rainbow Sheen Patch with Small Oil Spots (0.25-inch Wide) Observation on 12/01/2013
