Sheen Monitoring Report #7

Monitoring Period: Daily* from 12/02/2013 through 12/08/2013

Mayflower Pipeline Incident Response

Mayflower, Arkansas

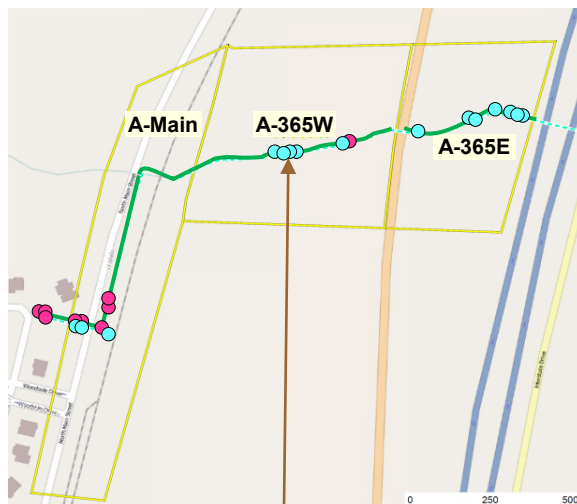
Drainage Ways (Summary of Observations from 12/02/2013 to 12/08/2013)

- A-Main
 - One patch of metallic sheens and two patches of rainbow sheens observed. Sheens broke apart when disturbed ("brittle")¹.
 - One patch of metallic/rainbow sheens; two covers (no particular structure) of metallic sheens; and two streamers and three patches (two with 0.25-inch wide oil spots) of rainbow sheens observed. Sheens did not break when disturbed ("non-brittle")².
- A365W
 - Five patches of brittle¹ metallic sheens observed.
 - One patch of non-brittle² metallic sheens observed.
- A365E
 - Six patches and one cover (no particular structure) of brittle¹ metallic sheens observed.

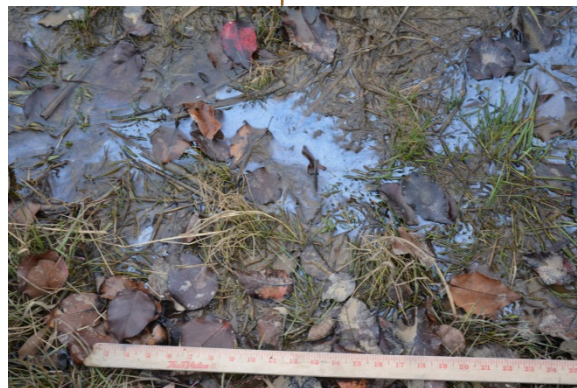
Metallic Sheen Patch Observation on 12/05/2013

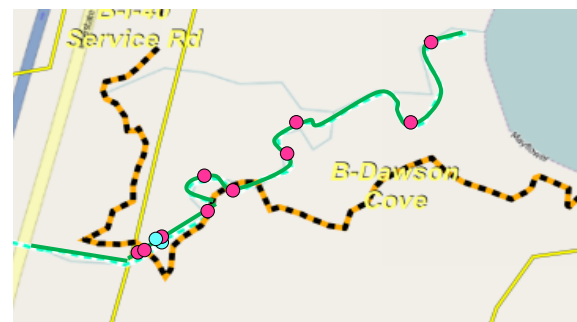
Dawson Cove Inlet Channel (Summary of Observations from 12/02/2013 to 12/08/2013)

- One cover (no particular structure) and one patch of brittle¹ metallic sheens observed.
- Three patches, two covers (no particular structure), and one streamer of non-brittle² metallic sheens; two streamers and one patch (with 0.1-inch wide oil spots) of non-brittle² rainbow sheens; and one streamer of non-brittle² metallic/rainbow sheens observed.

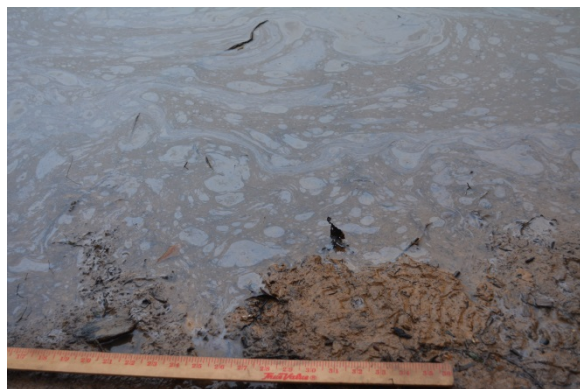
Rainbow Sheen Patch/Streamer with Small Oil Spots
(0.5-inch Wide) Observation on 12/03/2013

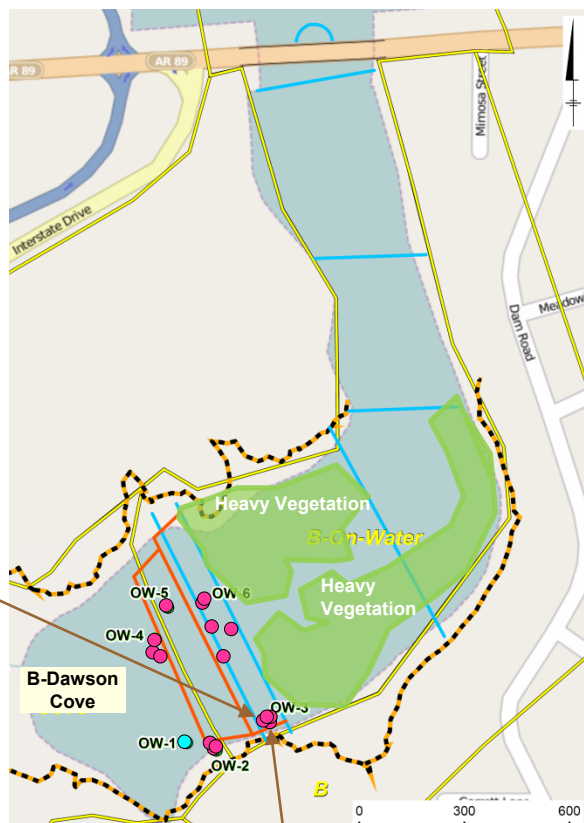
Dawson Cove (Summary of Observations from
12/02/2013 to 12/08/2013)

- One patch of brittle¹ metallic sheens observed.
- Four covers (no particular structure) and one patch (with 0.1-inch wide oil spots) of non-brittle² metallic sheens; five streamers, two patches/streamers, and one cover (no particular structure) with 0.1-, 0.25-, 0.5-, and 1-inch wide oil spots, and two patches (one with 0.1-inch wide oil spots) of non-brittle² rainbow sheens; and one streamer of non-brittle² metallic/rainbow sheens observed.

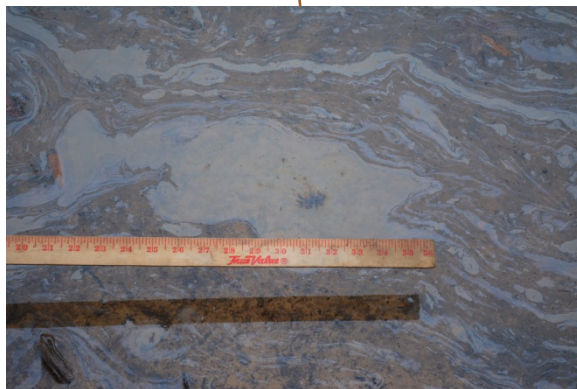
Rainbow Sheen Streamer with Small Oil Spots (1-inch
Wide) Observation on 12/02/2013
