Pre-Design Study Results

**Pre-Design Study – Revision 1
Mayflower Pipeline Incident Response, Mayflower, Arkansas**

Downstream Areas Pre-Design Study Photolog

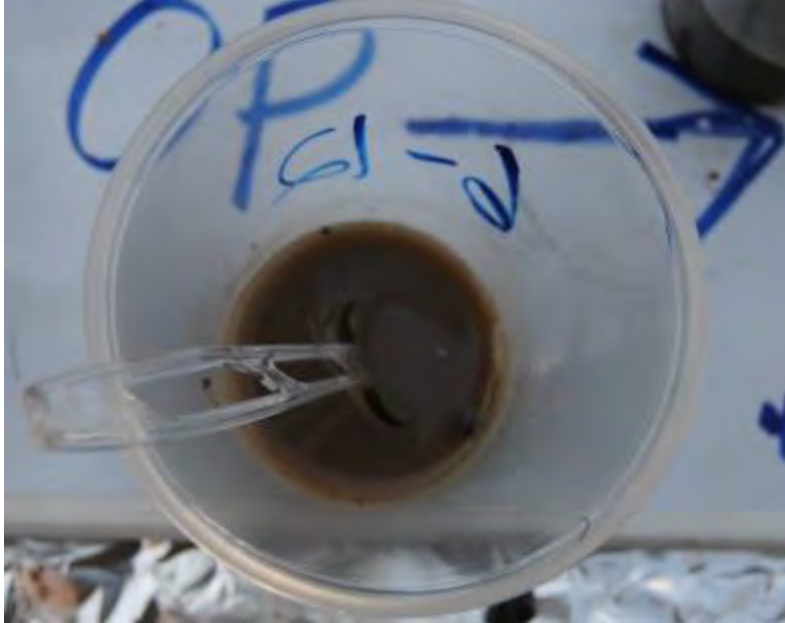
Sheen Stir-Test:

6-12 inches : Patch of silver gray sheen (Lighter)

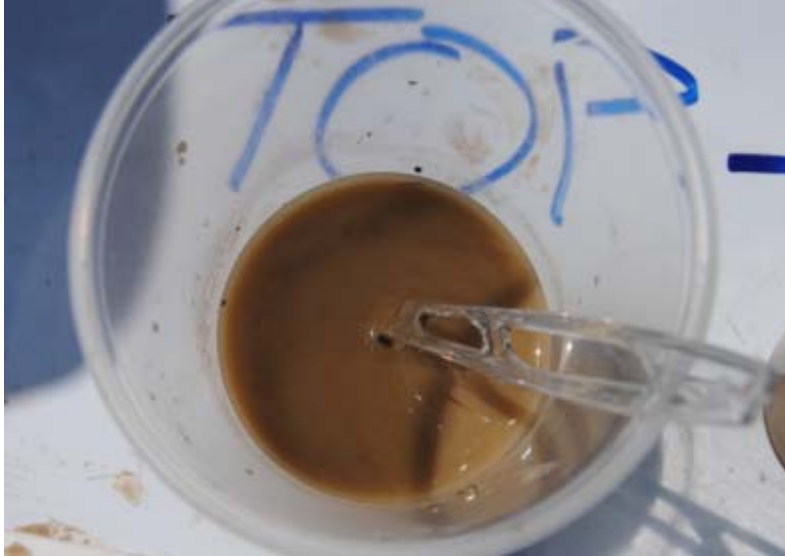
Sheen Stir-Test:

6-12 inches : Streamer of silver gray sheen (Lighter)

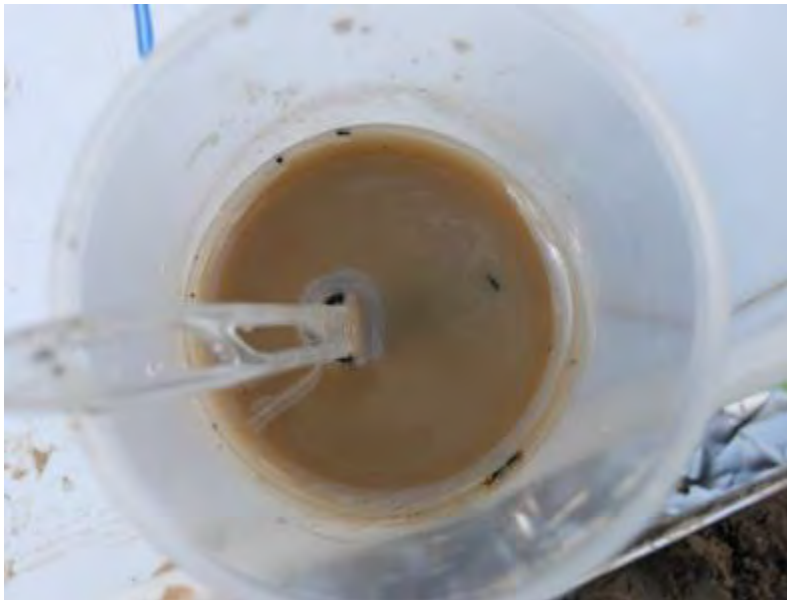
Sheen Stir-Test:

6-12 inches : Streamers of silver gray sheen (Lighter)

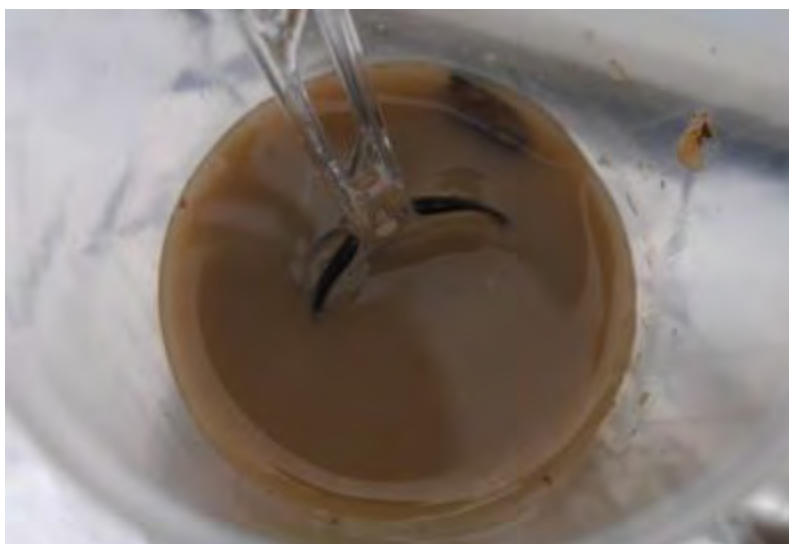
Sheen Stir-Test:

6-12 inches : Streamer of silver gray sheen (Lighter)

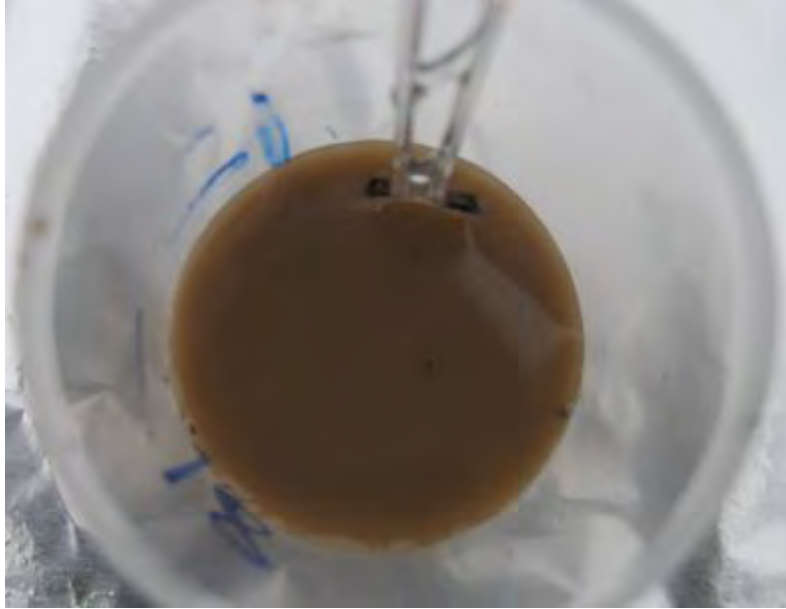
Sheen Stir-Test:

12-18 inches : Streamer of silver gray sheen
(Lighter)

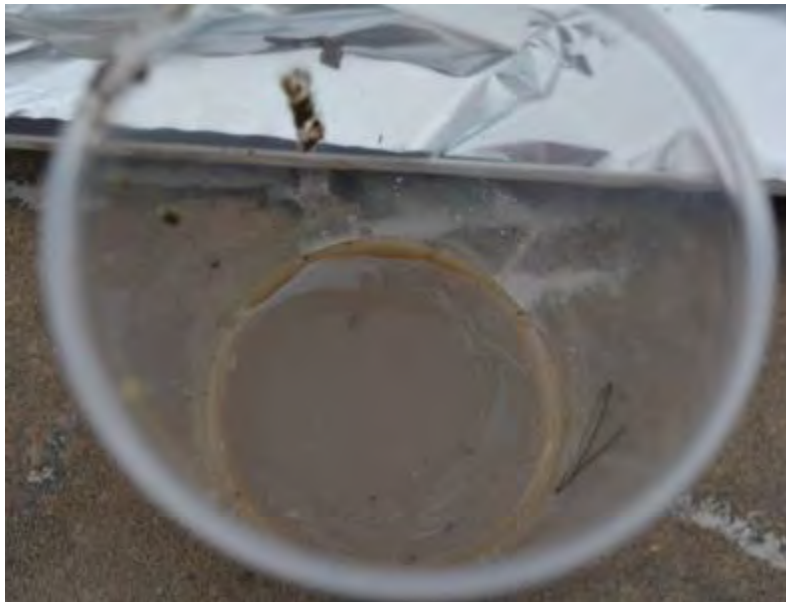
Sheen Stir-Test:

0-6 inches : Patches/streamers of silver gray sheen (Lighter)

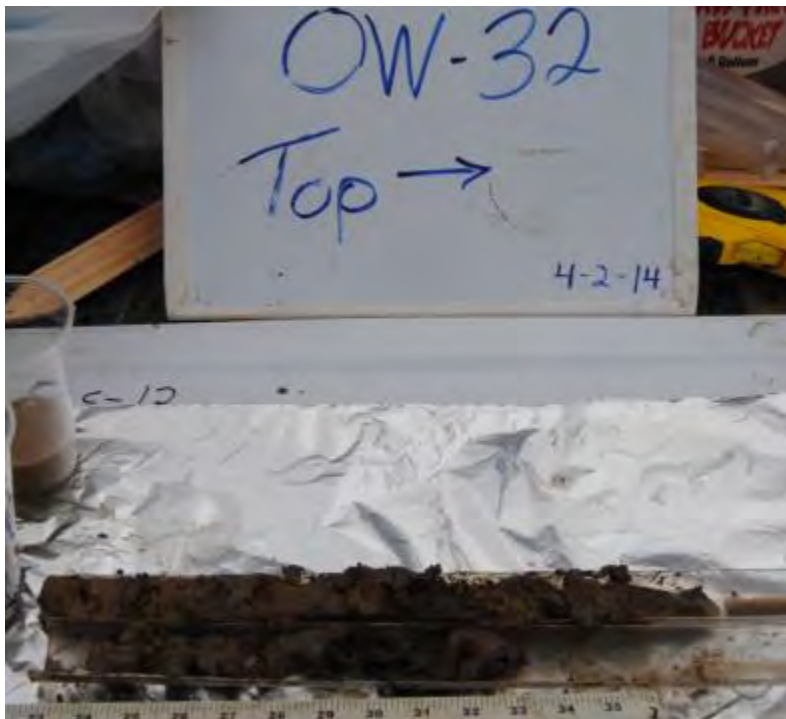
Cove Open Water
Area Location – OW-32

No description

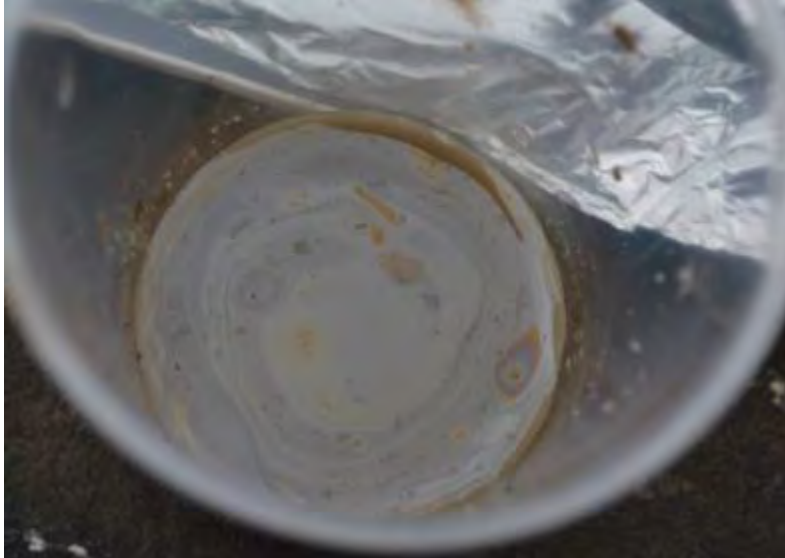
Sheen Stir-Test:

0-6 inches : Patches/streamers of rainbow sheen (Heavier)

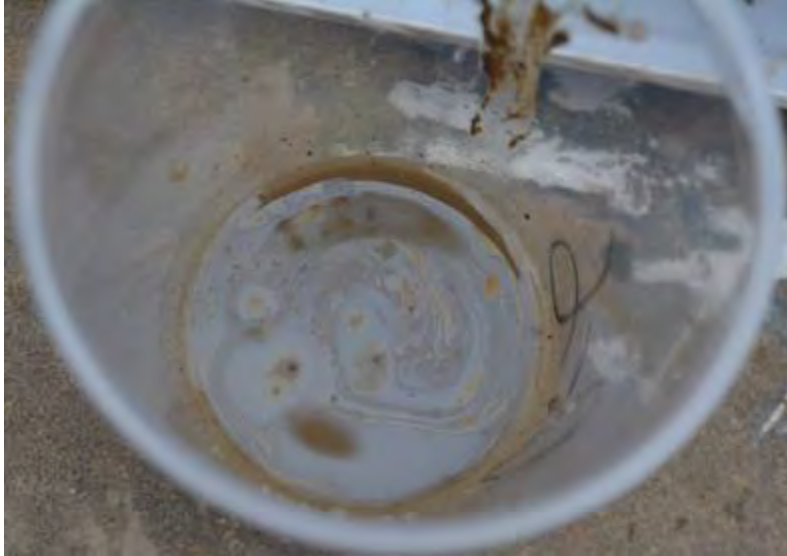
Sheen Stir-Test:

0-6 inches : Patches/streamers of rainbow sheen (Heavier)

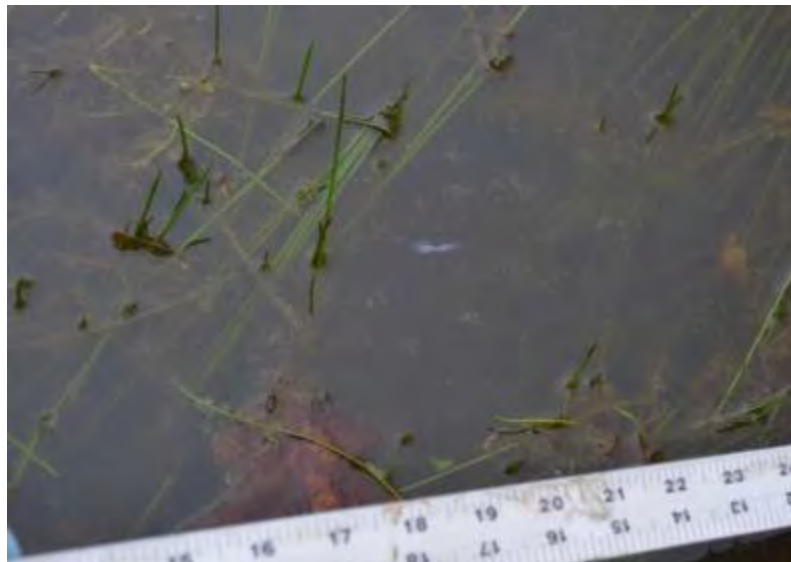
Initial Observation:

Streamers of non-brittle silver gray sheen

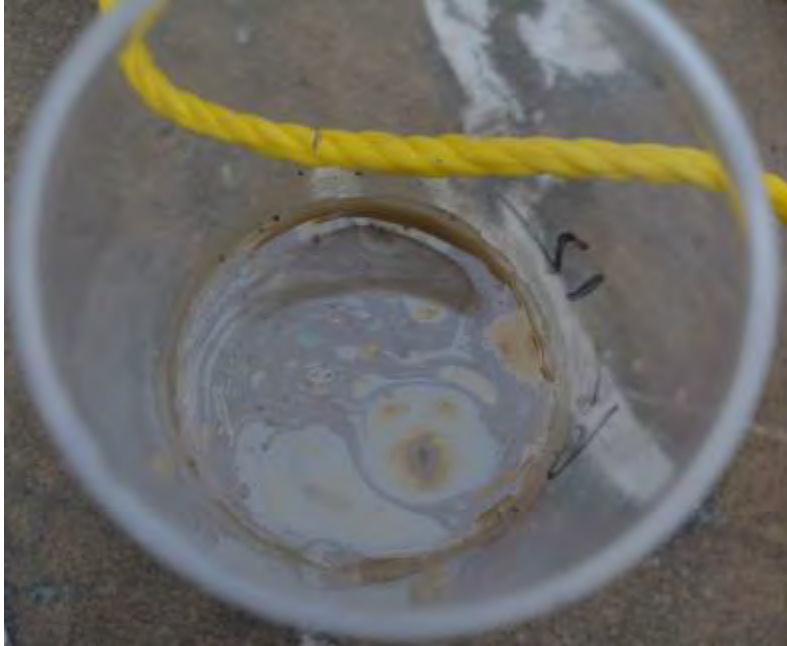
Sheen Stir-Test:

0-6 inches : Patches/streamers of rainbow sheen with oil spots (Heavier)

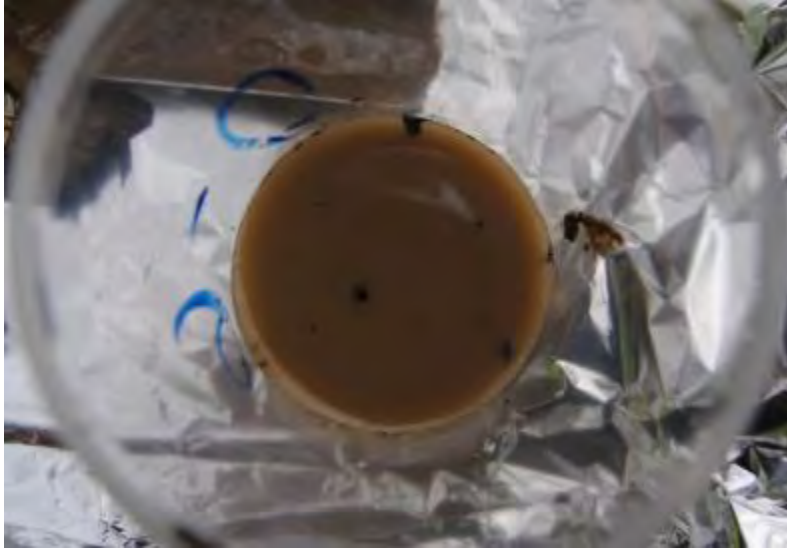
Sheen Stir-Test:

0-6 inches : Streamers of silver gray sheen (Medium)

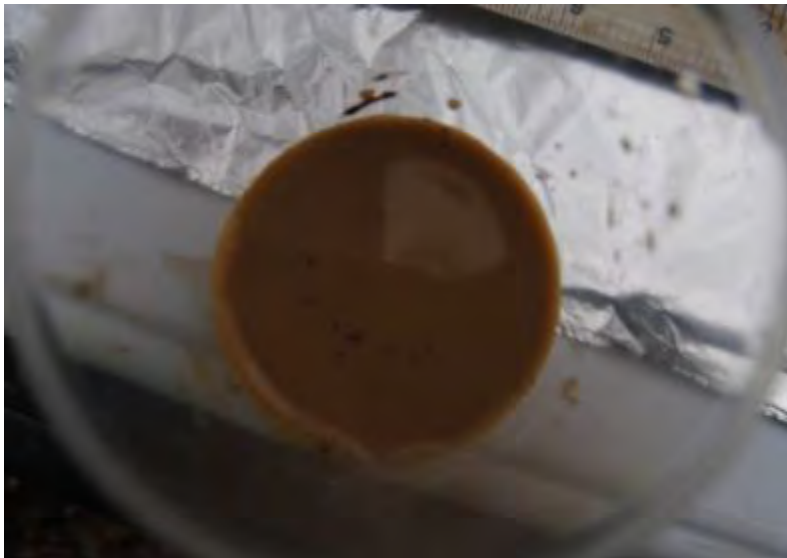
Sheen Stir-Test:

6-12 inches : Streamers of silver gray sheen (Lighter)

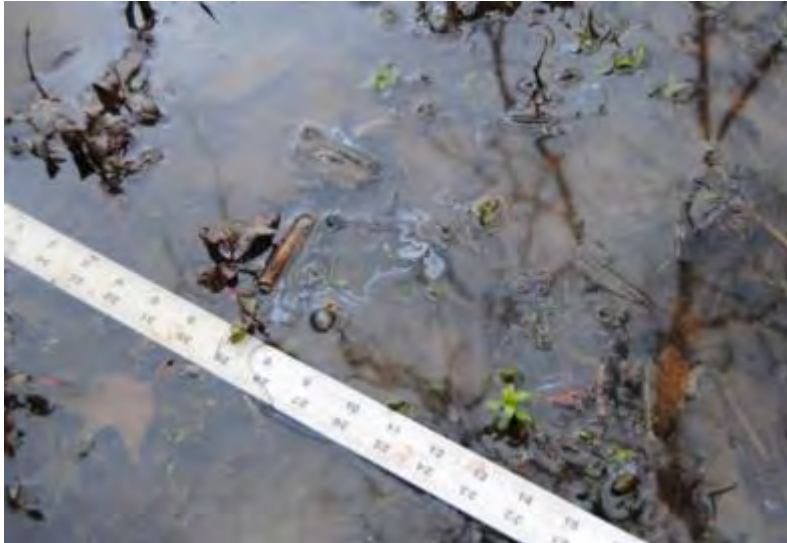
Initial Observation:

Patches/streamers of non-brittle silver gray sheen with oil spot (<0.25-inch wide)

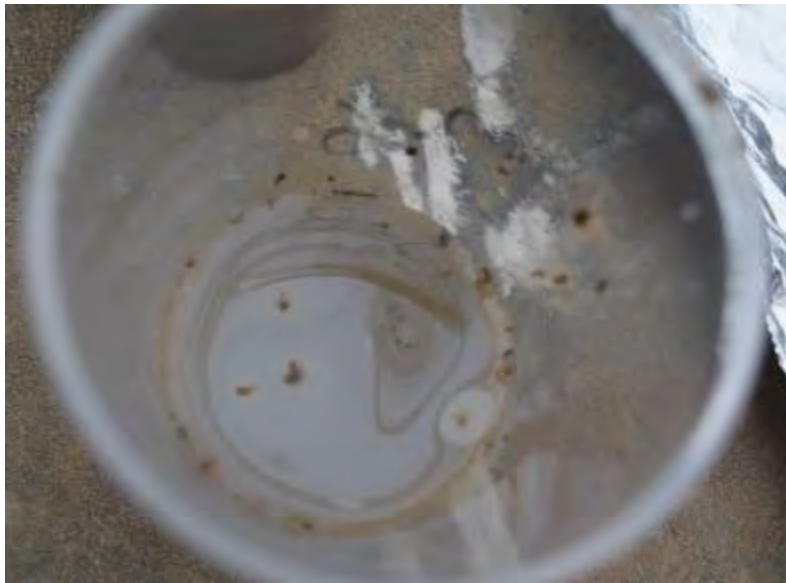
Sheen Stir-Test:

0-6 inches : Patches/streamers of rainbow sheen with five oil spots (Heavier)

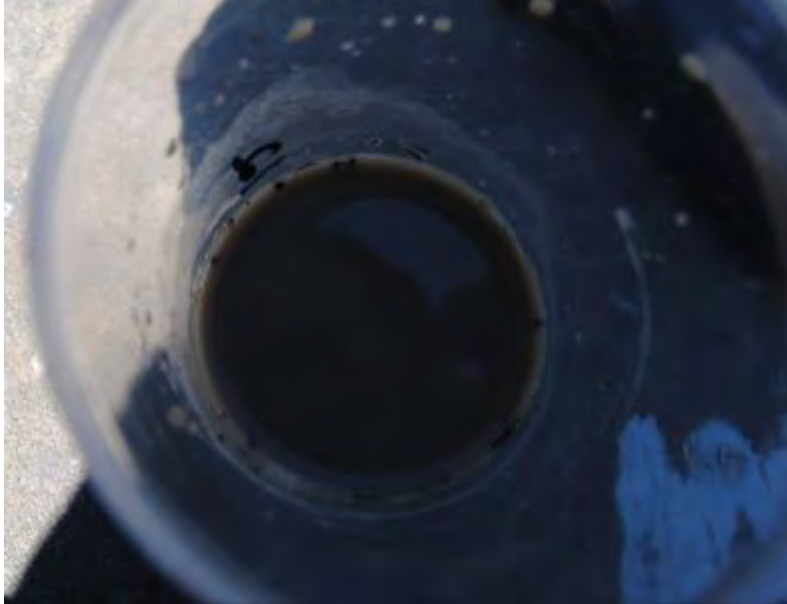
Sheen Stir-Test:

6-12 inches : Patch of silver gray sheen
(Lighter)

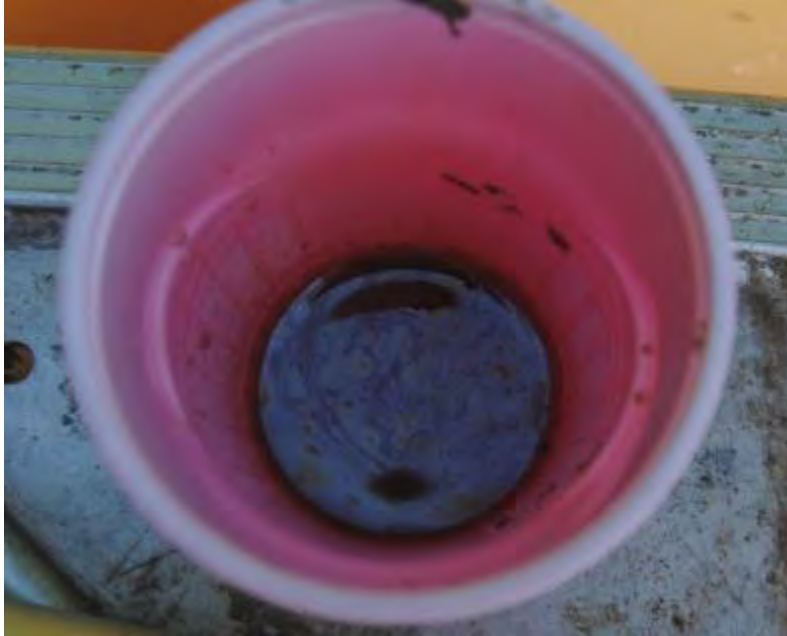
Sheen Stir-Test:

6-12 inches : Patches/streamers of rainbow sheen (Heavier)

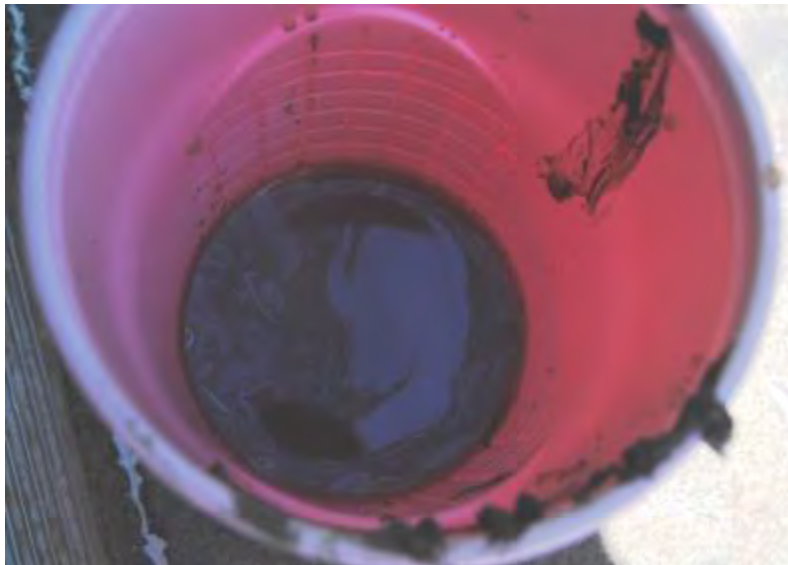
Sheen Stir-Test:

0-6 inches : Patches/streamers of silver gray sheen (Medium)

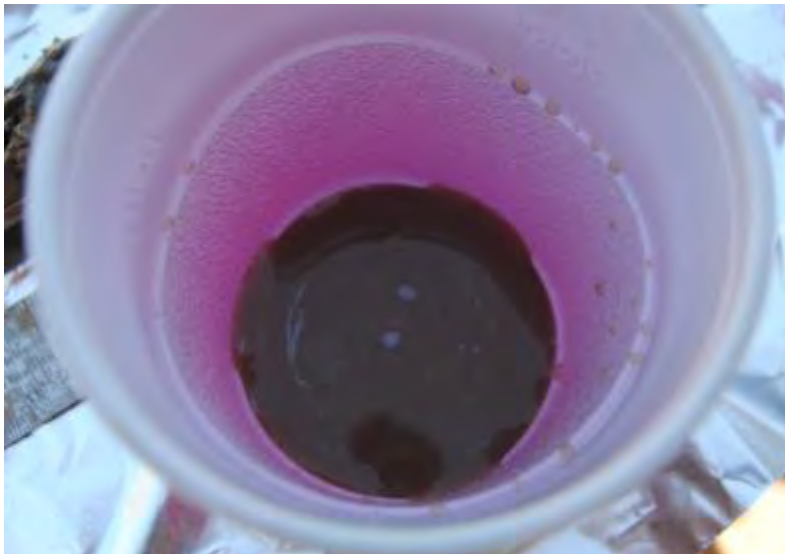
Sheen Stir-Test:

0-6 inches : Patches/streamers of silver gray sheen (Lighter)

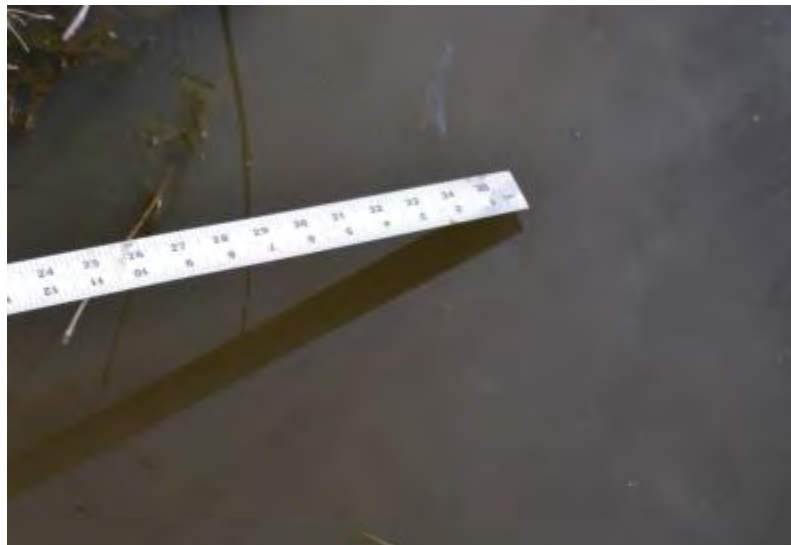
Initial Observation:

Patches of non-brittle silver gray sheen

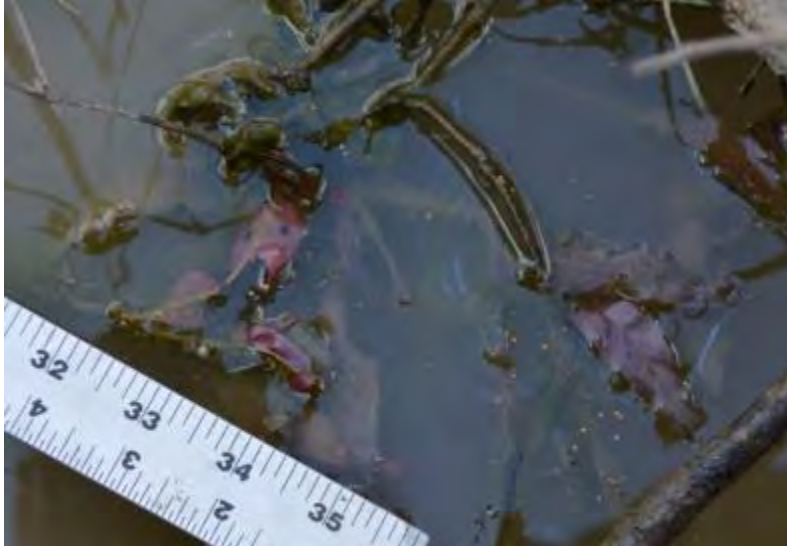
Initial Observation:

Patches/streamers of non-brittle silver gray sheen
