**Downstream Areas Pre-Design
Study**

**Pre-Design Study
Mayflower Pipeline Incident Response, Mayflower, Arkansas**

Downstream Areas Pre-Design Study
ExxonMobil Environmental Services Company
Mayflower Pipeline Incident Response, Mayflower, Arkansas

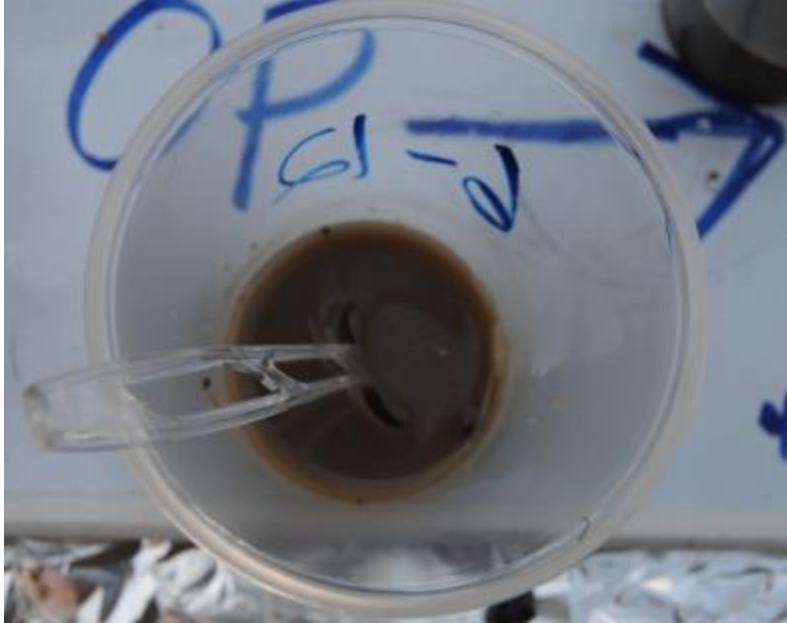
Sheen Stir-Test:

6-12 inches : Patch of silver gray sheen
(Lighter)

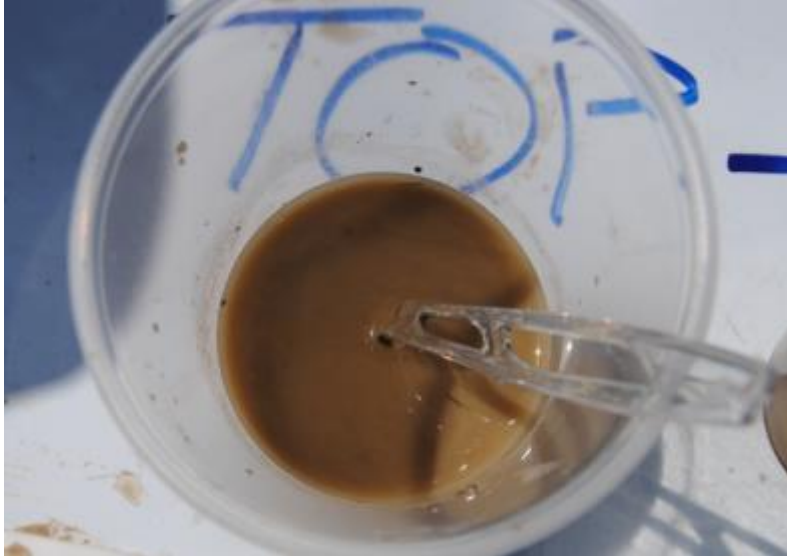
Sheen Stir-Test:

6-12 inches : Streamer of silver gray sheen (Lighter)

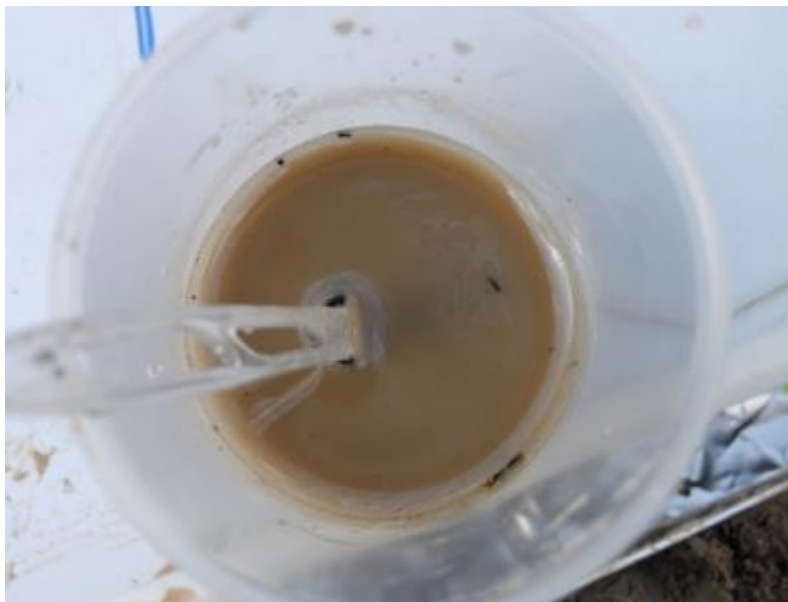
Sheen Stir-Test:

6-12 inches : Streamers of silver gray sheen (Lighter)

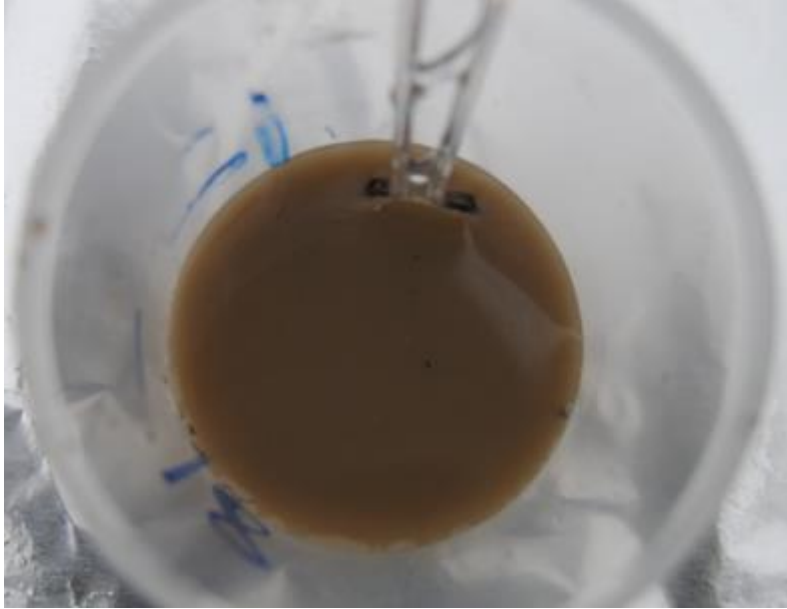
Sheen Stir-Test:

12-18 inches : Streamer of silver gray sheen (Lighter)

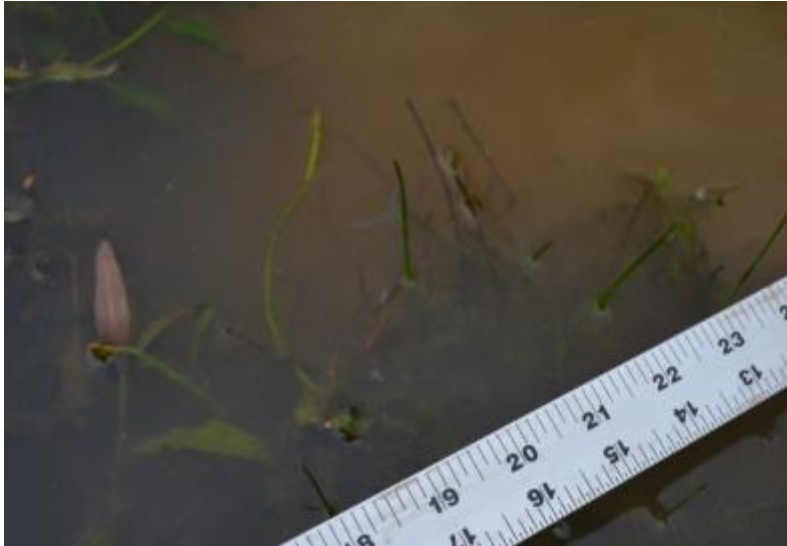
Probing Observation:

6-12 inches : Streamers of non-brittle silver gray sheen

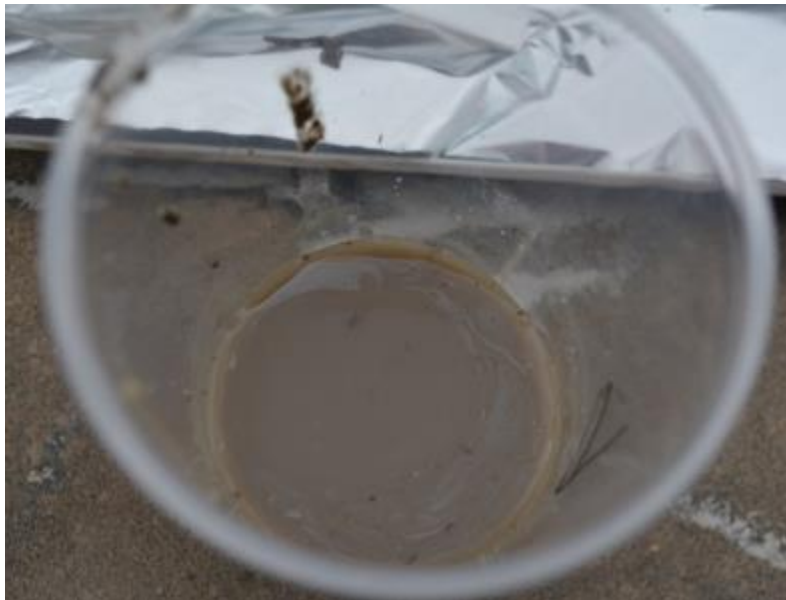
Sheen Stir-Test:

0-6 inches : Patches/streamers of silver gray sheen (Lighter)

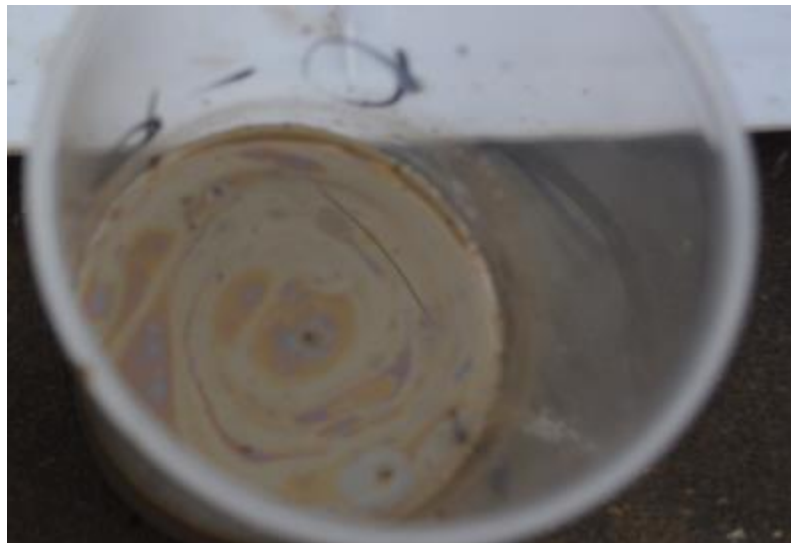
Sheen Stir-Test:

0-6 inches : Patches/streamers of rainbow sheen with 20 oil spots (Heavier)

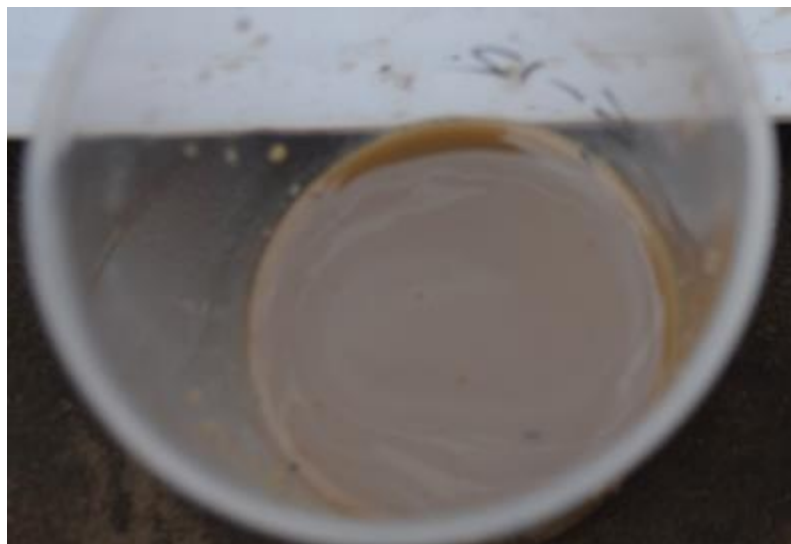
Sheen Stir-Test:

6-12 inches : Streamers of silver gray sheen with oil spot (Medium)

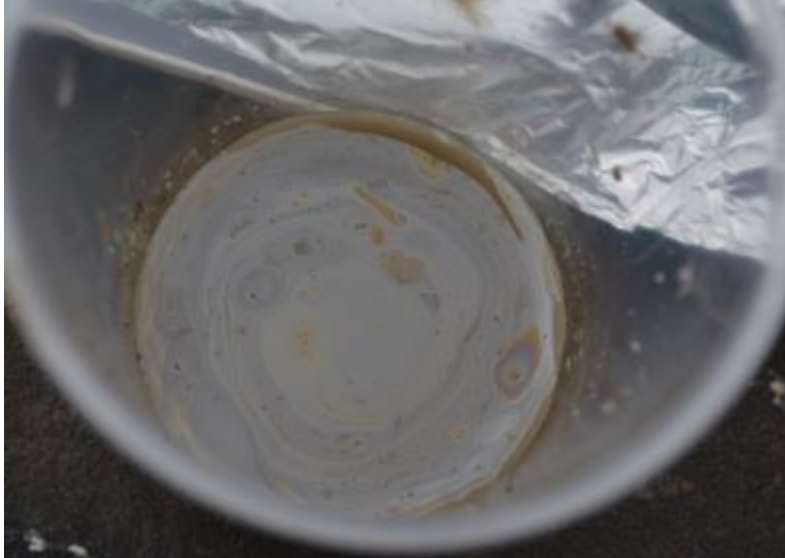
Sheen Stir-Test:

0-6 inches : Patches/streamers of rainbow sheen (Heavier)

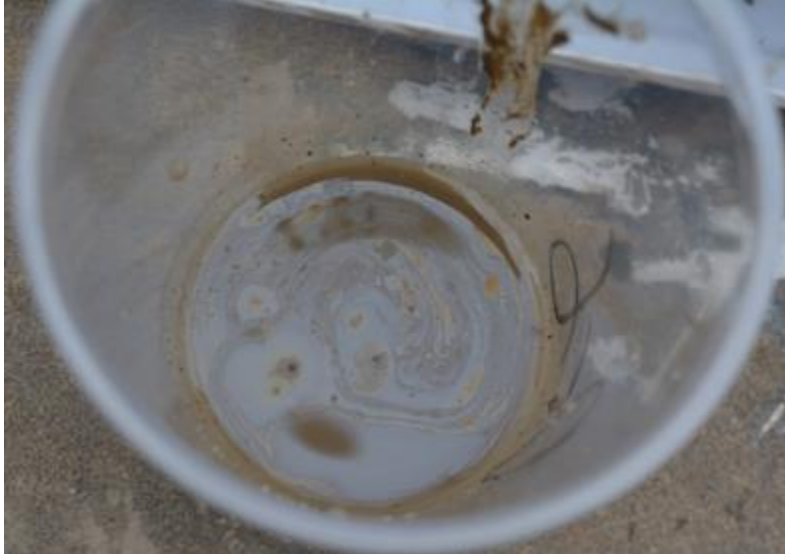
Sheen Stir-Test:

0-6 inches : Patches/streamers of rainbow sheen (Heavier)

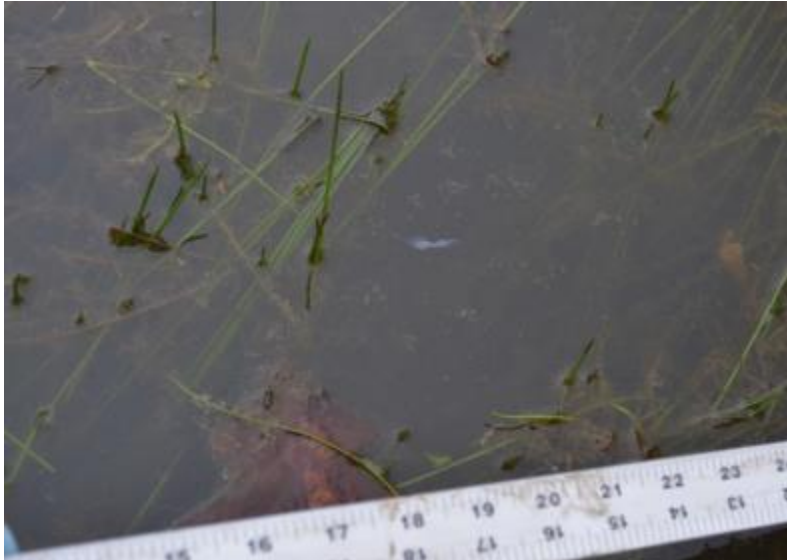
Initial Observation:

Streamers of non-brittle silver gray sheen

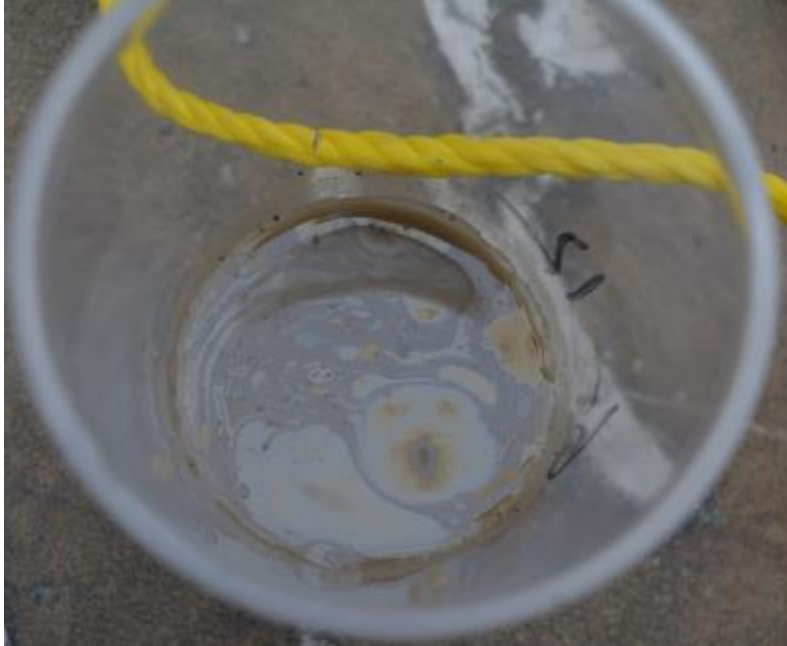
Sheen Stir-Test:

0-6 inches : Patches/streamers of rainbow sheen with oil spots (Heavier)

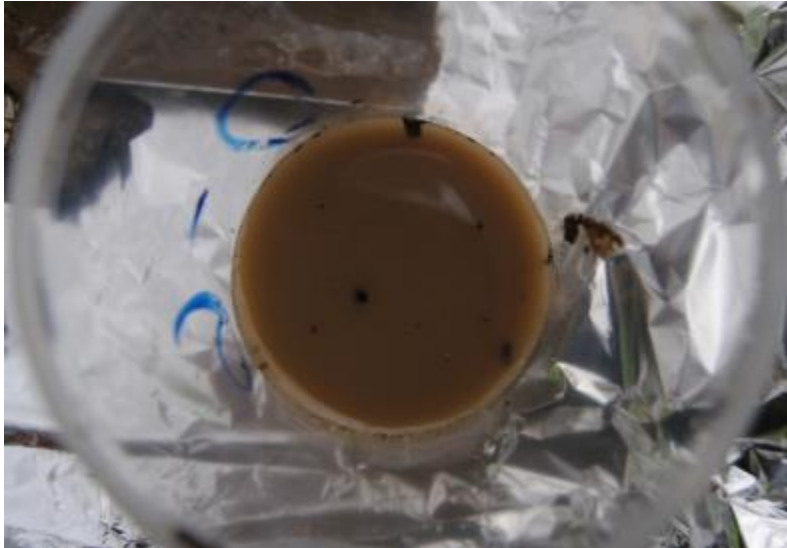
Sheen Stir-Test:

0-6 inches : Streamers of silver gray sheen (Medium)

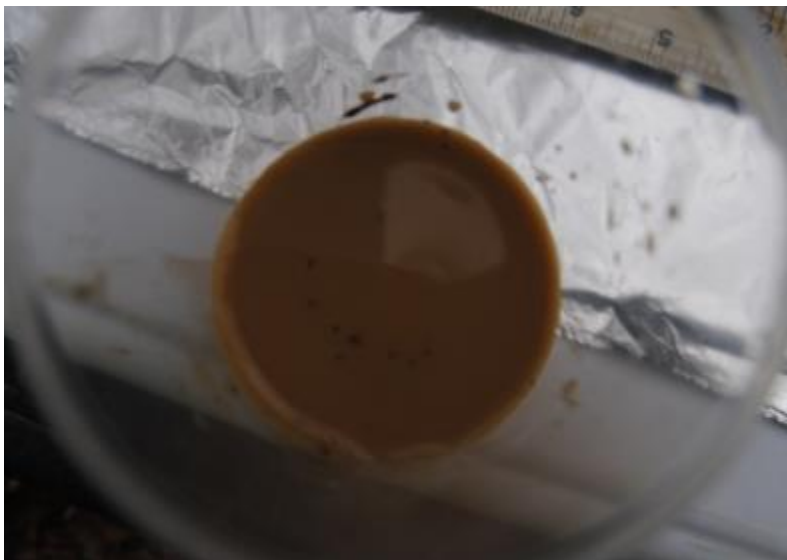
Sheen Stir-Test:

6-12 inches : Streamers of silver gray sheen (Lighter)

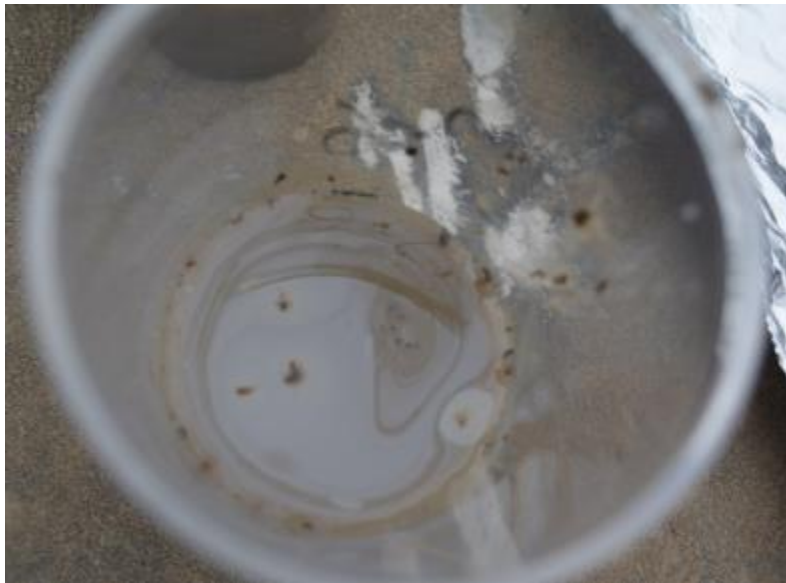
Sheen Stir-Test:

0-6 inches : Patches/streamers of rainbow sheen with five oil spots (Heavier)

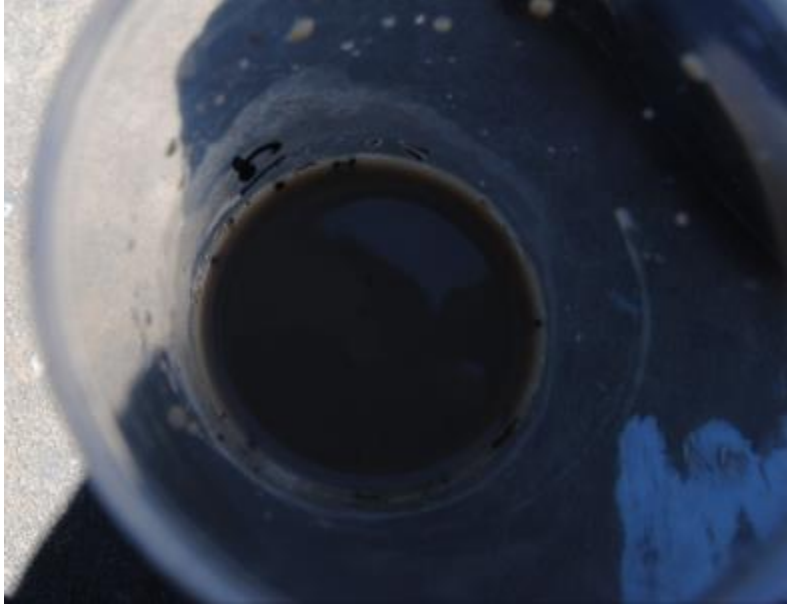
Sheen Stir-Test:

6-12 inches : Patch of silver gray sheen
(Lighter)

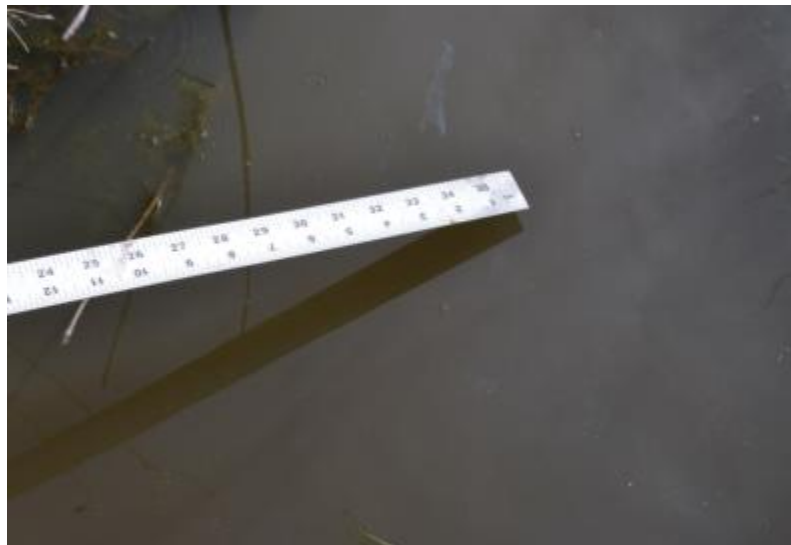
Initial Observation:

Patches of non-brittle silver gray sheen
