**Downstream Areas Pre-Design
Study**

**Pre-Design Study – Revision 1
Mayflower Pipeline Incident Response, Mayflower, Arkansas**

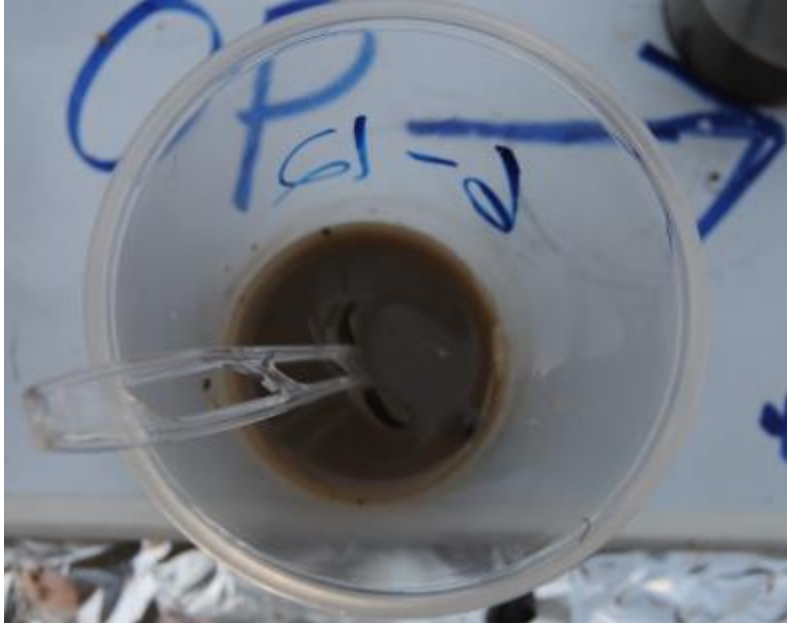
Sheen Stir-Test:

6-12 inches : Patch of silver gray sheen
(Lighter)

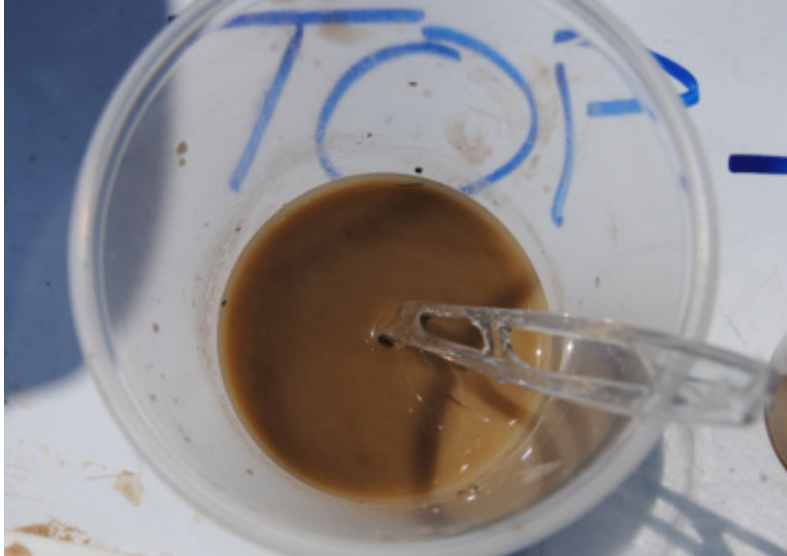
Sheen Stir-Test:

6-12 inches : Streamer of silver gray sheen (Lighter)

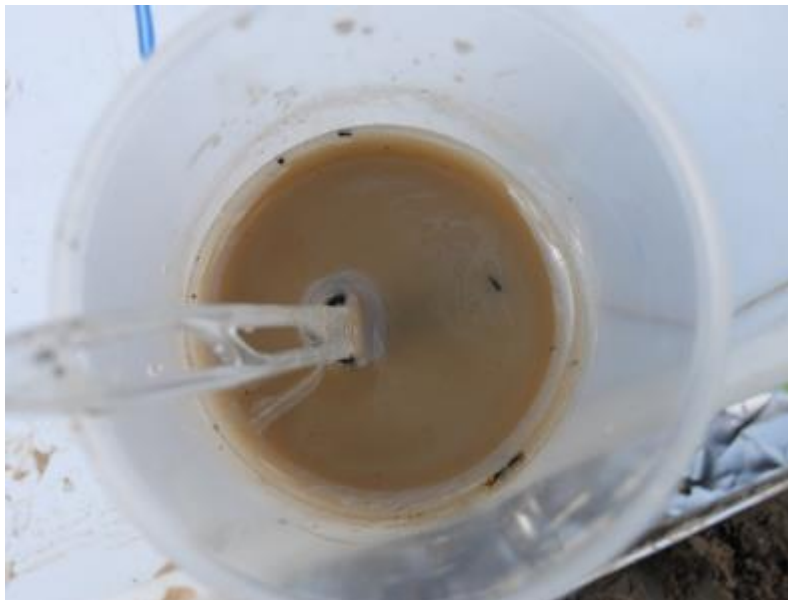
Sheen Stir-Test:

6-12 inches : Streamers of silver gray sheen (Lighter)

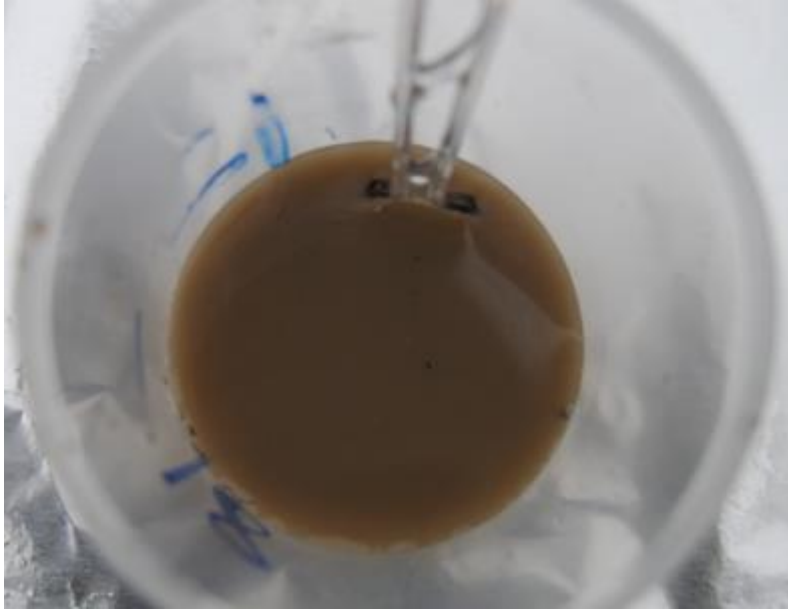
Sheen Stir-Test:

12-18 inches : Streamer of silver gray sheen
(Lighter)

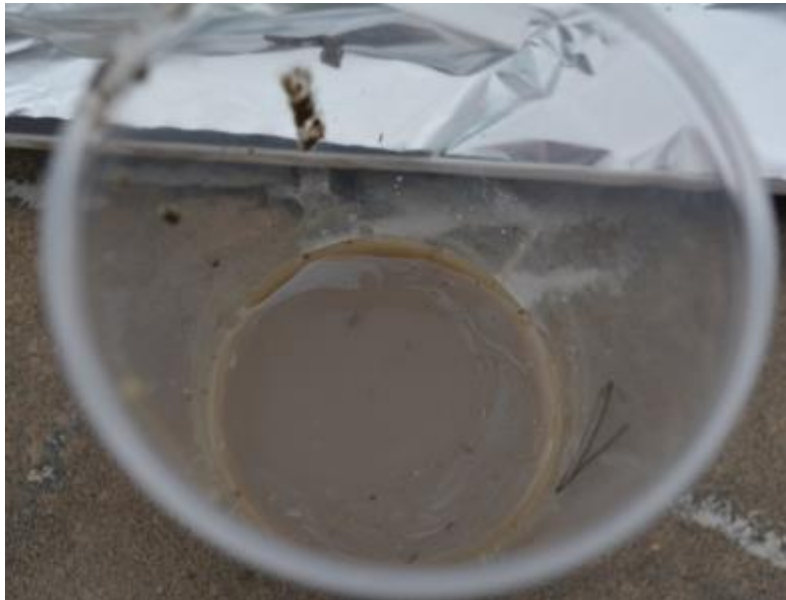
Sheen Stir-Test:

0-6 inches : Patches/streamers of silver gray sheen (Lighter)

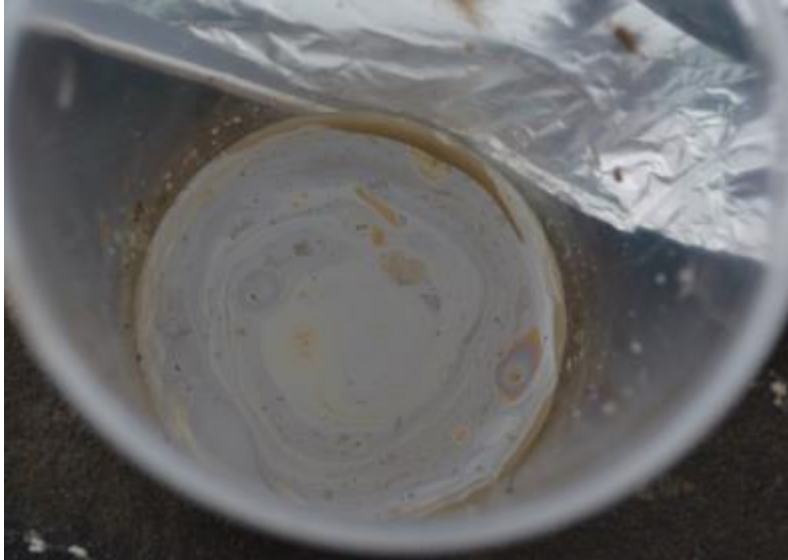
Sheen Stir-Test:

0-6 inches : Patches/streamers of rainbow sheen (Heavier)

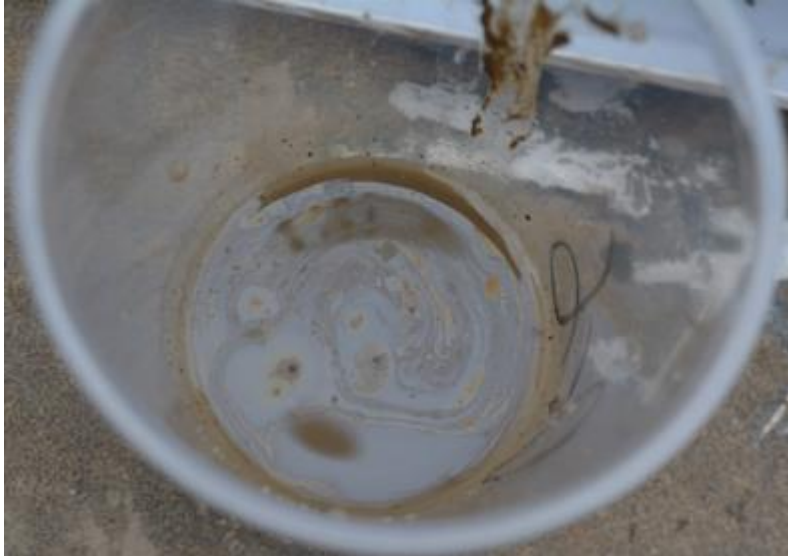
Sheen Stir-Test:

0-6 inches : Patches/streamers of rainbow sheen (Heavier)

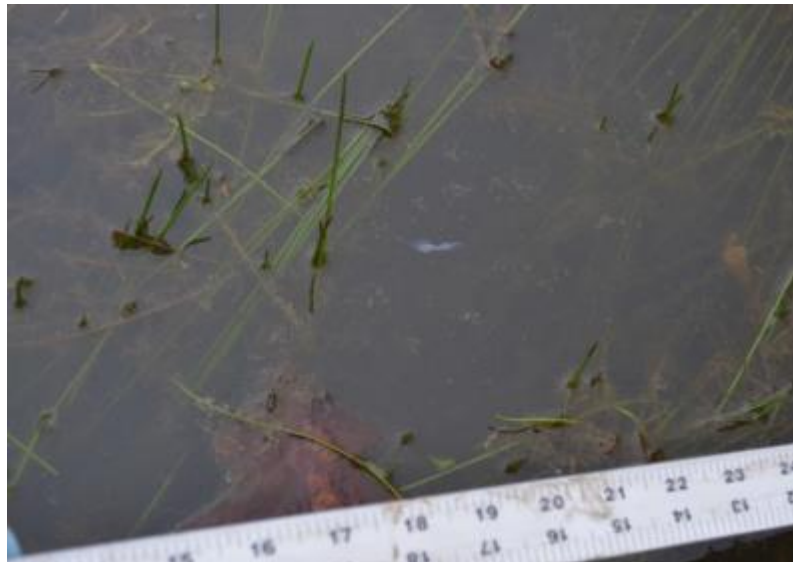
Initial Observation:

Streamers of non-brittle silver gray sheen

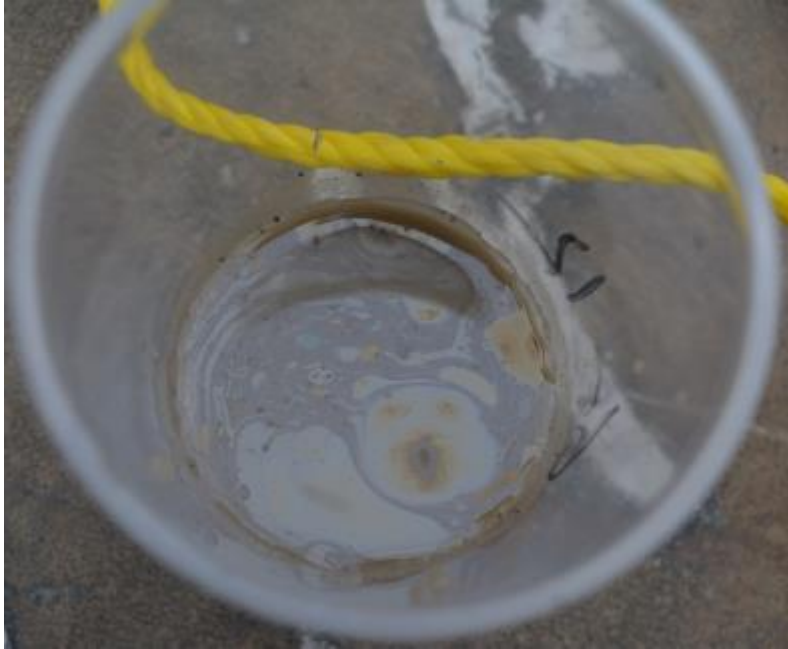
Sheen Stir-Test:

0-6 inches : Patches/streamers of rainbow sheen with oil spots (Heavier)

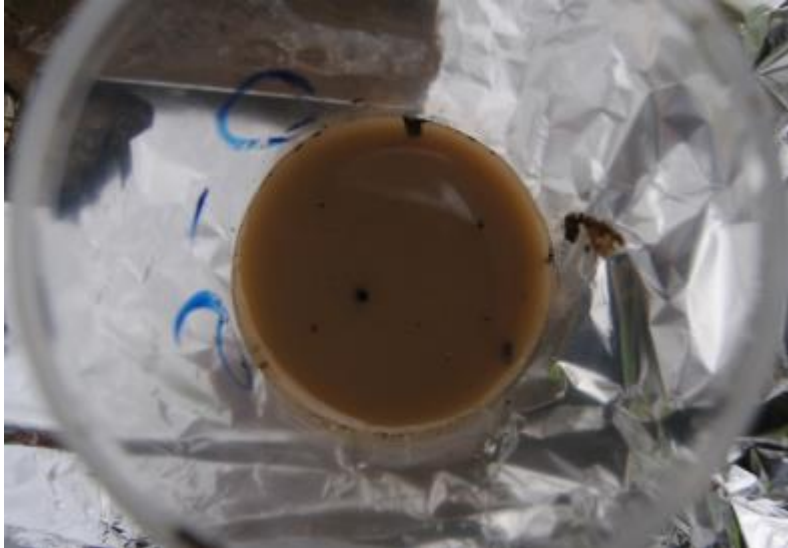
Sheen Stir-Test:

0-6 inches : Streamers of silver gray sheen (Medium)

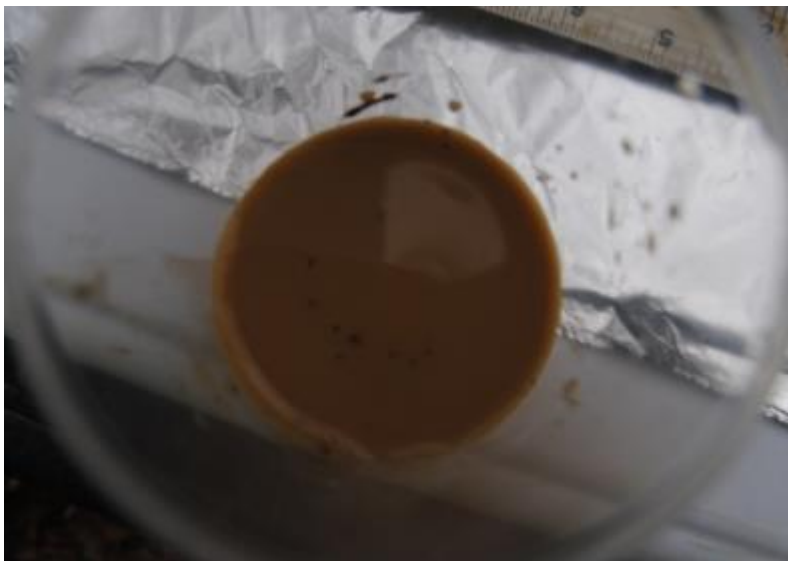
Sheen Stir-Test:

6-12 inches : Streamers of silver gray sheen (Lighter)

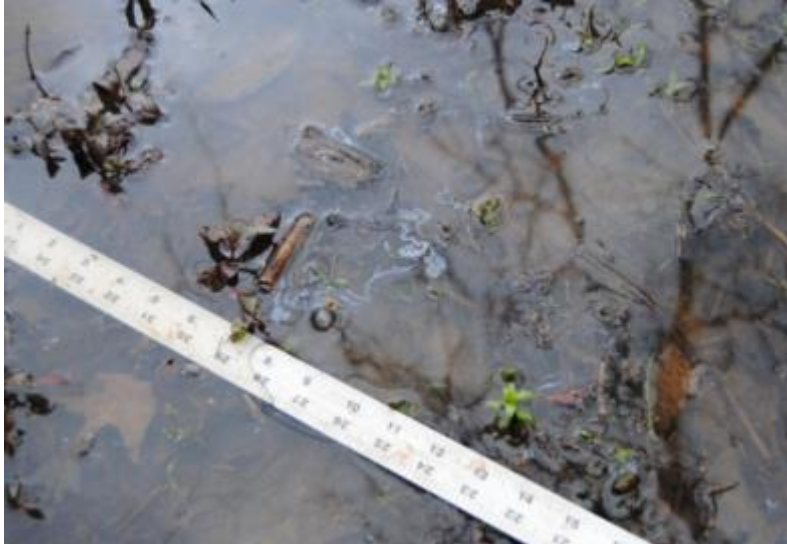
Initial Observation:

Patches/streamers of non-brittle silver gray sheen with oil spot (<0.25-inch wide)

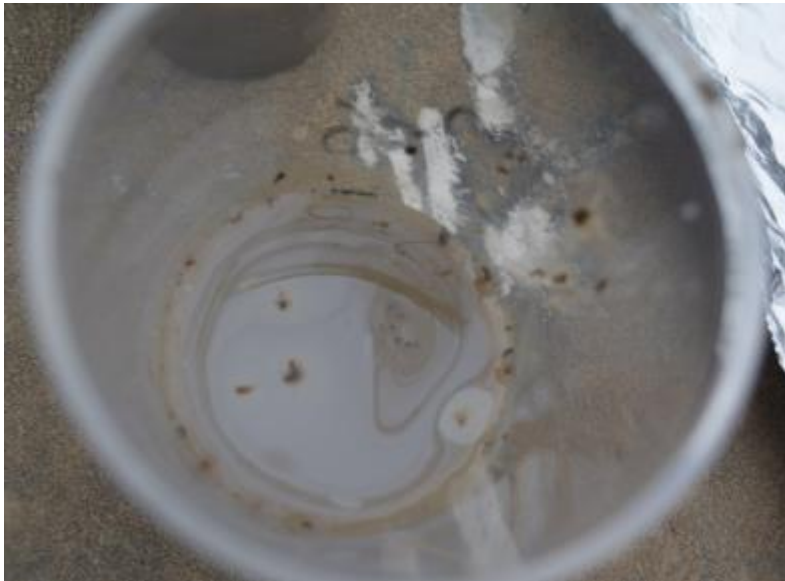
Sheen Stir-Test:

0-6 inches : Patches/streamers of rainbow sheen with five oil spots (Heavier)

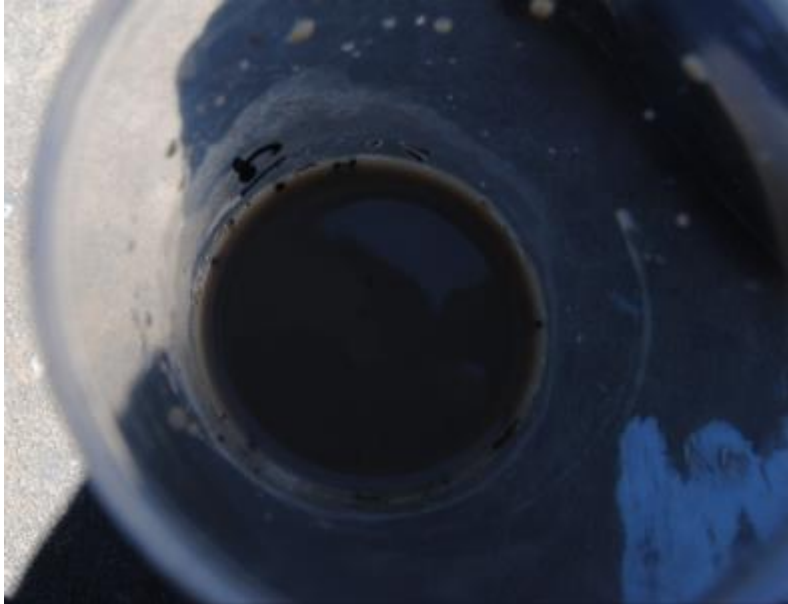
Sheen Stir-Test:

6-12 inches : Patch of silver gray sheen
(Lighter)

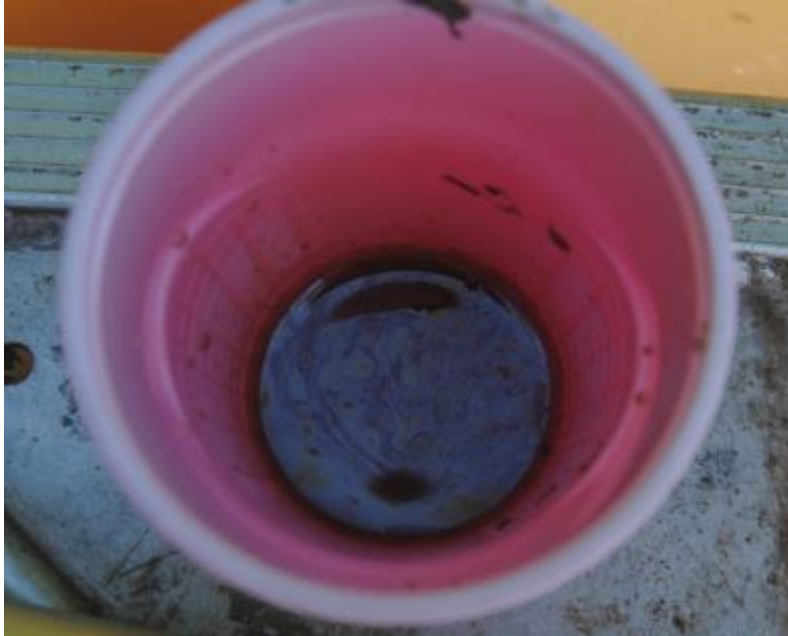
Sheen Stir-Test:

6-12 inches : Patches/streamers of rainbow sheen (Heavier)

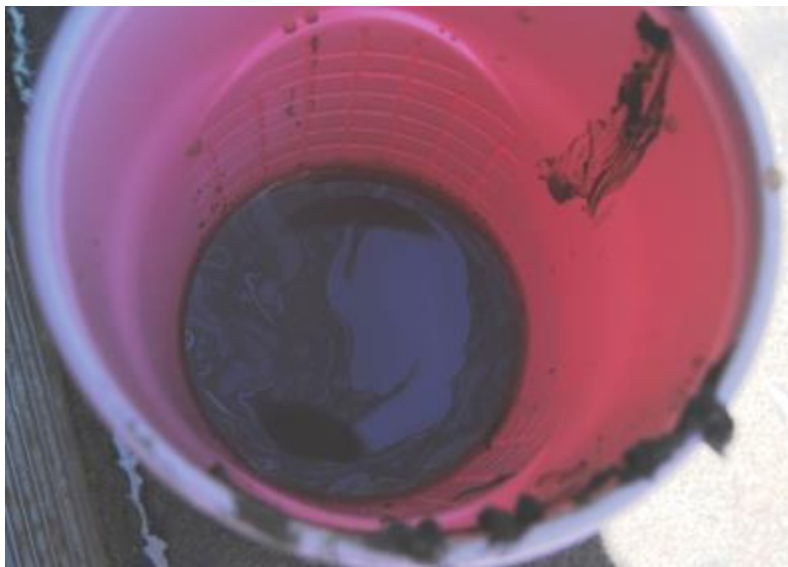
Sheen Stir-Test:

0-6 inches : Patches/streamers of silver gray sheen (Medium)

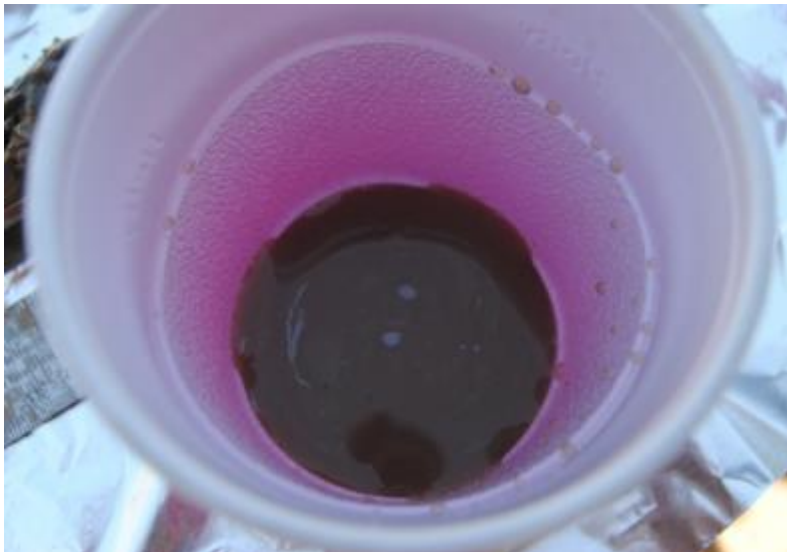
Sheen Stir-Test:

0-6 inches : Patches/streamers of silver gray sheen (Lighter)

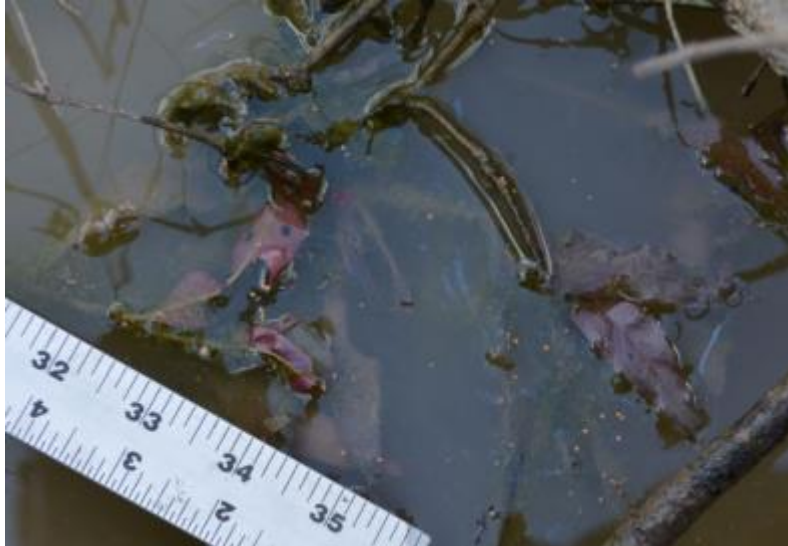
Initial Observation:

Patches/streamers of non-brittle silver gray sheen
