Status Report

To: Jarrod Zweifel, ADEQ
From: EnSafe Inc.
Date: January 31, 2019
Subject: Trafalgar Road Site — Project Status

Photo Log
January 24-30, 2019, Status Report
Trafalgar Road Site – Bella Vista, Arkansas

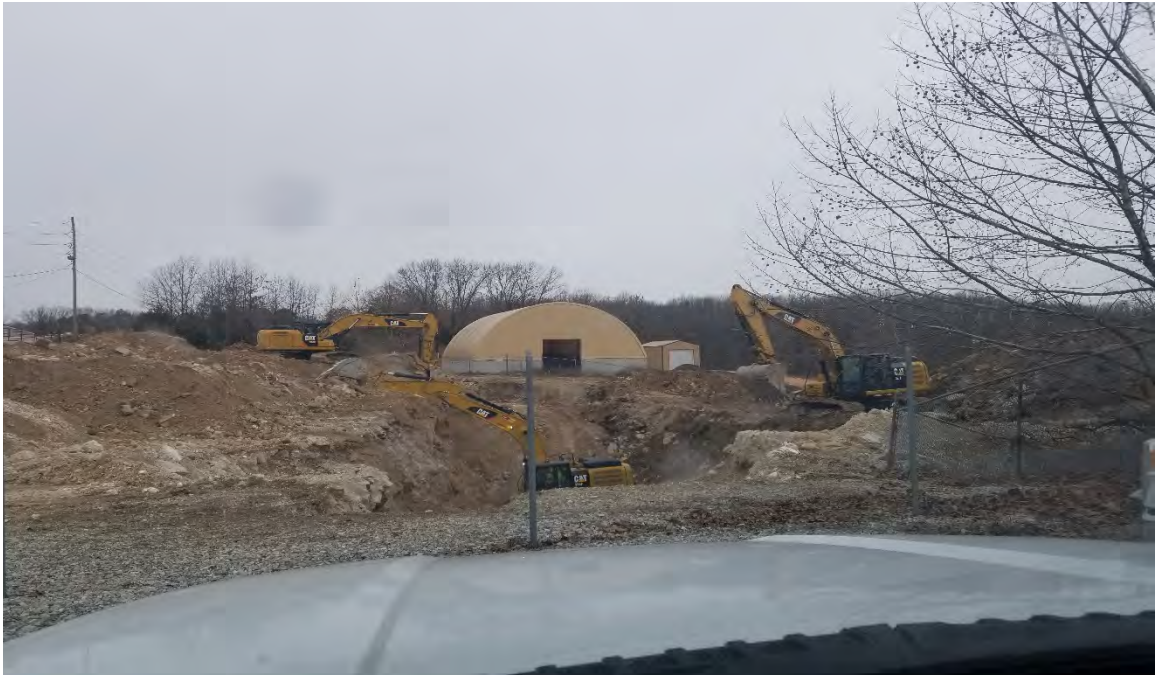
Photo 1: Trench excavation (view to west). Stockpile to south (left of photo) is segregated onsite “clean” soil from 0-15-foot bgs interval, and offsite clean fill. Stockpile to north (right of photo) is debris pile.

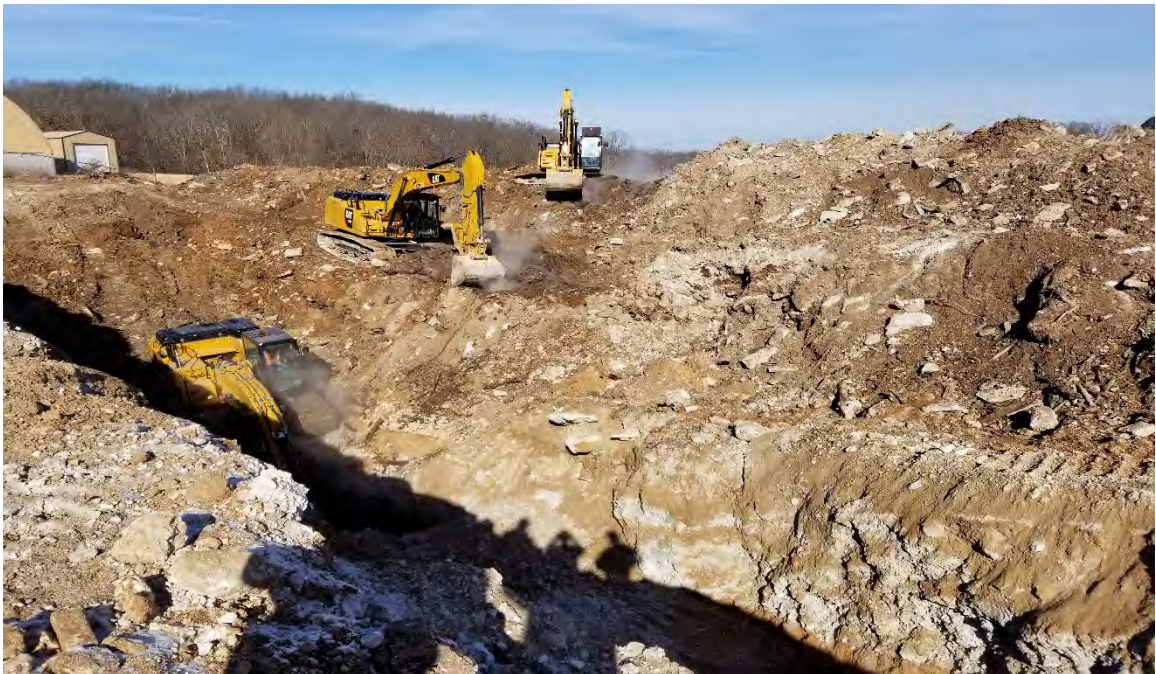
Photo 2: Trench excavation procedures, showing benched excavation. To achieve excavation to depths >40 feet bgs, the trench was widened. One trackhoe excavated material to mid-depth. A second trackhoe lifted material to near ground surface. A third trackhole manipulated material into the debris stockpile. Note stumps and concrete in stockpile.

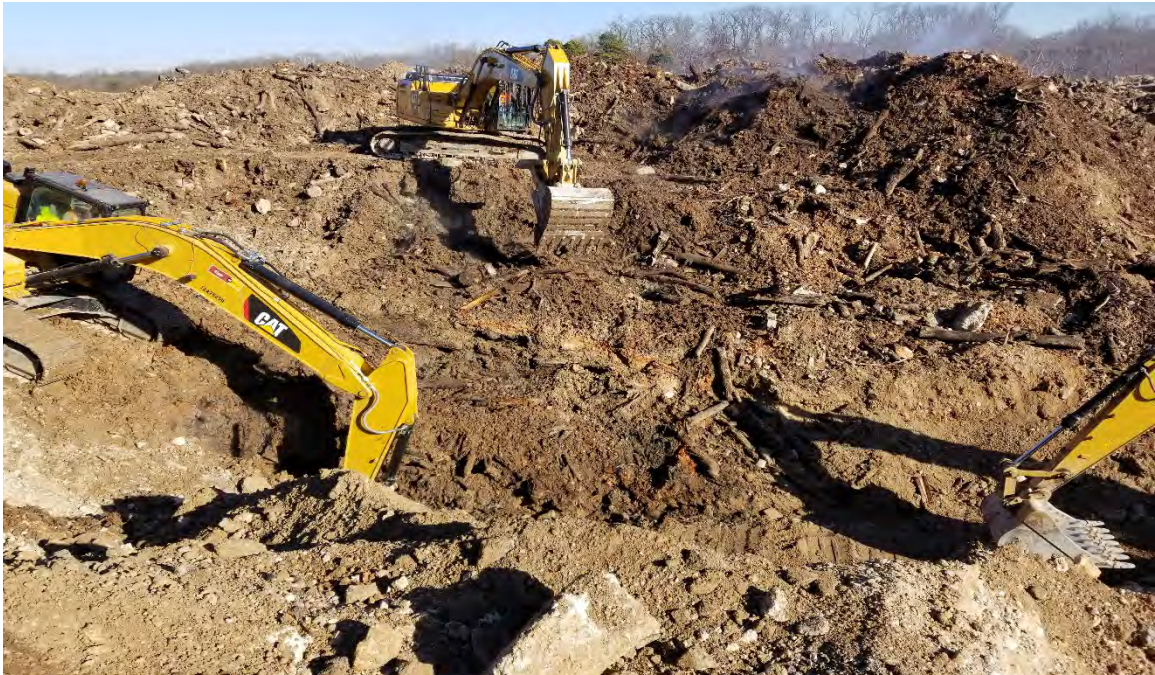
Photo 3: View to north, showing excavated debris and debris pile.

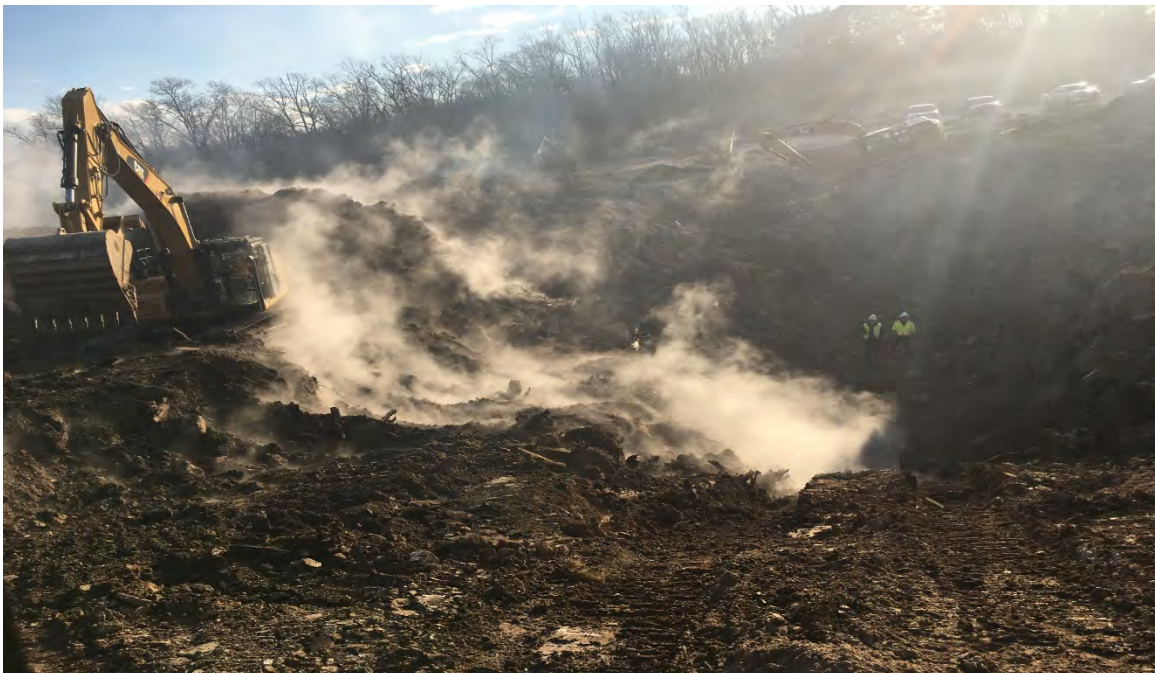
No fire was encountered in the trench. One smoke vent was observed in the trench at a depth of approximately 25 feet bgs. On the northern bench, one small fire was encountered and extinguished. It was unclear whether this was associated with the main fire or combustion of composting materials.

Photo 4: Smoke vent with steam approximately 25 feet bgs encountered on 27 January 2019. EnSafe personnel performing air monitoring of trench.

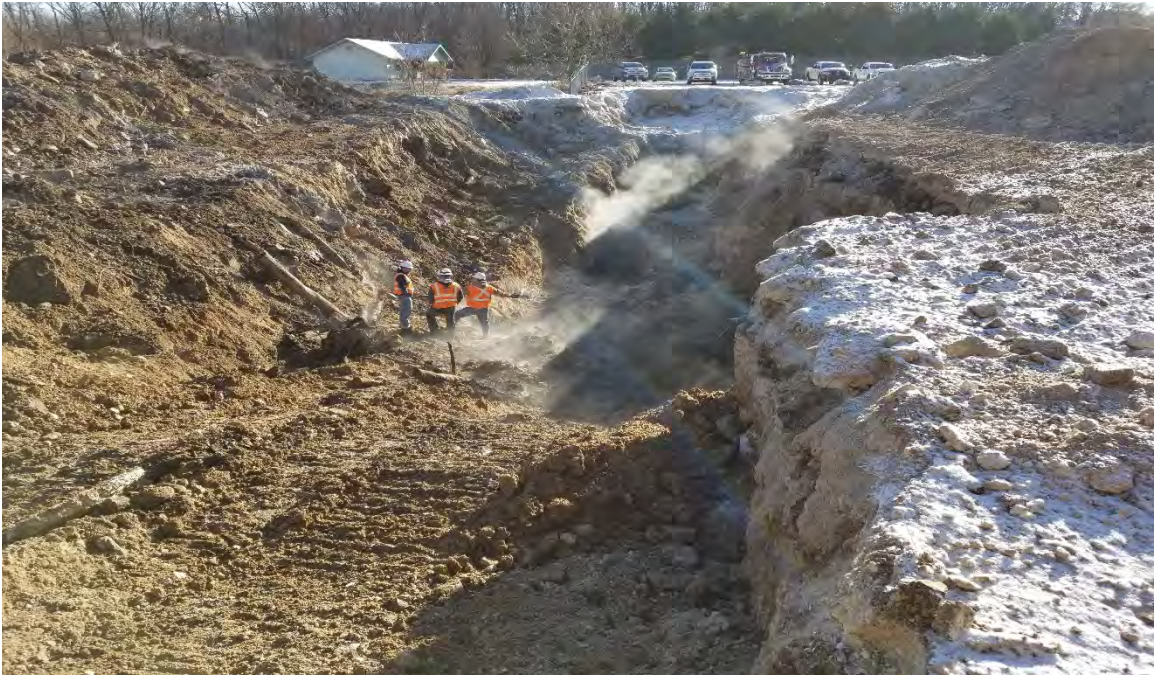
Photo 5: Excavated trench, view to east. Steam from composting wastes.

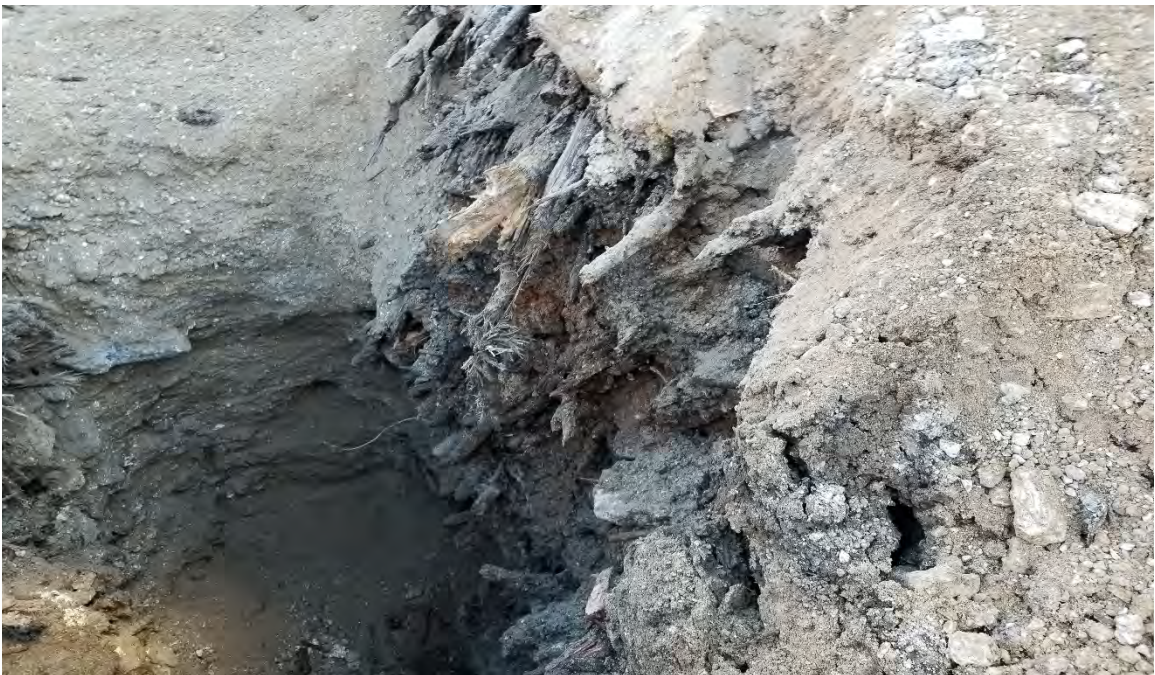
Photo 6: Close up of deep debris layer approximately 30-40 feet bgs (compacted soil, tree trunks, etc.)

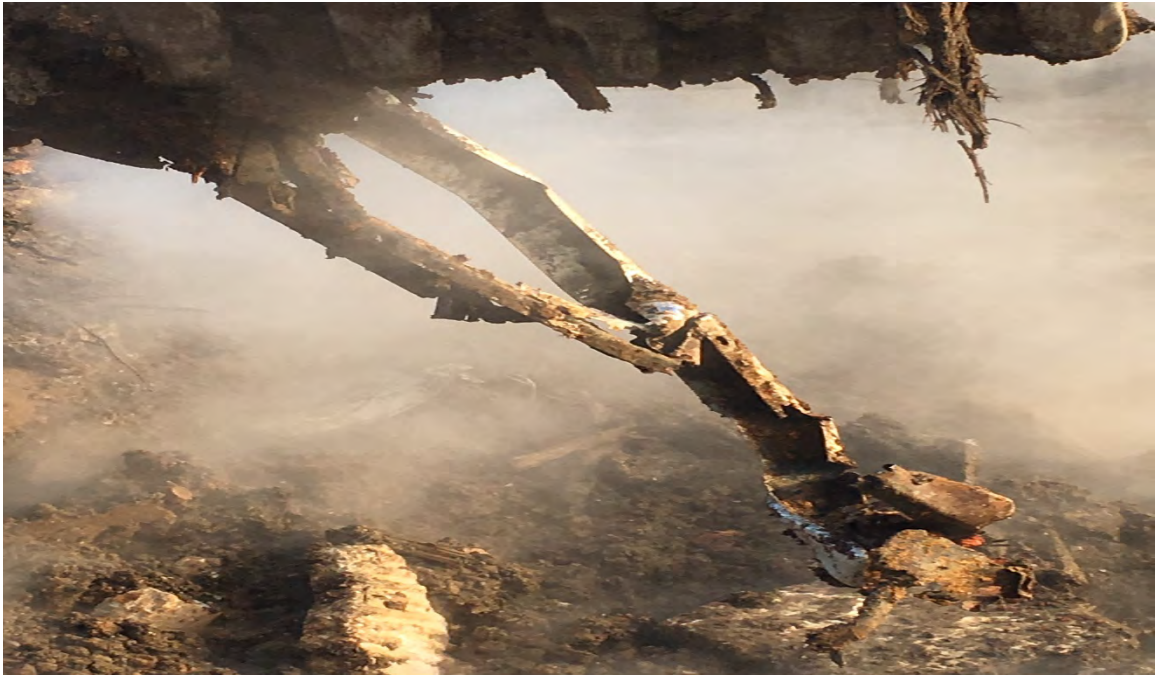
Photo 7: Possible car fender and suspension.

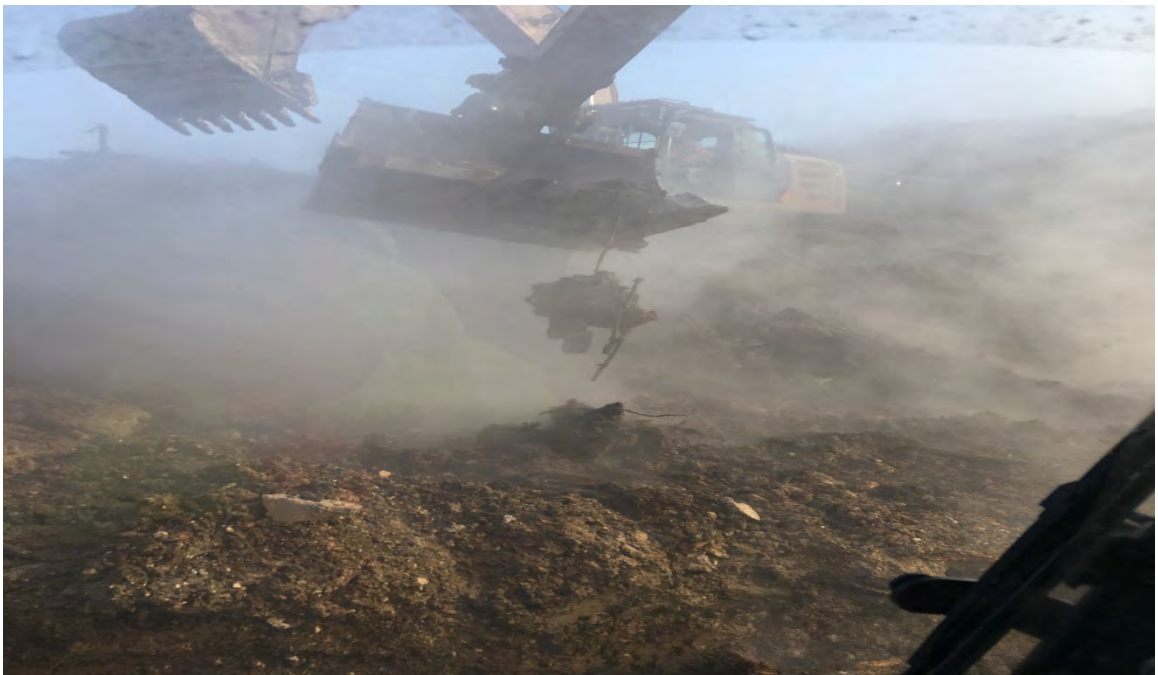
Photo 8: Possible vehicle transmission.

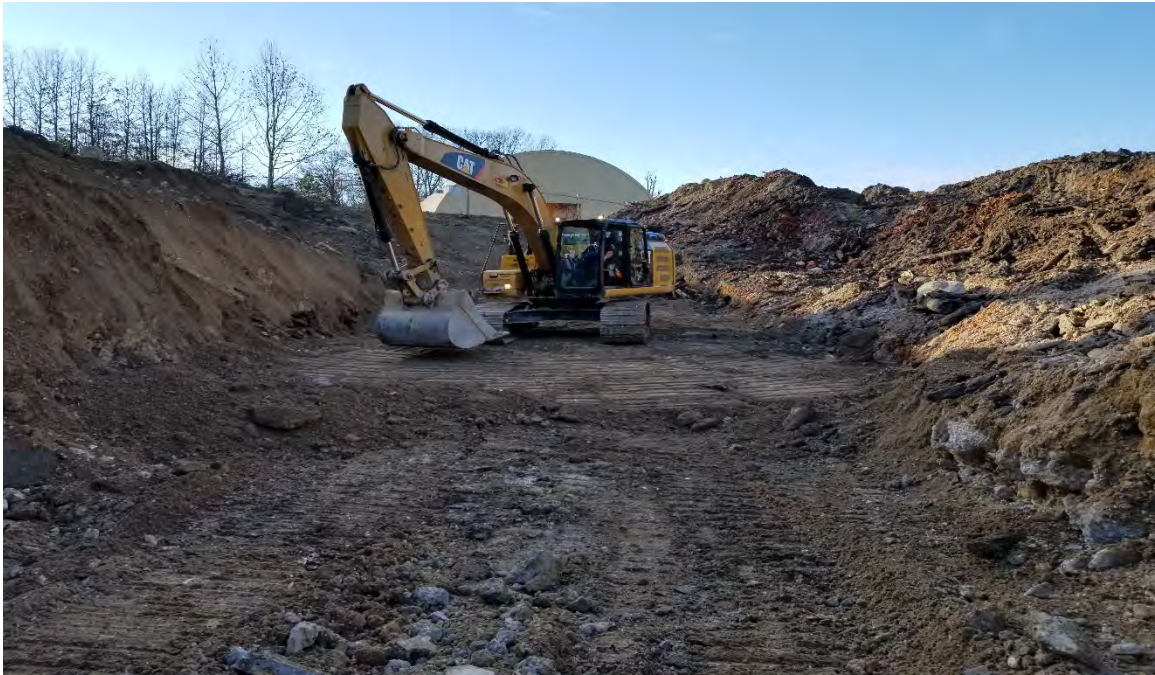
Photo 9: Filling trench to construct fire break (view to west). Clean fill material from on- and offsite was used to construct the subgrade fire break and to cover the south bench. The minimum cover over the waste was 5 feet; the minimum width of the trench was 5 feet.

The trench was backfilled with “clean” soil from soil from the excavation and fill from offsite as an underground fire break. The southern bench was also filled with “clean” excavated material and offsite soils, to provide a 5 to 15-foot cover of the wood material. The northern bench was filled with soil segregated from the debris stockpile. Segregation separated out most of the wood and other large debris, but small debris was present in the fill soil used to fill the northern bench. The remaining stockpiled debris pile remains onsite and was sloped to drain towards the north. Cuts were installed through the material to allow storm water to drain and limit ponding in the NWA Storage parking lot.

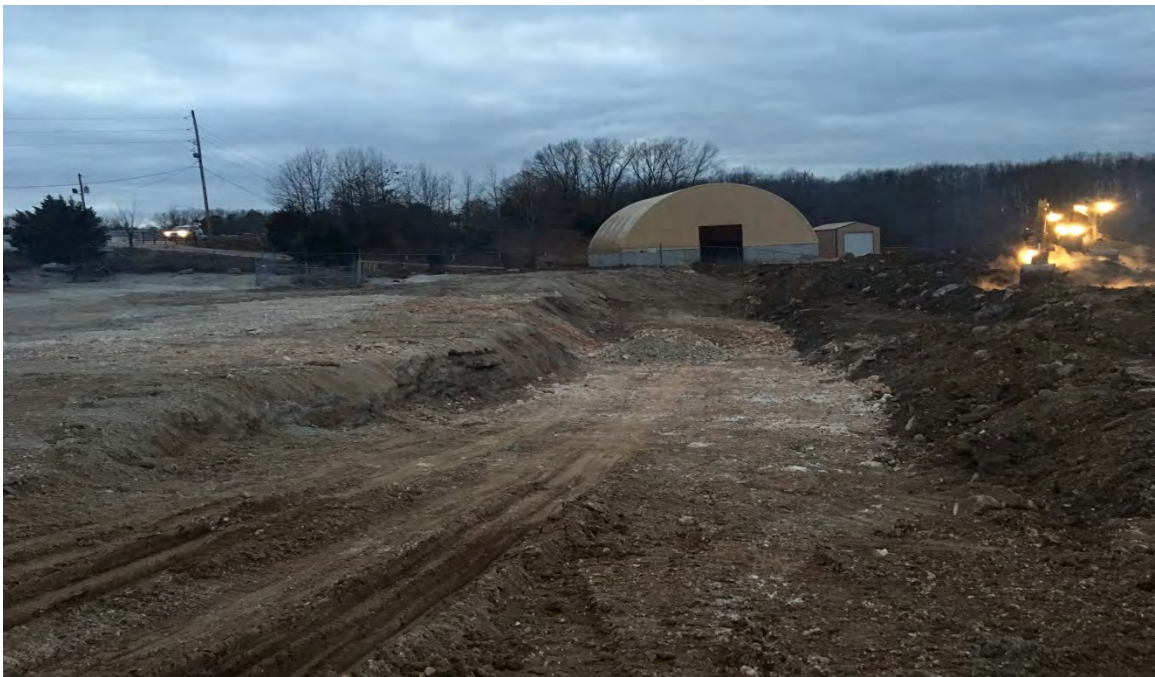
Photo 10: The trench and south bench area (view to west); fill and compaction activities occurring on north bench. Segregated soil from the debris pile was used to fill the north bench.

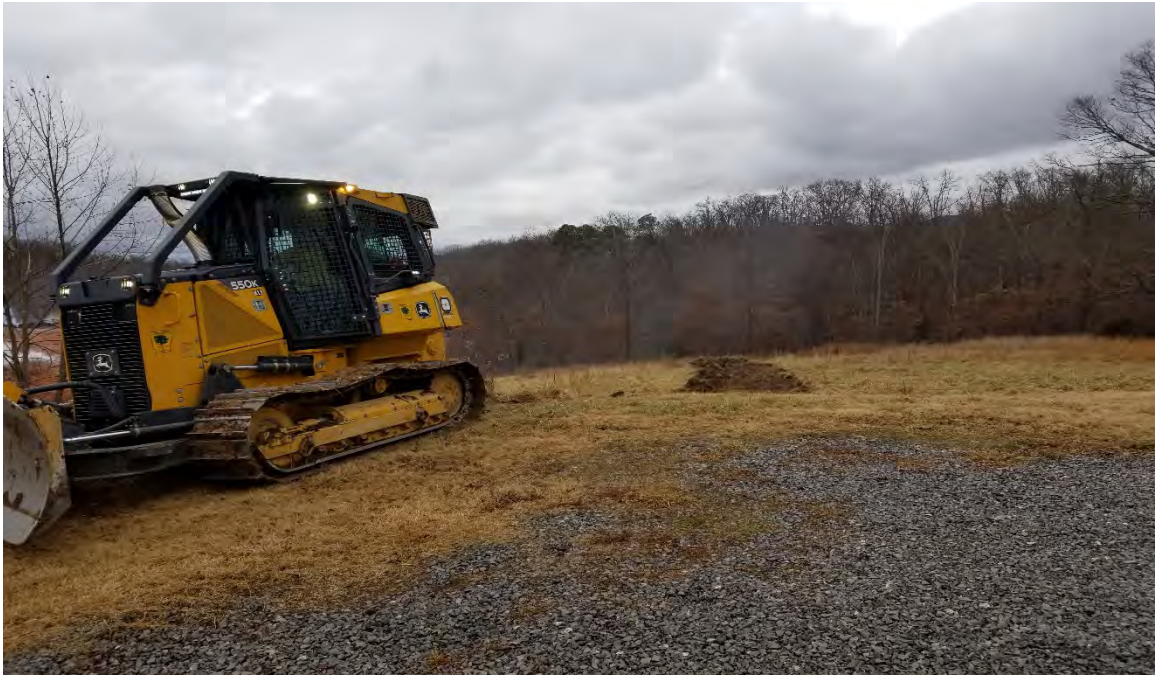
Photo 11: The Arkansas Forest Service was onsite to clear the fire break on 28-29 January 2019.

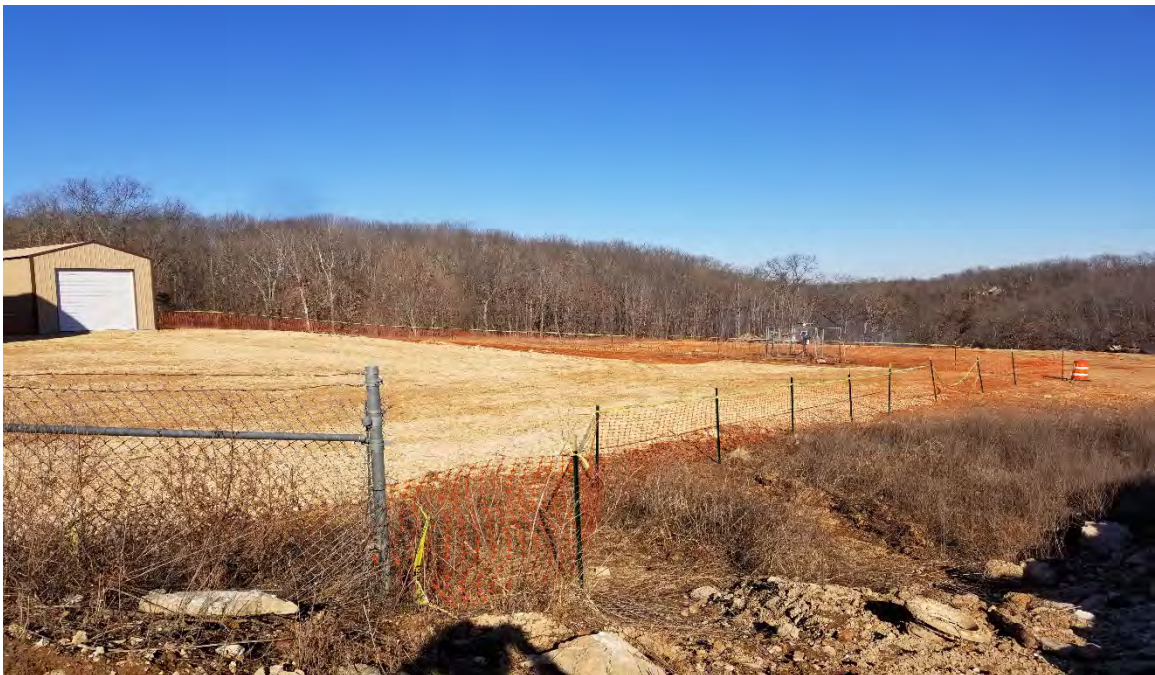
Photo 12: Orange construction fencing was placed to restrict entry onto the Trafalgar Road Site.
