ARKANSAS
Department of Environmental Quality

WATER DIVISION COMPLAINT REPORT

COMPLAINANT NAME: Anonymous MAILING ADDRESS: CITY, STATE, ZIP: PHONE & EXT: / FAX: / EMAIL: RESPONSE REQUESTED BY COMPLAINANT: ***	COMPLAINT AGAINST: Georgia Pacific - Crossett SITE ADDRESS: MAILING ADDRESS: 100 Mill Supply Rd. CITY, STATE, ZIP: Crossett AR 71635 PHONE & EXT: / FAX: / EMAIL:
--	---

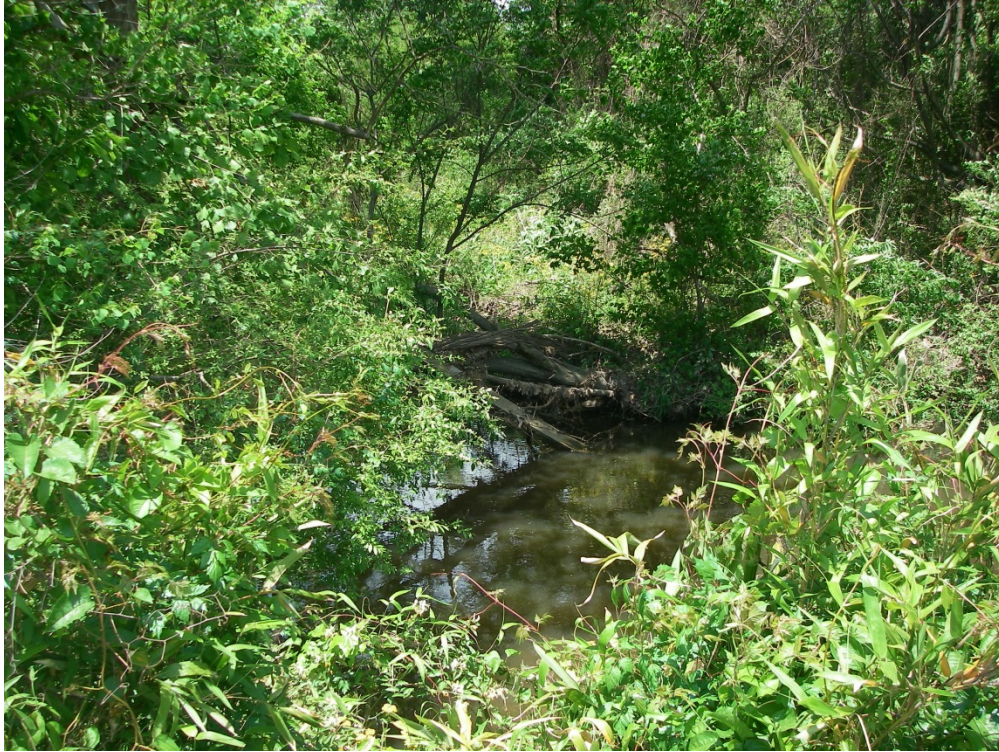
Location:	Georgia Pacific – Crossett				
Photographer:	Jason Bolenbaugh	Date:	May 7, 2014	Time:	
Witness:				Photo #:	1
Description:	GP05 – creek conditions on the north side of the City of Crossett’s WWTP.

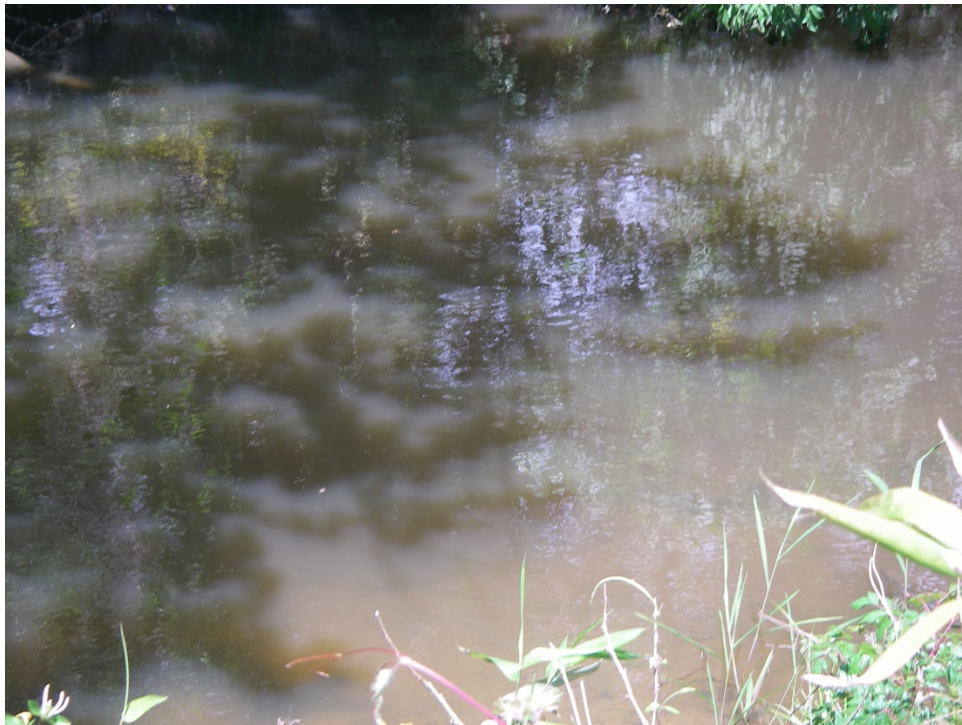
Photographer:	Jason Bolenbaugh	Date:	May 7, 2014	Time:	
Witness:				Photo #:	2
Description:	GP05 – closer view of above photograph.

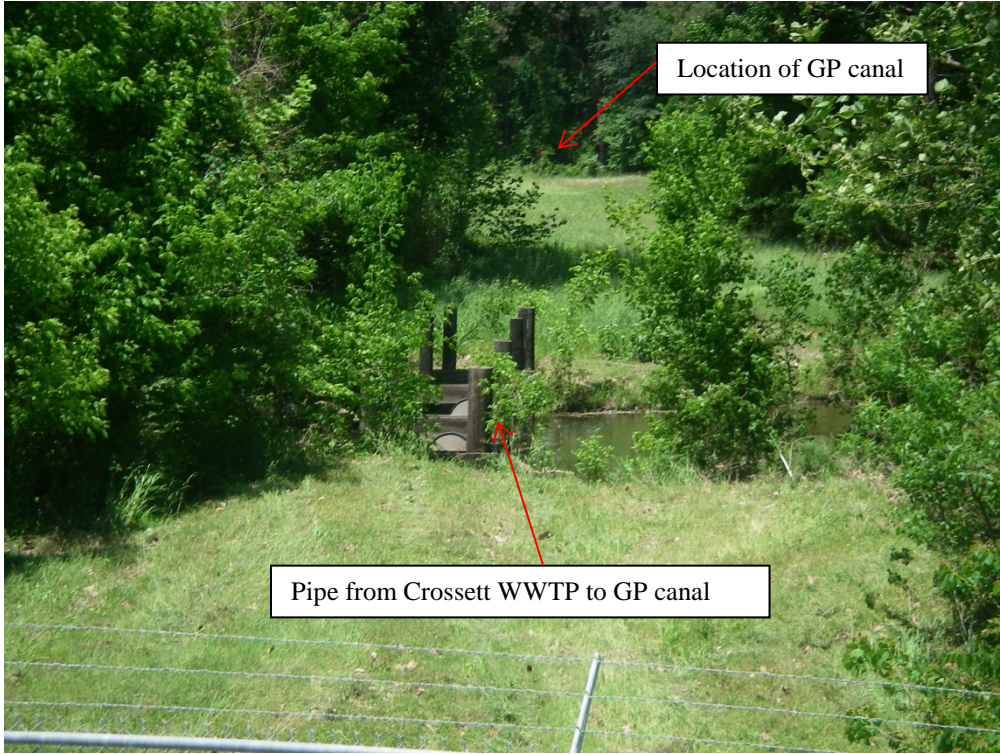
Location:	Georgia Pacific – Crossett		
Photographer:	Jason Bolenbaugh	Date:	May 7, 2014
Witness:		Time:	
		Photo #:	3
Description:	Effluent pipe from Crossett WWTP leading to the permittees canal just below the surge basin.

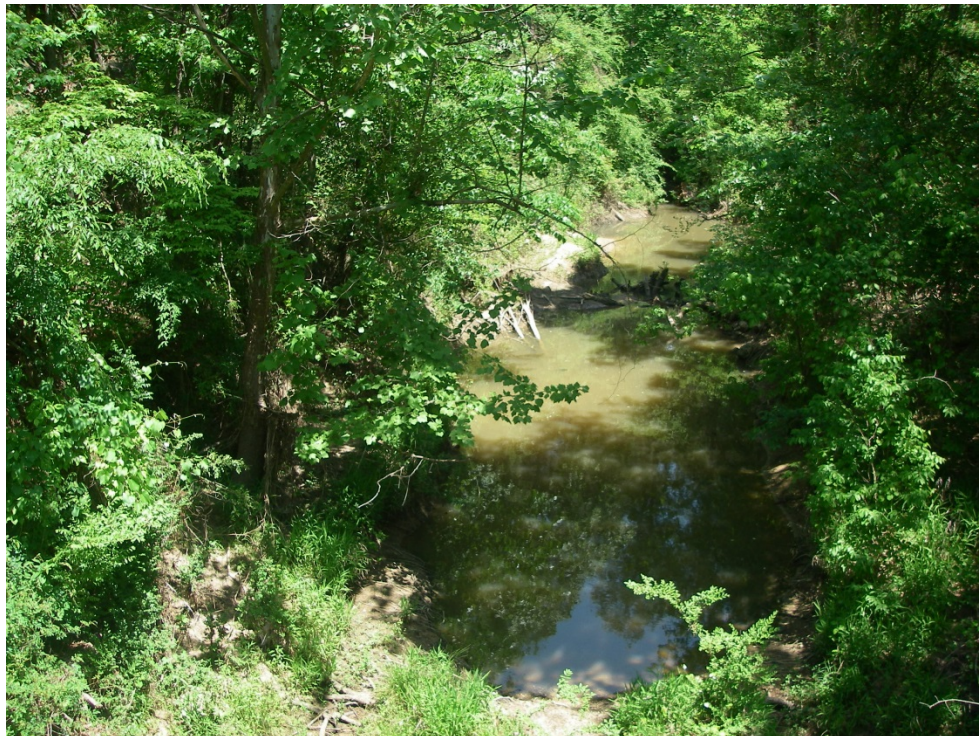
Photographer:	Jason Bolenbaugh	Date:	May 7, 2014
Witness:		Time:	
		Photo #:	4
Description:	GP06 Location – condition of Coffee Creek

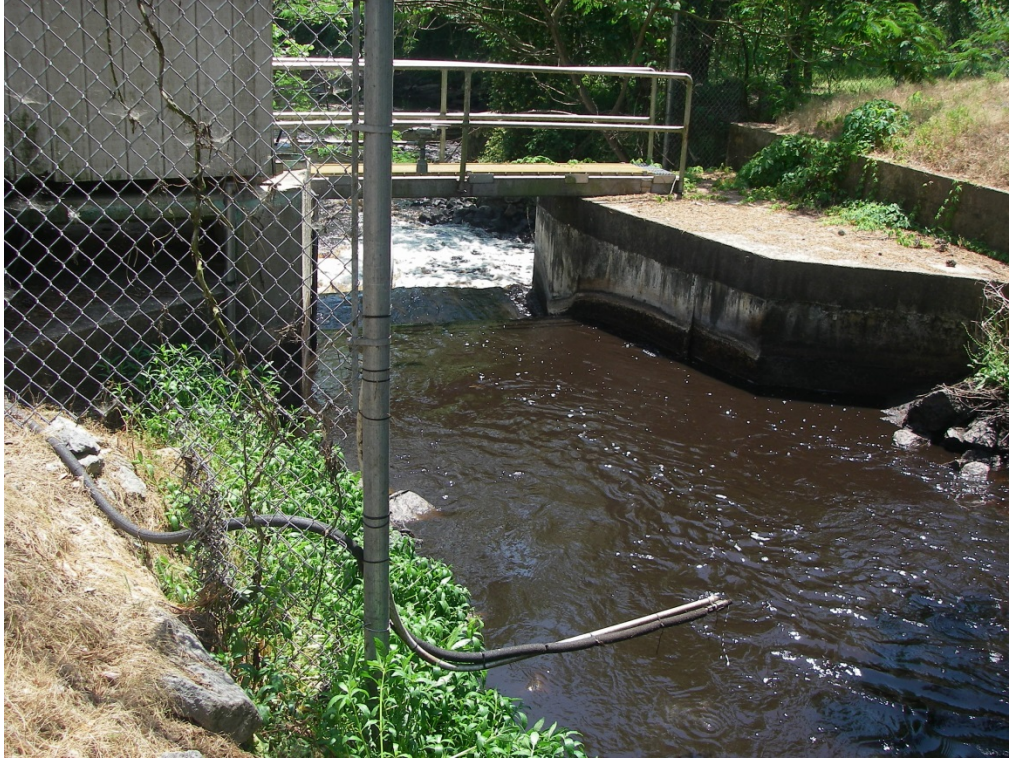
Location:	Georgia Pacific – Crossett		
Photographer:	Jason Bolenbaugh	Date:	May 7, 2014
Witness:		Time:	
		Photo #:	5
Description:	Permitted Outfall – discharge is

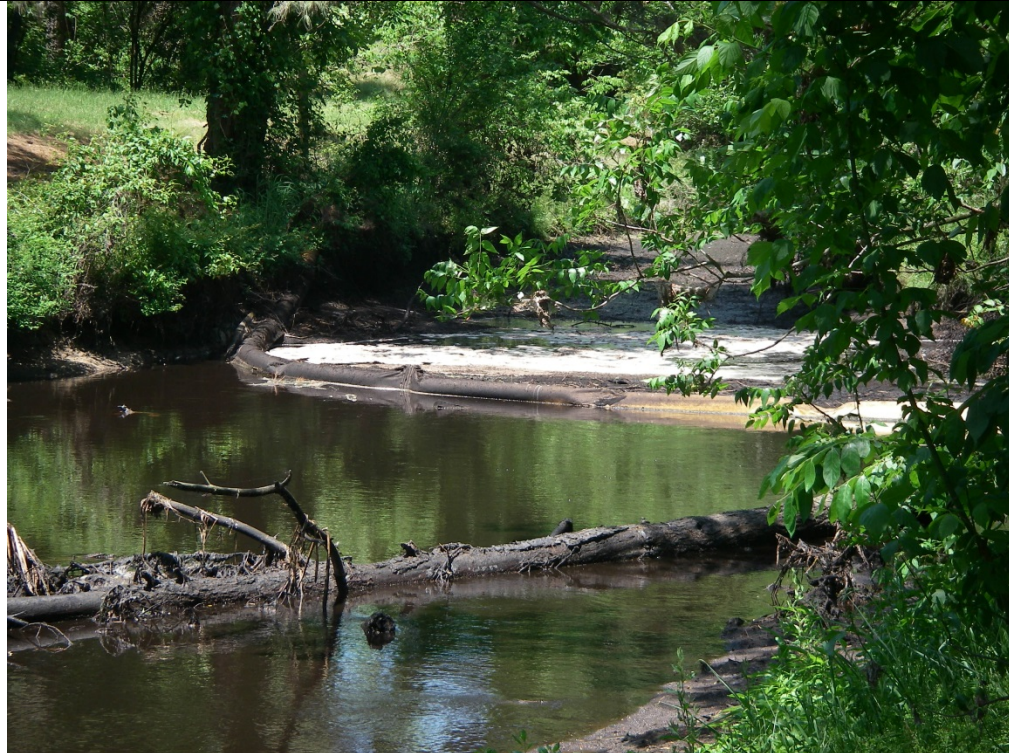
Photographer:	Jason Bolenbaugh	Date:	May 7, 2014
Witness:		Time:	
		Photo #:	6
Description:	Looking at the foam curtain upstream of the permitted outfall pictured above.
