ARKANSAS
Department of Environmental Quality

WATER DIVISION COMPLAINT REPORT

AFIN: 41-00002 PERMIT #: AR0002968

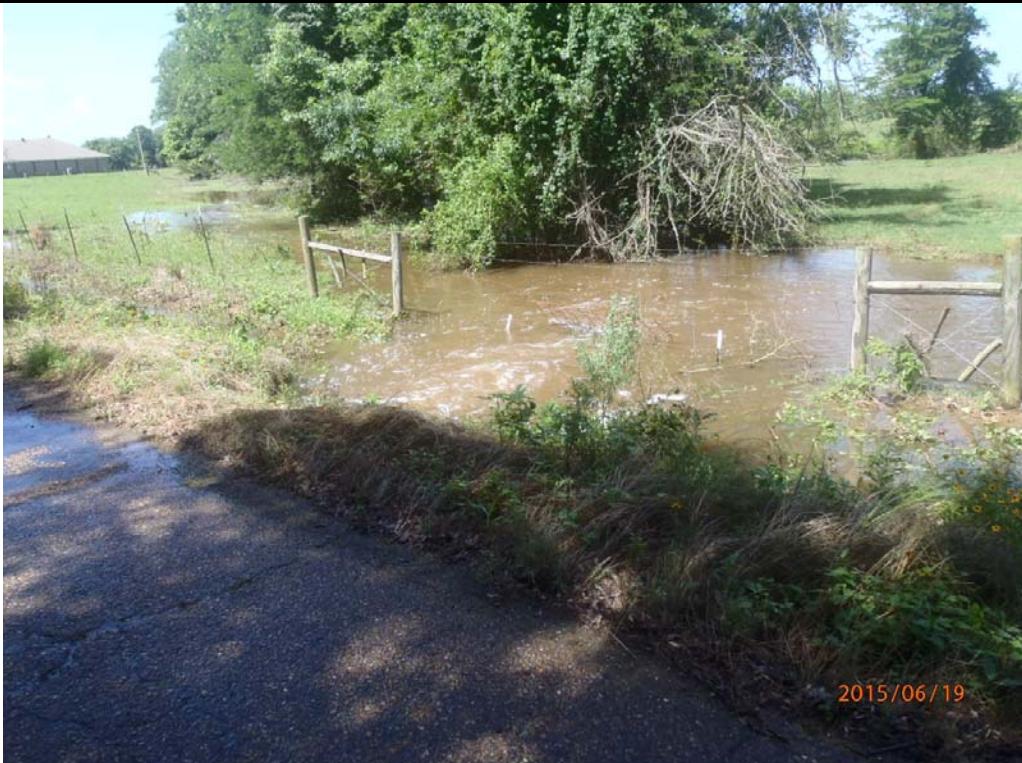
Witness:	Charles Allen, Domtar	Photo #:	1
----------	-----------------------	----------	---

Description:	Water flowing west to east through culverts under LR 23. No evidence of any runoff from Domtar.
--------------	---

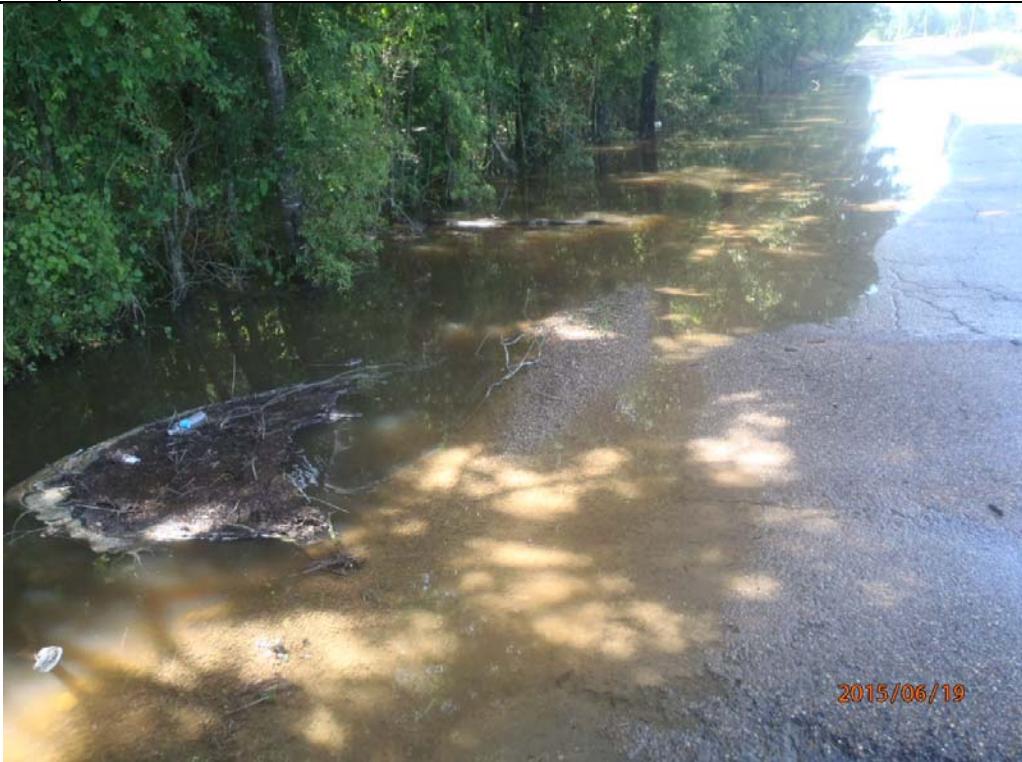
Witness:	Charles Allen, Domtar	Photo #:	2
----------	-----------------------	----------	---

Description:	Water on east-side of road. Earlier it had the road flooded.
--------------	--

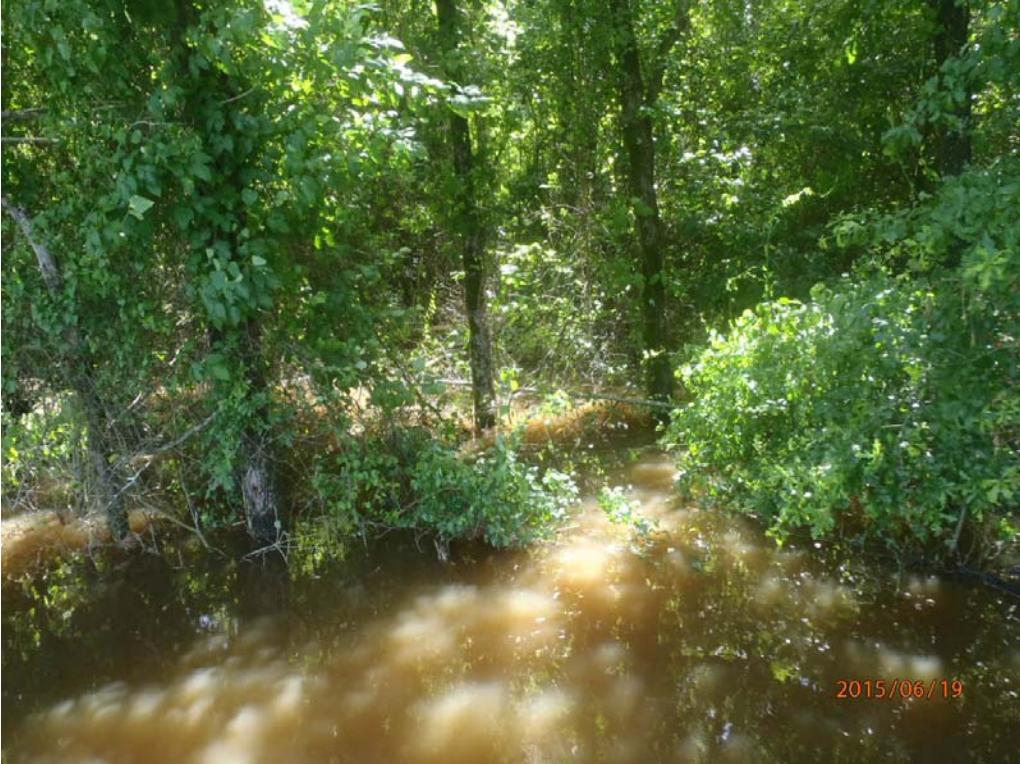
Location:	1.25 miles south of Hwy 32 West on LR 23 (Pine Prairie Rd) in Ashdown (33.634462; -94.134003).		
Photographer:	Red Smith	Date:	6/19/2015
Witness:	Charles Allen, Domtar		
Description:	Looking east from road into woods. This whole wooded area appeared to flooded.
