A R K A N S A S
Department of Environmental Quality

WATER DIVISION COMPLAINT REPORT

AFIN: 41-00002 PERMIT #: AR0002968

DETAILED DESCRIPTION OF COMPLAINT

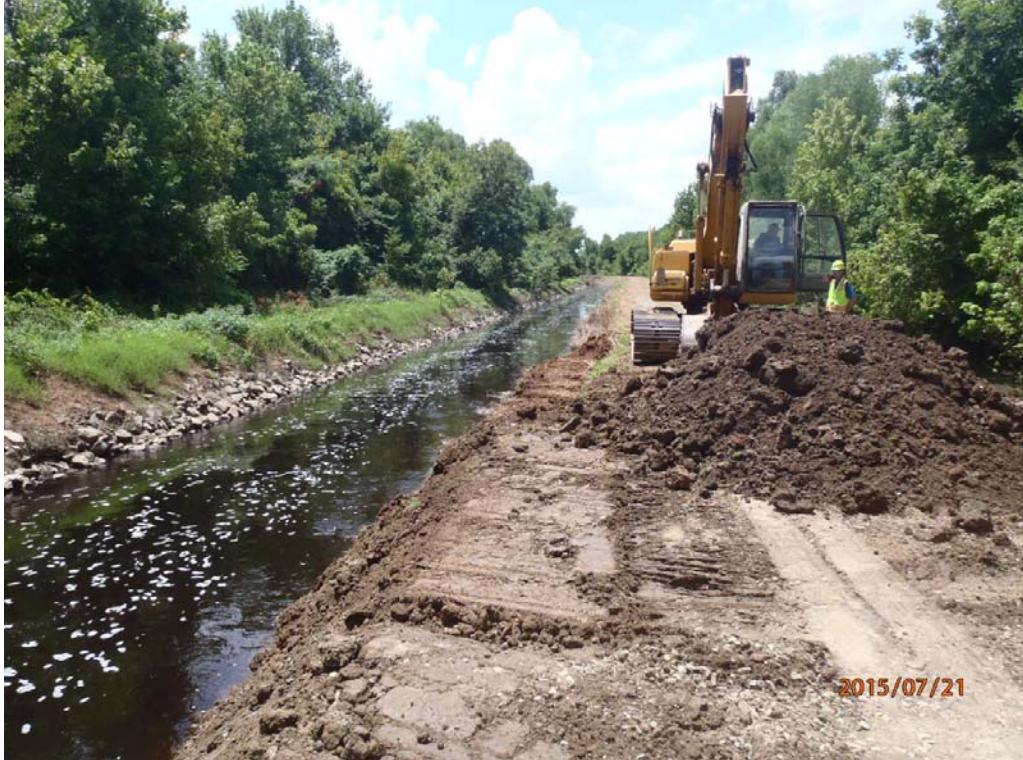
Water Division Photographic Evidence SheetLocation: **Domtar A.W. open canal flowing to Red River**Photographer: **Red Smith** Date: **7/21/2015** Time: **1304**Witness: **Brandon Ayers / Senior Env. Engineer, Domtar** Photo #: **1**Description: **Stabilizing a portion of the canal bank that was washed away due to the flood. This site was upstream approximately 300 feet from the levee breach.**

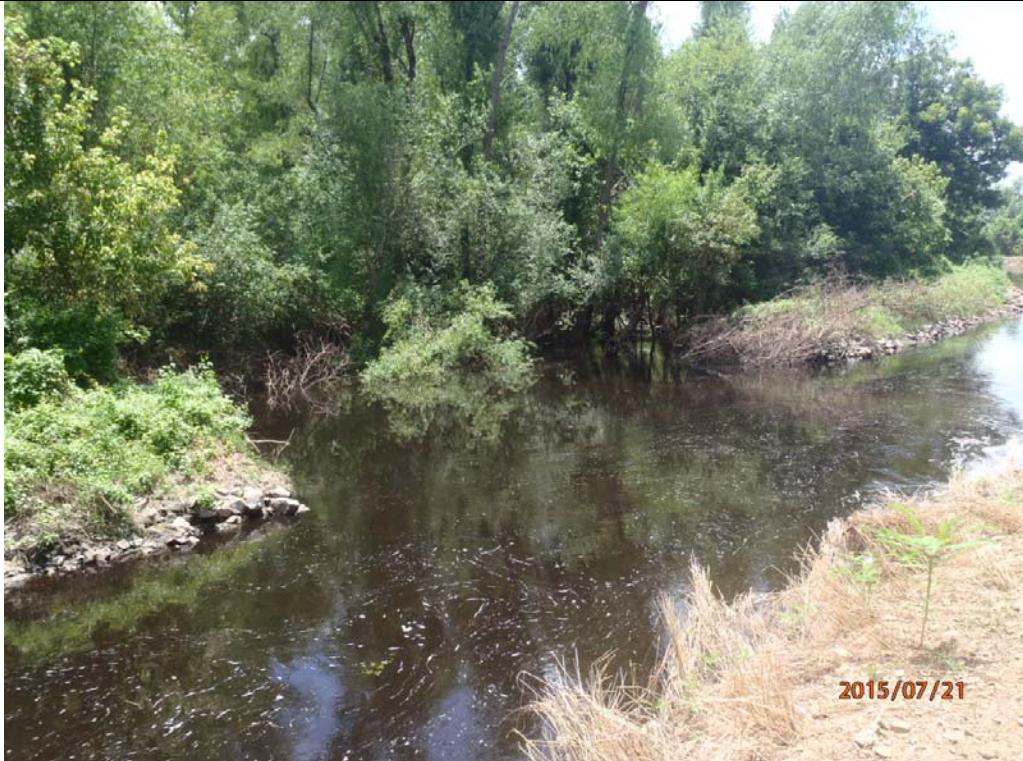
Photographer: **Red Smith** Date: **7/21/2015** Time: **1308**Witness: **Brandon Ayers / Senior Env. Engineer, Domtar** Photo #: **2**Description: **The levee breach estimated to be 40 to 50 feet wide.**

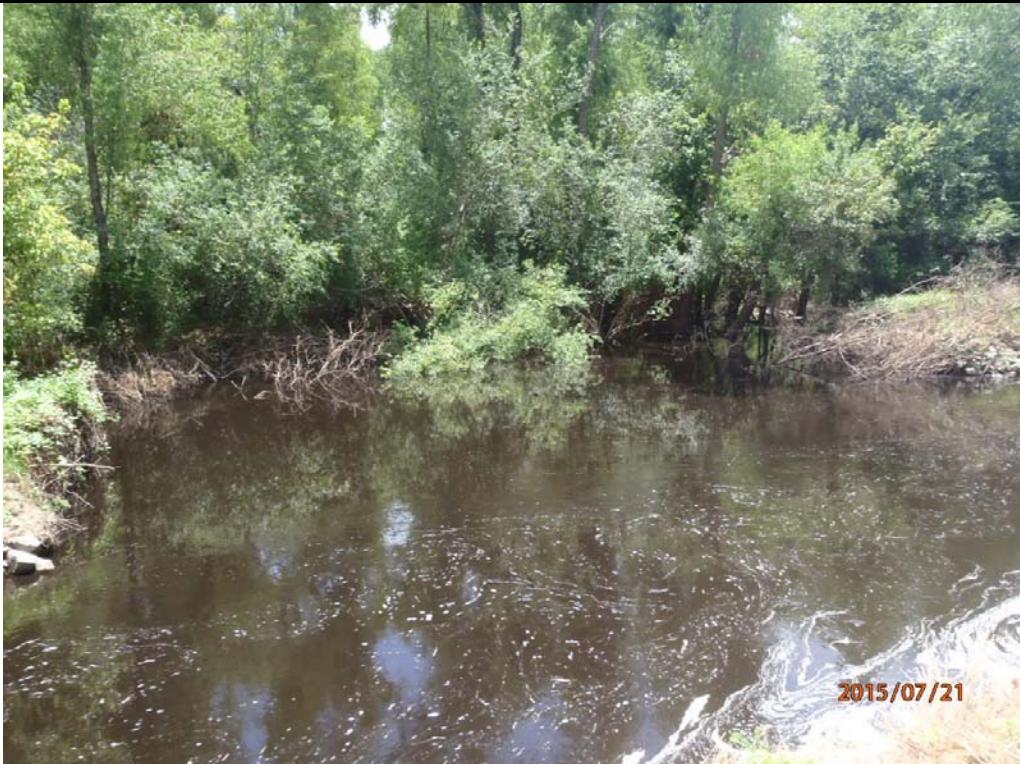
Witness: **Brandon Ayers / Senior Env. Engineer, Domtar** Photo #: **3**

Description: **Another view of breach. Some effluent was flowing into the woods.**
