ADEO	WATER DIVISION COMPLAINT REPORT					
ADEU	AFIN: 20-00017		PERMIT #: AR0047503			
	COUNTY: 20) Dalla	ıs	PDS #: 024475		
ARKANSAS Department of Environmental Quality	GPS LOCAT		LAT: 33.076997 LON			
COMPLAINANT NAME:			scharge Site / 🔲 Ge	neral Area / 🗵 Entrance	<u>}</u>	
Anonymous MAILING ADDRESS:			Idaho Timber of Ca	rthage, LLC		
CITY, STATE, ZIP:			322 N Oak Street C	arthage, AR		
			P.O. Box 37			
PHONE & EXT: / FAX:			CITY, STATE, ZIP: Carthage AR 71725			
EMAIL:			PHONE & EXT: / FAX:	_

Complaint Report: Idaho Timber of Carthage, LLC, AFIN: 20-00017, Permit #: AR0047503

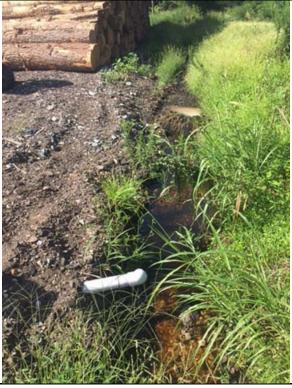
Water Division Photographic Evidence Sheet						
Location: Idaho Timber of Carthage, LLC						
Photographer: John Peaslee, General Manager	Date:	09/13/2018	Time:			
Witness:			Photo #:	1

Description: Photo 1 supplied by John Peaslee.

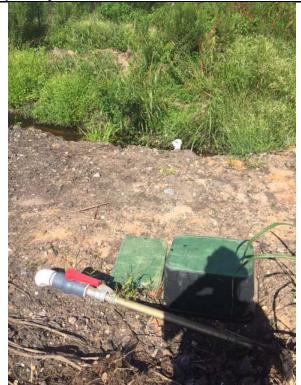
Photographer: John Peasle	Date:	09/13/2018	Time:	
Witness:			Photo #:	2

Description: Photo 2 supplied by John Peaslee.
