POTW Pretreatment Program

Industrial Site Visit

Name of Industry: Kraft Foods North America, Inc.

Date of Visit: May 10, 2007

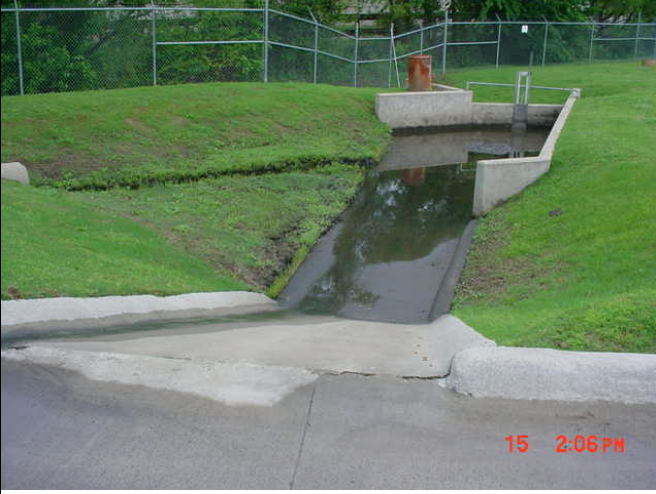
Location:		Kraft Foods North America, Inc					
Photographer:		John Fazio			Witness:		NA
Photo #	1	Of	20	Date:		5-15-07	Time: 2:06 p.m.
Description:		MVC-003.					
<p>Storm water collection swale located at NE corner of facility parking lot: receives storm water from parking lot runoff, storm water pond (discharge culvert from pond on left side of photo) and storm water grate on parking lot. Discharge from this area travels from metal gate valve (visible in photo) eastward to creek beyond chain-link fence.</p>

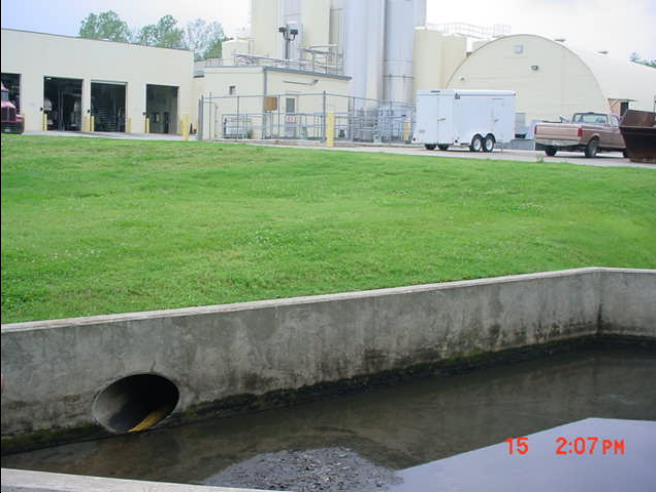
Photographer:		John Fazio			Witness:		NA
Photo #	2	Of	20	Date:		5-15-07	Time: 2:07 p.m.
Description:		MVC-004.					
<p>Swale from previous photo. Discharge culvert from parking lot grate (drop inlet) in lower left portion of photo. Look direction to SW.</p>

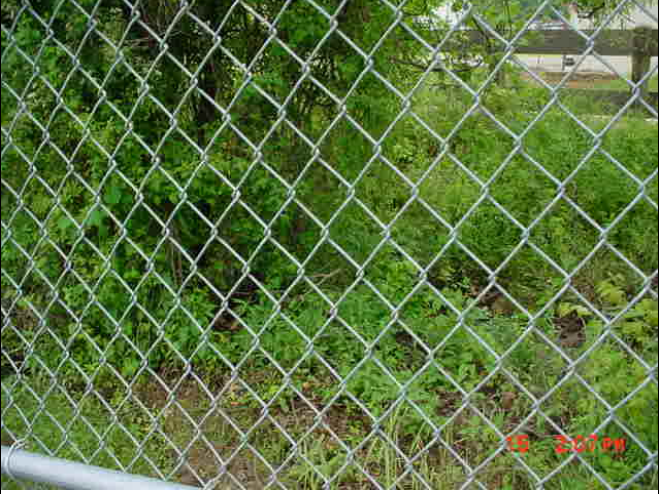
Location:		Kraft Foods North America, Inc					
Photographer:		John Fazio			Witness:		NA
Photo #	3	Of	20	Date:		5-15-07	Time: 2:07 p.m.
Description:		MVC-005					
Creek to which storm water discharges visible within vegetation.

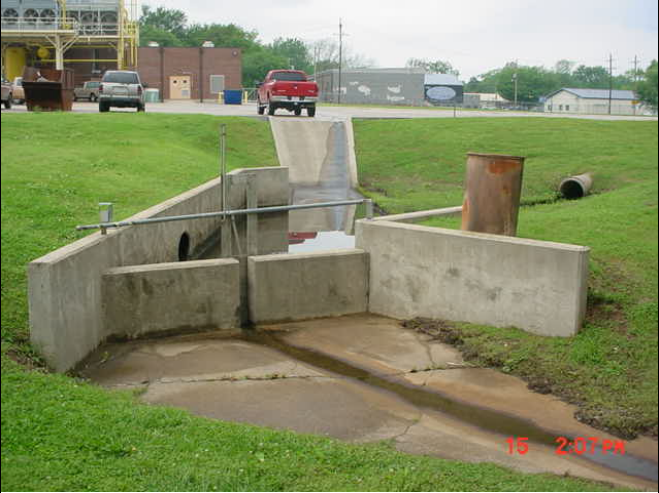
Photographer:		John Fazio			Witness:		NA
Photo #	4	Of	20	Date:		5-15-07	Time: 2:07 p.m.
Description:		MVC-006.					
Storm water drainage from gate valve. Look direction to west.

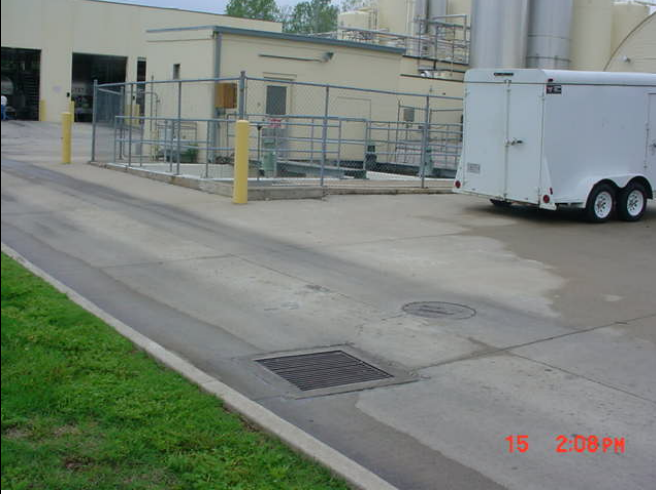
Location:		Kraft Foods North America, Inc						
Photographer:		John Fazio			Witness:		NA	
Photo #	5	Of	20	Date:		5-15-07	Time:	2:08 p.m.
Description:		MVC-007.						
Storm water grate and storm sewer in parking lot adjacent to pH equalization basins and discharge measurement flume. Looking SW.

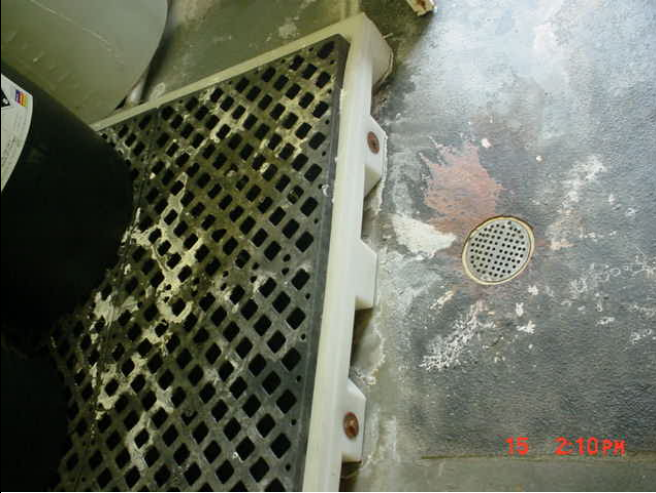
Photographer:		John Fazio			Witness:		NA	
Photo #	6	Of	20	Date:		5-15-07	Time:	2:10 p.m.
Description:		MVC-008.						
Floor drain adjacent to acid and caustic containers in storage building next to pH adjustment basins. Some evidence of spills visible on floor.

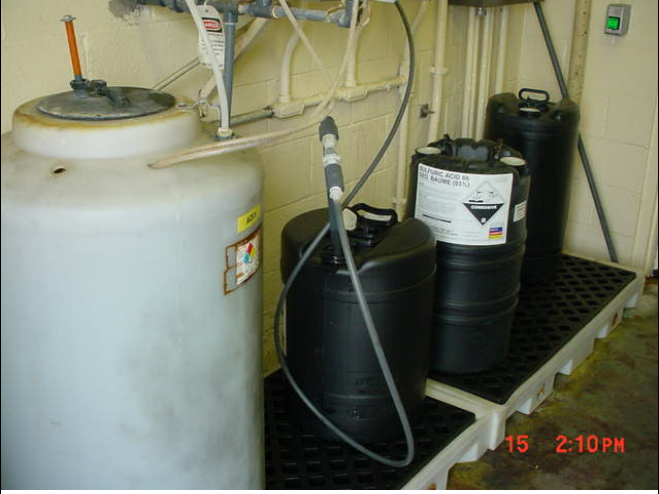
Location:		Kraft Foods North America, Inc					
Photographer:		John Fazio			Witness:		NA
Photo #	7	Of	20	Date:		5-15-07	Time: 2:10 p.m.
Description:		MVC-009.					
Acid and caustic containers in storage room.

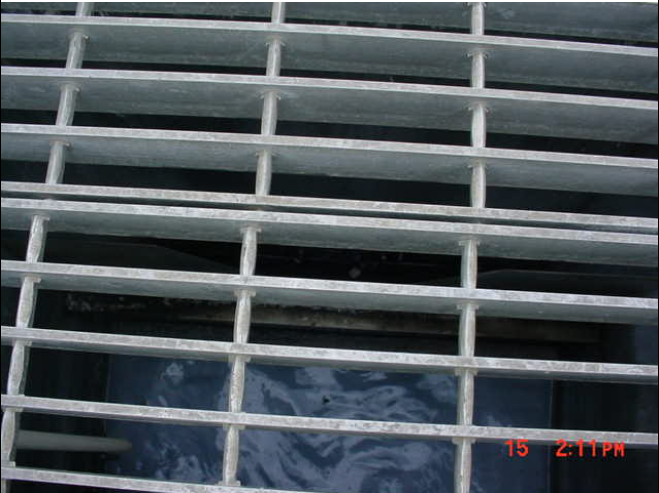
Photographer:		John Fazio			Witness:		NA
Photo #	8	Of	20	Date:		5-15-07	Time: 2:11 p.m.
Description:		MVC-010.					
Small basin that receives Kraft waste stream. From here, waste stream enters pH adjustment basins.

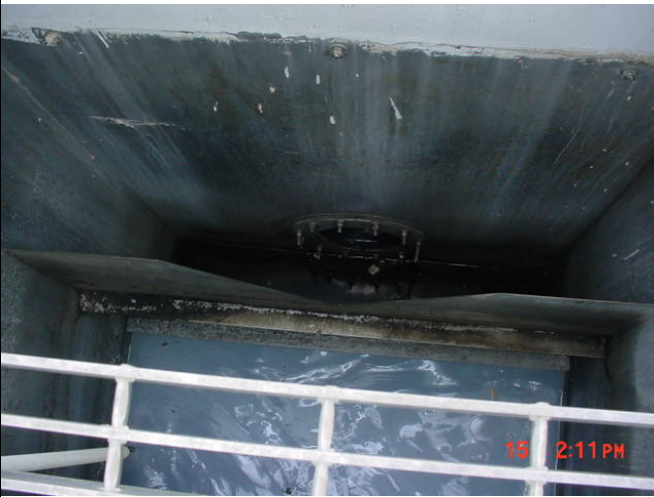
Location:		Kraft Foods North America, Inc					
Photographer:		John Fazio			Witness:		NA
Photo #	9	Of	20	Date:		5-15-07	Time: 2:11 p.m.
Description:		MVC-011.					
<p>Wastewater collection basin seen in previous photo. Wastewater enters this basin from the west (not visible), and enters the pH adjustment basins to the south (below bottom of photo). Visible in the north end of this basin is a partition plate with a v-notch, and a discharge pipe. During periods of high flow, the v-notch appears to allow for discharge (before final treatment) to either the sanitary sewer or to the waters of the State. The "high water mark" suggests that this has occurred.</p>

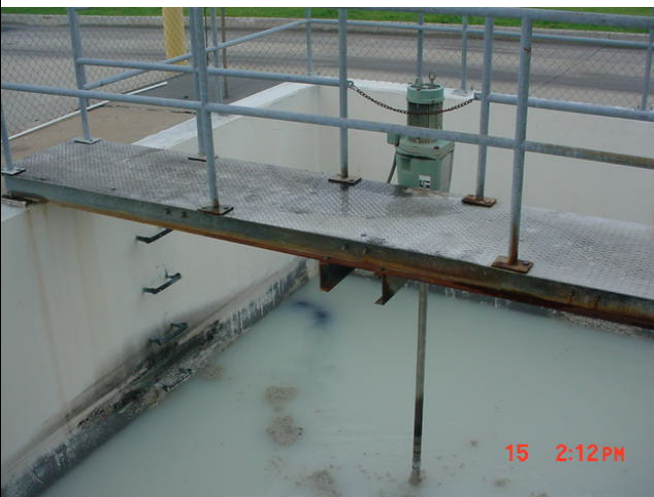
Photographer:		John Fazio			Witness:		NA
Photo #	10	Of	20	Date:		5-15-07	Time: 2:12 p.m.
Description:		MVC-012.					
<p>First of two pH adjustment basins after collection basin (seen in previous photo).</p>

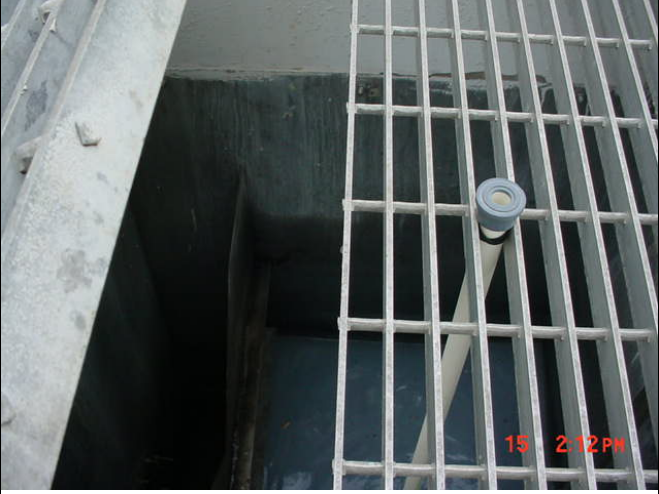
Location:		Kraft Foods North America, Inc					
Photographer:		John Fazio			Witness:		NA
Photo #	11	Of	20	Date:		5-15-07	Time: 2:12 p.m.
Description:		MVC-013.					
<p>Another view (look direction E) of high wastewater mark in collection basin before pH adjustment basin. V-notch visible to left.</p>

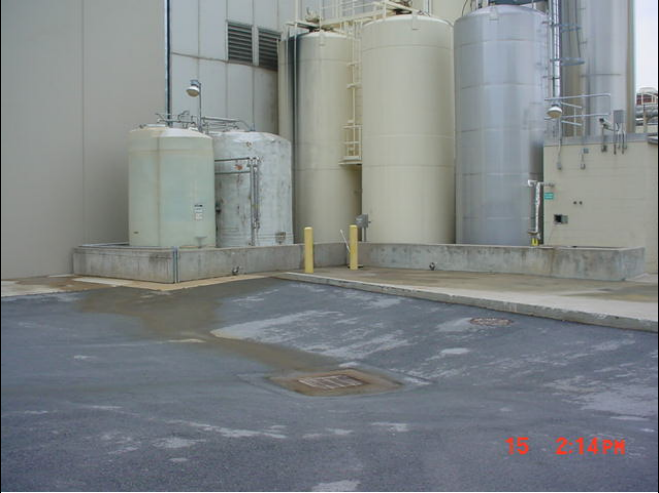
Additional Comments: Facility needs additional measures to prevent spills. Facility had three reported spill/slugs in 2006 (2/21-2/22; 3/13, and 6/18). Releases from the outside acid and caustic soda tanks secondary containment structures have been allowed to enter the waters of the State. Evidence of either a bypass to the POTW or a direct discharge to the waters of the State exists in a basin prior to the pH adjustment basins. Oil & grease grab samples have not been taken in accordance with the requirements of the pretreatment regulations. Flow meter accuracy check (percent error) has not been calculated properly.

Photographer:		John Fazio			Witness:		NA
Photo #	12	Of	20	Date:		5-15-07	Time: 2:14 p.m.
Description:		MVC-014.					
<p>Acid and caustic tanks (left) and product tanks (right) within their respective secondary containment basins. Located on south end of facility. Evidence of discharges (staining) from these containment basins to the storm water sewer is visible in photo. Two more drains are on concrete next to product tanks. Look direction NW.</p>

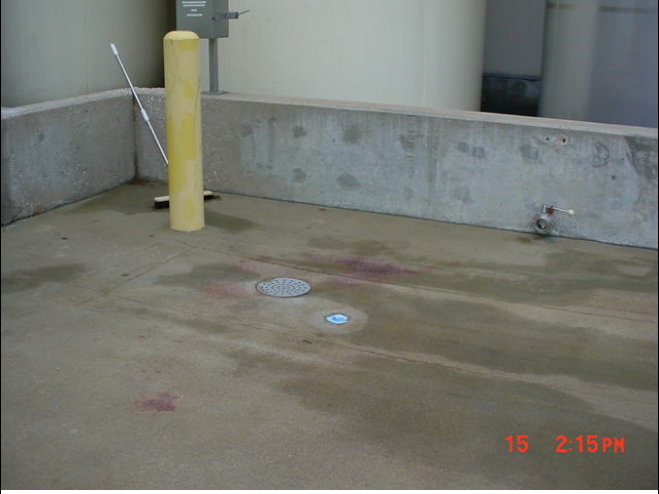
Location:		Kraft Foods North America, Inc					
Photographer:		John Fazio			Witness:		NA
Photo #	13	Of	20	Date:		5-15-07	Time: 2:15 p.m.
Description:		MVC-015.					
<p>Red staining around drain near product tanks. Secondary containment discharge valve visible.</p>

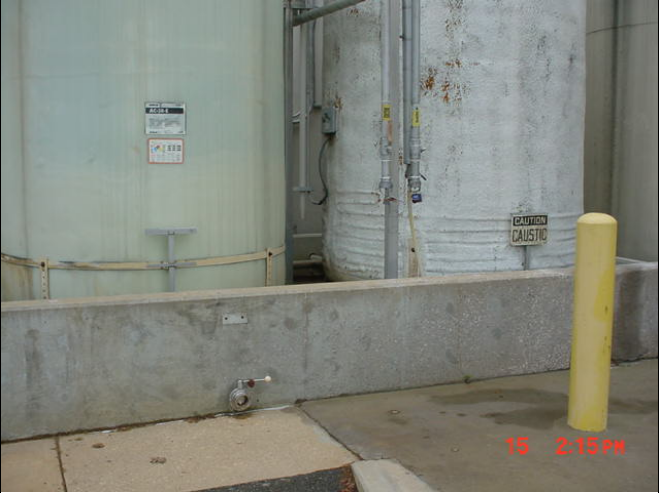
Photographer:		John Fazio			Witness:		NA
Photo #	14	Of	20	Date:		5-15-07	Time: 2:15 p.m.
Description:		MVC-016.					
<p>Acid tank (left) and caustic tank (right). Secondary containment discharge valve visible. Fill pipes visible (in caustic tank foreground).</p>

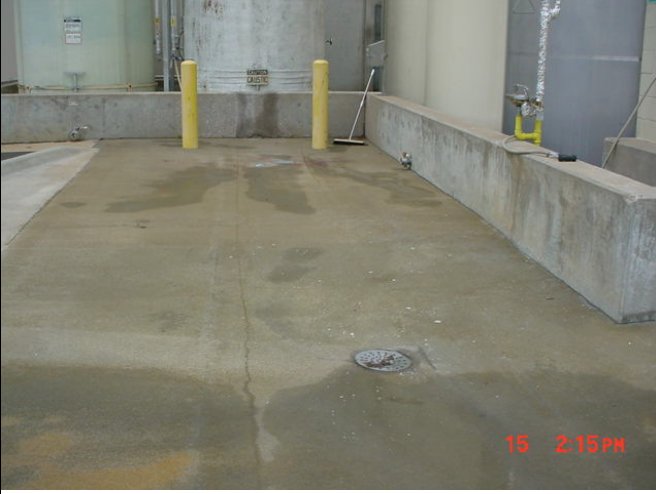
Location:		Kraft Foods North America, Inc					
Photographer:		John Fazio			Witness:		NA
Photo #	15	Of	20	Date:		5-15-07	Time: 2:15 p.m.
Description:		MVC-017.					
Two drains adjacent to tanks. Look direction W.

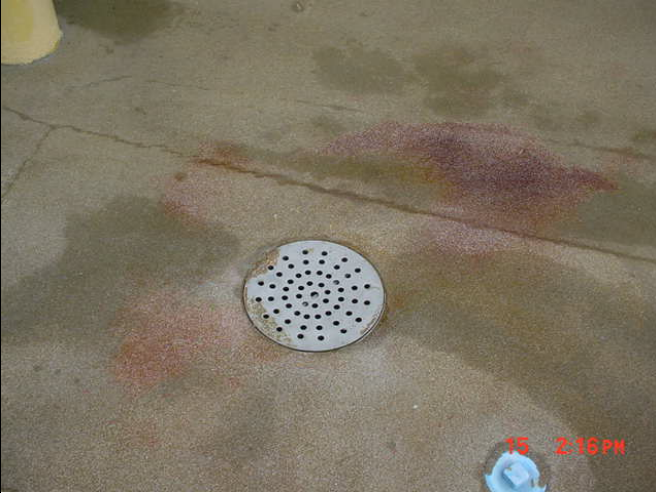
Photographer:		John Fazio			Witness:		NA
Photo #	16	Of	20	Date:		5-15-07	Time: 2:16 p.m.
Description:		MVC-018.					
Close-up of staining around westernmost drain.

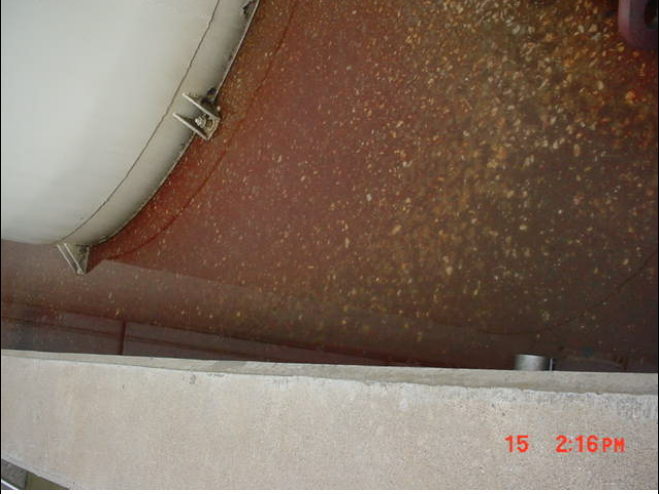
Location:		Kraft Foods North America, Inc					
Photographer:		John Fazio			Witness:		NA
Photo #	17	Of	20	Date:		5-15-07	Time: 2:16 p.m.
Description:		MVC-019.					
Stormwater and red substance in product tanks secondary containment structure.

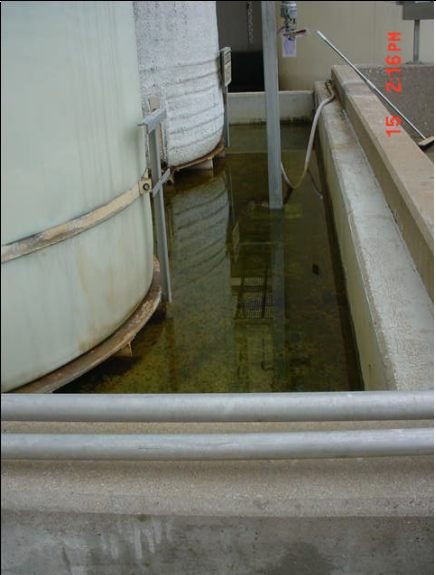
Photographer:		John Fazio			Witness:		NA
Photo #	18	Of	20	Date:		5-15-07	Time: 2:16 p.m.
Description:		MVC-020.					
Storm water and spilled product (likely occurs during acid/caustic tank filling) in acid and caustic tanks secondary containment structure.

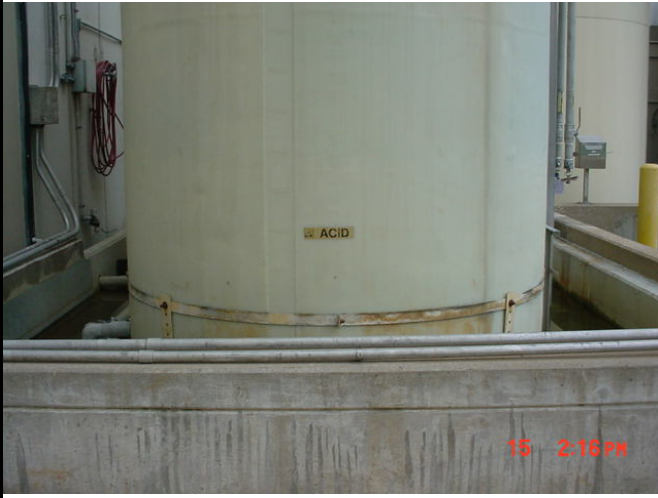
Location:		Kraft Foods North America, Inc					
Photographer:		John Fazio			Witness:		NA
Photo #	19	Of	20	Date:		5-15-07	Time: 2:16 p.m.
Description:		MVC-021.					
Acid tank.
