NPDES Compliance Inspection Report

Name and Location of Facility Inspected (For industrial users discharging to POTW, also include POTW name and NPDES permit number) Kraft Foods North America, Inc. POTW: City of Bentonville 507 SE "E" Street Permit #: AR0022403 Bentonville, AR 72712		Entry Time /Date 1105 / 09-24-07	Permit Effective Date NA
		Exit Time/Date 1145 / 09-24-07	Permit Expiration Date NA
Name(s) of On-Site Representative(s)/Title(s)/Phone and Fax Number(s) Glen Wells, Maintenance Lead / 479-273-5561		Other Facility Data	
Name, Address of Responsible Official/Title/Phone and Fax Number Rich Holtquist/Plant Manager / 479-273-5561, Ext 115 / 479-273-2433 507 SE "E" Street Bentonville, AR 72712		Contacted Yes <input type="checkbox"/> No <input checked="" type="checkbox"/>

RE: Pretreatment Bypass - Kraft Foods, 507 Southeast E. Street, Bentonville

Subject: Anhydrous Ammonia Release, Kraft Foods, Bentonville, Arkansas
Case #07-61102

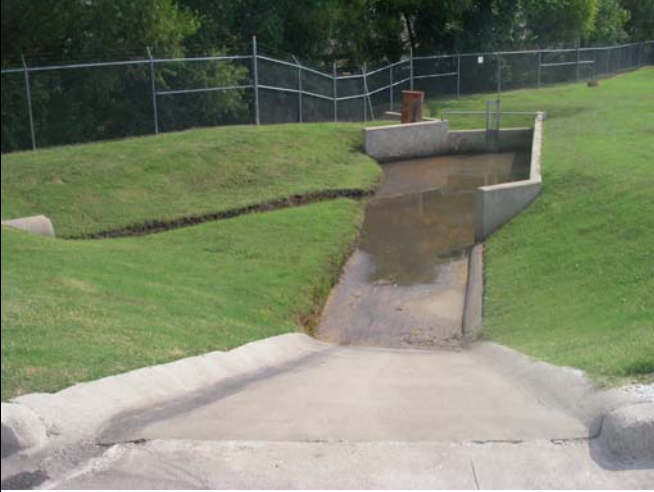
Anhydrous ammonia refrigerant had been found to be releasing from the cooling system following a 09/22/07 report to the Fire Department from an area resident of an ammonia odor. According to Kraft Foods, ~15 lbs of the gas had been released. To alleviate the vapors, Kraft directed the escaping gas into water at two locations and released the solution to their storm water retention basin. The outfall gate was partially open and released the solution to the receiving stream. This incident has been assigned #07-60211.

Location:		Kraft Foods, Bentonville						
Photographer:		John Fazio			Witness:		Alison West	
Photo #	1	Of	2		Date:	09/24/07	Time:	1117
Description:								
<p>Anhydrous ammonia/water had discharged through outfall gate to receiving stream, where ammonia was reported as having dissipated to atmosphere.</p>

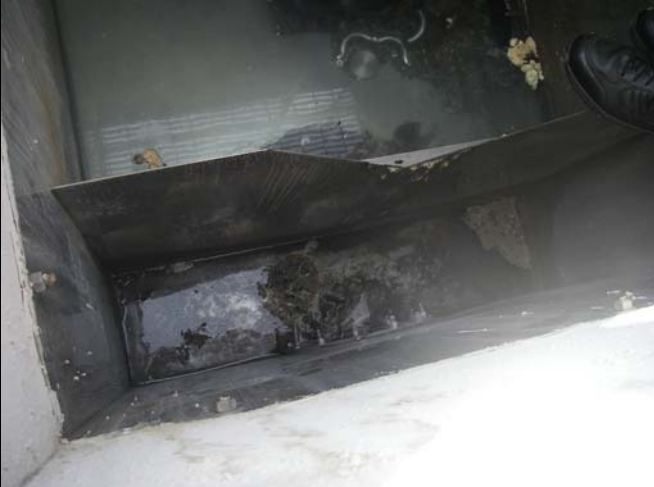
- Evidence of bypasses to the POTW via a v-notch weir in a split basin prior to the pH adjustment basins. According to Glen Wells, Kraft Foods Maintenance Lead, Kraft was not aware that pretreatment bypasses had been occurring and, therefore, Kraft had not notified the Bentonville POTW of the bypasses.

Process waste solids were observed on both sides of the v-notch weir that divides an effluent receiving basin located before the equalization basins. As you recall from site conditions observed during the May 10, 2007 SIU inspection, during periods of low flow, all wastewater discharges from this split basin to the pH equalization basins. However, during periods of high flow, a portion of the wastewater is directed through the weir and discharged untreated to the WWTP. When this evidence was presented to Glen Wells, Kraft Foods Maintenance Lead, he stated that Kraft Foods had not been aware of any bypasses, but concurred that the evidence confirmed that they have been occurring. This suggests that the Bentonville WWTP had not been notified of the bypasses.

Photographer:		John Fazio			Witness:		Alison West	
Photo #	2	Of	2		Date:	09/24/07	Time:	1121
Description:								
<p>V-notch weir to POTW before pH adjustment basins. When discharges are high, some of the waste water is routed through the weir and to the Bentonville POTW prior to pretreatment. Photo documents evidence that this has occurred – process waste solids visible on both sides of weir. Discharge pipe inlet (to POTW) visible at bottom of photo. POTW not notified of bypass according to Kraft personnel.</p>

Kraft has engaged the services of an engineer to assist in this project. It has been determined that the weir can be raised 17" without causing manholes to over flow in high flow situations. This weir will be raised with bolts and sealant for the immediate future. Engineers are continuing to work on the issue.

I spoke with A.J. Rorie, Kraft Business Unit Leader this morning. They are considering capping the inlet for the bypass line and securing it with a numbered security seal as they do with all the trucks leaving their facility. In an emergency situation, Should a bypass be necessary they would notify the POTW when the seal was broken. Pretreatment personnel would have the number of the seal and could check it at any time to verify compliance.
