ARKANSAS DEPARTMENT OF ENVIRONMENTAL QUALITY

MEMORANDUM

SUBJECT: Preformed Line Products Company

NPDES Compliance Inspection Report

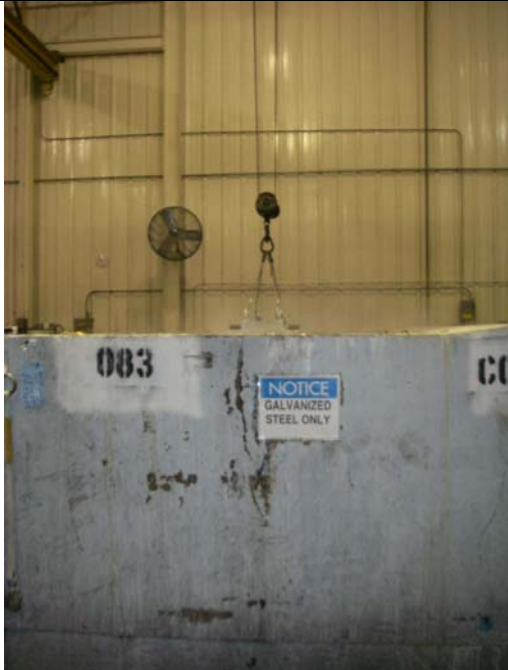
Location:	Preformed Line Products Company						
Photographer:	Alison West			Witness:	None		
Photo #	1	Of	6	Date:	11-19-08	Time:	8:19 a.m.
Description:	IMG2042. Wash tank for galvanized water.

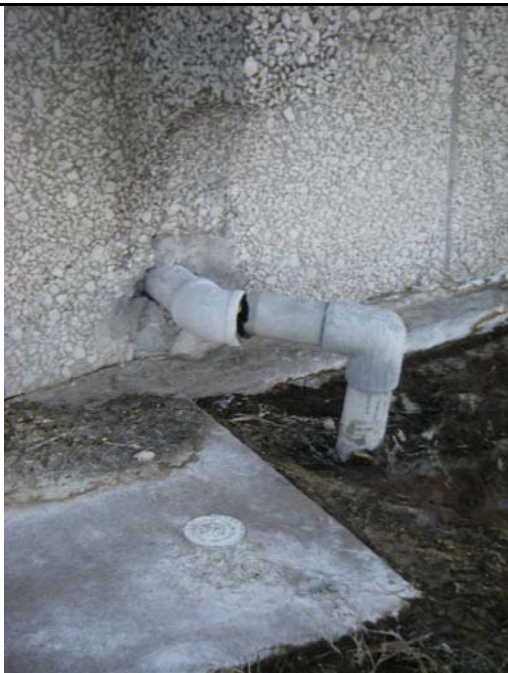
Photographer:	Alison West			Witness:	None		
Photo #	2	Of	6	Date:	11-19-08	Time:	8:21 a.m.
Description:	IMG2043. Discharge of galvanized water through broken pipe.

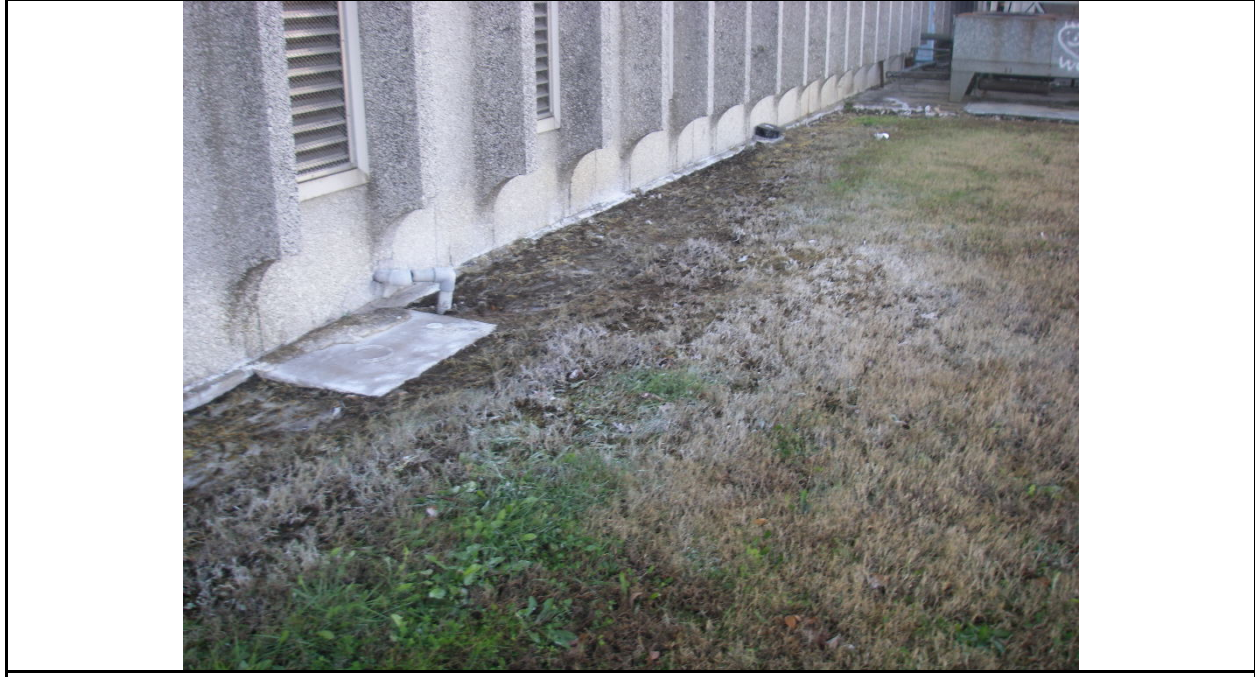
Photo #	3	Of	6	Date:	11-19-08	Time:	8:21 a.m.
----------------	---	-----------	---	--------------	----------	--------------	-----------

Description:	IMGP2044. Area of discharge at broken pipe.						
---------------------	---	--	--	--	--	--	--

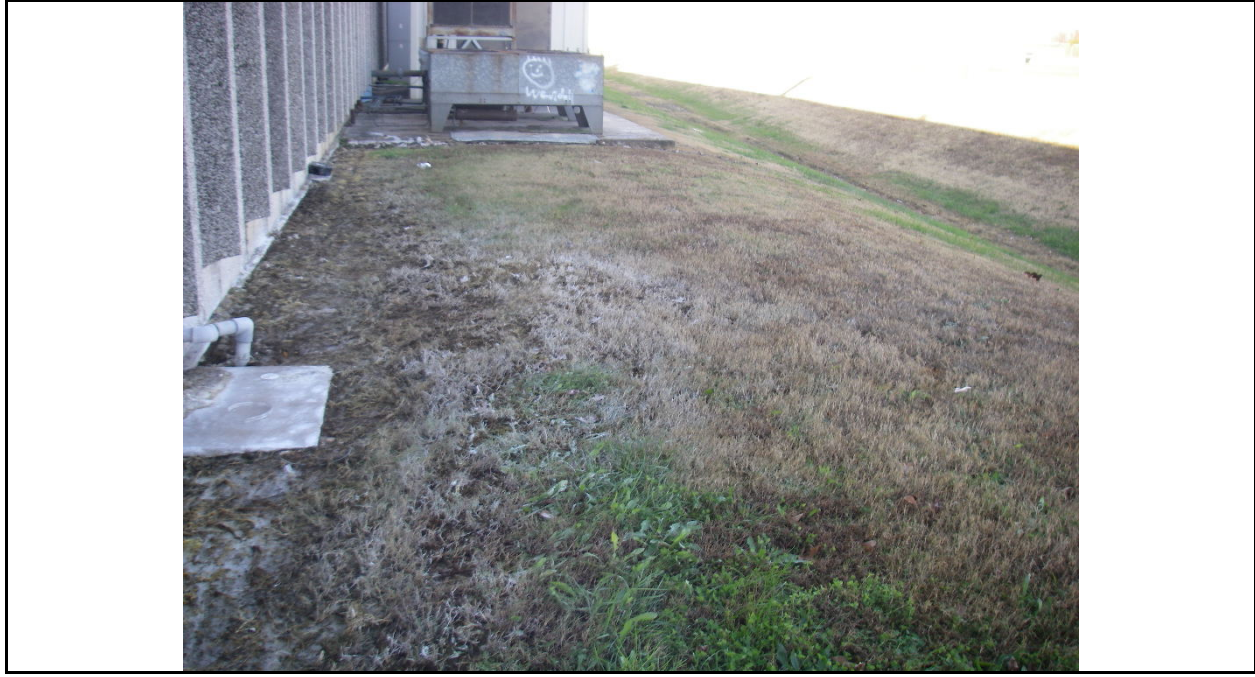
Photo #	4	Of	6	Date:	11-19-08	Time:	8:21 a.m.
----------------	---	-----------	---	--------------	----------	--------------	-----------

Description:	IMGP2045. Waste was discharged into the drainage ditch northwest of the pretreatment monitoring flume.						
---------------------	--	--	--	--	--	--	--

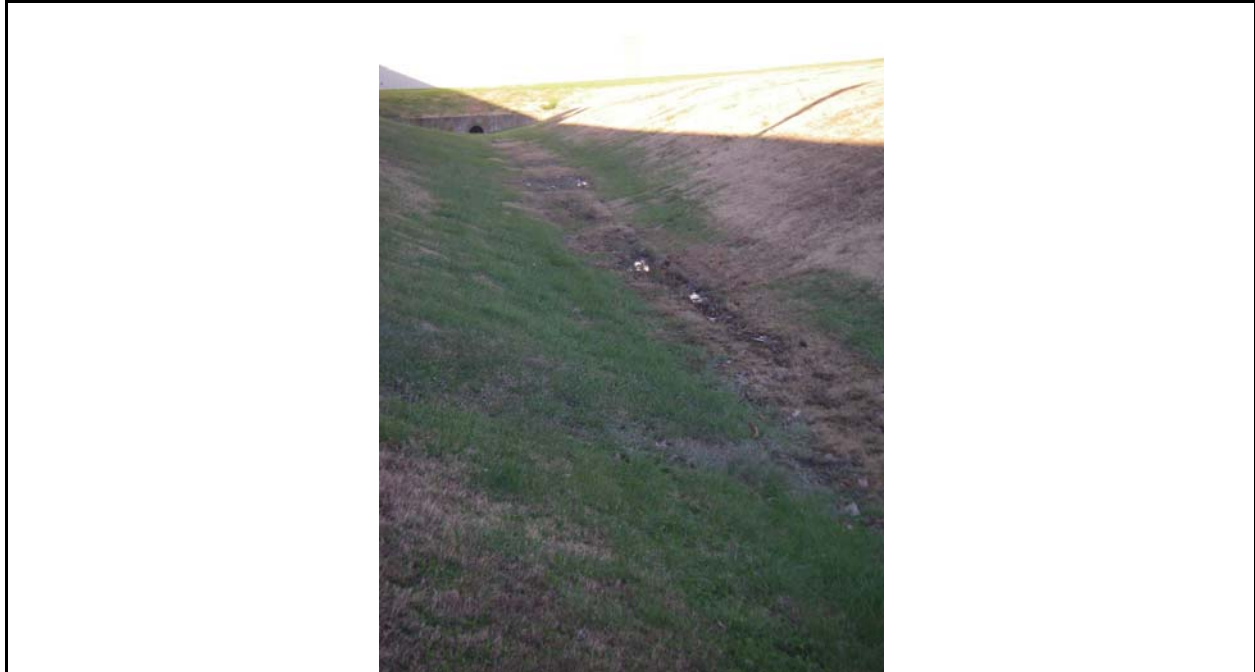
Photo # 5 **Of** 6 **Date:** 11-19-08 **Time:** 8:22 a.m.

Description: IMG2046. The waste passed through a culvert underneath a building.

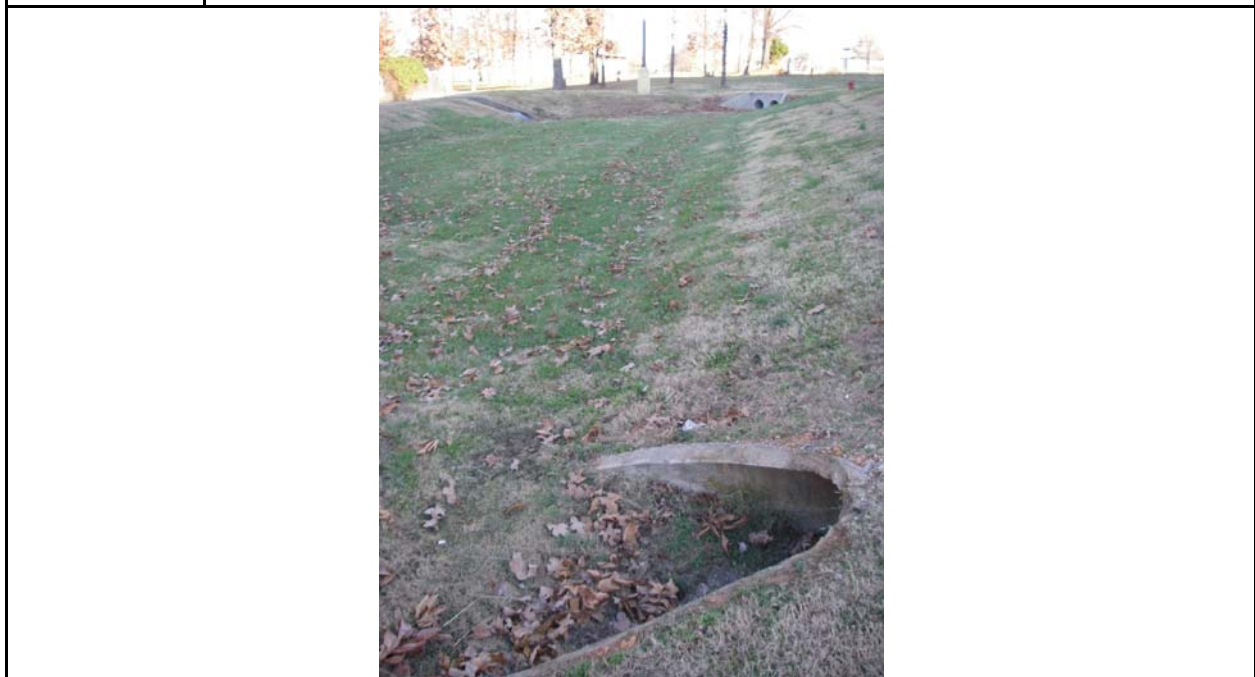
Photo # 6 **Of** 6 **Date:** 11-19-08 **Time:** 8:26 a.m.

Description: IMG2049. The waste discharged into a larger storm water drainage ditch that flows south/southwest.
