ARKANSAS  
Department of Environmental Quality

AFIN: 57-00042 NPDES Permit No.: AR0036692

## NPDES Compliance Inspection Report

**Subject:** 18 inch sewer main break at Polk 54 in Mena

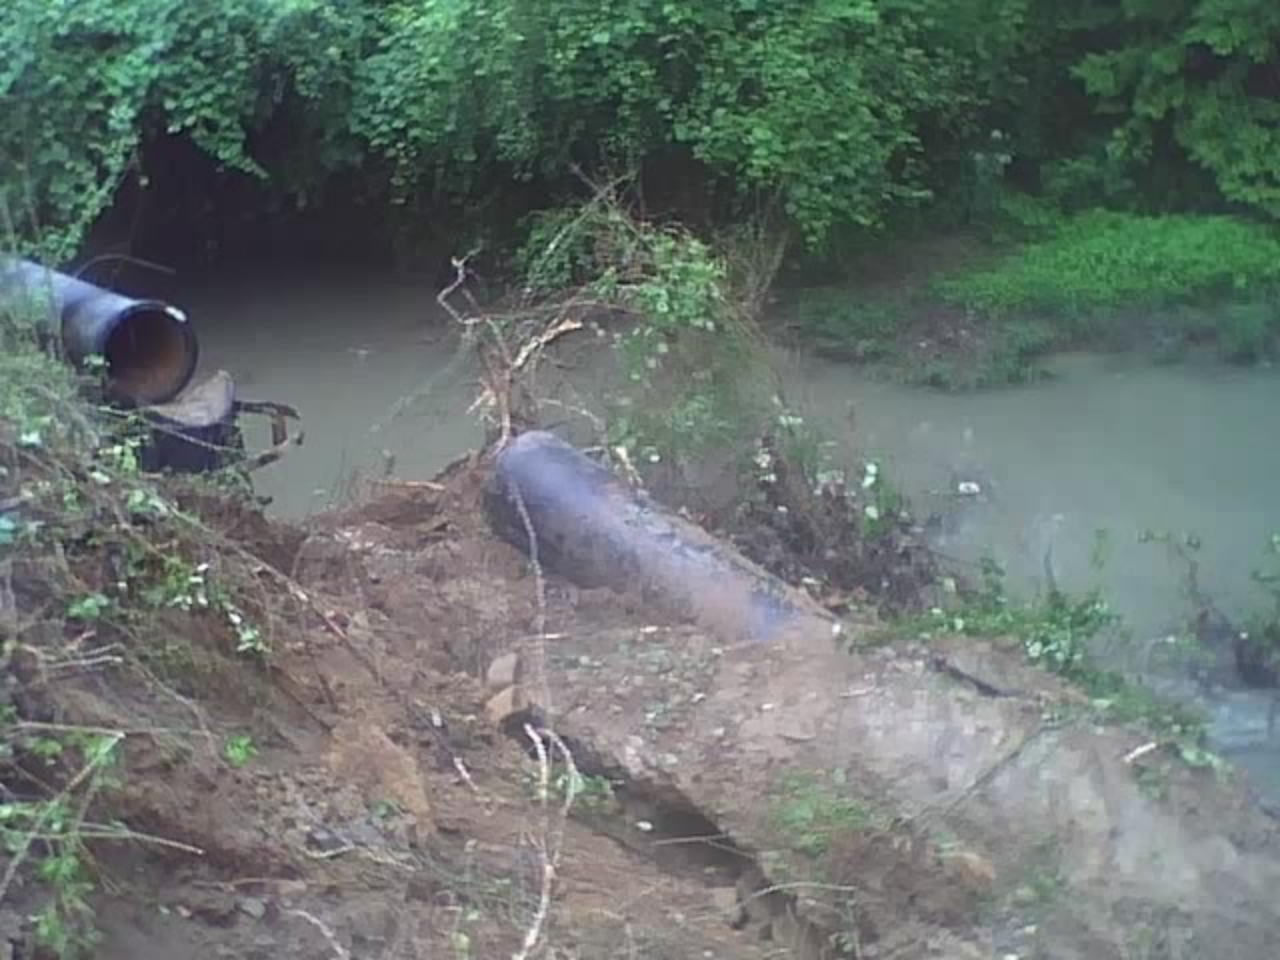
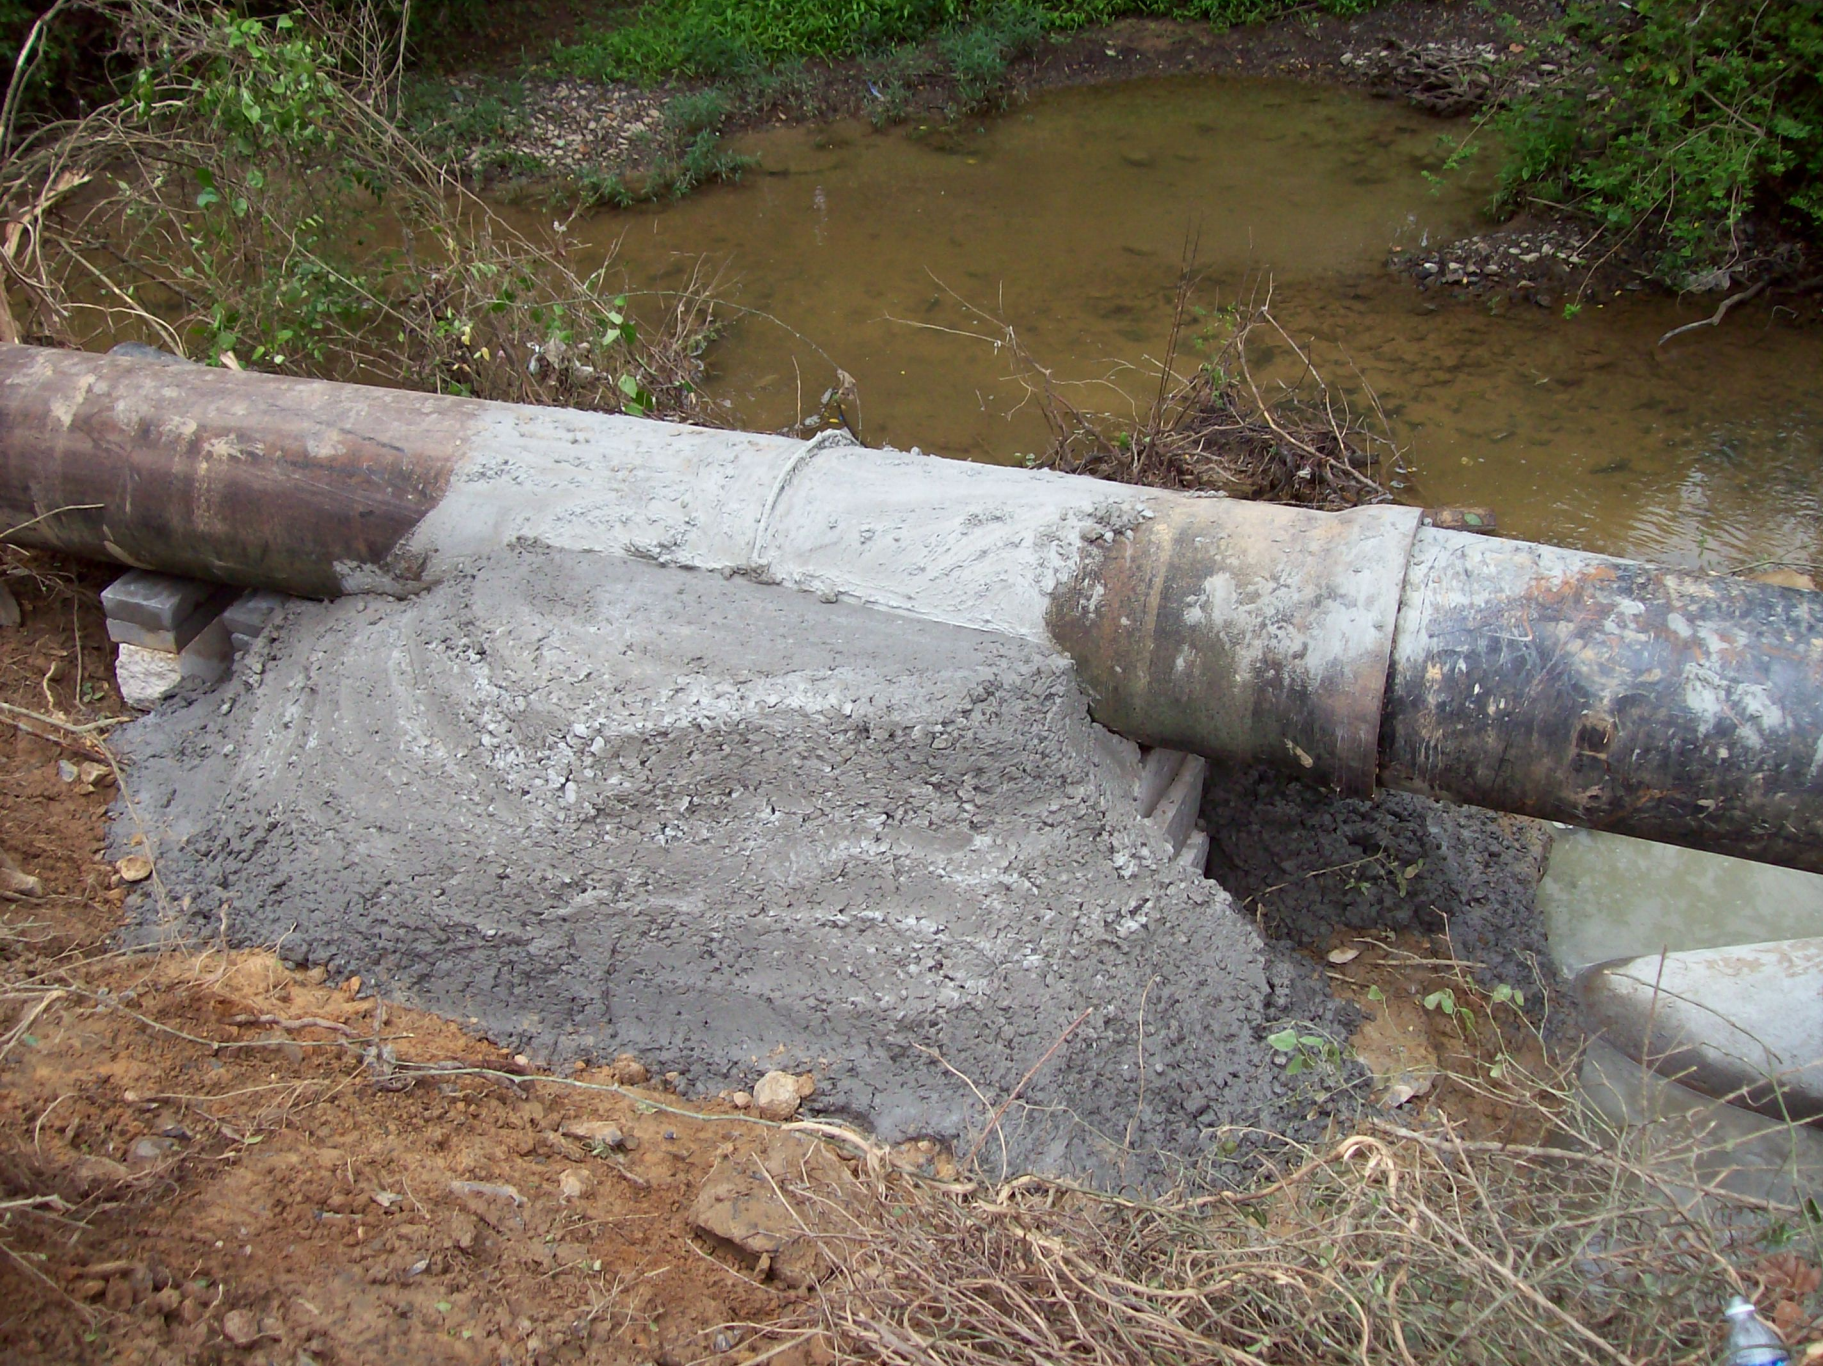
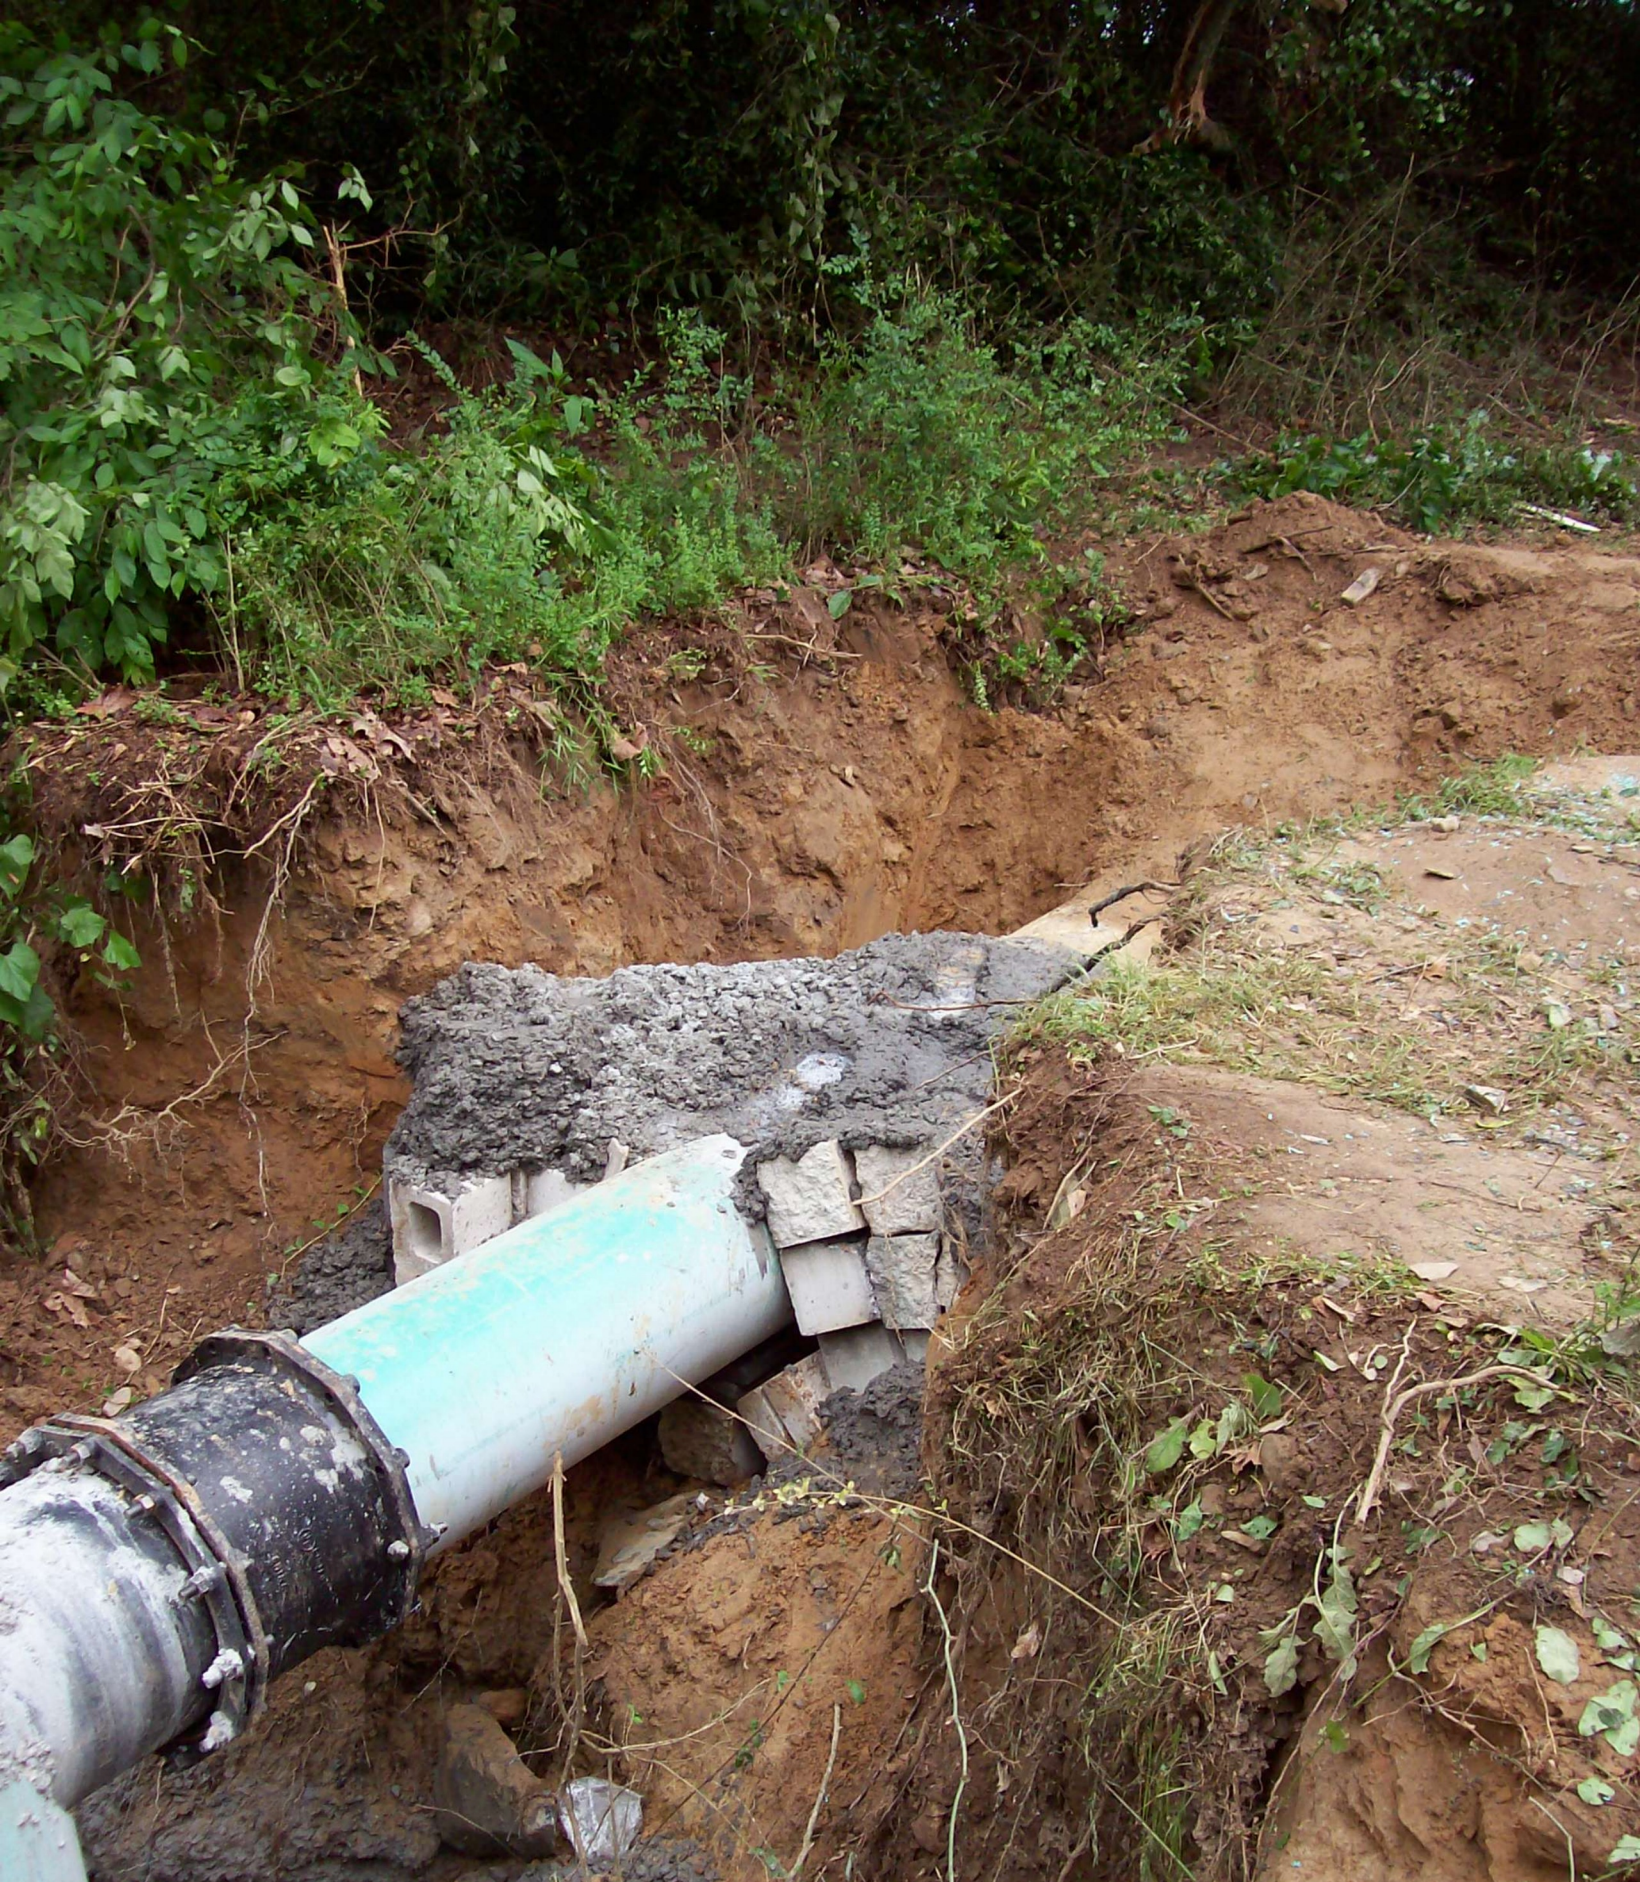
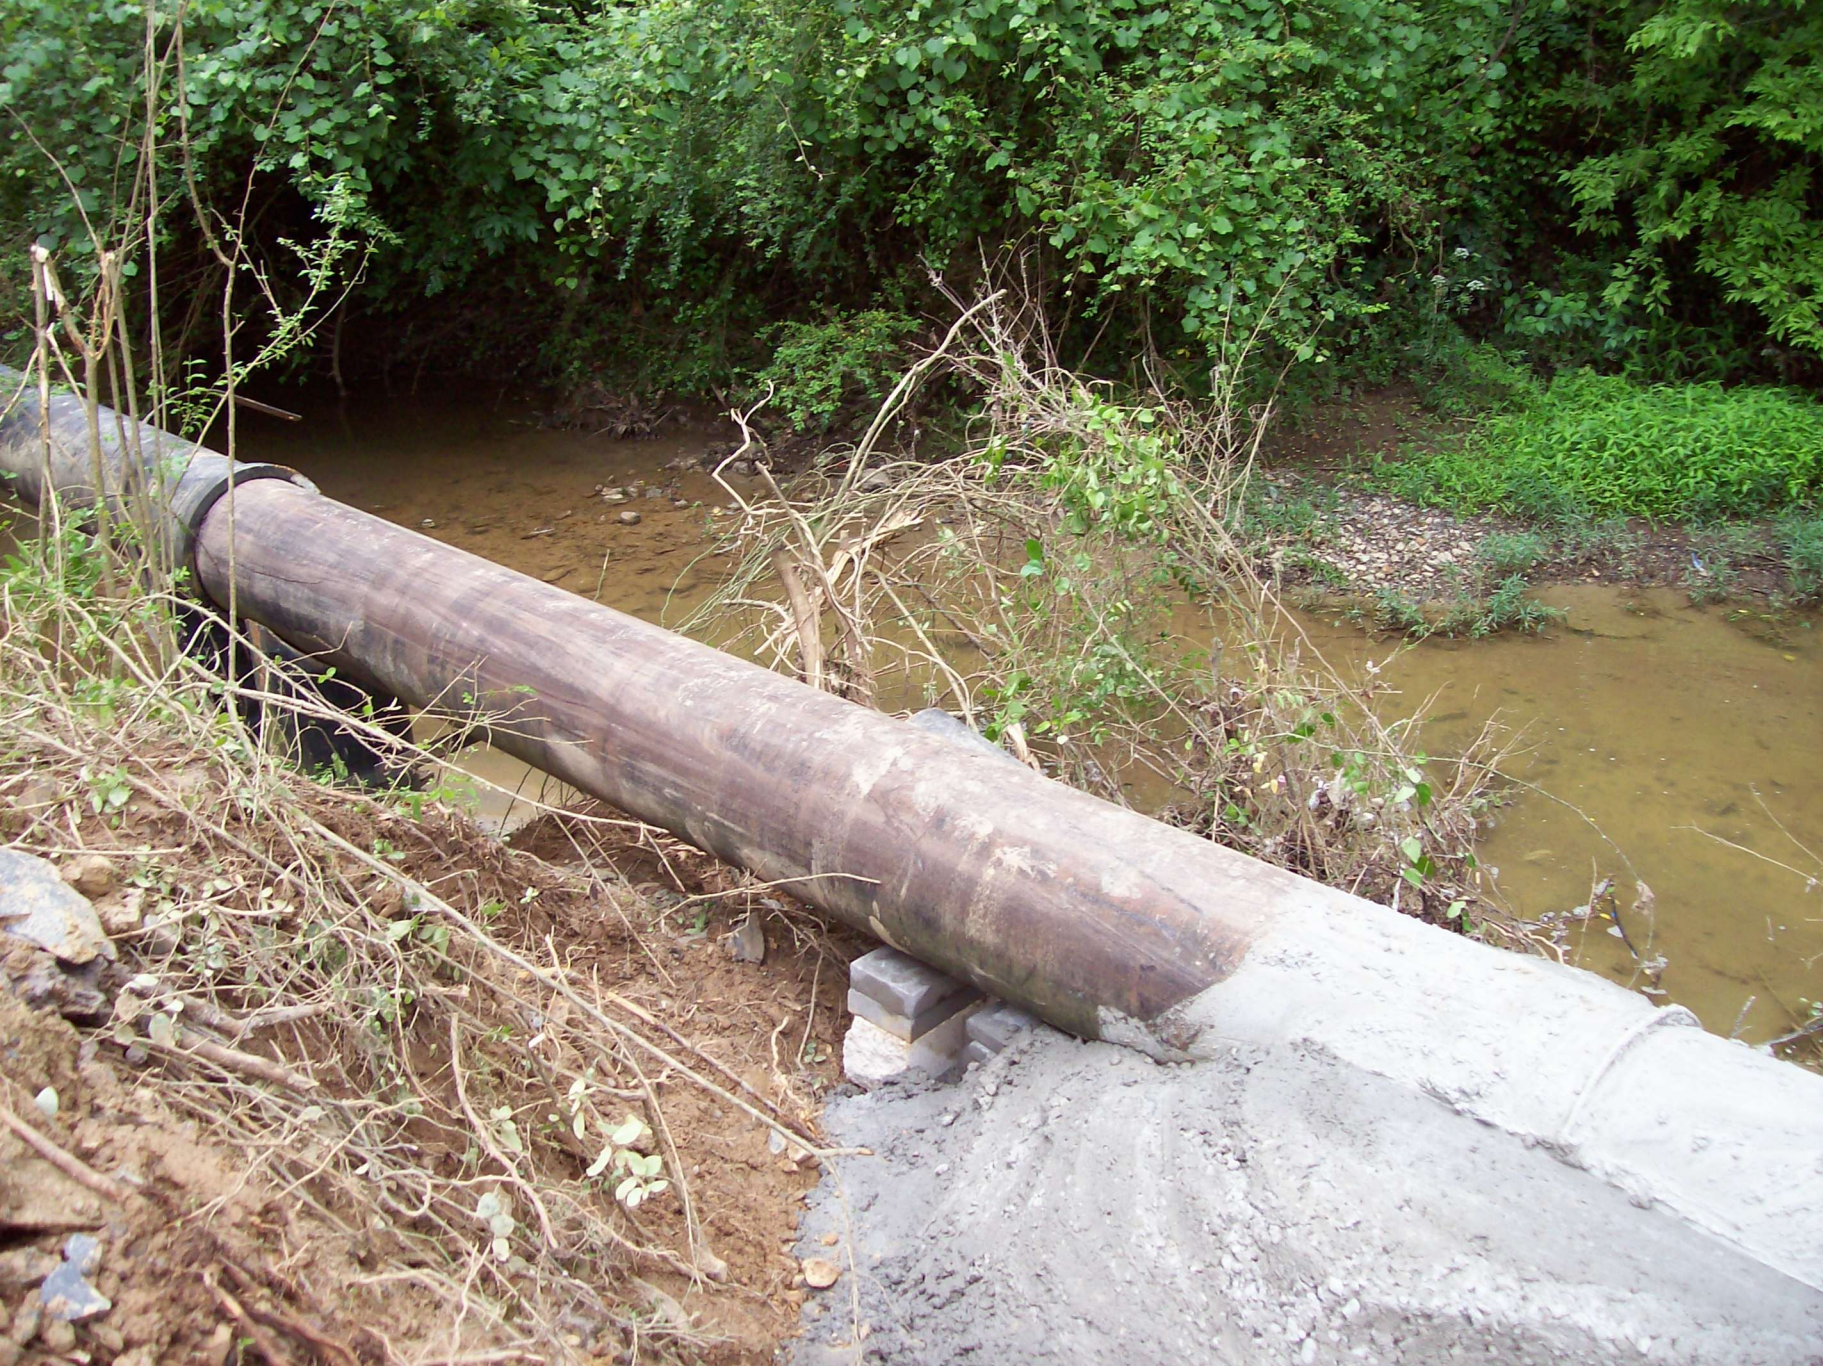
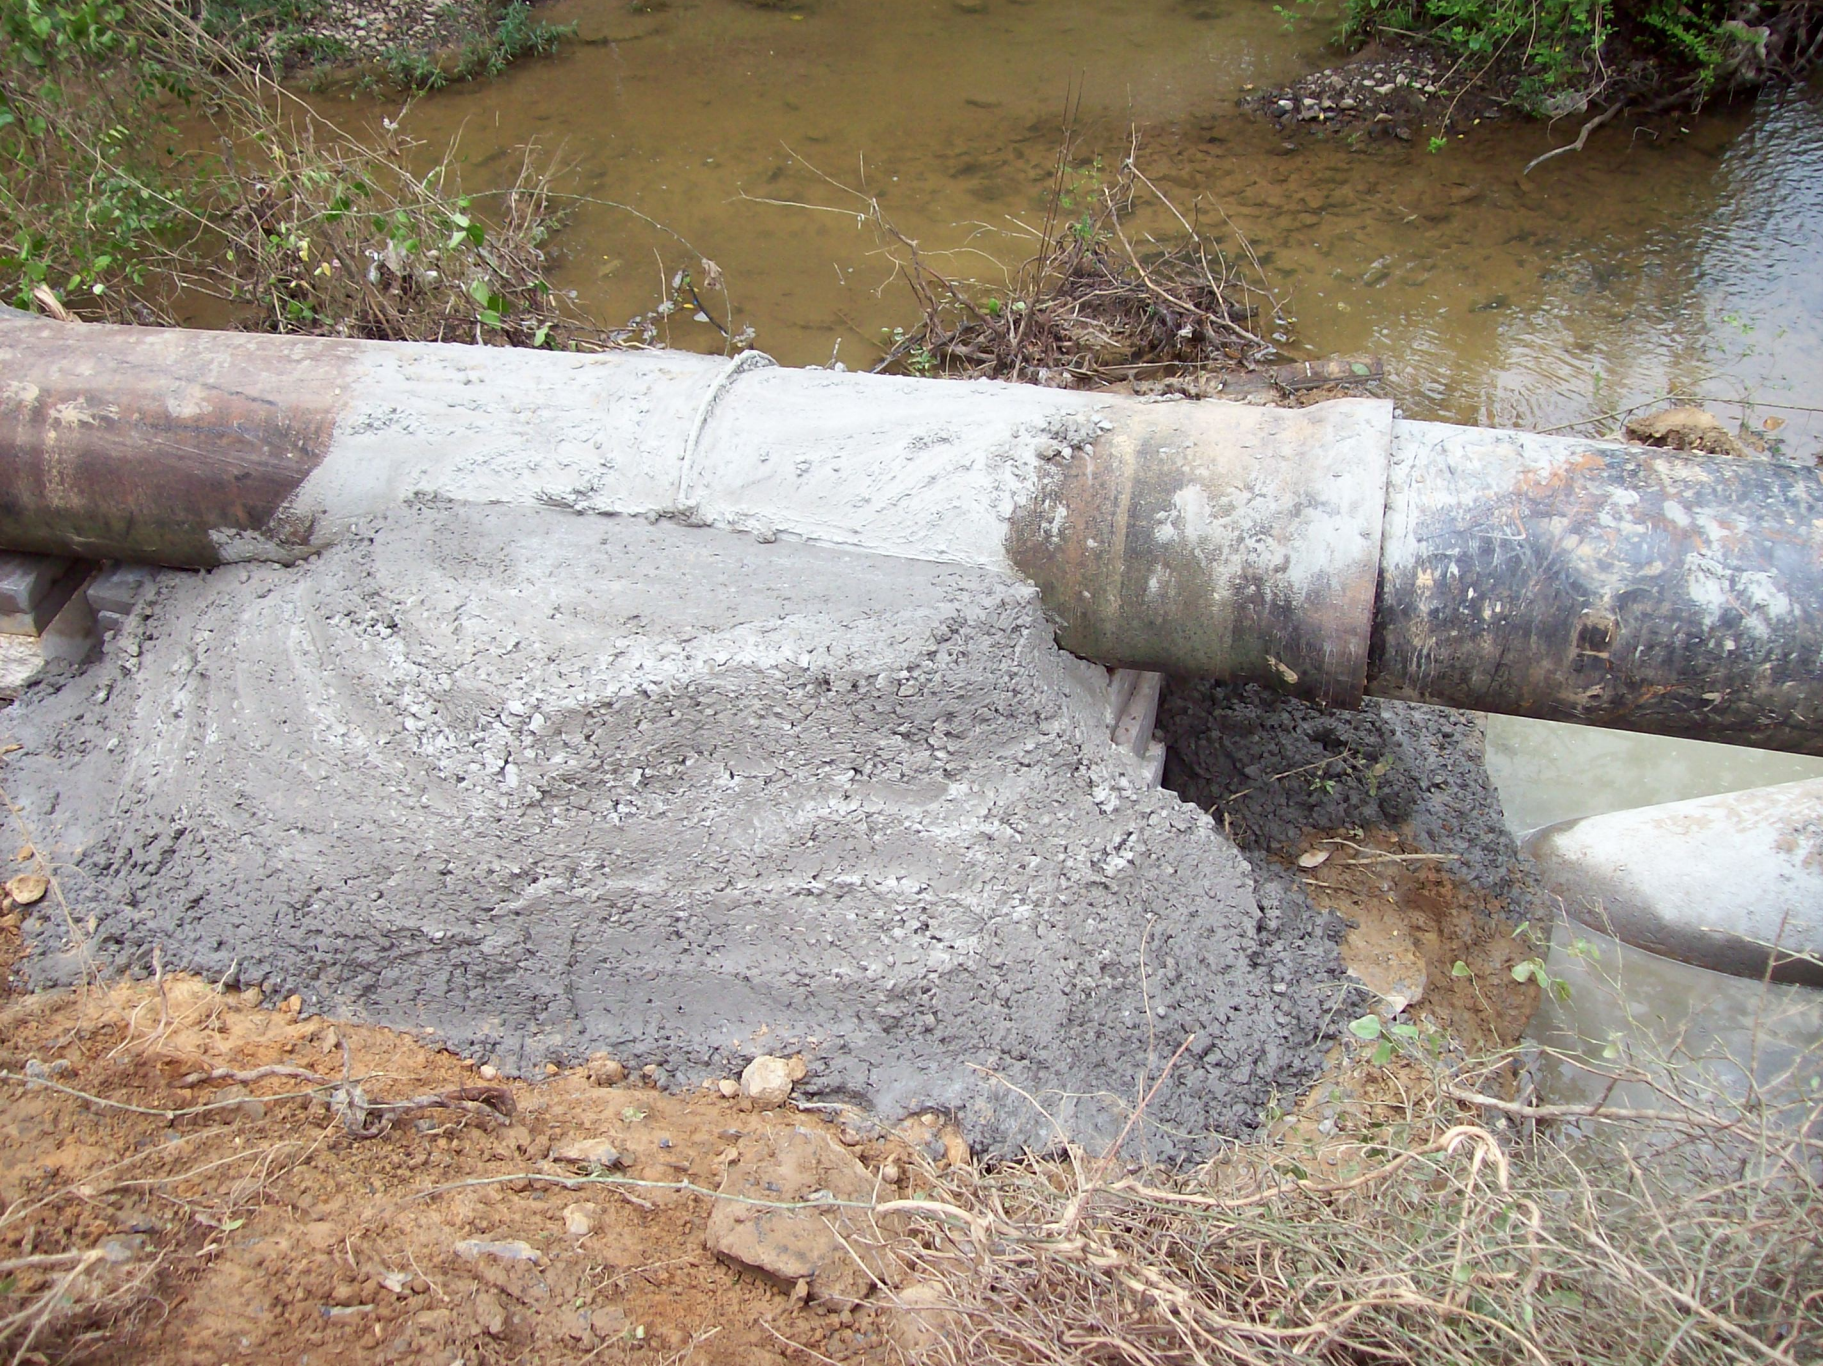
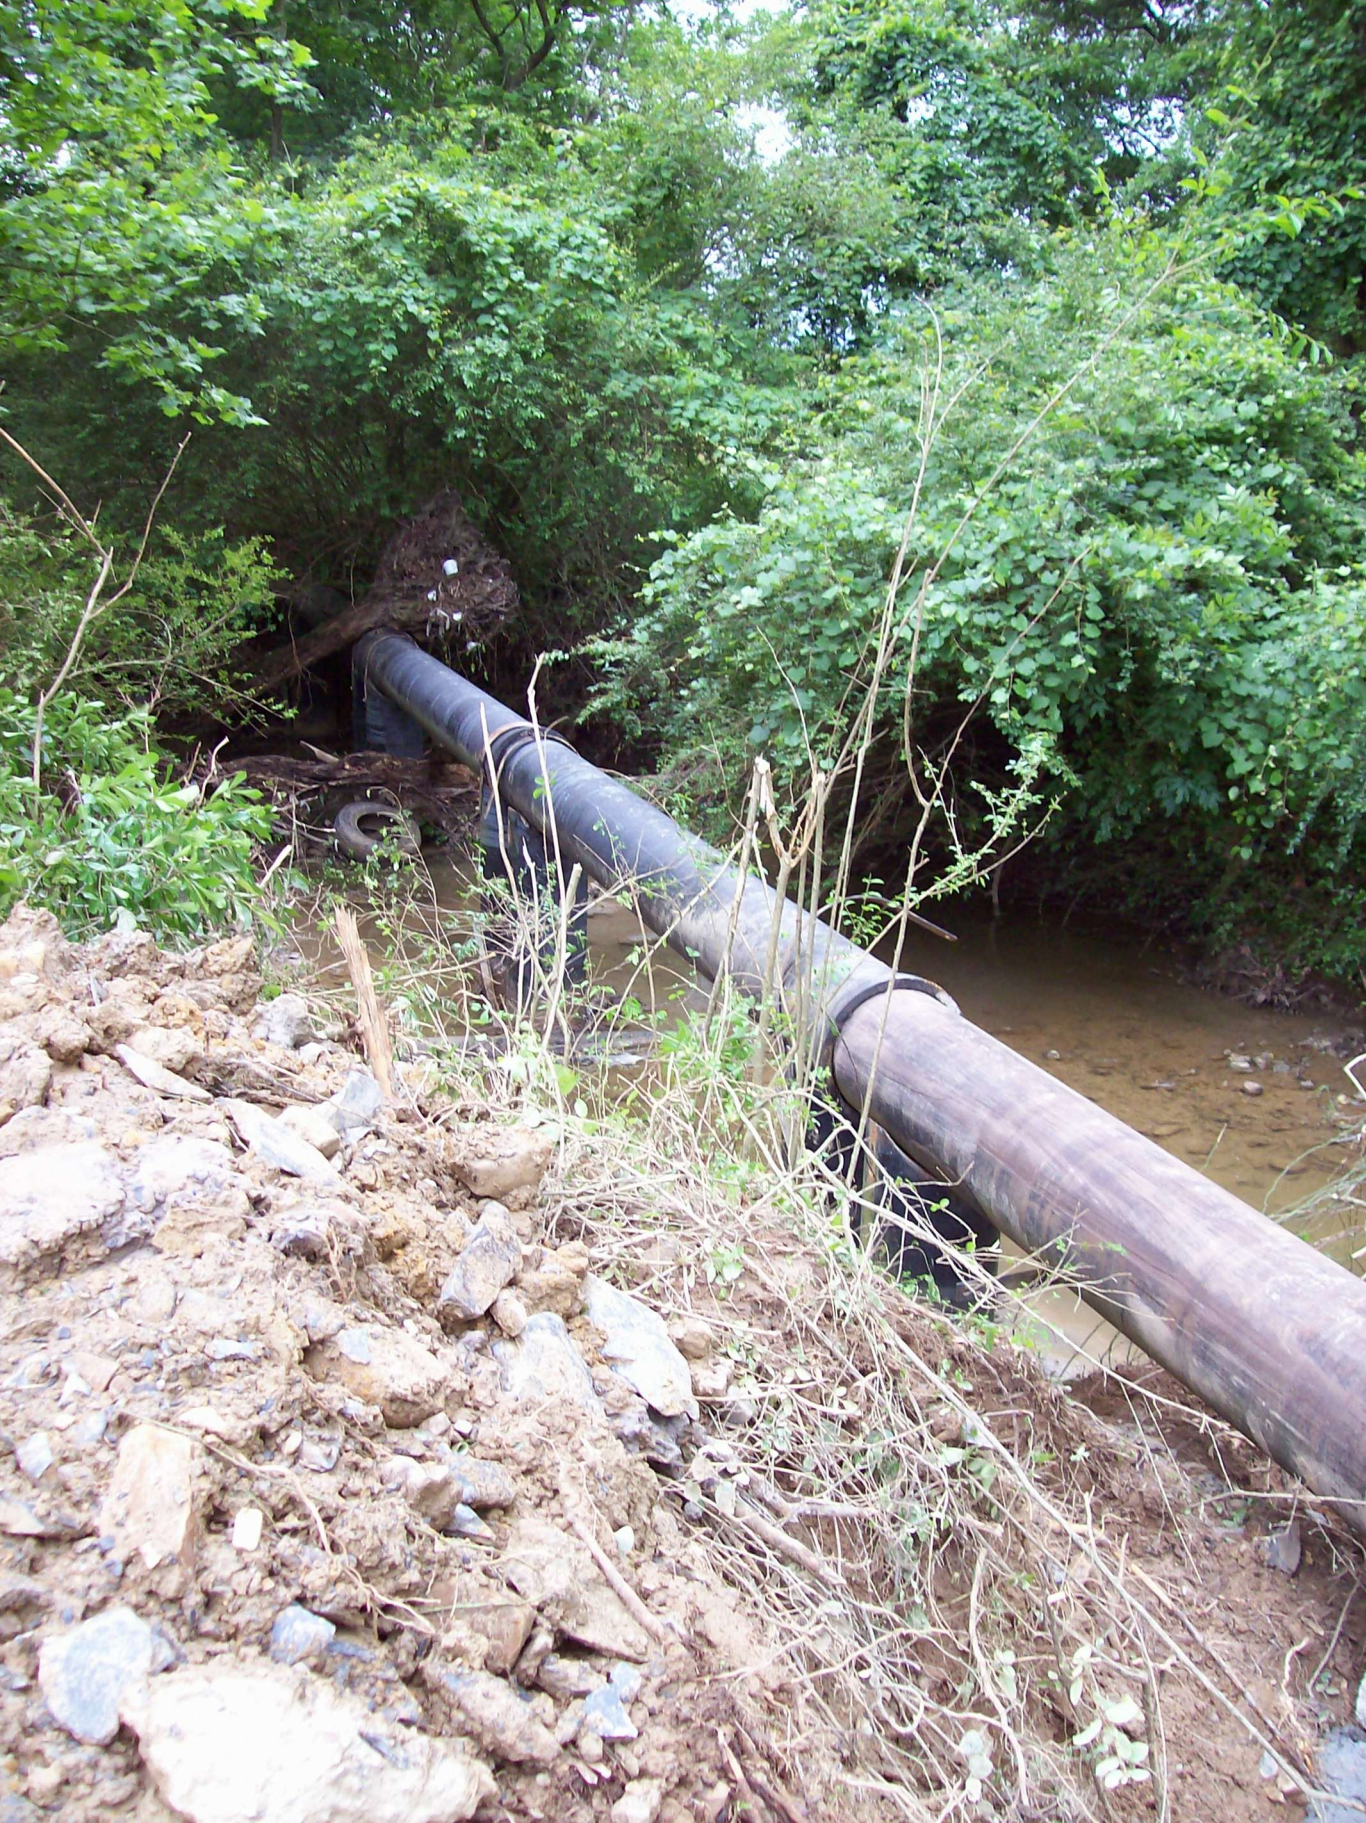
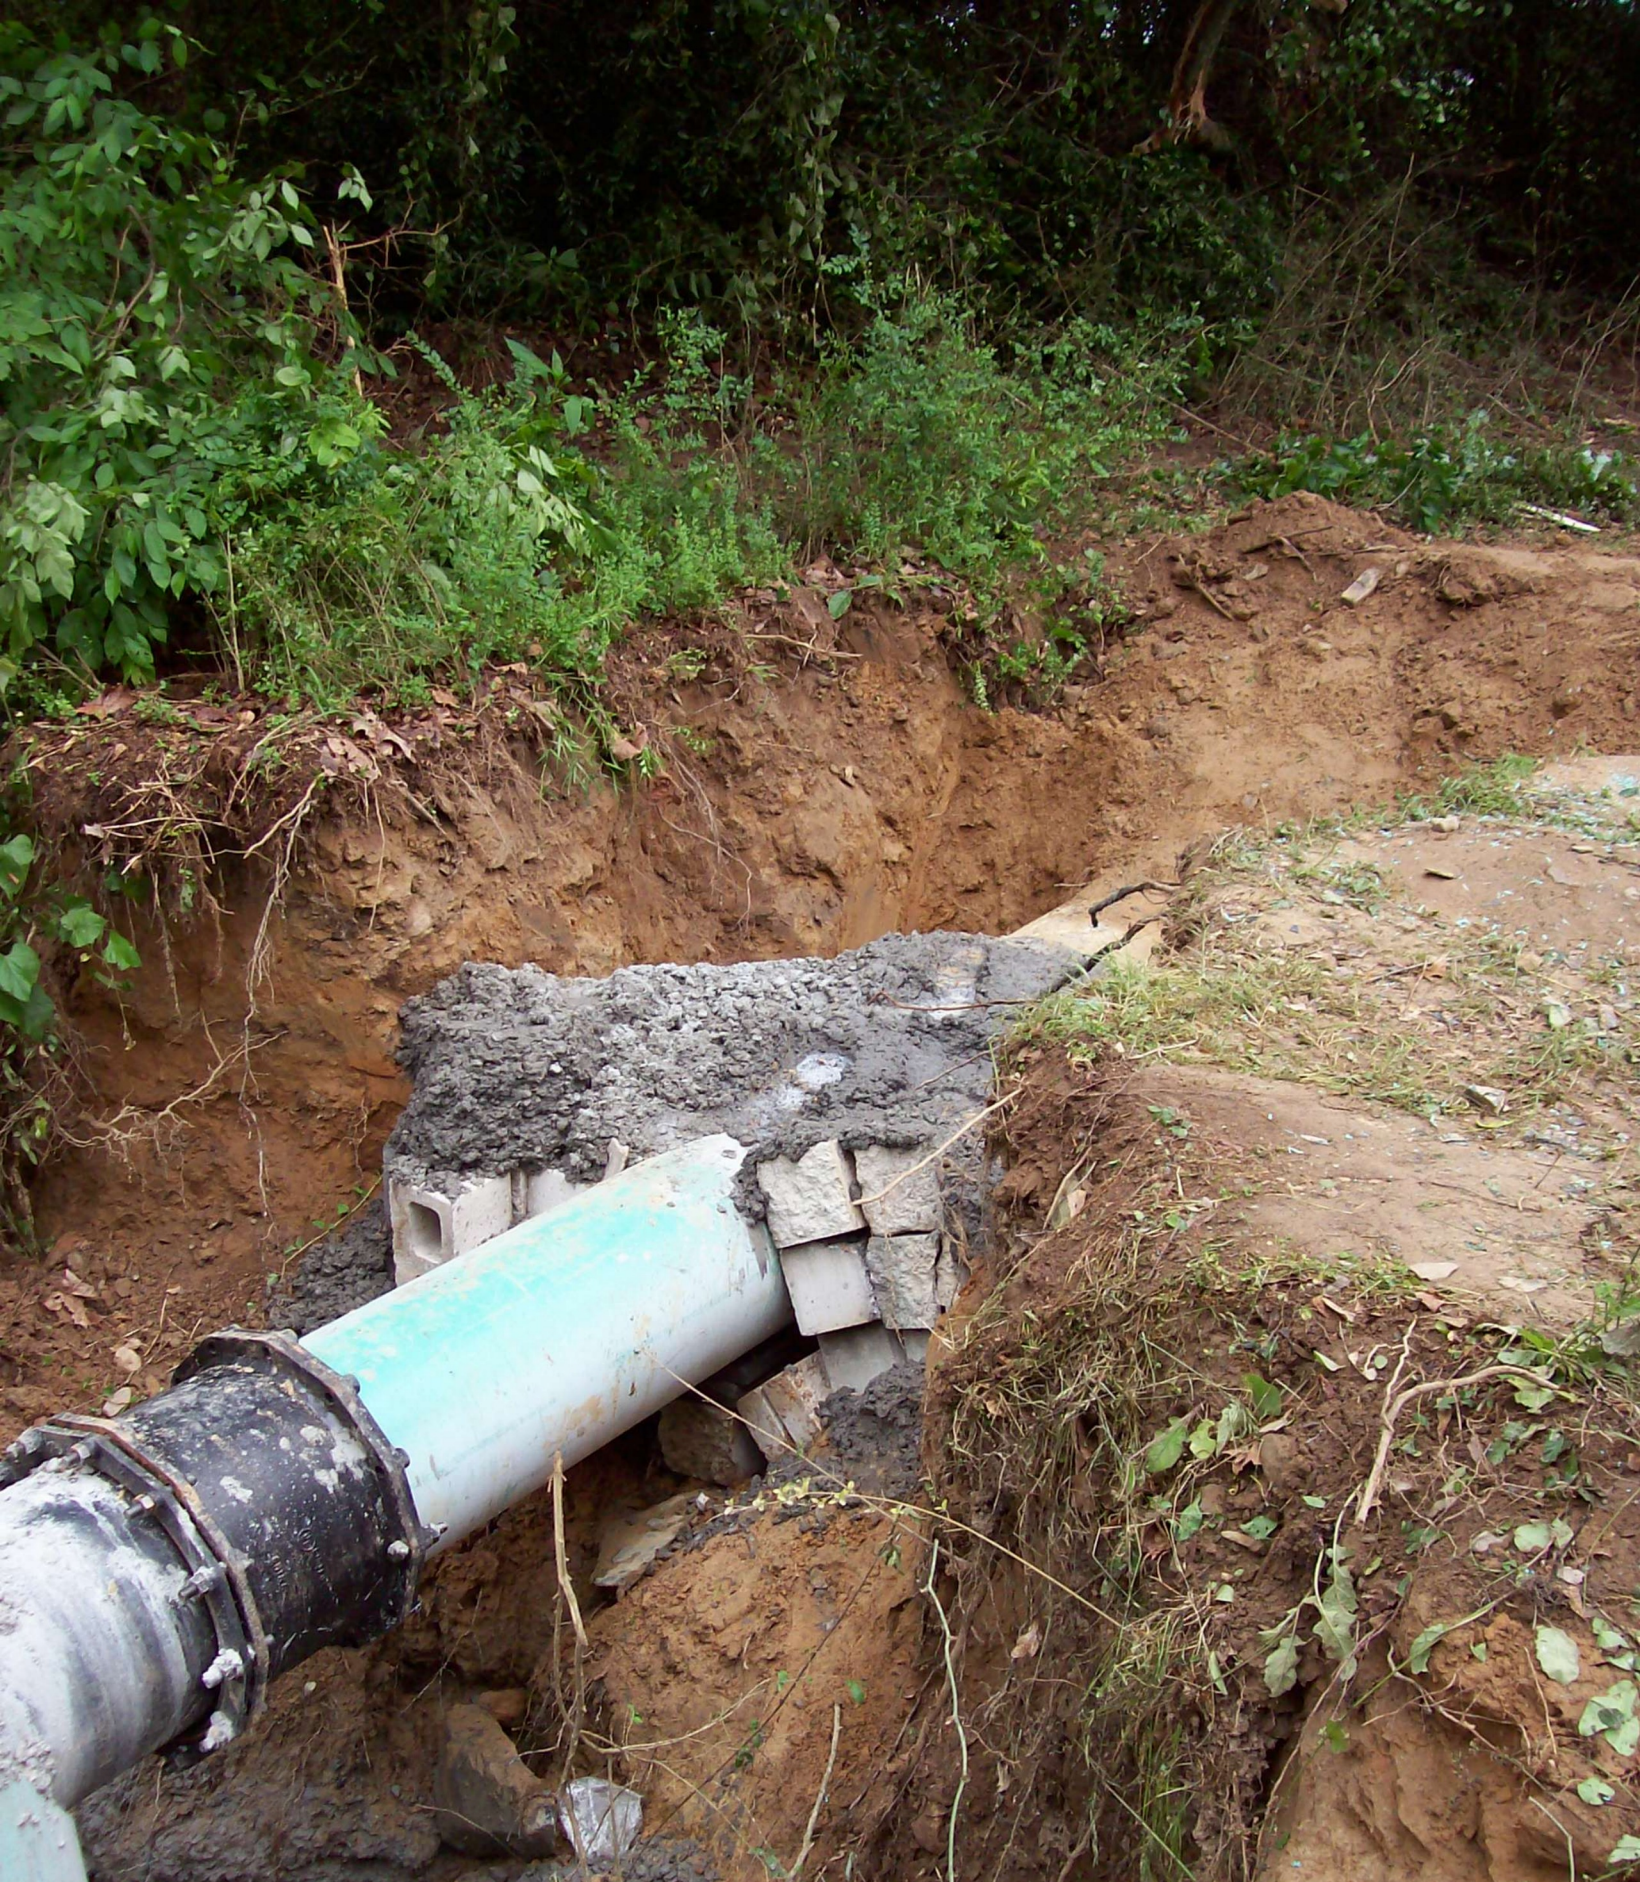
As per your request, here is a time line of our progress. On June 2, Shan Lynch notified Mena Water Utilities regarding the sewer main break at Ward Creek. According to our observation, erosion of the creek bank caused the sewer main to shift and break. That afternoon we performed the preparatory work for the sewer main repair. We ordered materials, moved trees and brush, and removed the damaged pipe.

On June 3 we built a pier to support the new section of pipe and repaired the pipe using the following materials: twenty feet of eighteen inch ductile iron, fourteen feet of eighteen inch PVC sewer pipe, a solid 24 x 18 coupling, twenty-four inch PVC pipe for pier construction, twenty blocks and ten yards of concrete. The following day we added six more yards of concrete and ten loads of fill dirt to support the pipe and deter future erosion.
