Form Approved OMB No. 2040-0003 **⊕**EPA UNITED STATES ENVIRONMENTAL PROTECTION AGENCY
Washington, D.C. 20460 **NPDES Compliance Inspection Report** Section A: National Data System Coding NPDES Yr/Mo/Day Transaction Code Inspec. Type Inspector Fac. Type **3** 11 12 **0** Remarks Facility Evaluation Rating Inspection Work Days **OA** 70 N Ν 80 Section B: Facility Data Name and Location of Facility Inspected (For industrial users discharging to POTW, also Permit Effective Date Entry Time/Date include POTW name and NPDES permit number) 11:04 /6/26/2009 MAGNOLIA, CITY OF 10/1/2005 Sewer collection system, Exit Time/Date Permit Expiration Date Warnock Springs Road, 12:18/6/26/2009 9/30/2010 Magnolia, AR Name(s) of On-Site Representative(s)/Title(s)/Phone and Fax Number(s) Other Facility Data Russell Thomas, Manager, 870-234-2454 Name, Address of Responsible Official/Title/Phone and Fax Number Russell Thomas, 870-234-2454 Contacted MAGNOLIA, CITY OF-BIG CREEK WA P.O. Box 666 N_0 Magnolia, AR 71754 Section C: Areas Evaluated During Inspection (S = Satisfactory, M = Marginal, U = Unsatisfactory, N = Not Evaluated) Permit Flow Measurement Operations & Maintenance Sampling N N Records/Report

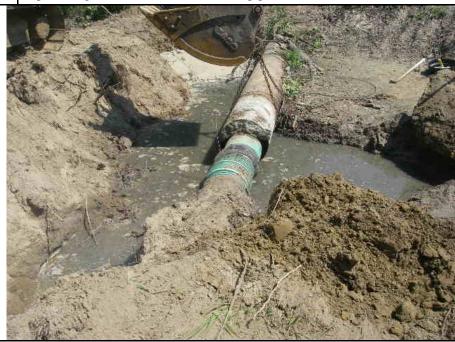
Water Division NPDES Photographic Evidence Sheet										
Location:	Location: MAGNOLIA, CITY OF-									
Photographer: John W. Lamb Witness: None										
Photo #	1	Of	3		Date:	6/26/2009	Time:	11:19

Description: Repair being made of disconnected sewer pipeline.

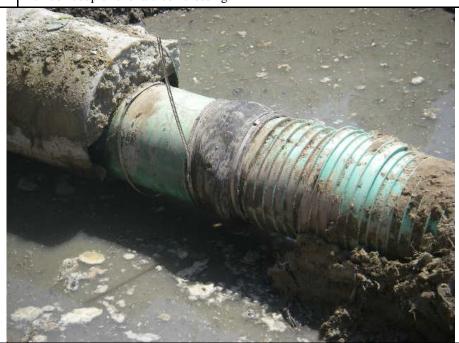
Photograph	hotographer: John W. Lamb			Witness:	None	None		
Photo #	2	Of	3	Date:	6/26/2009	Time:	11:19

Showing detail of where pipe had separated from smooth pvc to corrugated pvc using a rubber "fernco" coupler over a creek crossing.

At the time of the inspection, the joint had been repaired and the facility was pumping sewage out of the unnamed tributary and back into a manhole. Mr. Thomas stated that pipe had been ordered to replace this section of pipe and get rid of this joint in the creek crossing. The sewage had ran down the unnamed tributary approximately 50 yards before entering Nations Creek. The sewage was noted in Nations for approximately 150 yards to the Warnock Springs Road Crossing. I advised Mr. Thomas to pump the sewage out of Nations Creek back into a nearby sewer line, then once pumped, to flush with fresh water if possible.

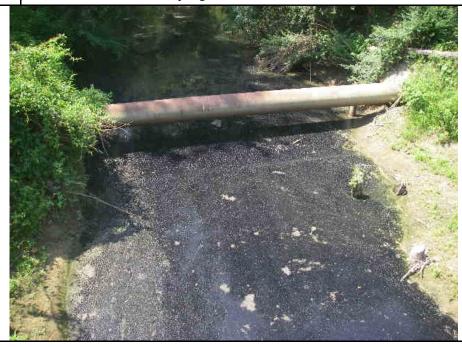
Water Division NPDES Photographic Evidence Sheet									
Location: MAGNOLIA, CITY OF-									
Photographer: John W. Lamb Witness: None									
Photo # 3 Of 3		3		Date:	6/26/2009	Time:	11:43

Nations Creek at Warnock Springs Road. **Description:**
