ARKANSAS
Department of Environmental Quality

RE: Sanitary Sewer Manhole Overflows and Sewer Main Cleanout Discharge

AFIN: 04-00052 NPDES Permit No.: AR0022292

NPDES Compliance Inspection Report

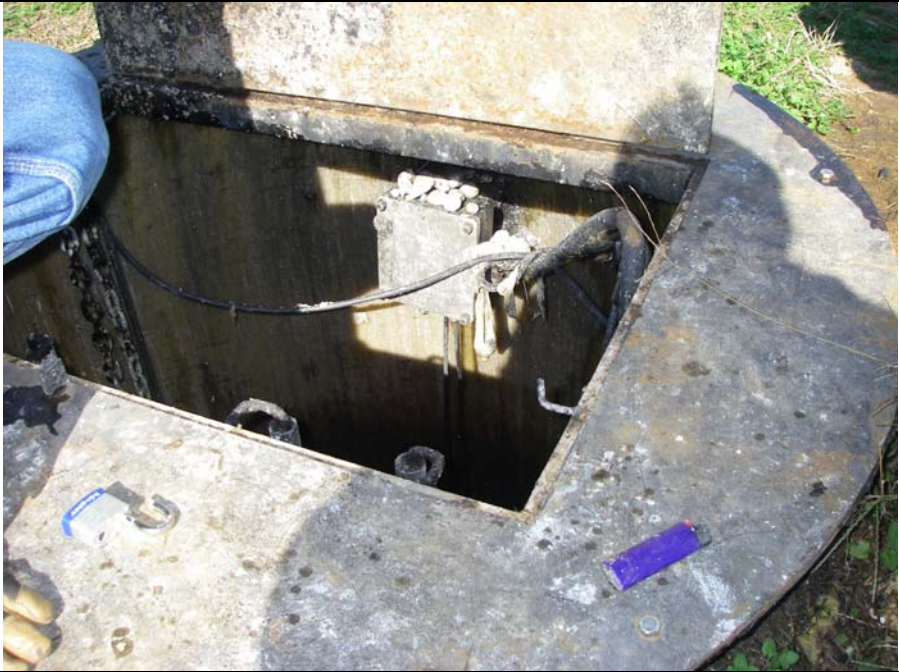
Photo # 1 **Of** 4 **Date:** 11/03/09 **Time:** 1211

On this date, I met with Altin Verser, City of Decatur staff, at a lift station located just south of the intersection of Hwy 102 and Mt. Olive Rd in Decatur. Sewage waste solids were present on electrical wiring and a junction box located at the top of the lift station wet well just below the lid. Solids were also present on the base of the well lid. Mr. Verser stated that the lift station well overflowed on October 8, 2009 and/or October 9, 2009 as a result of heavy rains. The following violation was noted:

Description: Balls of grease visible atop junction box below lid. Solids also present on base of well lid.

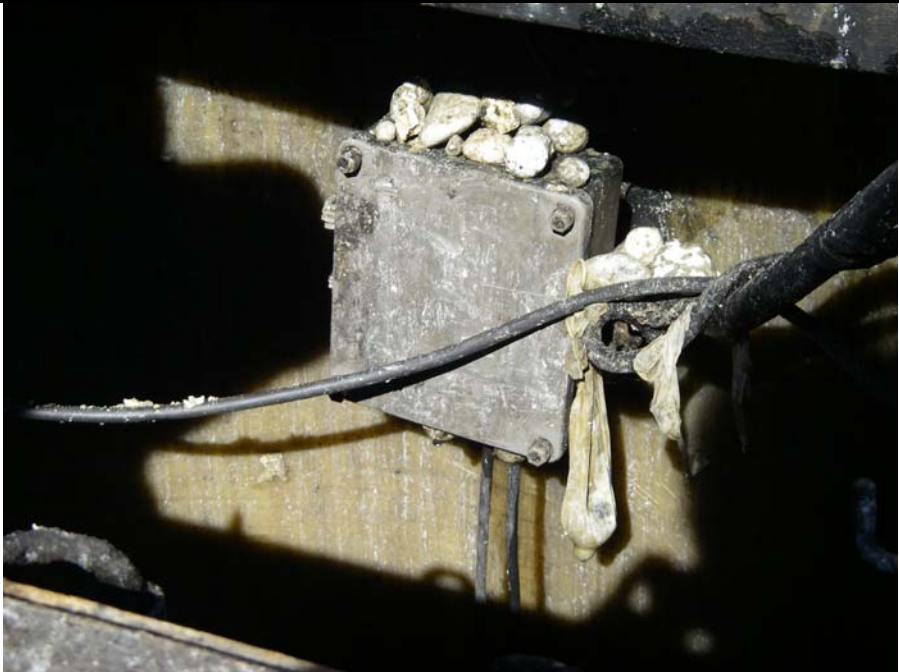
Photo # 2 **Of** 4 **Date:** 11/03/09 **Time:** 1211

Description: Grease and condoms on box and wiring at top of well.

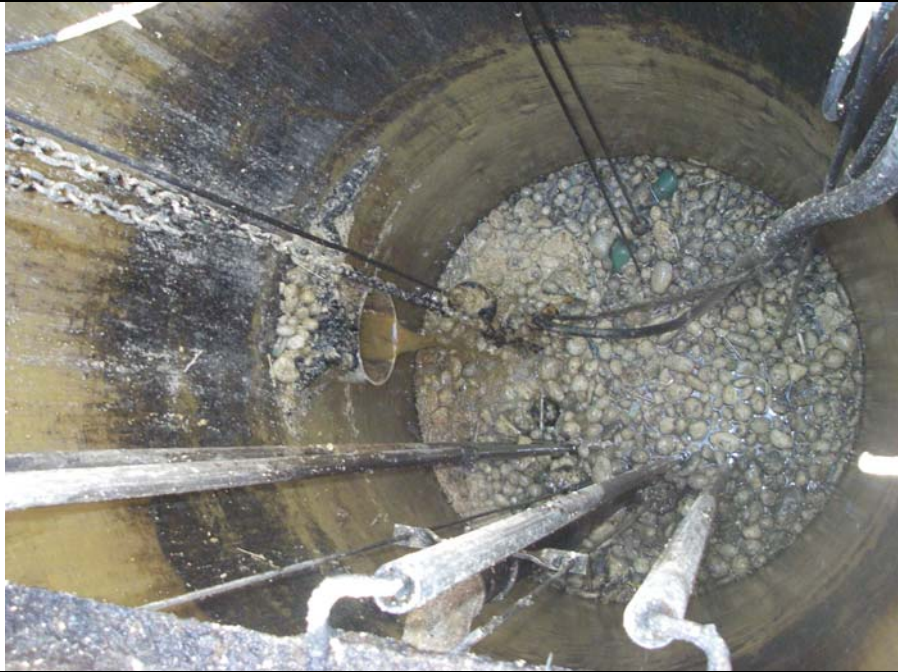
Photo #	3	Of	4	Date:	11/03/09	Time:	1212
----------------	---	-----------	---	--------------	----------	--------------	------

On November 3, 2009, I met with Altin Verser, City of Decatur, at a lift station where he was performing maintenance. The lift station is located just south of the intersection of Mt. Olive Rd. & Hwy 102. Based on the level of solids in the wet well (see attached photos), it was evident that the well had overflowed recently. Mr. Verser stated that an overflow was occurring at this station on 10/08/09 and/or 10/09/09. The following violation was noted:

Description:	Conditions in wet well.
---------------------	-------------------------

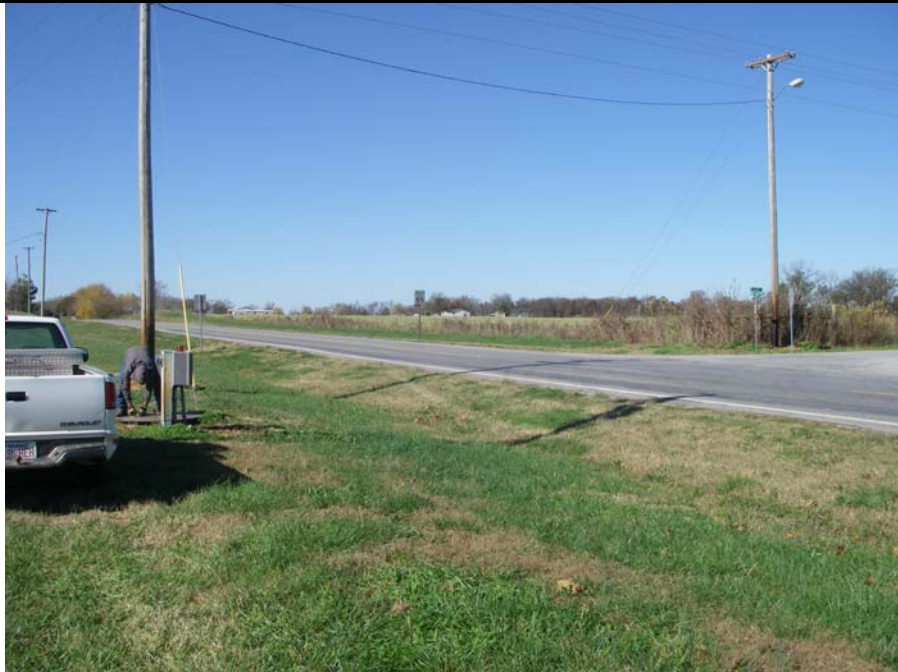
Photo #	4	Of	4	Date:	11/03/09	Time:	1215
----------------	---	-----------	---	--------------	----------	--------------	------

Description:	Location of lift station. Looking to northwest.
---------------------	---
