ARKANSAS
Department of Environmental Quality

RE: Sanitary Sewer Overflow/Collection System Inspection

AFIN: 04-00052 NPDES Permit No.: AR0022292

NPDES Compliance Inspection Report

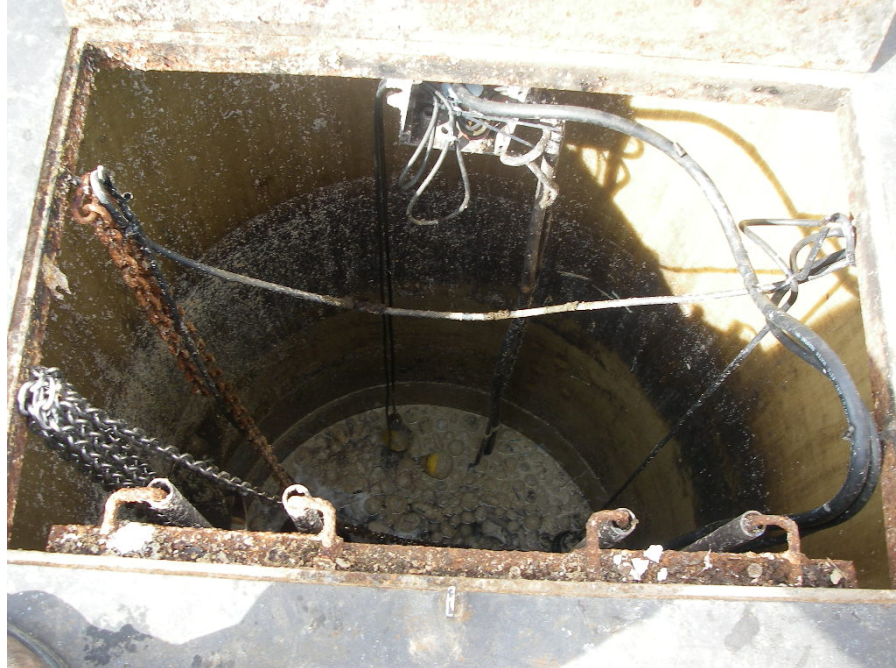
Location:	City of Decatur Collection System						
Photographer:	Dale Washam			Witness:	John Fazio		
Photo #	1	Of	3	Date:	03/23/10	Time:	1606
Description:	Excessive grease and evidence of overflow at the Park lift station.

- There are no provisions for back-up power at the five lift stations;
- Excessive grease exists in the two lift station wet wells visited during the inspection. Regular maintenance is necessary to prevent interference with floats, pumps and pumping capacity;
- There was evidence of overflows at the two lift stations visited during the inspection;
- A section of clay tile lines south of town, which are a major source of infiltration, need repair or replacement;
- Locks are needed on all lift station power boxes that are accessible to the public to prevent tampering;
- Contact information is necessary at all lift stations;
- Fencing is recommended around all lift stations.

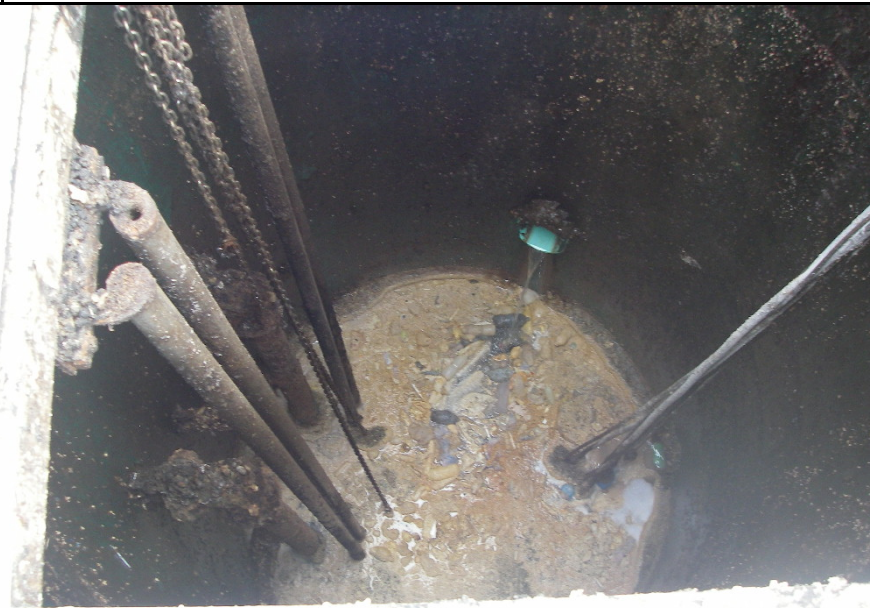
Photographer:	Dale Washam			Witness:	John Fazio		
Photo #	2	Of	3	Date:	03/23/10	Time:	1615
Description:	Excessive grease and evidence of overflow at the Grant St. lift station.

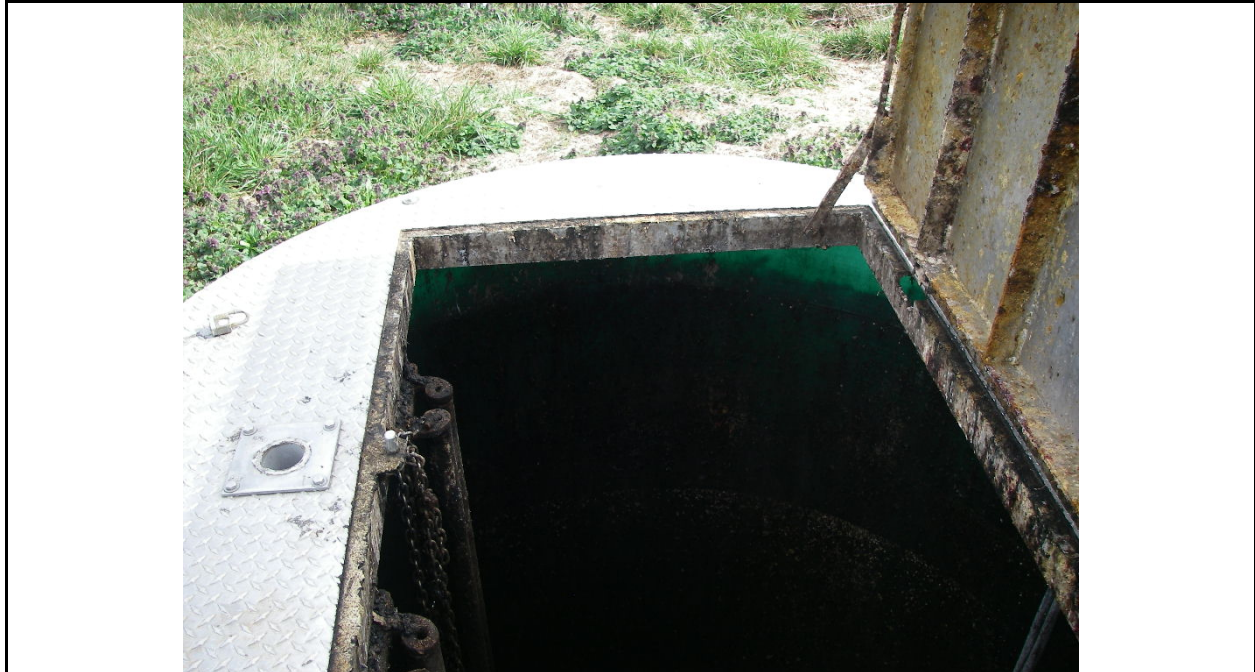
Location:	City of Decatur Collection system						
Photographer:	Dale Washam			Witness:	John Fazio		
Photo #	3	Of	3	Date:	03/23/10	Time:	1616
Description:	Evidence of overflow on lid at the Grant St. lift station.
