RE: Satellite System Sanitary Sewer Overflow Investigation

NPDES Compliance Inspection Report

Name and Location of Facility Inspected (<i>For industrial users discharging to POTW, also include POTW name and NPDES permit number</i>) Northwest Arkansas Regional Airport (discharges to City of Bentonville POTW) One Airport Blvd., Suite 100 Bentonville, Arkansas 72712	Entry Time/Date 1145 / 08-24-10	Permit Effective Date March 1, 2009
	Exit Time/Date 1205 / 08-24-10	Permit Expiration Date February 28, 2014
Name(s) of On-Site Representative(s)/Title(s)/Phone and Fax Number(s) No-one present	Other Facility Data SSO Location: 36.2966, -94.3032 Manhole before North Lift Station	
Name, Address of Responsible Official/Title/Phone and Fax Number Steve Keith, Airport Facilities Manager Northwest Arkansas Regional Airport One Airport Blvd., Suite 100 Bentonville, Arkansas 72712 479-205-1019, 479-790-9929	Contacted Yes <input type="checkbox"/> No <input checked="" type="checkbox"/>

Water Division NPDES Photographic Evidence Sheet							
---	--	--	--	--	--	--	--

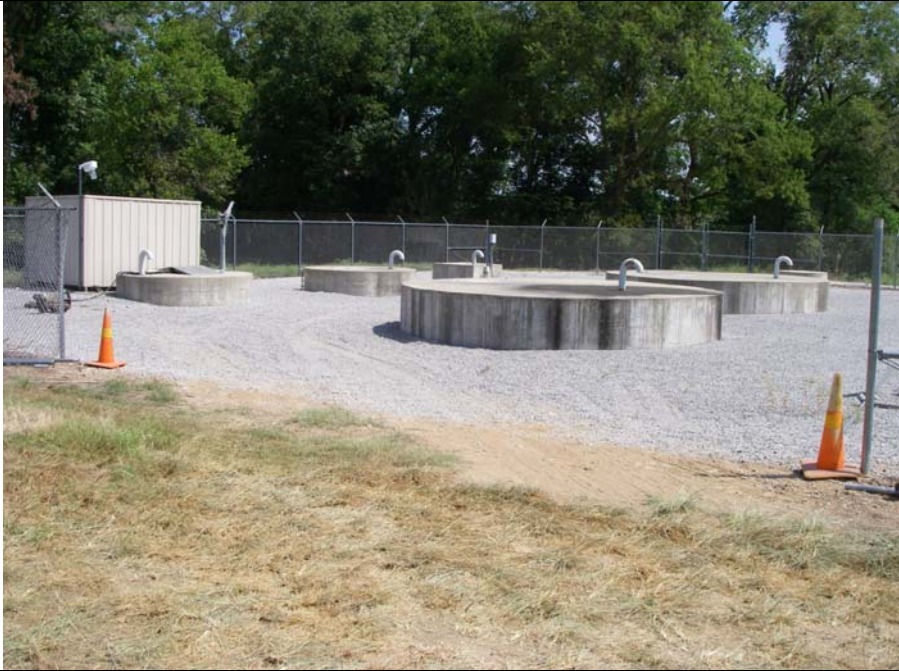
Photo #	1	Of	6	Date:	08/24/10	Time:	1159
----------------	---	-----------	---	--------------	----------	--------------	------

Description:	North Lift Station.						
---------------------	---------------------	--	--	--	--	--	--

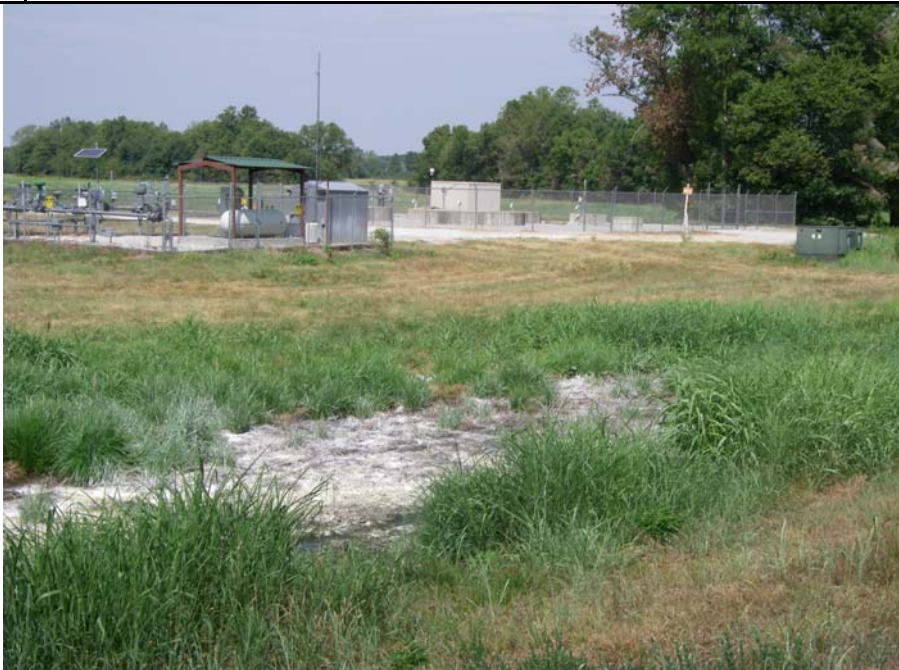
Photo #	2	Of	6	Date:	08/24/10	Time:	1155
----------------	---	-----------	---	--------------	----------	--------------	------

Description:	Wastewater to be recovered.						
---------------------	-----------------------------	--	--	--	--	--	--

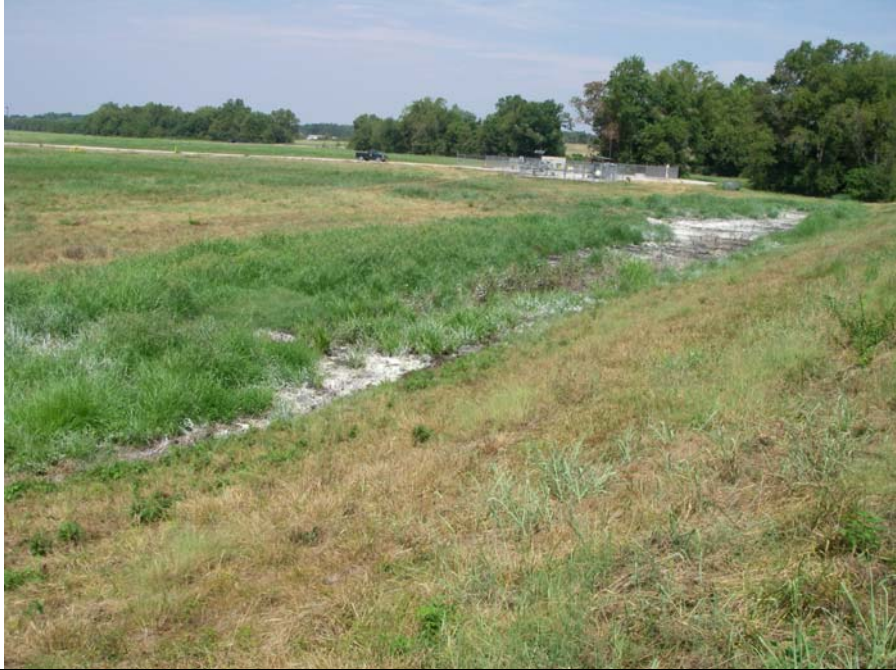
Photo # 3 **Of** 6 **Date:** 08/24/10 **Time:** 1153

Description: Wastewater to be recovered. Looking from south to ~ north. Impacted area over 300 in length.

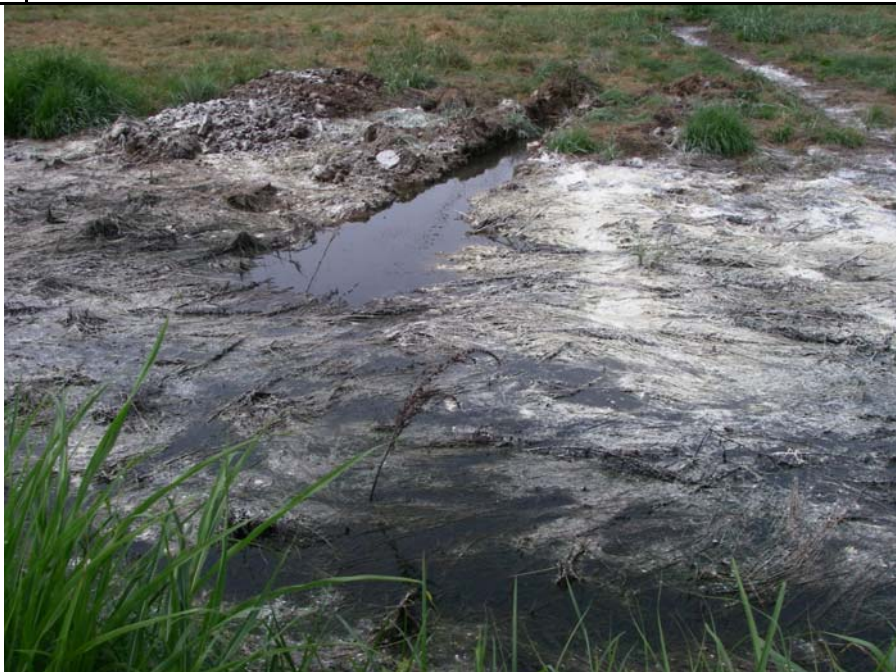
Photo # 4 **Of** 6 **Date:** 08/24/10 **Time:** 1155

Description: Wastewater to be recovered.

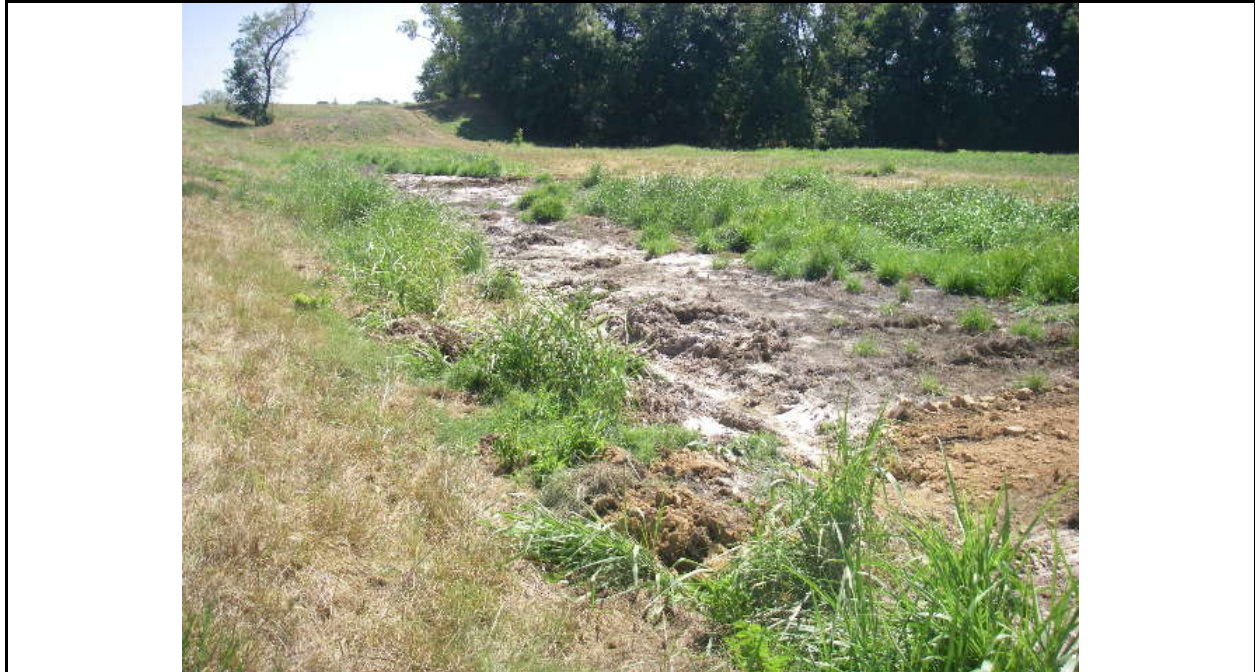
Photo #	5	Of	6	Date:	08/27/10	Time:	1436
----------------	---	-----------	---	--------------	----------	--------------	------

Description:	Follow-up inspection: cleanup satisfactory.						
---------------------	---	--	--	--	--	--	--

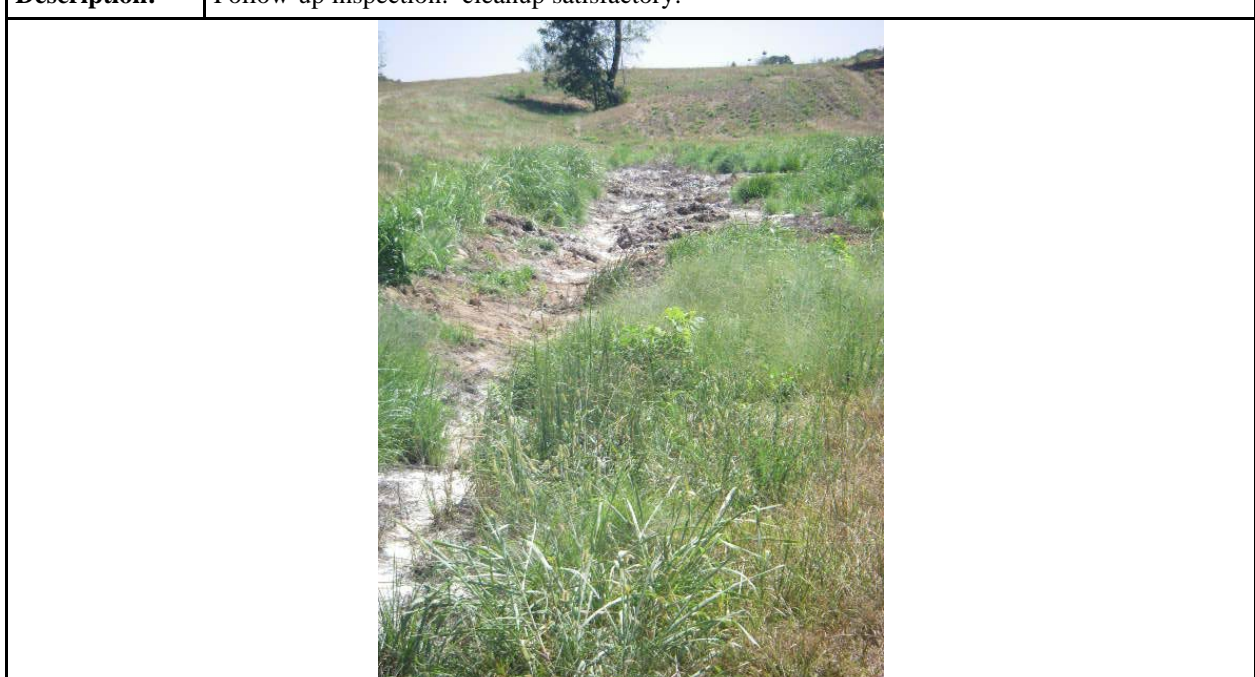
Photo #	6	Of	6	Date:	08/27/10	Time:	1437
----------------	---	-----------	---	--------------	----------	--------------	------

Description:	Follow-up inspection: cleanup satisfactory.						
---------------------	---	--	--	--	--	--	--
