RE: NPDES Sanitary Sewer Overflow Inspection, West Memphis WWTP

AFIN: 18-00879 NPDES Permit No.: AR0022039

NPDES Compliance Evaluation Inspection Wastewater Treatment Plant NPDES Sanitary Sewer Overflow Inspection Pretreatment Compliance Inspection

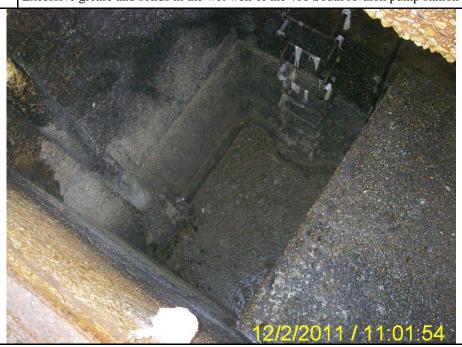
Water Division NPDES Photographic Evidence Sheet								
<b>Location:</b>	Wes	st Men	nphis WV	VTP				
Photograph	er:	Michae	el Greenv	vay	Witness:	Brent Walke	r	
Photo #	3	Of	14		Date:	12-02-2011	Time:	11:01
Description	<b>Description:</b> Excessive grease and solids in the wet well of the 401 South Avalon pump station (Station # 6).

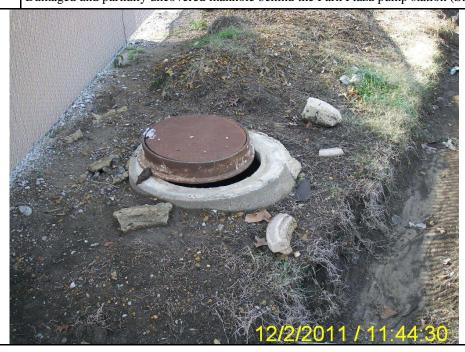
Water Division NPDES Photographic Evidence Sheet										
<b>Location:</b> West Memphis WWTP										
Photograph	er: N	Aichae	el Greenv	vay	Witness:	Brent Walker				
Photo #	7	Of	14		Date:	12-02-2011	Time:	11:44		
<b>Description:</b>		Damaged and partially uncovered manhole behind the Park Plaza pump station (Station #13a).

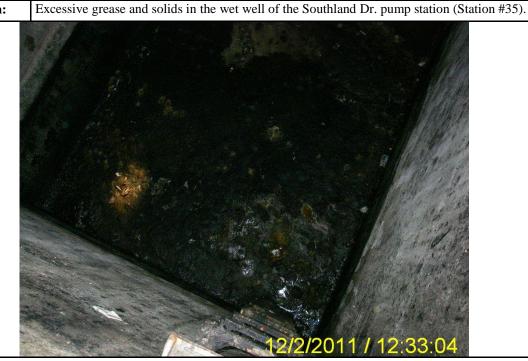
Photo #
 8
 Of
 14
 Date:
 12-02-2011
 Time:
 12:33

Description:
 Excessive grease and solids in the wet well of the Southland Dr. pump station (Station #35).

- a) Wet well has been cleaned and will be on a cleaning schedule. (See picture-Pump Station #35 (Southland Drive)-Wet Well-1).
- b) Lights are now operational. (See picture-Pump Station #35 (Southland Drive)-Inside-1).
- c) This has been corrected.
- d) This will be corrected.
- 8. Station #33 (Bill's Grill)
  - a) There was excessive grease and solids in the wet well.
  - b) The door to the pumps station was unlocked. Additionally, the door could not be unlocked with a key from the outside.
  - c) Guards did not adequately cover drive shafts.
