ARKANSAS
Department of Environmental Quality

NPDES Permit No.: AR0021466

NPDES Compliance Inspection Report

Location: 1032 Harris Drive-Alma

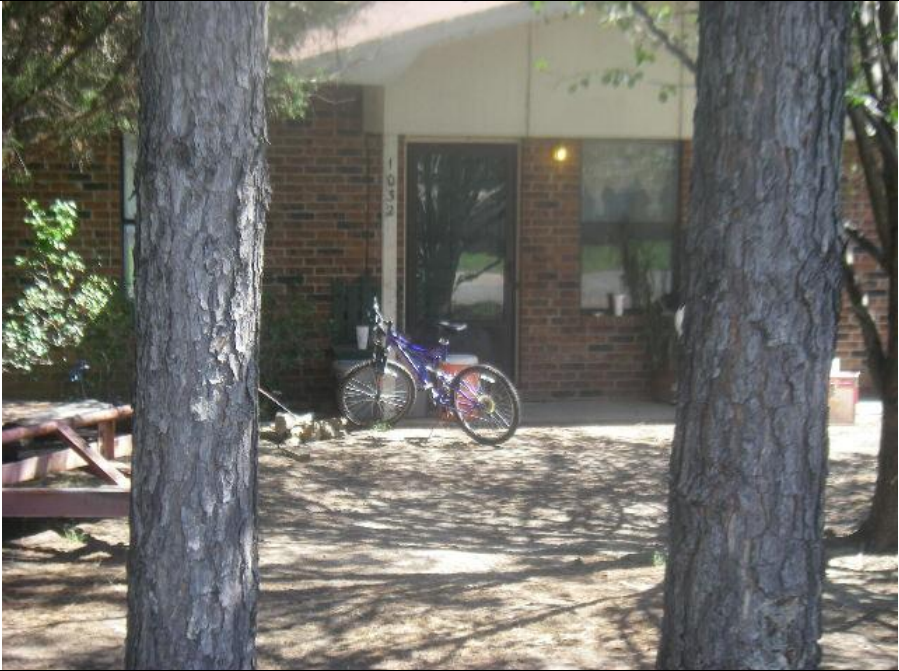
Photo # 1 **Of** 4 **Date:** 09-19-12 **Time:** 1222

Description: View of the home located at 1032 Harris Drive in Alma.

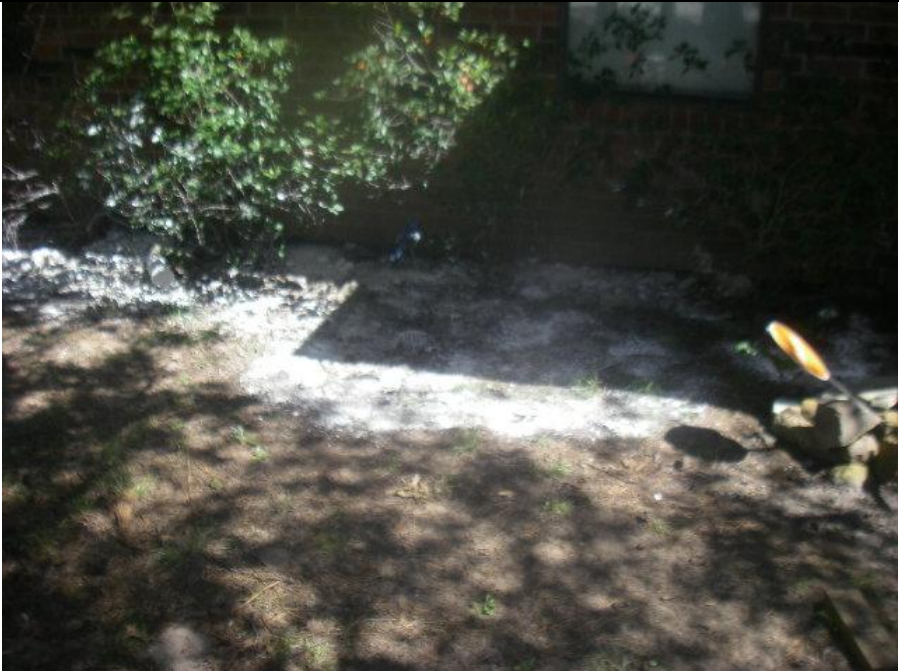
Photo # 2 **Of** 4 **Date:** 09-19-12 **Time:** 1223

It was apparent that a sewer overflow had occurred in the front yard of the home located at 1032 Harris Drive. Upon arrival I observed that lime had been applied to the impacted area at the residence. The area had been cleaned and I did not observe any raw sewage on the ground. It appeared that the overflow had occurred at the clean-out which was an open ended slotted grate flush with the top of the ground located adjacent to the front porch.

Description: Location where sewer overflow occurred with evidence of lime applied to impacted area.

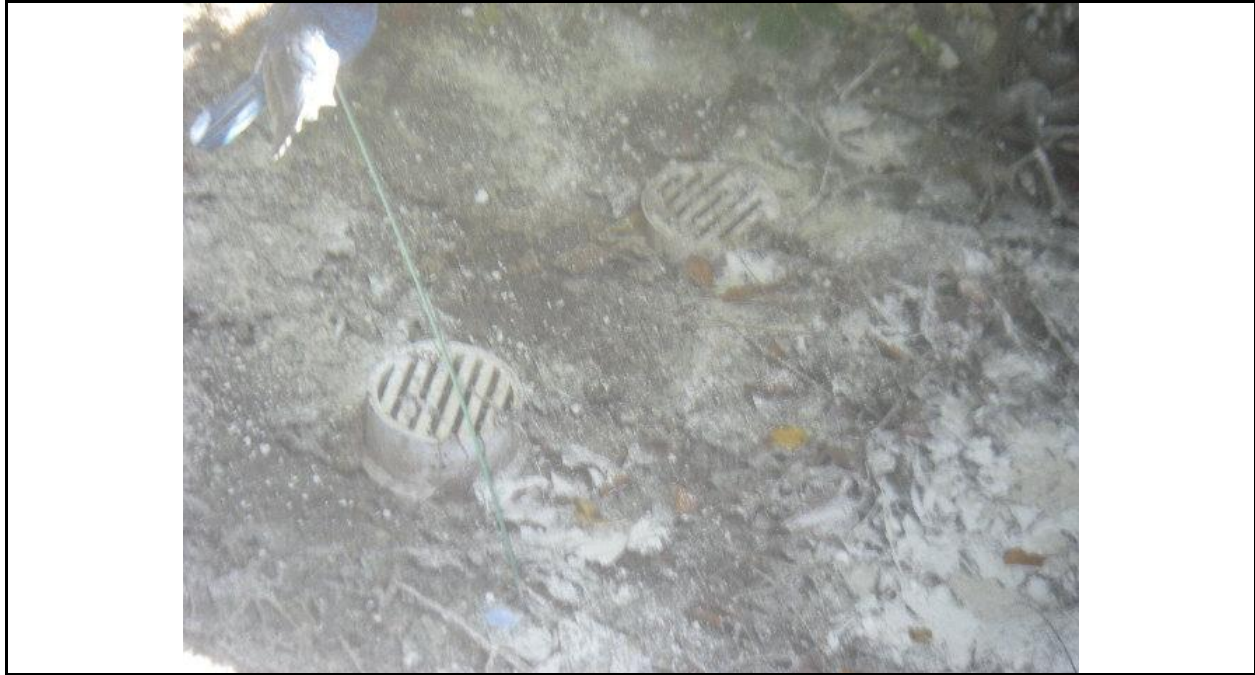
Photo # 3 **Of** 4 **Date:** 09-19-12 **Time:** 1223

Description: Two clean-outs located in front of house, note the open ended slotted grate cover.

During the field inspection, (2) improper open drain type clean-outs were discovered, which is against City policy. The homeowner has been notified via letter and telephone (a copy of this letter was sent to Jeff Tyler), asking for installation of proper clean-out caps as soon as possible.

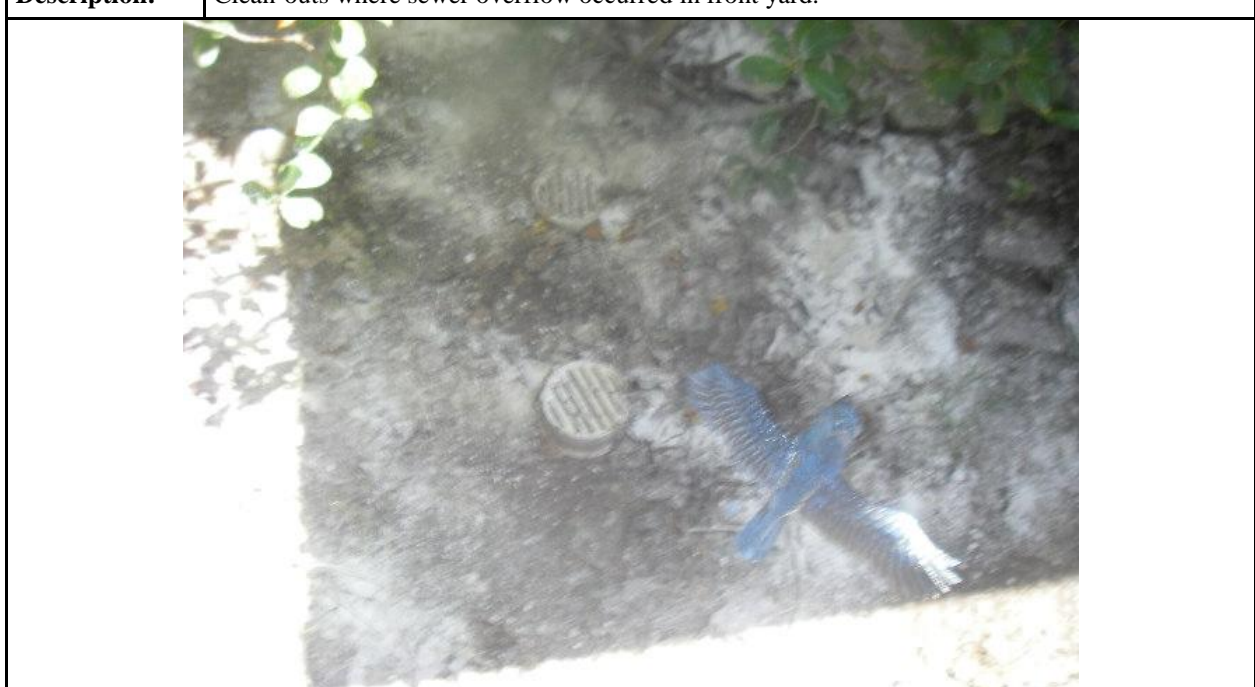
Photo # 4 **Of** 4 **Date:** 09-19-12 **Time:** 1224

Description: Clean-outs where sewer overflow occurred in front yard.

I write concerning the field inspection by Jeff Tyler of an apparent sewage overflow at the residence located at 1032 Harris Drive. The overflow discharged from un-capped clean-outs, near the front of the house.

The cause for the partial blockage in the main appeared to be a bundle of tri-fold paper towels. This particular location, due to the elevation of the house slab, will back up when less than $\frac{3}{4}$ of the main is full. Visual inspections of the collection system, including looking into manholes, occur in this area on a weekly basis, usually on Friday. These preventative measures usually prevent backups in the area, although occasionally backups still occur at this residence. The homeowner has been encouraged to install a backwater valve to prevent any backups in the future.
