RE: Quarterly Inspection; AFIN 18-00094; Permit Number 0245-S1-R1.

Solid Waste Management Division

Class 1 Landfill Inspection

Site Name	Crittenden County Class I	County	Crittenden	AFIN	18-00094
Facility Address	South off Hwy 70	Phone Number	LF: 870-732-4290 Off: 870-732-6580	Permit Number	0245-S1-R1
Permittee Address	Crittenden Co. Judge	E-Mail Address	arredllc@swb.net	PDS #	071257
Date	4-17-13	Entry Time	11:45 AM	Exit Time	1:30 PM

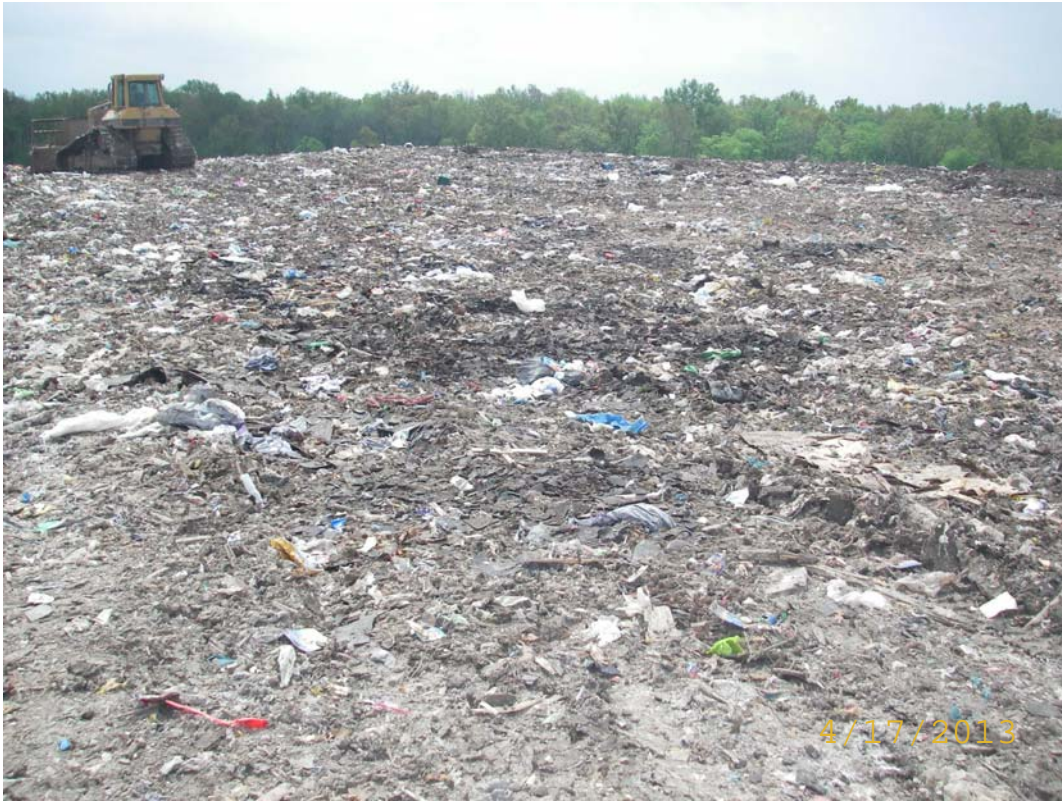
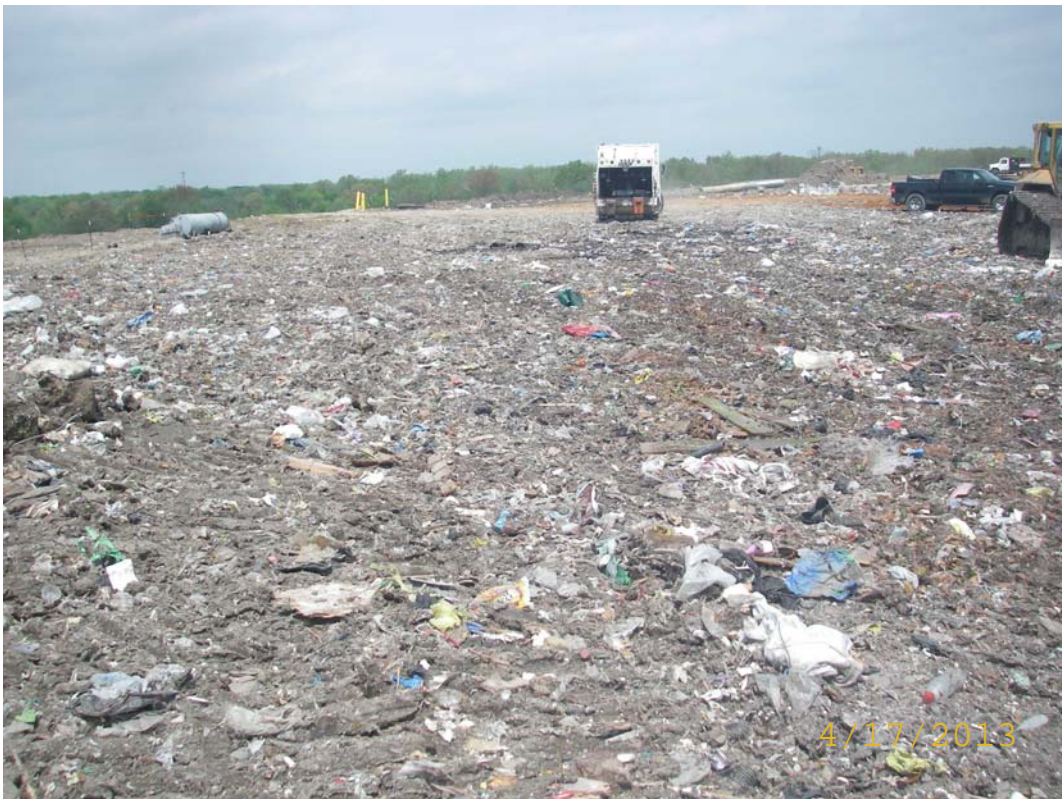
1&2

Comments: The active working face was not a practical working size. Measured 150 feet by 250 feet in size. Photos 1&2.

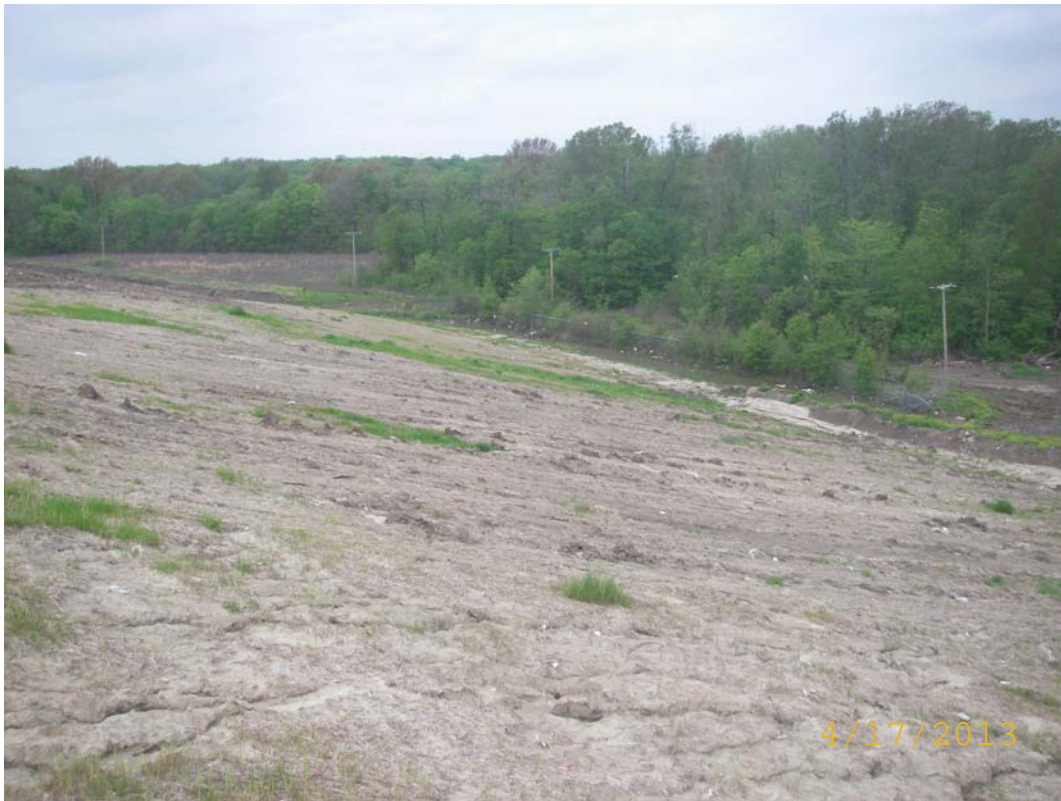
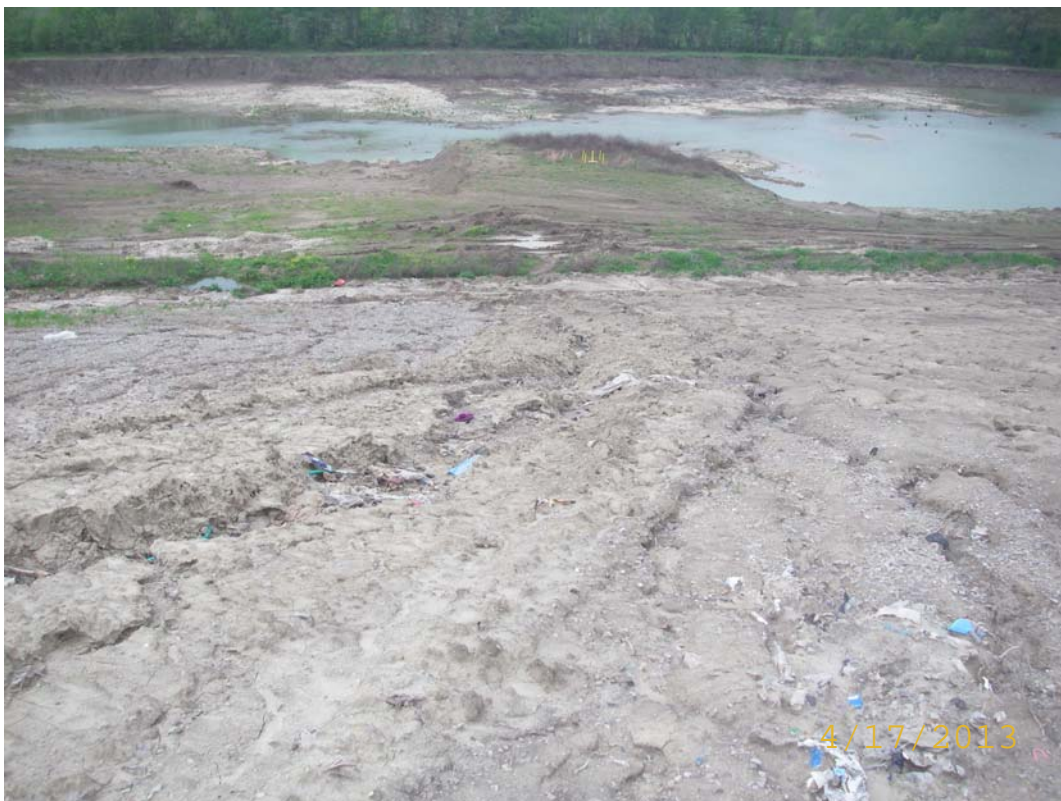
3&4

Comments: No surface water control system in place along north and west slopes of active portion of landfill to minimize erosion cuts. Photos 3&4.

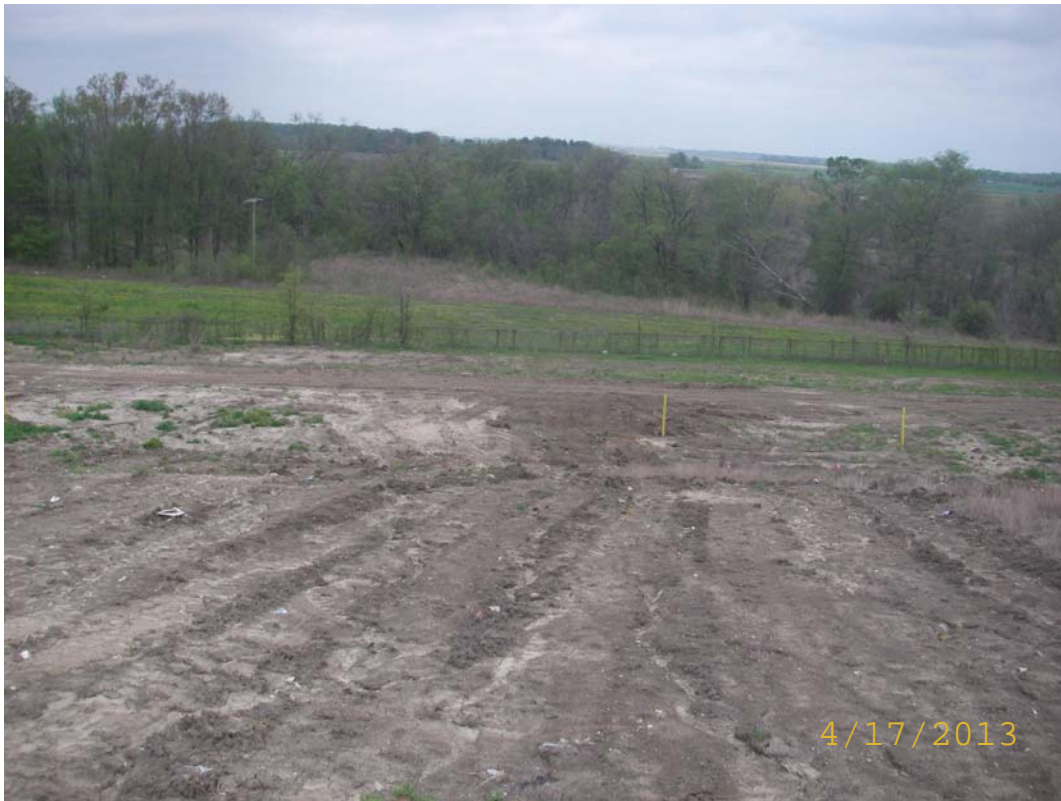
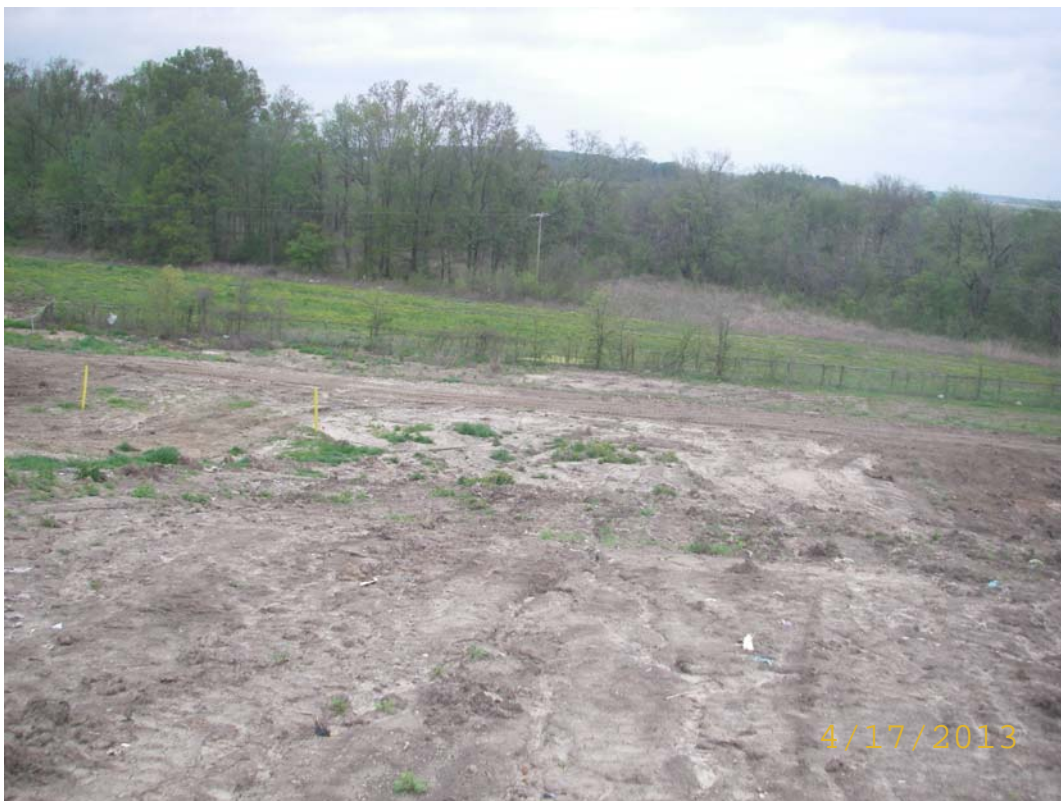
5&6

Comments: Noted off-site sediment accumulation a long north slopes of active portion flowing into nearby field. Photos 5to8.

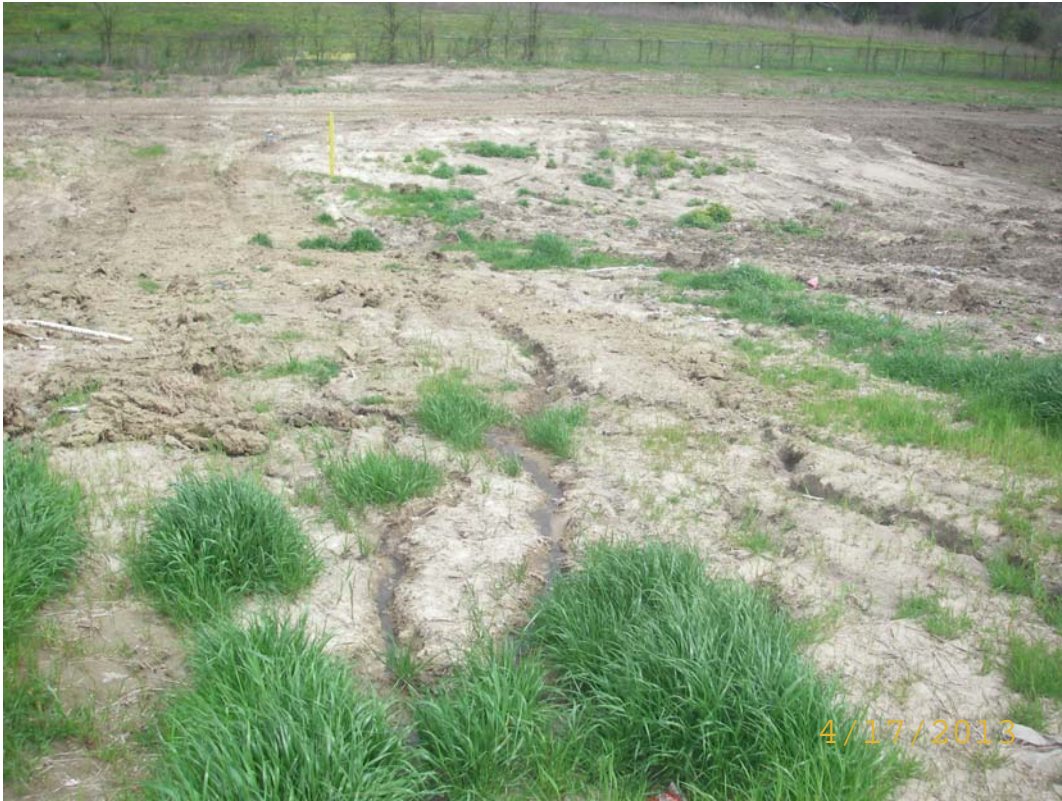
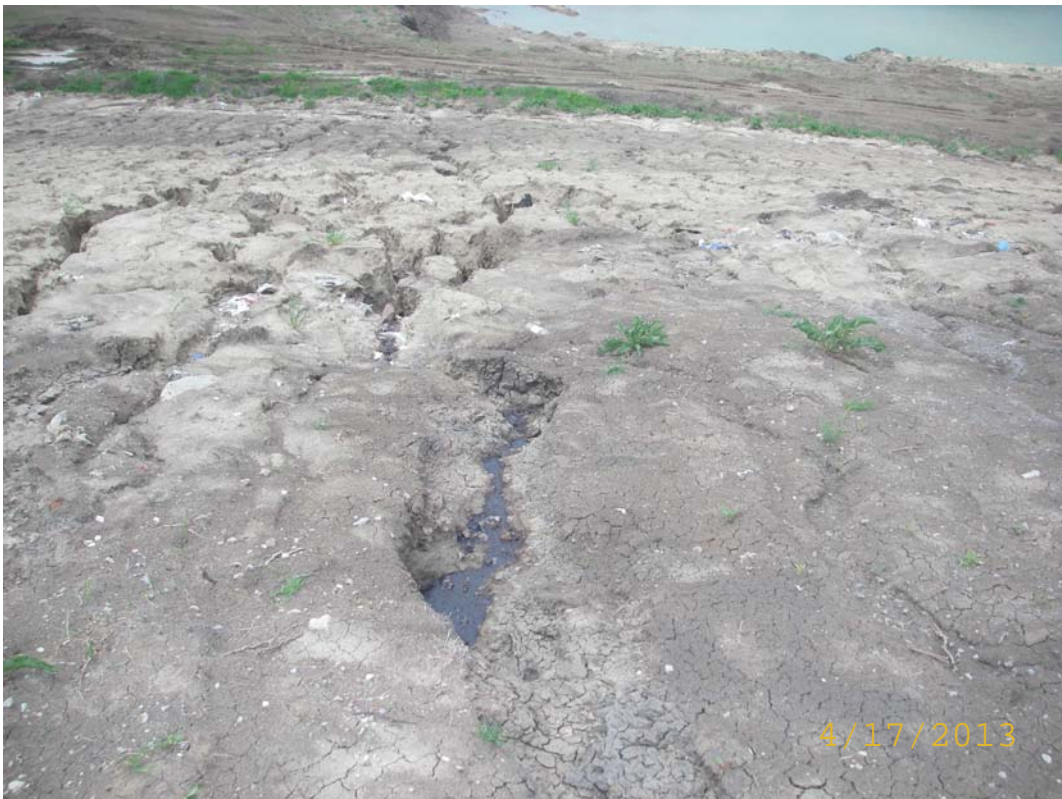
9&10

Comments: Noted Leachate leaks a long west and north slopes of active portion of landfill. Furthermore, Some of the leachate leaks were observed flowing into storm water ditches. Photos 9to14.

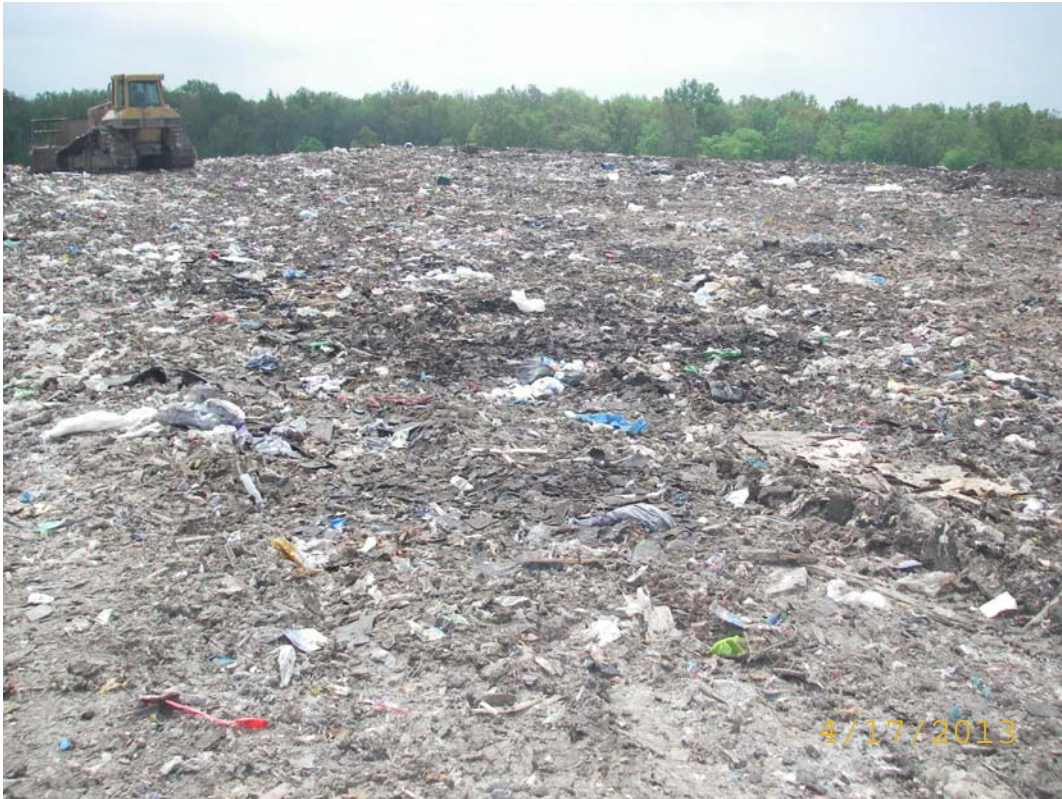
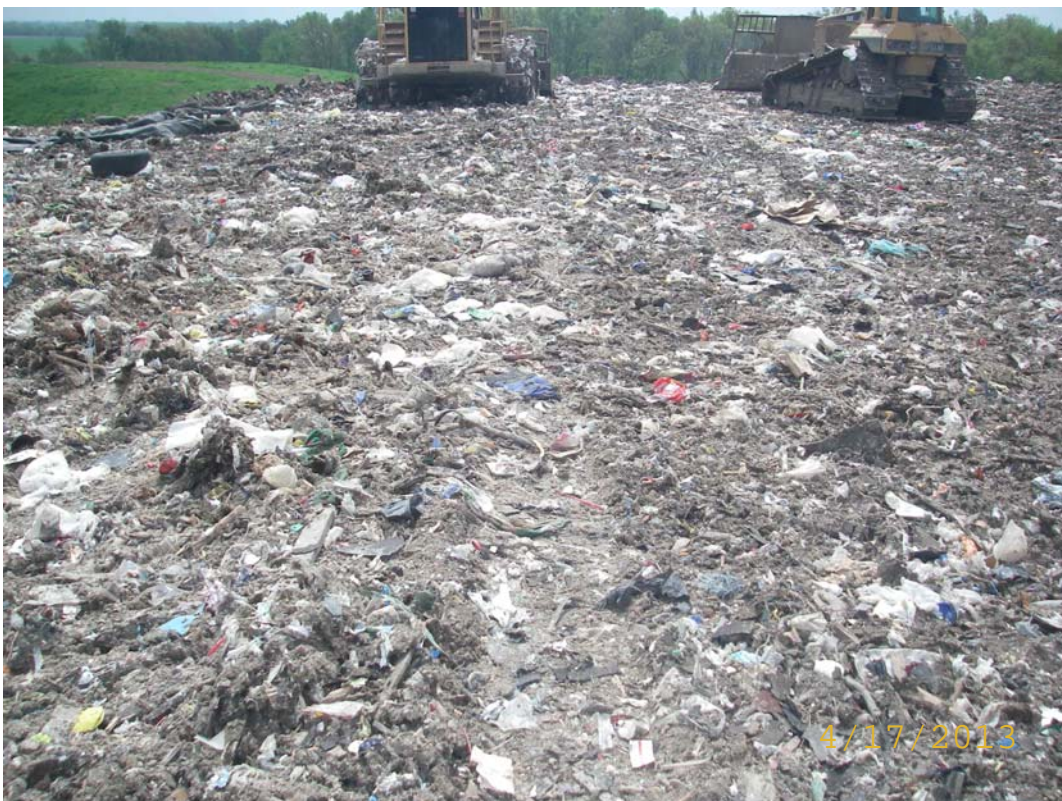
15&16

Comments: According to Jeff Papasan, the facility operator, do to weather conditions the active working face had not been completely covered with soil material in a week. Working face was noted too large in size. Photos 15&18.

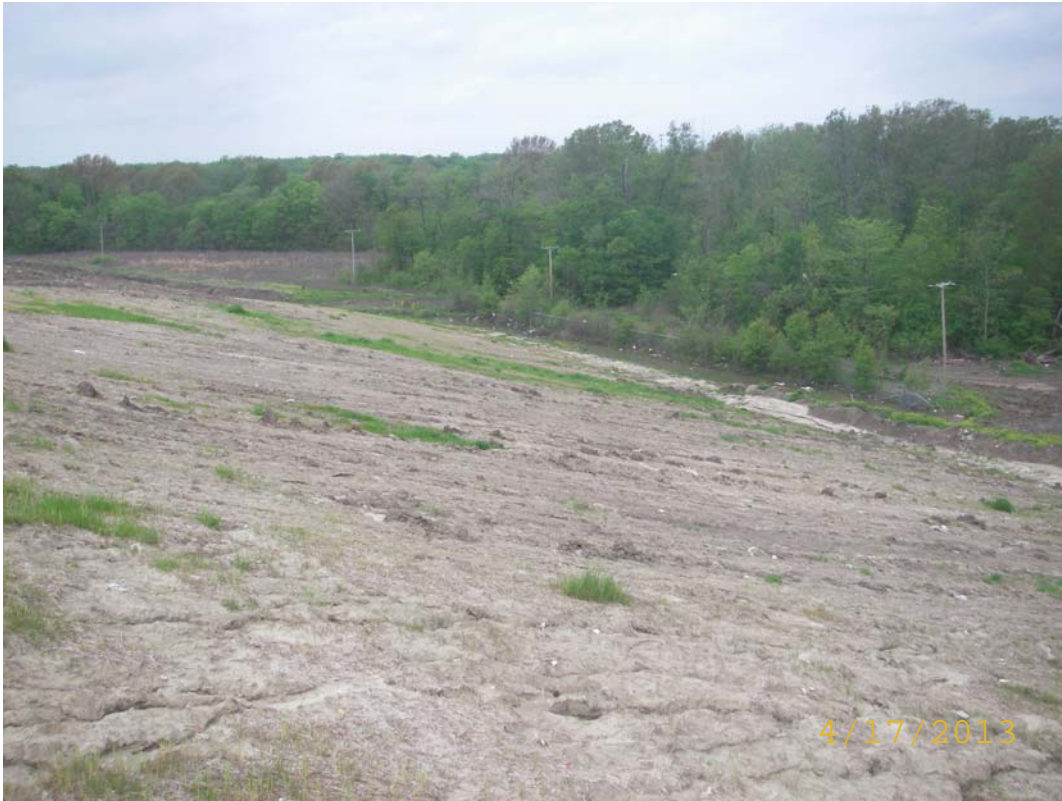
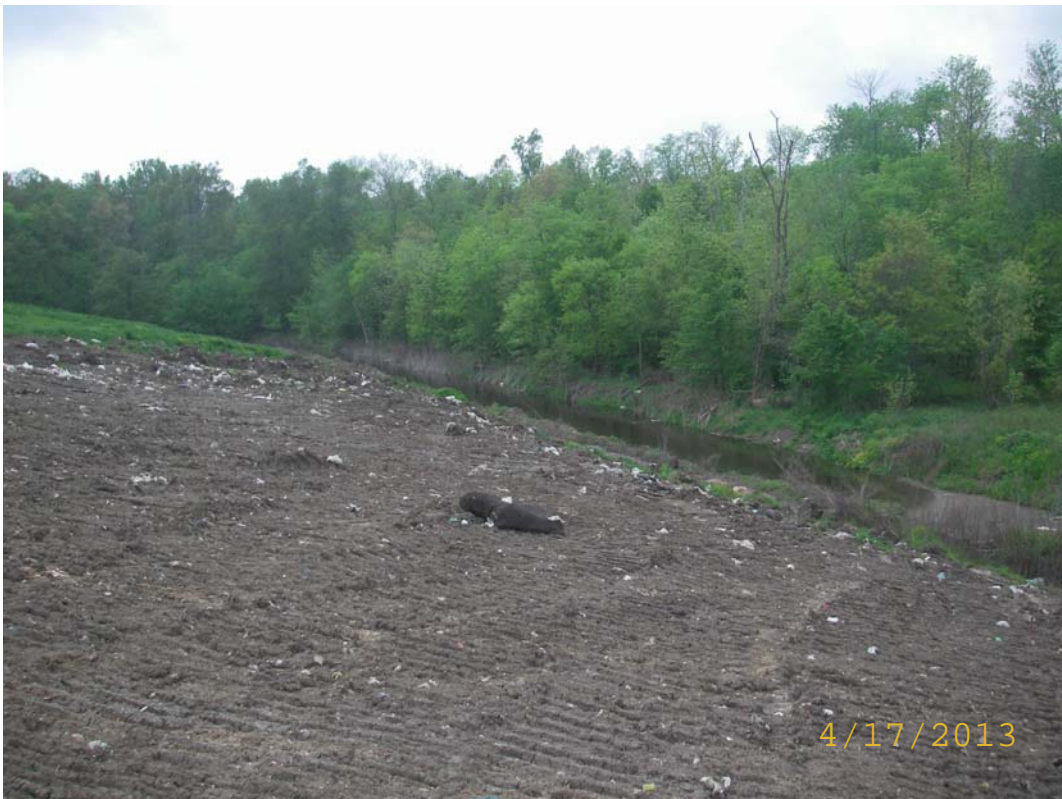
19&20

Comments: Noted inadequate vegetative cover along the north, south and west slopes of active portion of landfill. Photos 19&20.

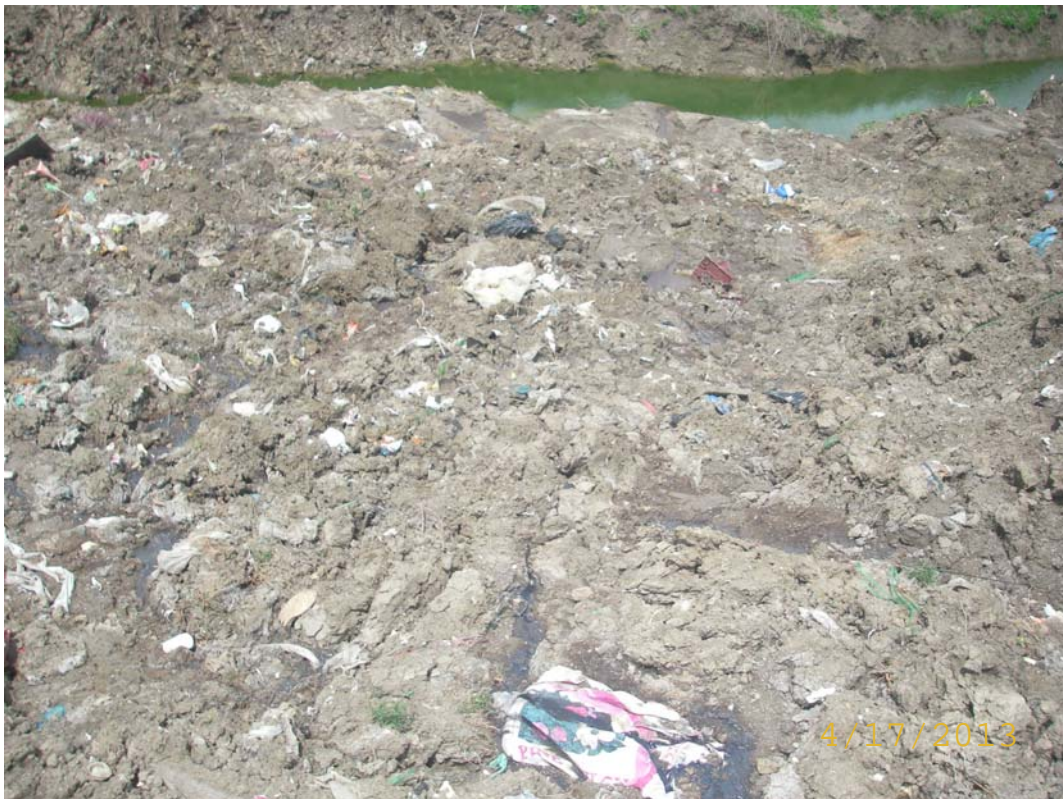
21&22

Comment: Noted leachate flowing into storm water ditches which drain into storm water pond to be discharge off-site. Photos 22 to25.

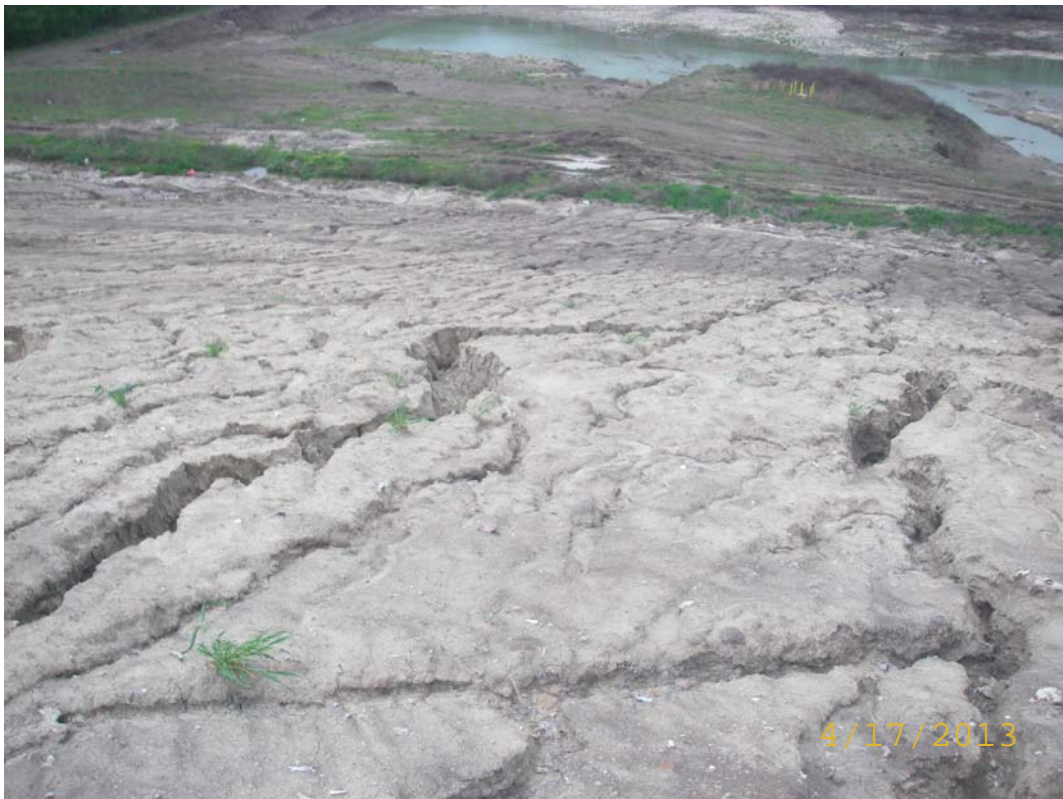
25&26

Comments: Noted erosion cuts with exposed waste a long the north and west slopes of active portion of landfill. Cell 1(A). Photos 26&28.
