RE: Quarterly Inspection; AFIN 18-00094; Permit Number 0245-S1-R1.

### Class 1 Landfill Inspection

<b>Site Name</b>	<b>Crittenden County Class I</b>	<b>County</b>	Crittenden	<b>AFIN</b>	18-00094
<b>Facility Address</b>	<b>South off Hwy 70</b>	<b>Phone Number</b>	LF: 870-732-4290 Off: 870-732-6580	<b>Permit Number</b>	0245-S1-R1
<b>Permittee Address</b>	<b>Crittenden Co. Judge</b>	<b>E-Mail Address</b>	arredllc@swb.net	<b>PDS #</b>	072674
<b>Date</b>	7-17-13	<b>Entry Time</b>	1:00 PM	<b>Exit Time</b>	2:20 PM

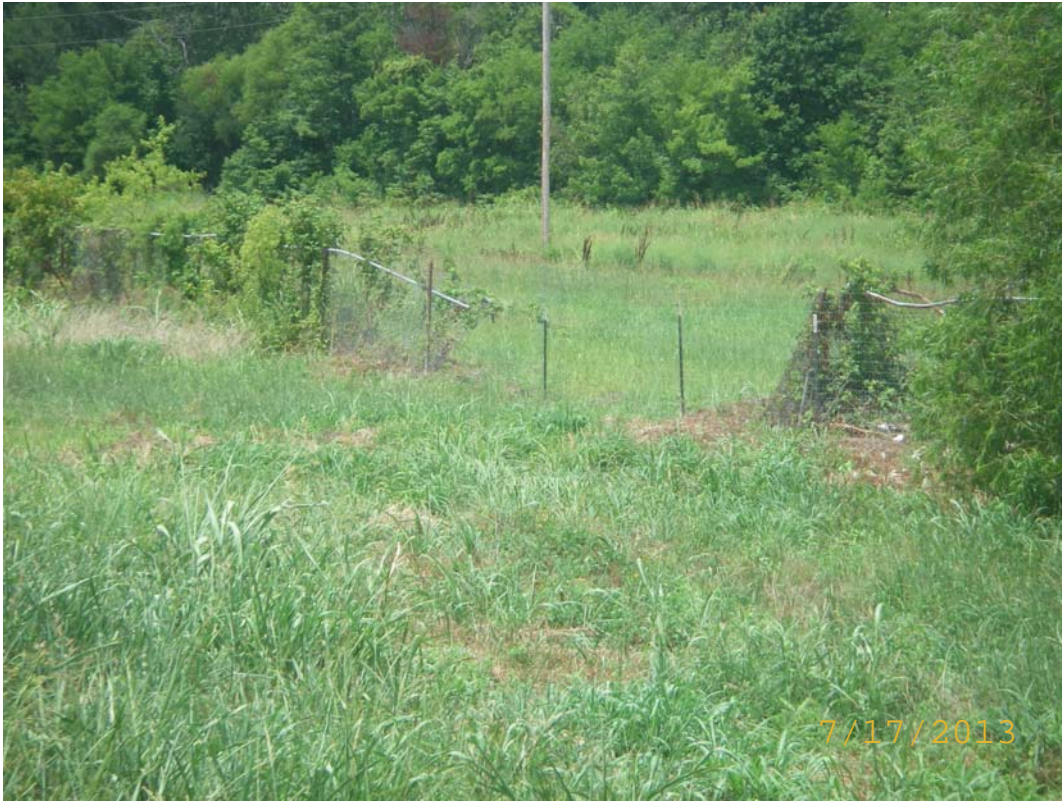
0245-S1-R1 1

411(f)(1)	Scavenging of waste prohibited	
	411(p)	Proper wet weather repairs	
	411(b)	Operations by licensed on-site personnel at all times	
	411(d)	Waste spread and compacted as unloaded	
X	411(g)	Litter control provisions maintained	Noted wind-blown litter along north fence line. Photo 1
	414(a)	Disease vectors controlled

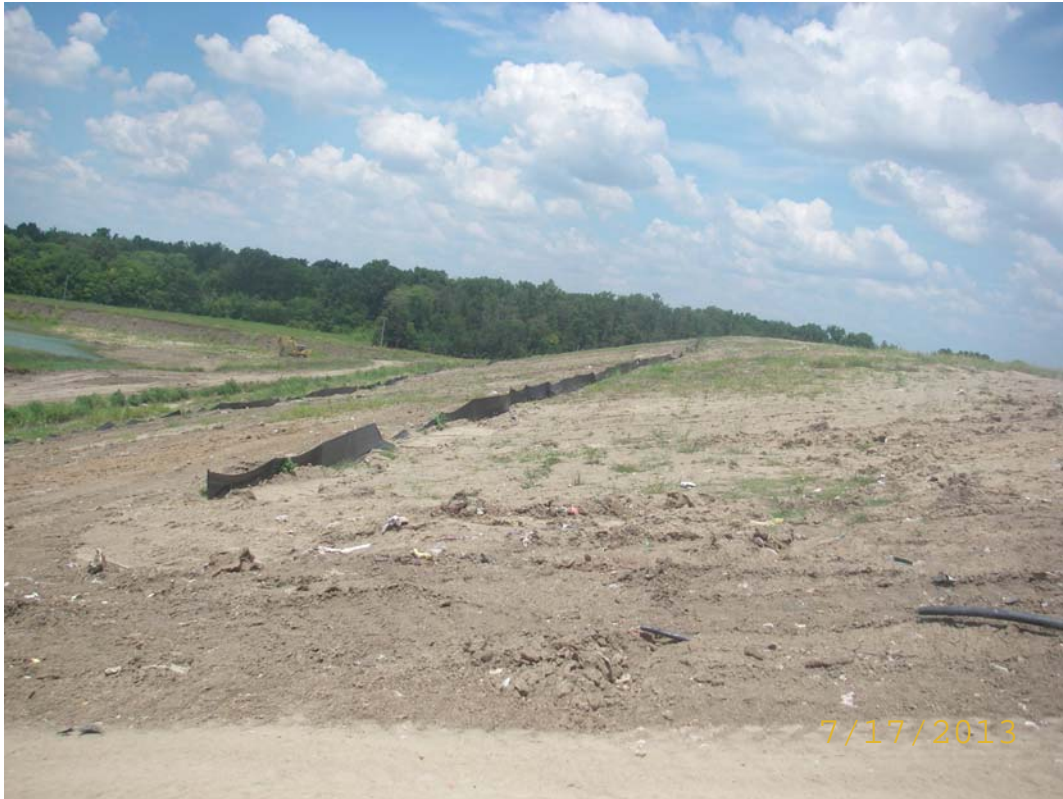
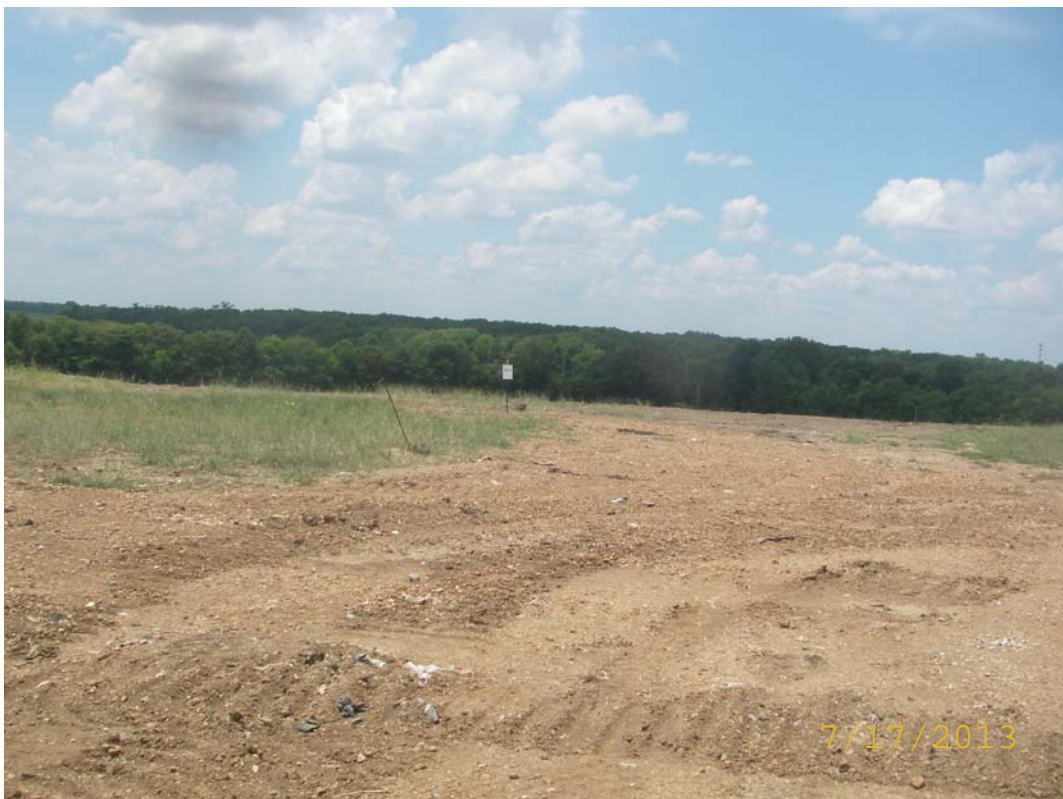
0245-S1-R1 2&3

R	413(c)	Satisfactory intermediate cover					Noted inadequate vegetative cover along the north, south and west slopes of active portion of landfill. Photos 2&3							
	416(b),411(f)(4)	Open burning prohibited												
	419	Cause discharge/leachate discharge leaving landfill												
	411(f)(3),419(a)(4)	Depositing waste in standing water prohibited												
R	411(o)	Erosion or other cover defects resulting in exposed refuse					Noted erosion cuts with exposed waste along the north slopes of active portion of landfill. Cell 1(A). Photos 4&5							
	309(c)	Overfill/Off lined area												
Regulation 22 - Records														
421(a)(8), 1203(k)		Date of last groundwater monitoring report			6-30-13									
423(b)		Date of last engineering report			March 2013									
428		Liner construction in progress		Yes/No	No	Notice of liner construction		Yes/No	No	Third party CQA on-site during construction			Yes/No	No
