ARKANSAS
Department of Environmental Quality

RE: Bentonville Reconnaissance Inspections
AFIN: 04-00154 Permit No.: AR0022403

<h1 style="margin:0;">ADEQ</h1> <p style="margin:0; font-size: small;">A R K A N S A S Department of Environmental Quality</p>		WATER DIVISION INSPECTION REPORT			
		AFIN: 04-00154		PERMIT #: AR0022403	
COUNTY: 04 Benton		PDS #: 075477		MEDIA: W	
GPS LOCATION: LAT: 36.336018 LONG: -94.190447					
<input type="checkbox"/> Outfall / <input checked="" type="checkbox"/> General Area / <input type="checkbox"/> Entrance / <input type="checkbox"/> Sample Point					
FACILITY INFORMATION			INSPECTION INFORMATION		
NAME: Bentonville POTW			DATE(S):	10/1/2013	10/4/2013
LOCATION: 1706 S.E. Walton Blvd and 2003 S.E. Walton Blvd			ENTRY TIME:	10:30	12:20
			EXIT TIME:	14:45	14:40
CITY: Bentonville			INSPECTION TYPE: Reconnaissance		
RESPONSIBLE OFFICIAL			INSPECTOR ID#: 14939 S - State		
CONTACTED DURING INSPECTION: No			FACILITY TYPE: 1 - Municipal		
NAME: Mike Roberts			PERMIT EFFECTIVE DATE: 3/1/2009		
TITLE: Wastewater Utility Manager			PERMIT EXPIRATION DATE: 2/28/2014

Water Division Photographic Evidence Sheet

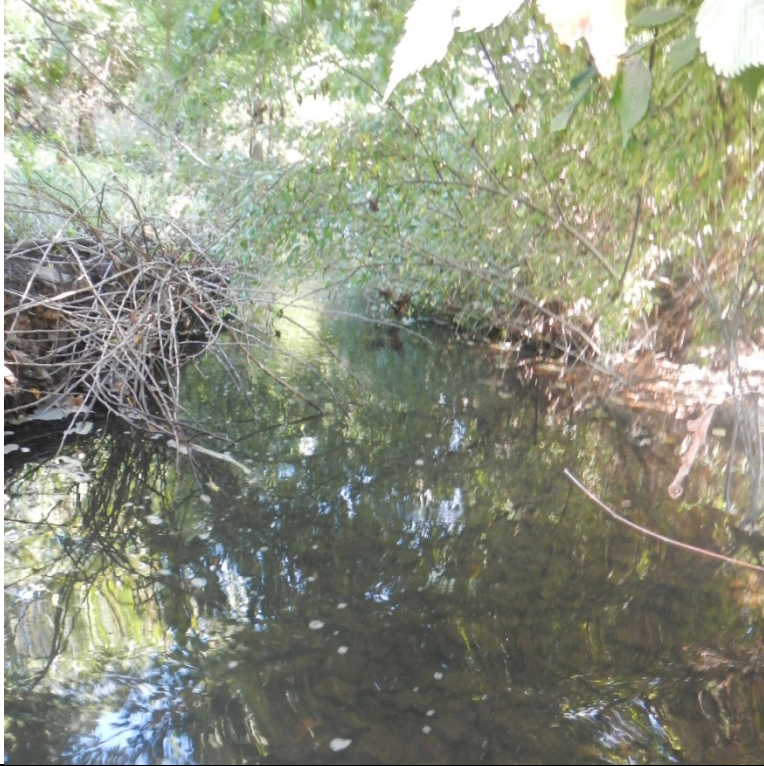
Location:	Osage Tributary 1		
Photographer:	Alison West	Date:	10-1-2013
Witness:	NA	Time:	9:41
		Photo #:	1
Description:	DSCN1172. Upstream of 203 S.E. Walton Blvd

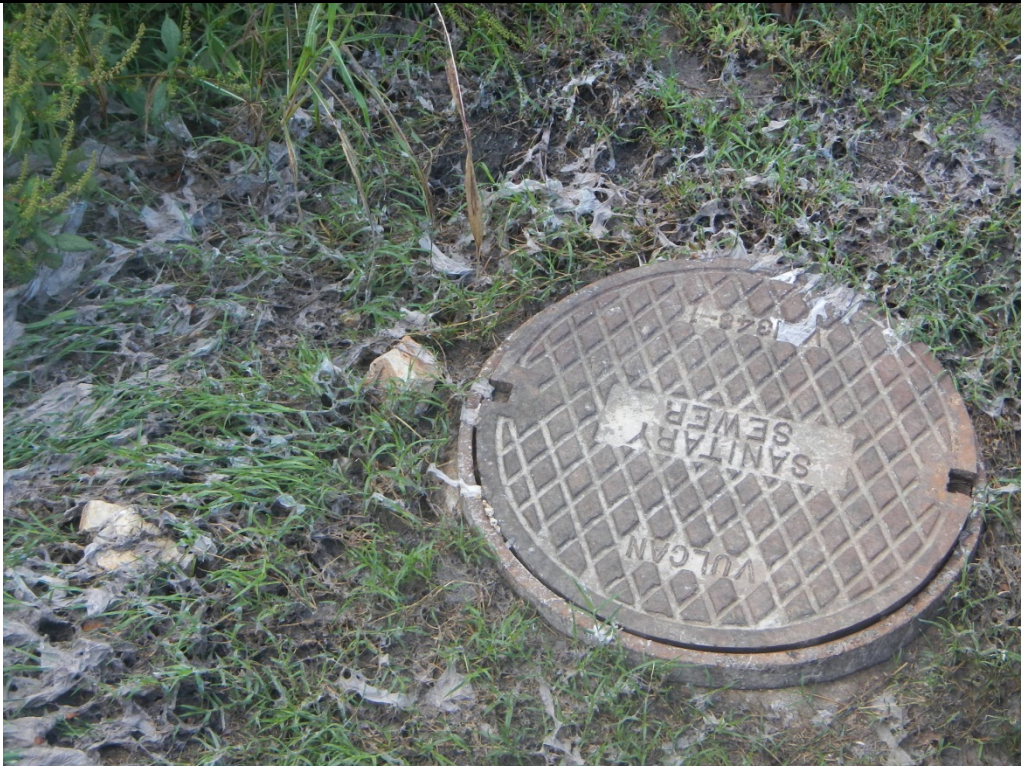
Photographer:	Alison West	Date:	10-1-2013
Witness:	NA	Time:	9:41
		Photo #:	2
Description:	DSCN1165. Manhole near 203 S.E. Walton Blvd. Solids observed around the manhole.

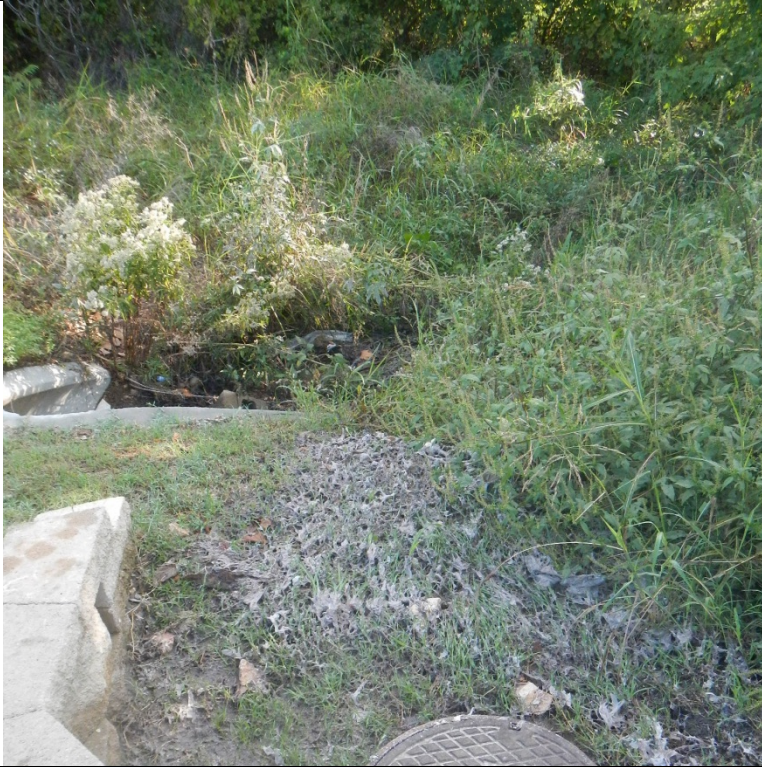
Location:	Manhole near 2003 S.E. Walton Blvd.		
Photographer:	Alison West	Date:	10-1-2013
Time:	9:41	Witness:	NA
Photo #:	3	Description:	DSCN1166. Evidence of sanitary sewer overflow on the west side of Osage Tributary 1 near Southeast Medical Center Parkway.

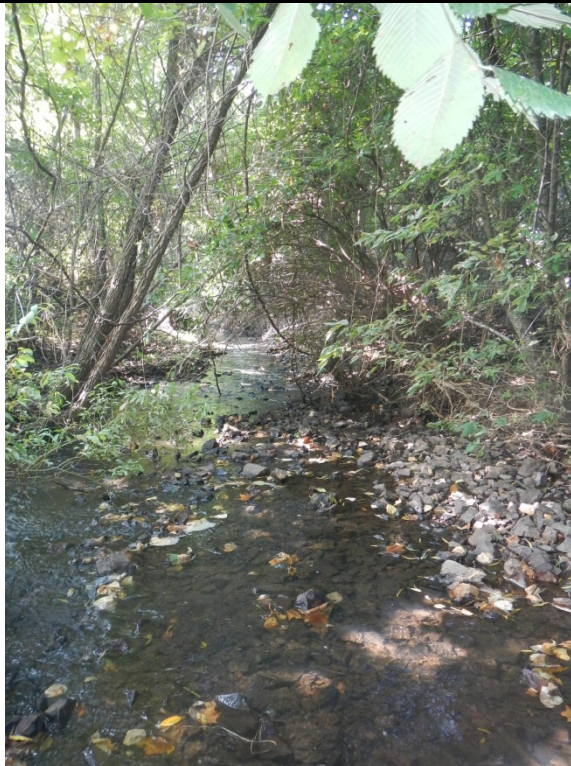
Photographer:	Alison West	Date:	10-1-2013
Time:	9:41	Witness:	NA
Photo #:	4	Description:	DSCN1173. Upstream of SSO located near 2003 S.E. Walton Blvd.

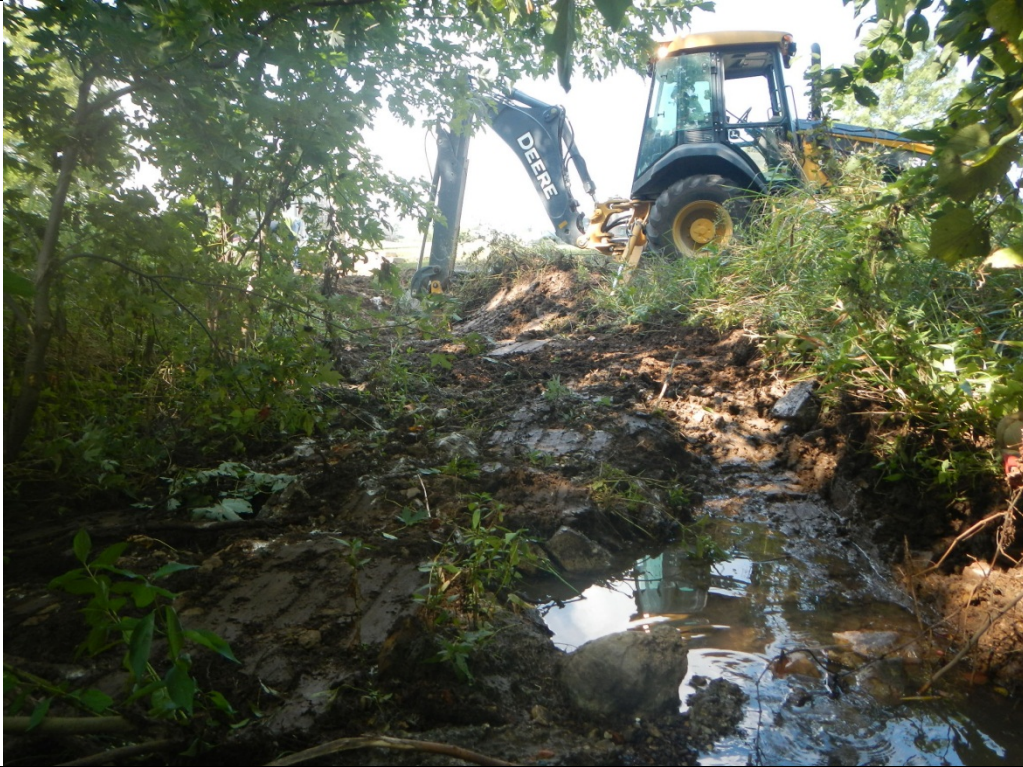
Location:	Manhole near 2003 S.E. Walton Blvd.		
Photographer:	Alison West	Date:	10-1-2013
Witness:	NA	Time:	11:10
		Photo #:	5
Description:	DSCN1174. Backhoe being used to remove solids near manhole at 2003 S.E. Walton Blvd.

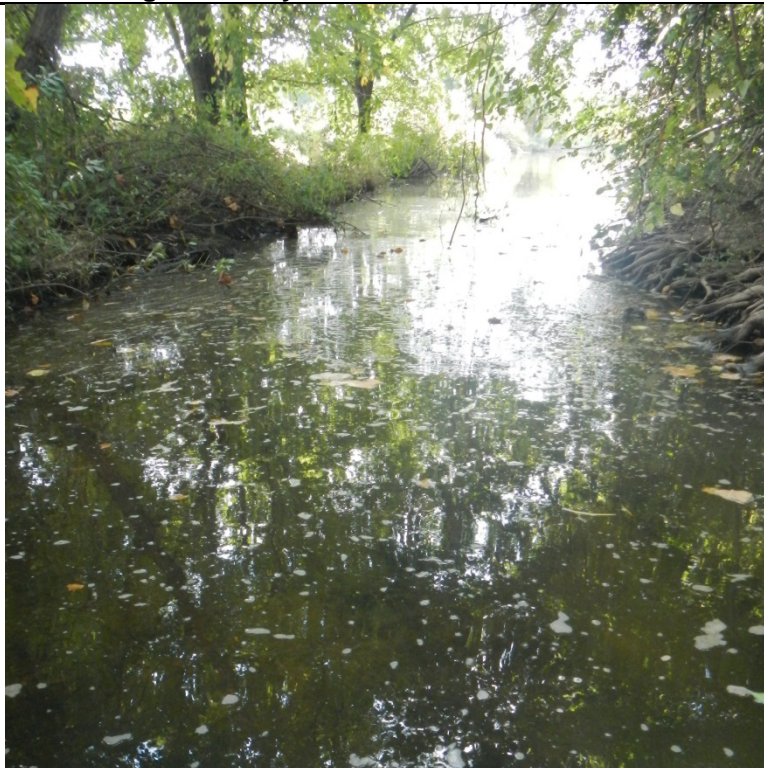
Photographer:	Alison West	Date:	10-1-2013
Witness:	NA	Time:	11:24
		Photo #:	6
Description:	DSCN1176. Osage Tributary 1 below the manhole near 2003 S.E. Walton Blvd.

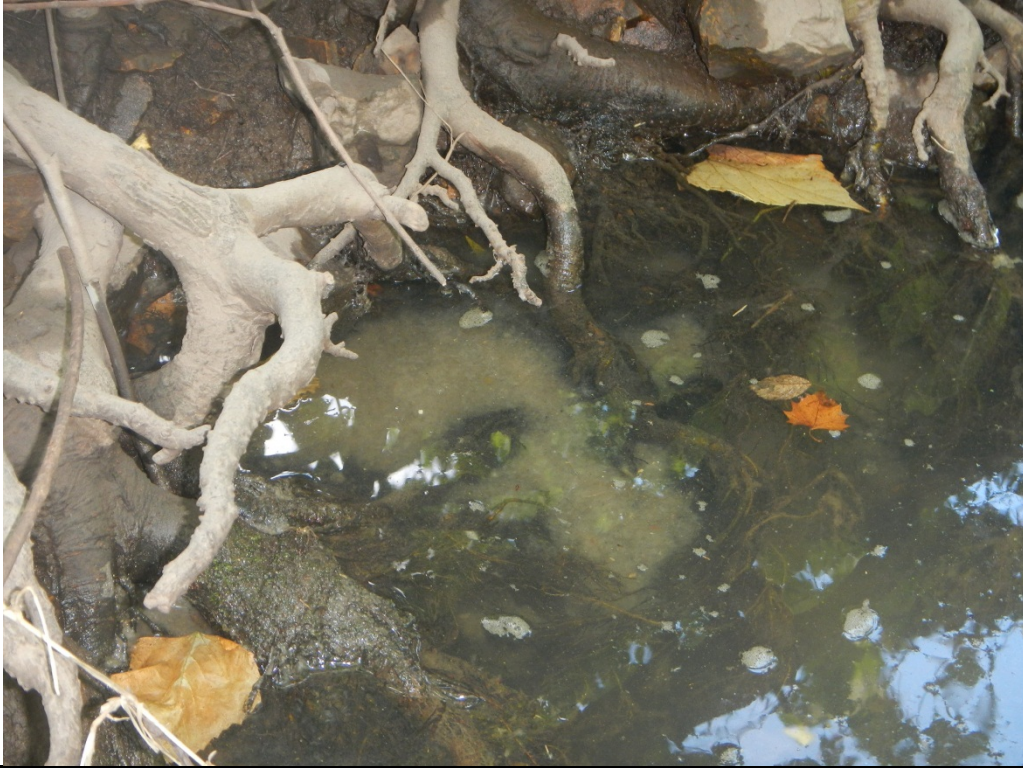
Location:	Osage Tributary 1		
Photographer:	Alison West	Date:	10-1-2013
Witness:	NA	Time:	11:24
		Photo #:	7
Description:	DSCN1179. Solids observed in Osage Tributary 1 below the manhole near 2003 S.E. Walton Blvd.

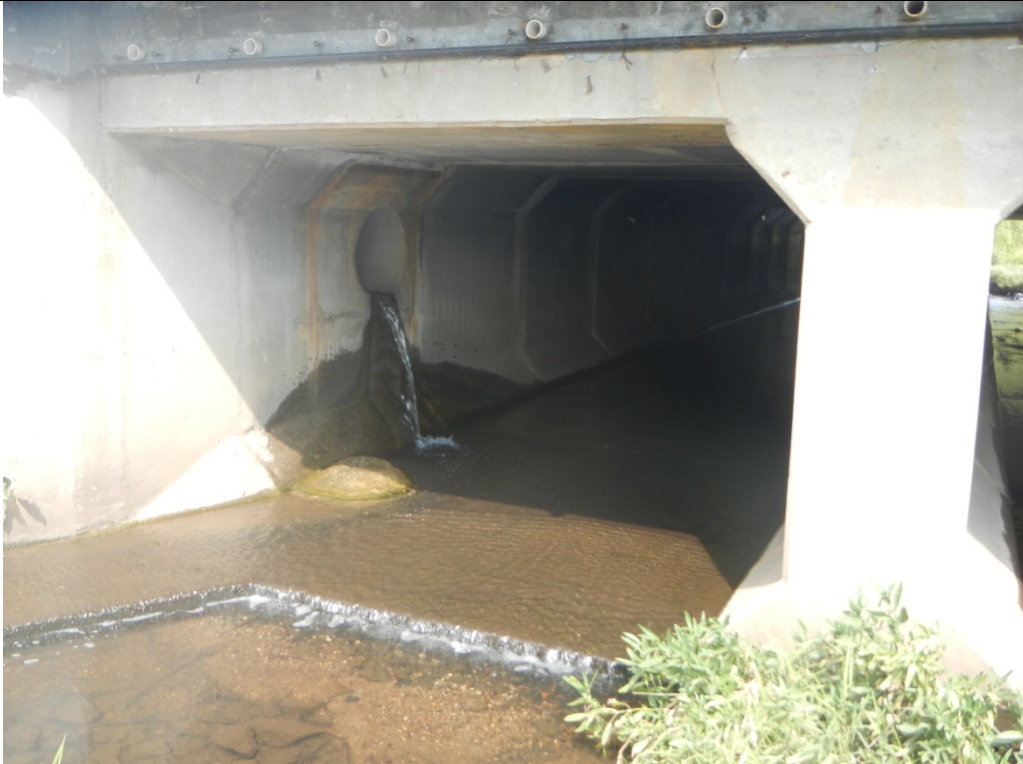
Photographer:	Alison West	Date:	10-1-2013
Witness:	NA	Time:	11:25
		Photo #:	8
Description:	DSCN1180. Water discharging on the southwest side of the road culvert on Walton Blvd.

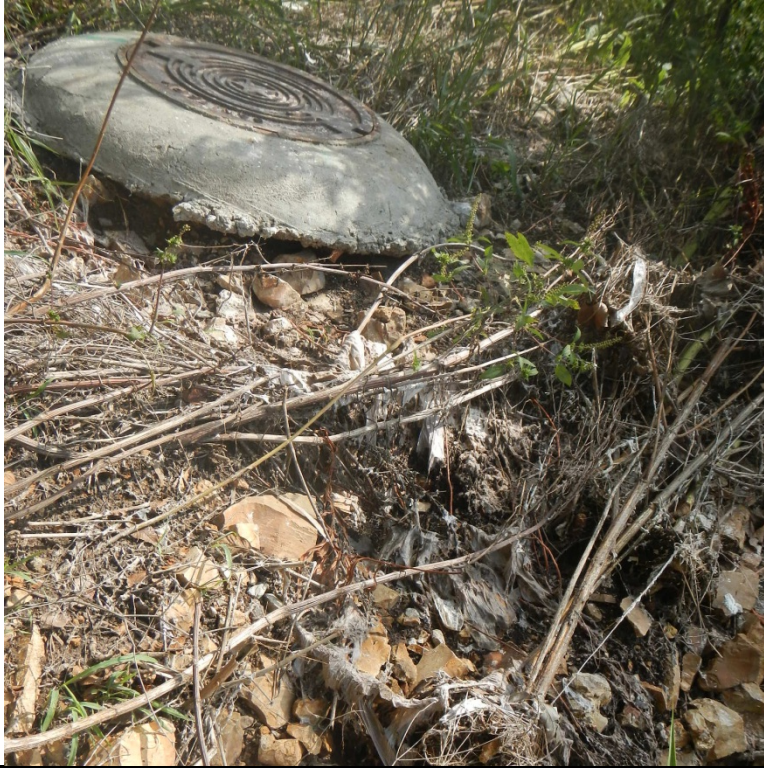
Location:	Manhole located near 1706 S.E. Walton Blvd.		
Photographer:	Alison West	Date:	10-1-2013
Witness:	NA	Time:	12:05
		Photo #:	9
Description:	DSCN1185. Manhole located near 1706 S.E. Walton Blvd. Solids observed on the ground near the manhole.

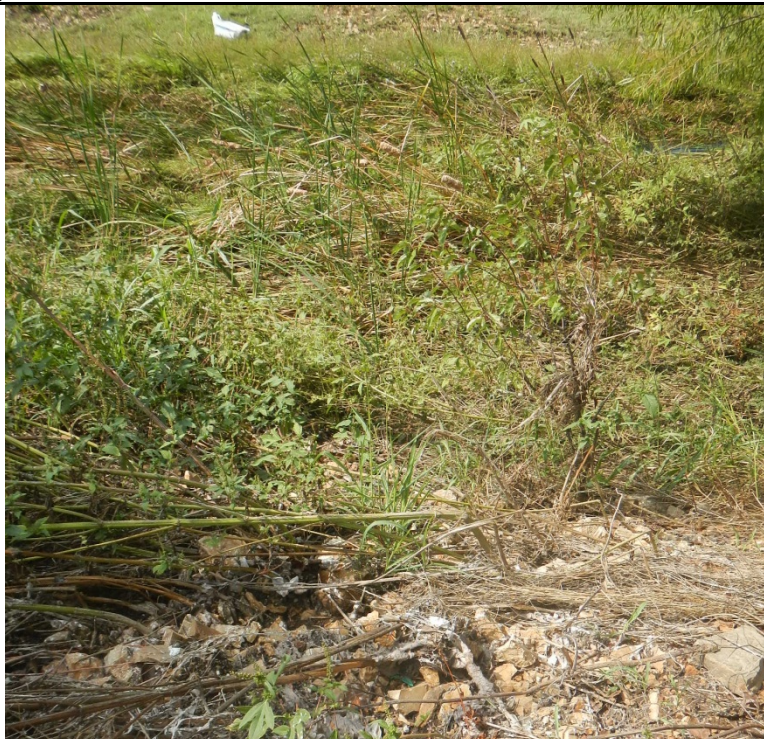
Photographer:	Alison West	Date:	10-1-2013
Witness:	NA	Time:	12:07
		Photo #:	10
Description:	DSCN1186. Solids observed on the ground located near 1706 S.E. Walton Blvd. Osage Tributary 1 in the background.

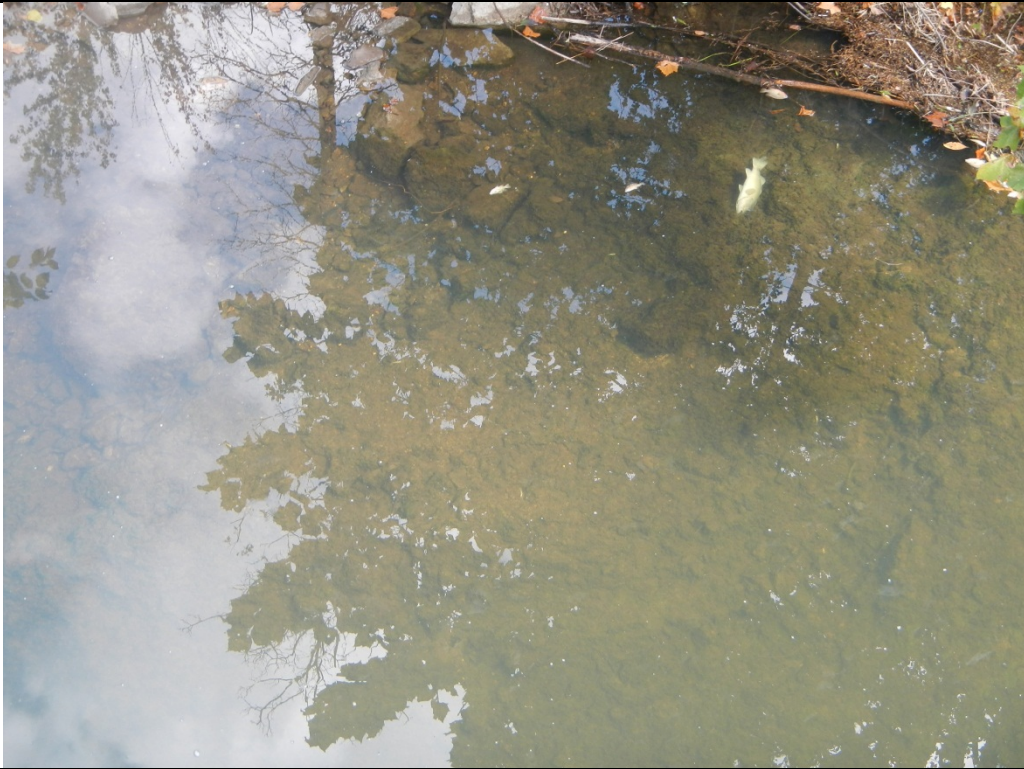
Location:	Osage Tributary 1		
Photographer:	Alison West	Date:	10-1-2013
Witness:	NA	Time:	12:36
		Photo #:	11
Description:	DSCN1192. Dead fish observed in Osage Tributary 1 near Riviera and Medical Center Parkway.

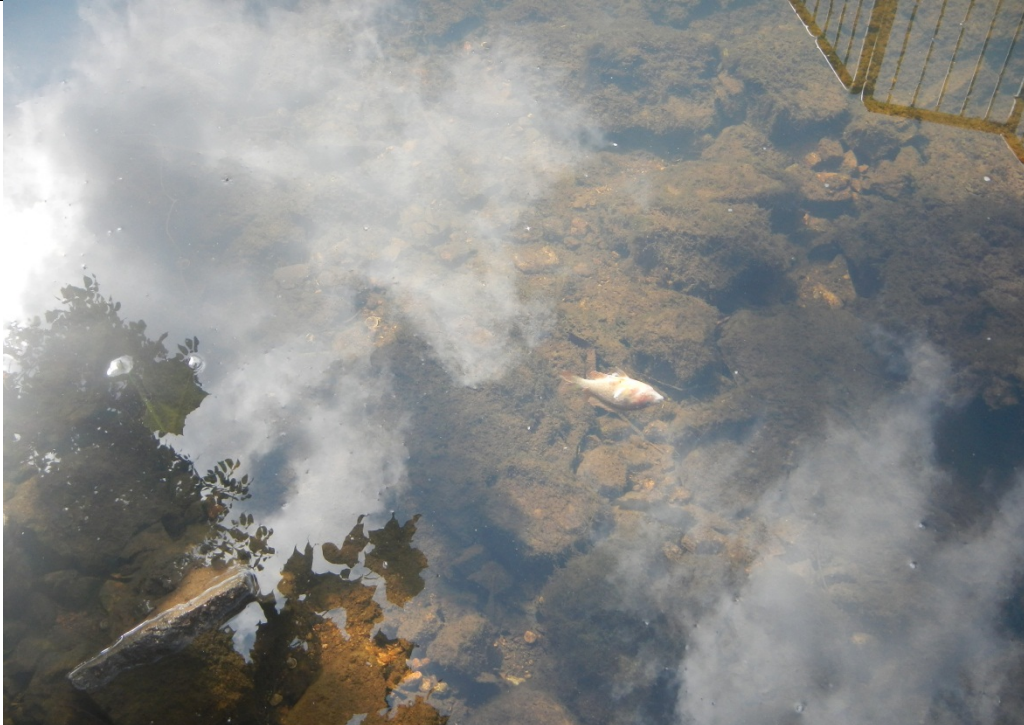
Photographer:	Alison West	Date:	10-1-2013
Witness:	NA	Time:	12:38
		Photo #:	12
Description:	DSCN1194. Dead fish observed in Osage Tributary 1 near Riviera and Medical Center Parkway.

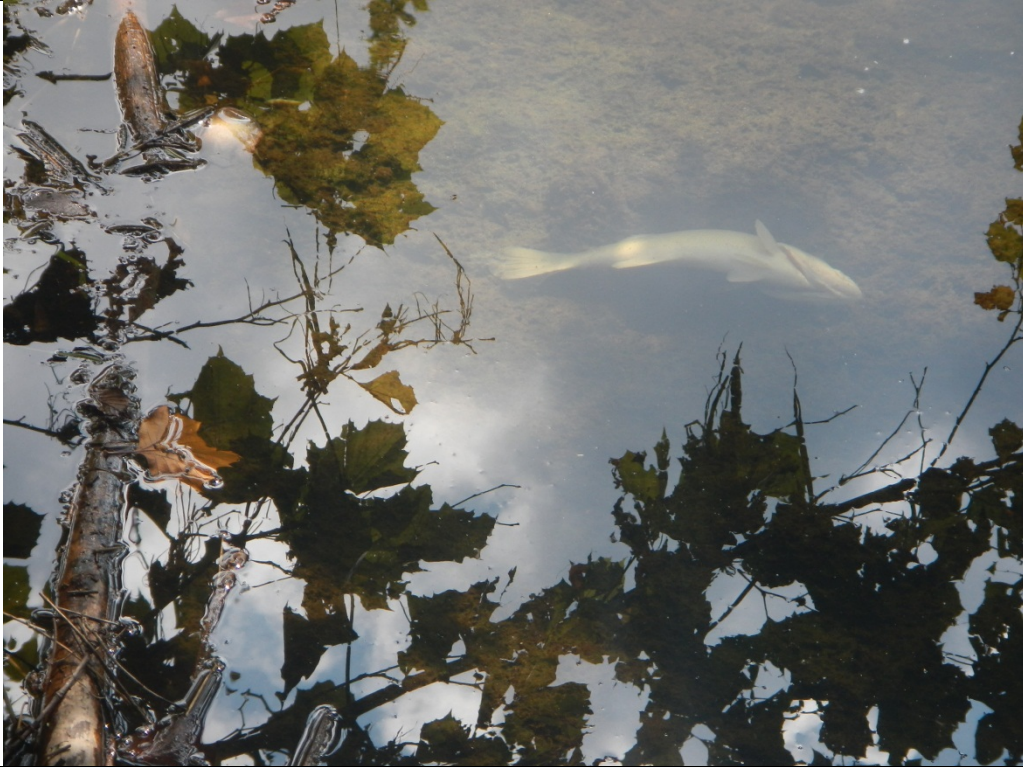
Location:	Osage Tributary 1		
Photographer:	Alison West	Date:	10-1-2013
Witness:	NA	Time:	12:38
		Photo #:	13
Description:	DSCN1195. Dead fish observed in Osage Tributary 1 near Riviera and Medical Center Parkway.

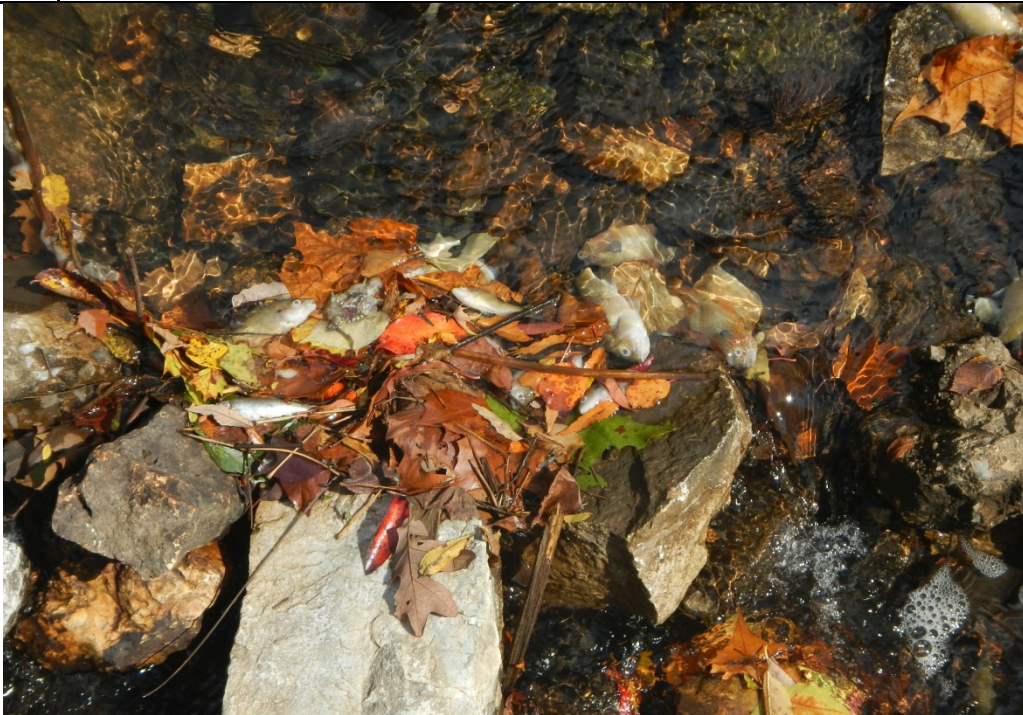
Photographer:	Alison West	Date:	10-1-2013
Witness:	NA	Time:	12:38
		Photo #:	14
Description:	DSCN1198. Dead fish observed in Osage Tributary 1 downstream of Riviera and Medical Center Parkway.

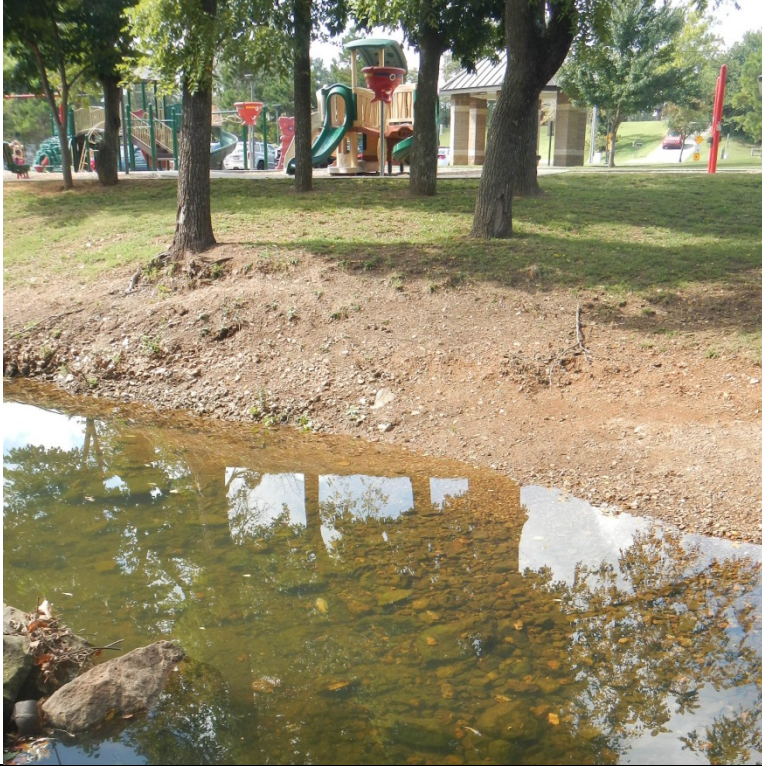
Location:	Osage Tributary 1		
Photographer:	Alison West	Date:	10-1-2013
Witness:	NA	Time:	12:56
		Photo #:	15
Description:	DSCN1203. Dead fish observed in Osage Tributary 1 at Horsebarn Park.

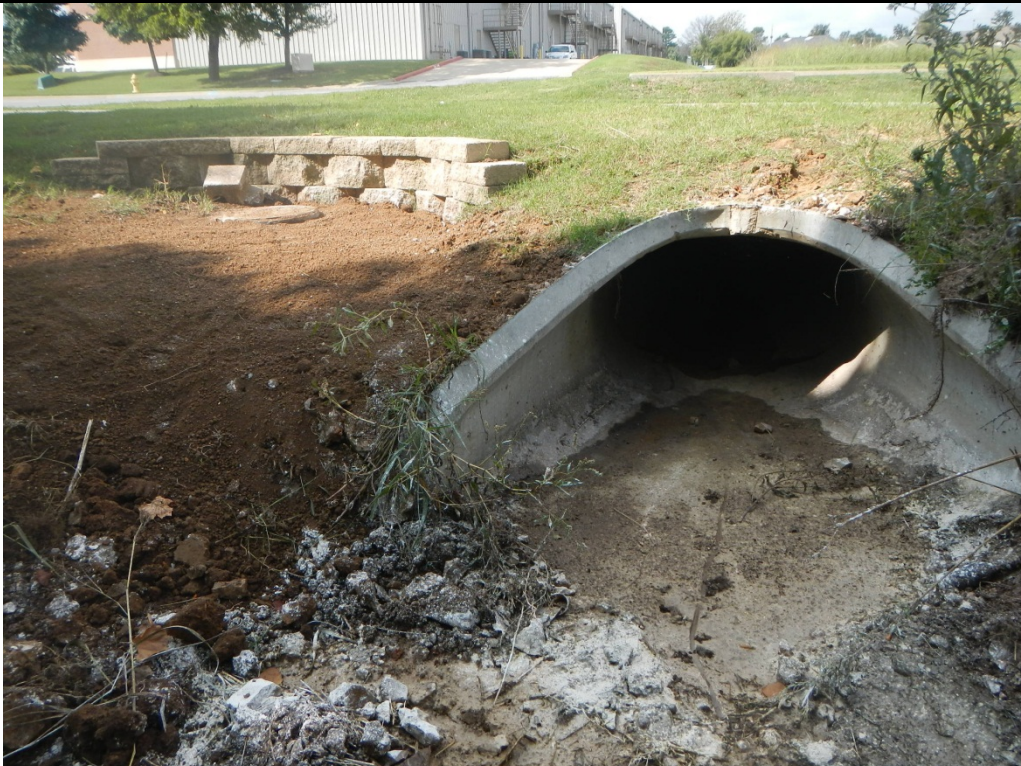
Photographer:	Alison West	Date:	10-4-2013
Witness:	NA	Time:	11:32
		Photo #:	16
Description:	DSCN1214. Area around manhole at 2003 S.E. Walton Blvd. Solids had been removed. Area had been limed.

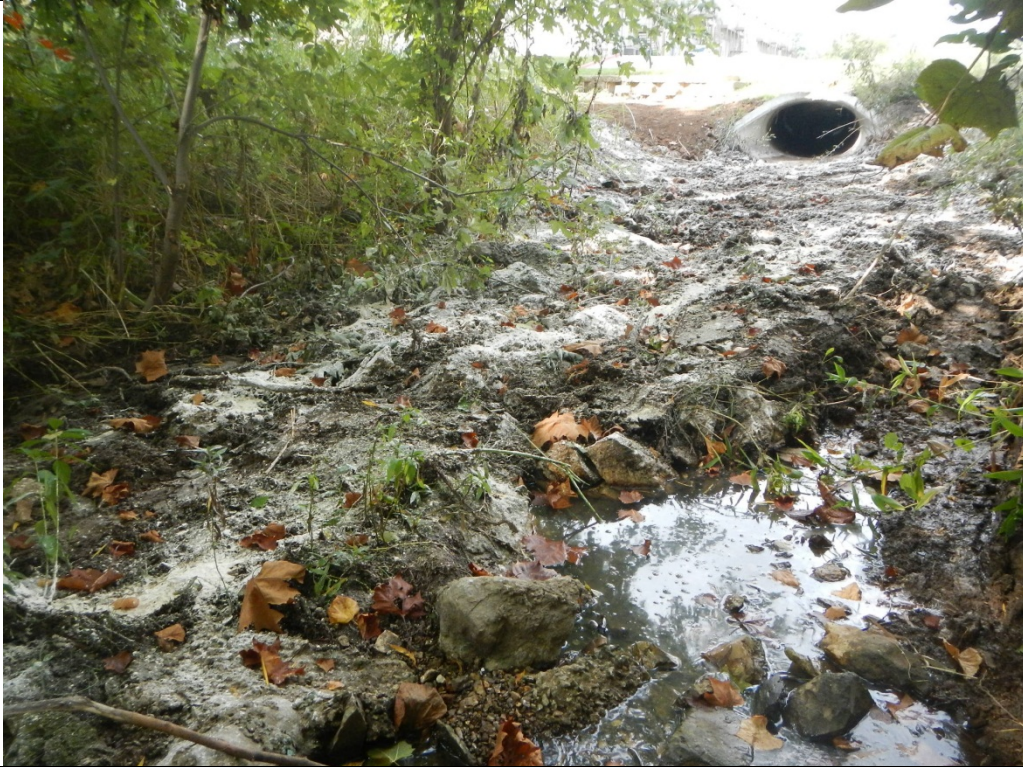
Location:	Manhole near 2003 S.E. Walton Blvd		
Photographer:	Alison West	Date:	10-4-2013
Witness:	NA	Time:	11:32
		Photo #:	17
Description:	DSCN1213. Area around 2003 S.E. Walton Blvd. Solids had been removed. Area had been limed.

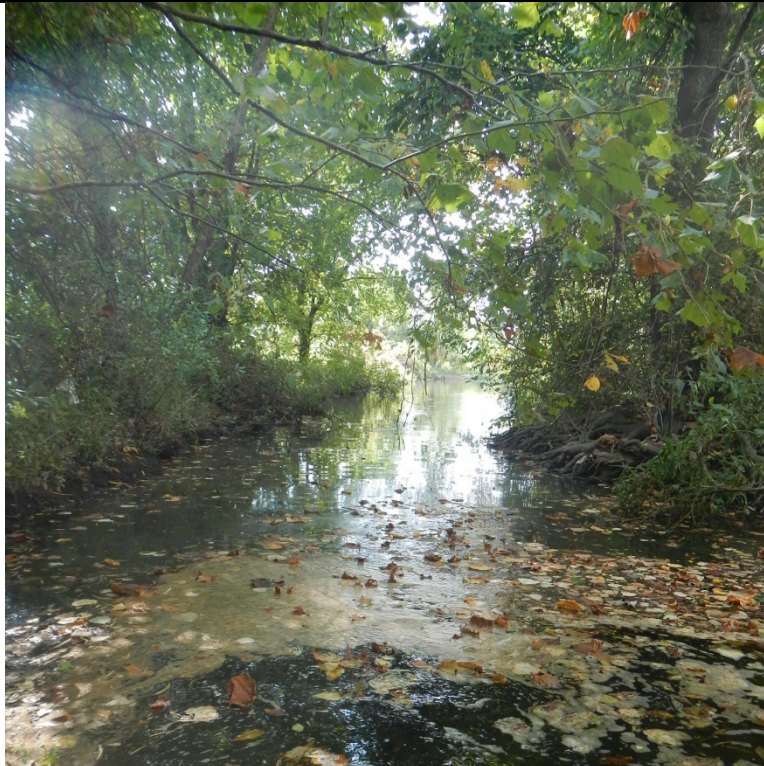
Photographer:	Alison West	Date:	10-4-2013
Witness:	NA	Time:	11:32
		Photo #:	18
Description:	DSCN1217. Osage Tributary 1 near 2003 S. E. Walton Blvd manhole.

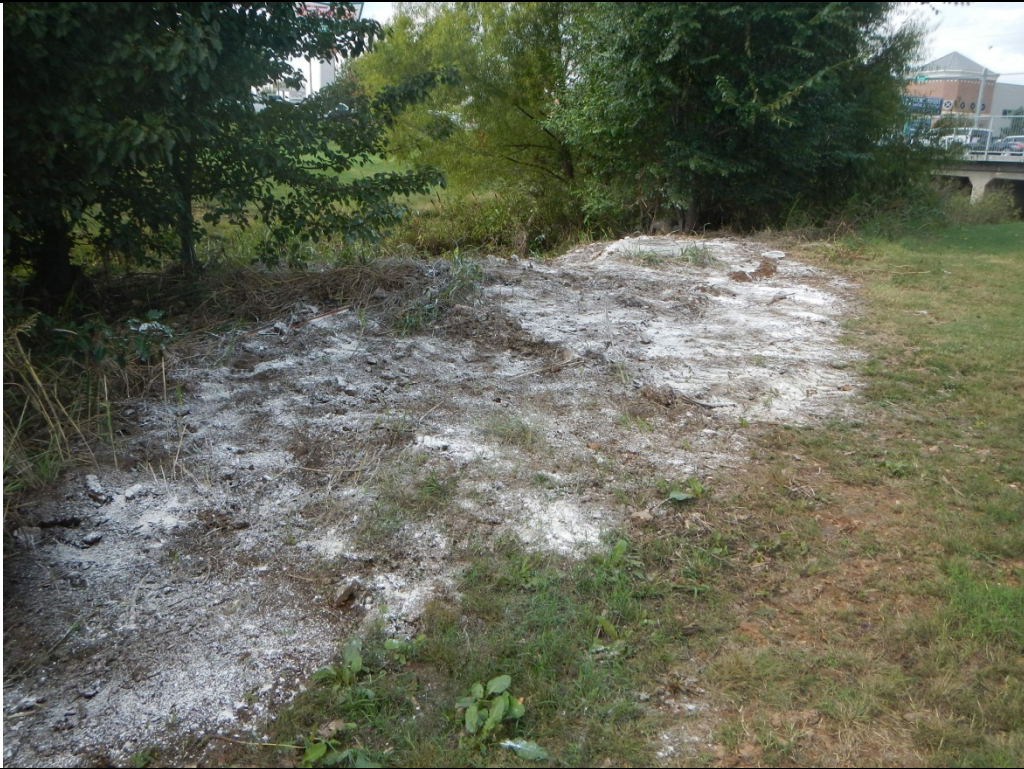
Location:	Manhole near 1706 S.E. Walton Blvd.		
Photographer:	Alison West	Date:	10-4-2013
Witness:	NA	Time:	12:08
		Photo #:	19
Description:	DSCN1224. Solids had been removed from the ground. Area had been limed.

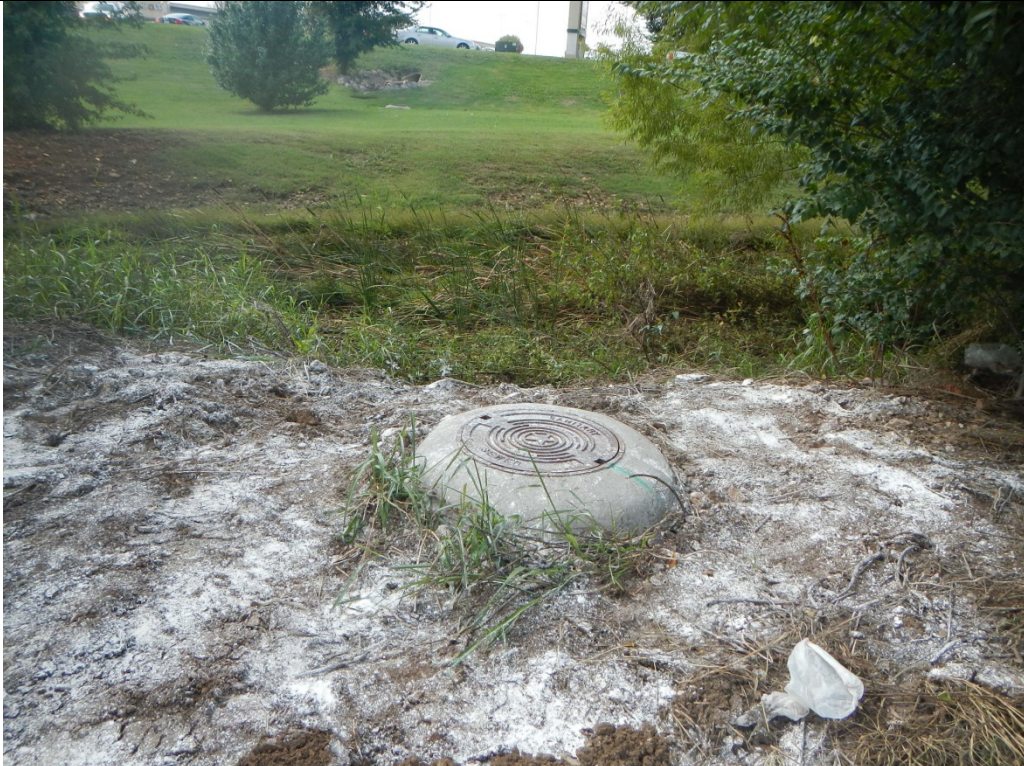
Photographer:	Alison West	Date:	10-4-2013
Witness:	NA	Time:	13:43
		Photo #:	20
Description:	DSCN1225. Solids had been removed from the ground. Area had been limed.

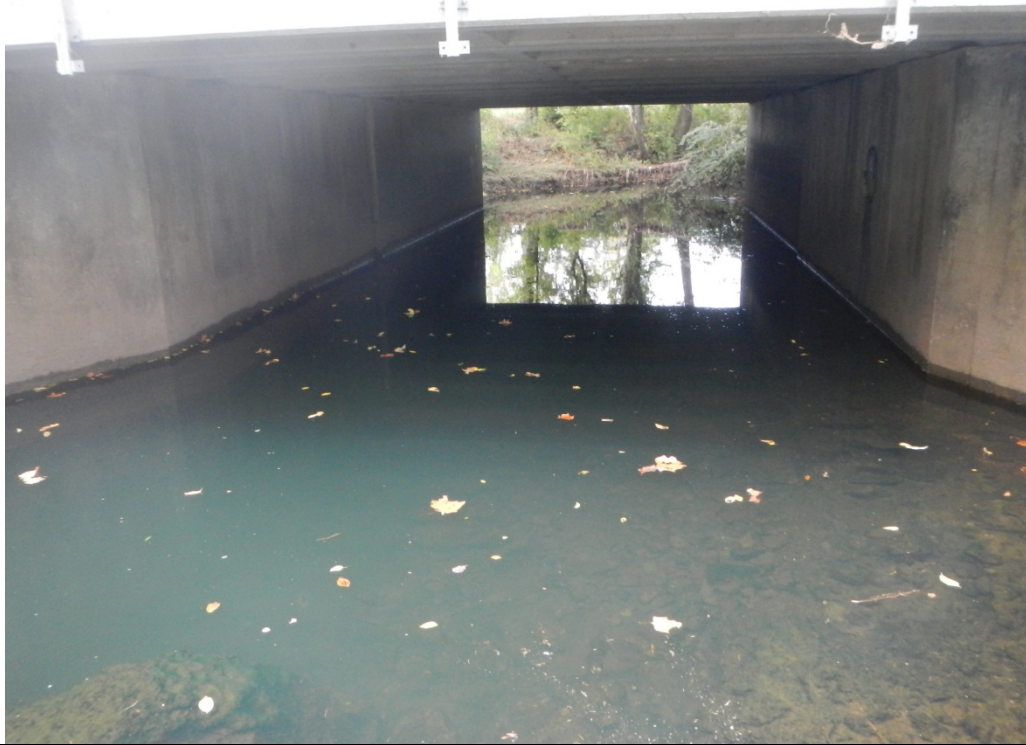
Location:	Osage Tributary 1		
Photographer:	Alison West	Date:	10-4-2013
Witness:	NA	Time:	11:33
		Photo #:	21
Description:	DSCN1218. Osage Tributary 1 downstream of road culvert at Riviera.

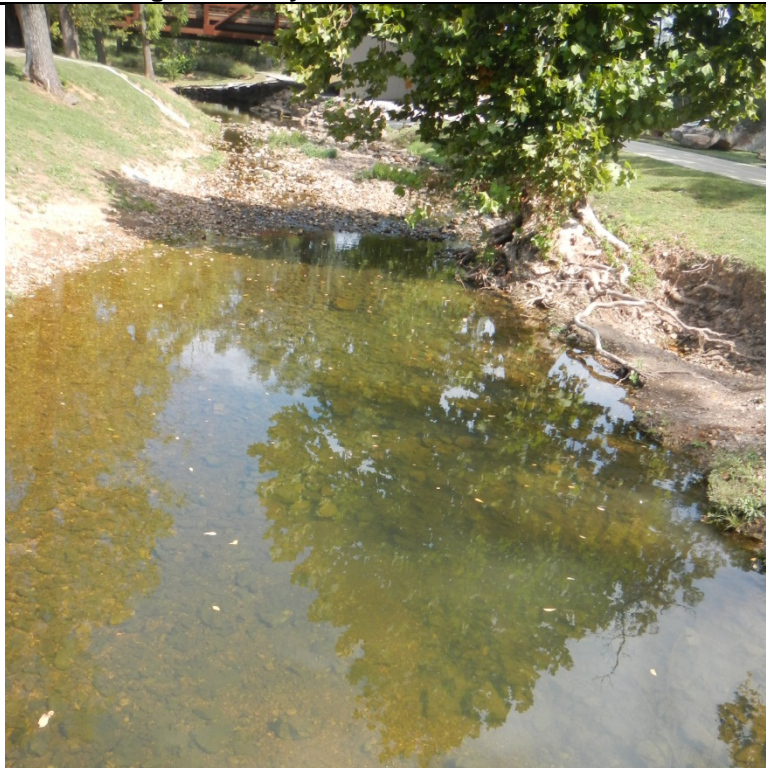
Photographer:	Alison West	Date:	10-4-2013
Witness:	NA	Time:	12:08
		Photo #:	22
Description:	DSCN1221. Osage Tributary 1 at Horsebarn Park.
