ARKANSAS
Department of Environmental Quality

RE: Reconnaissance Inspection (Carroll Co)
AFIN: 08-00036 **NPDES Permit No.: AR0021865**

A R K A N S A S Department of Environmental Quality		WATER DIVISION INSPECTION REPORT					
		AFIN: 08-00036		PERMIT #: AR0021865		DATE: 7/22/2014	
		COUNTY: 08 Carroll		PDS #: 078938		MEDIA: WN	
		GPS LAT: 36.3963		LONG: -93.7350		LOCATION: General Area	
FACILITY INFORMATION				INSPECTION INFORMATION			
NAME: City of Eureka Springs POTW LOCATION: 100 Hwy 23 North CITY: Eureka Springs				FACILITY TYPE: 1 - Municipal		INSPECTOR ID#: 26588 S - State	
				FACILITY EVALUATION RATING: N		INSPECTION TYPE: Reconnaissance	
				DATE(S): 7/22/2014		ENTRY TIME: 10:15	
				EXIT TIME: 11:30		PERMIT EFFECTIVE DATE: 3/1/2013	
				PERMIT EXPIRATION DATE: 2/28/2018			
RESPONSIBLE OFFICIAL				FAYETTEVILLE SHALE RELATED: N			
NAME / TITLE: Dwayne Allen / Public Works Director COMPANY: City of Eureka Springs MAILING ADDRESS: 3174 E. Van Buren CITY, STATE, ZIP: Eureka Springs AR 72632 PHONE & EXT: / FAX: 479-253-9600 / EMAIL:				FAYETTEVILLE SHALE VIOLATIONS: N

Water Division Photographic Evidence Sheet

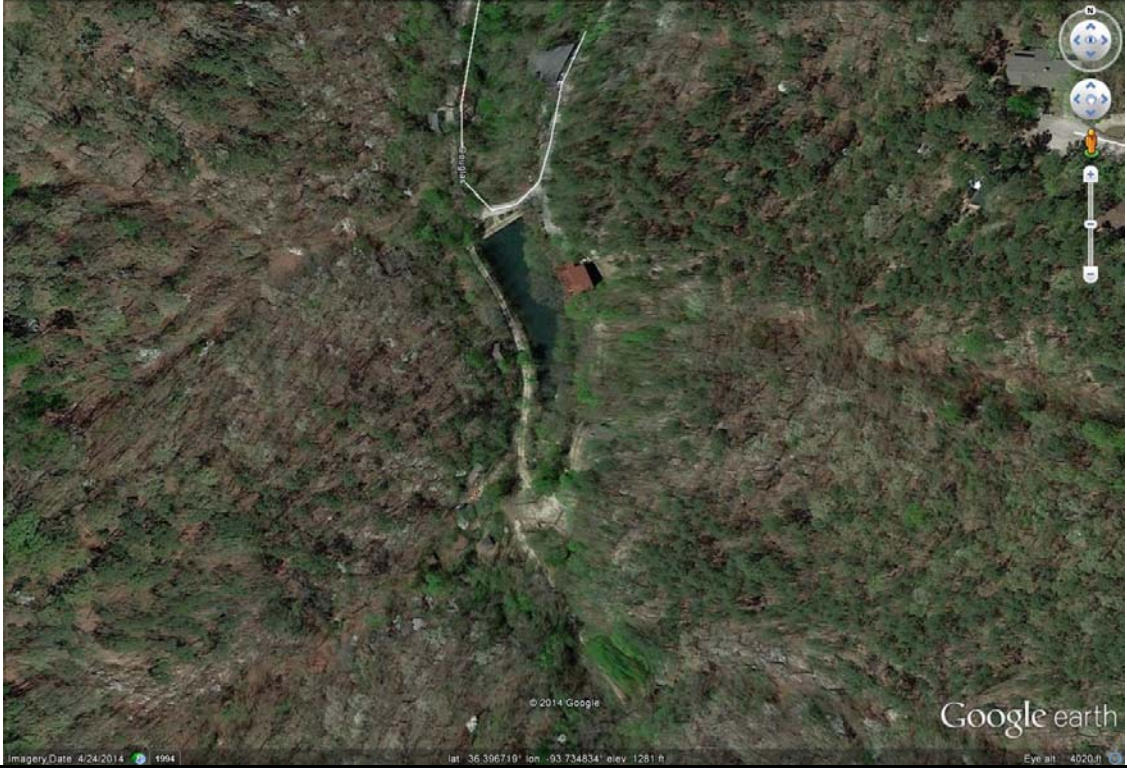
Location:	City of Eureka Springs POTW		
Photographer:	Google Earth Image	Date:	4/24/2014
Witness:		Time:	
		Photo #:	1
Description:	The manhole overflow occurred at the upper end of Little Eureka Lake.

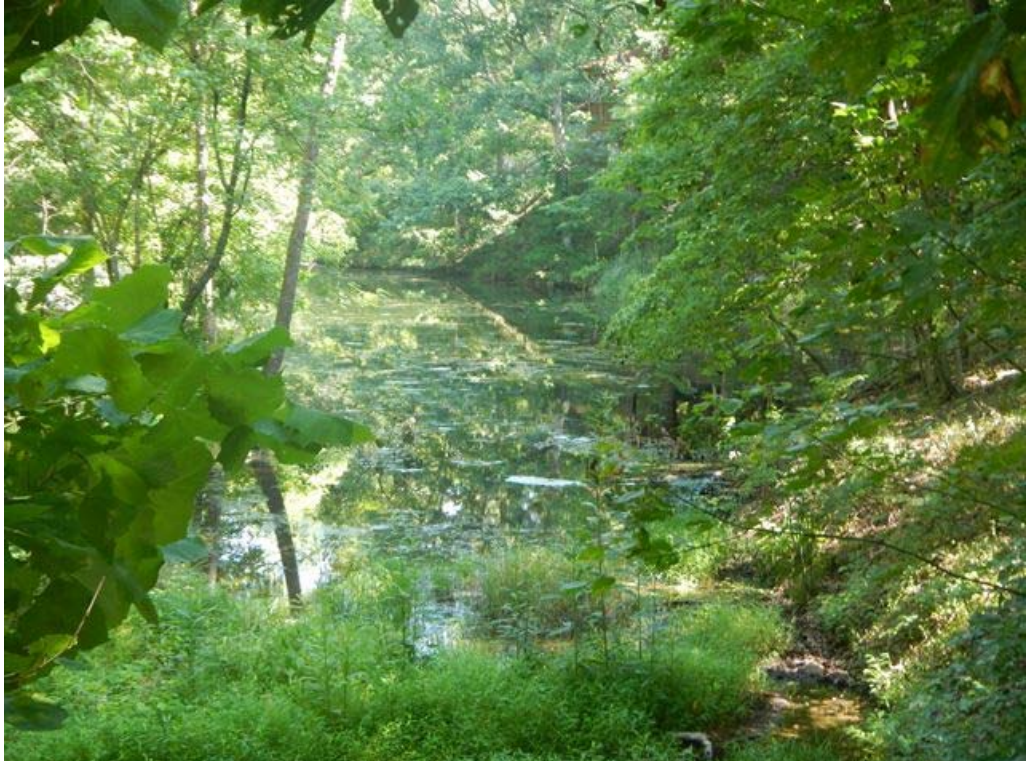
Photographer:	Tony Morris	Date:	7/22/2014
Witness:	Rob Mullins	Time:	10:39
		Photo #:	2
Description:	The point where the wastewater overflow entered Little Eureka Lake.

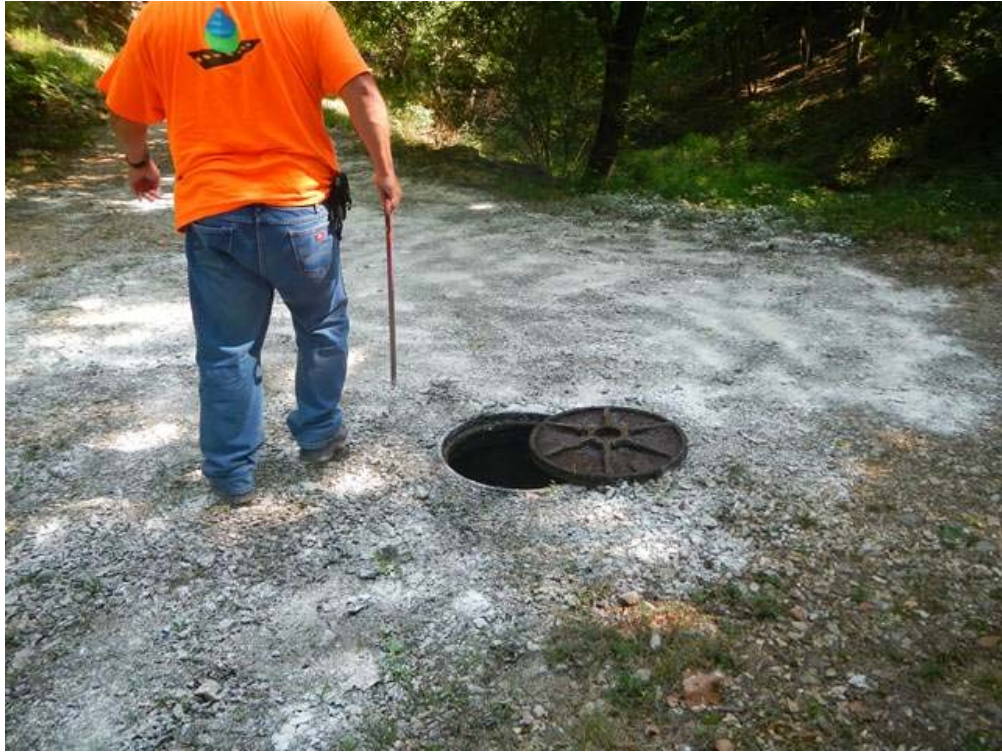
Location:	City of Eureka Springs POTW		
Photographer:	Tony Morris	Date:	7/22/2014
Time:	10:31	Witness:	Rob Mullins
Photo #:	3	Description:	The manhole which overflowed with spill area limed to kill potential pathogens.

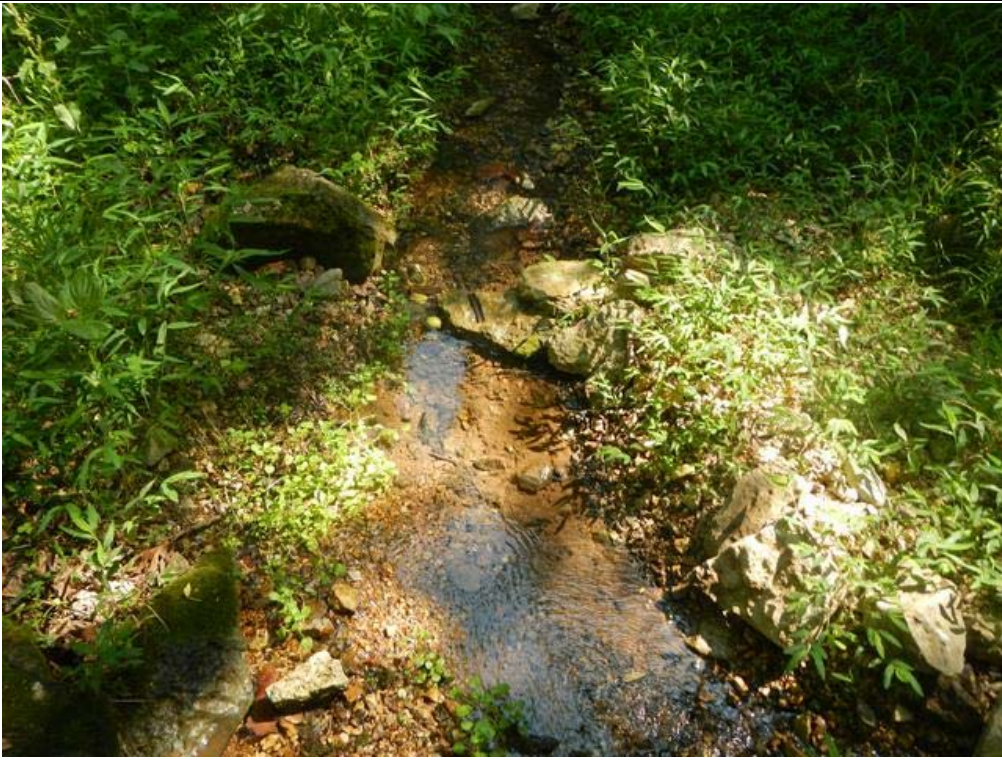
Photographer:	Tony Morris	Date:	7/22/2014
Time:	10:34	Witness:	Rob Mullins
Photo #:	4	Description:	The receiving stream with clear water just before discharge to Little Eureka Lake.
