RE: Quarterly Inspection; AFIN 18-00094; Permit Number 0245-S1-R1.

Class 1 Landfill Inspection

Site Name	Crittenden County Class I	County	Crittenden	AFIN	18-00094
Facility Address	South off Hwy 70	Phone Number	LF: 870-732-4290 Off: 870-732-6580	Permit Number	0245-S1-R1
Permittee Address	Crittenden Co. Judge	E-Mail Address	arredllc@swb.net	PDS #	084072
Date	5/12/2015	Entry Time	9:55 AM	Exit Time	12:20 PM

Response to
Arkansas Department of Environmental Quality
May 18 , 2015 Inspection

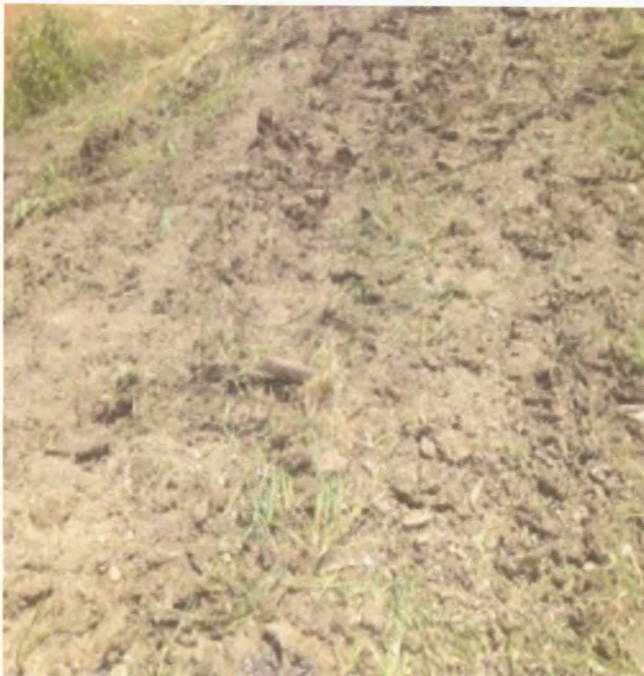
- 1** **Regulation 411(o) Leachate leaks or evidence of leachate seepage**
Corrective Action: **Area has been repaired and awaiting grass matting protective cover**

West Slope Area at North End Area Repaired

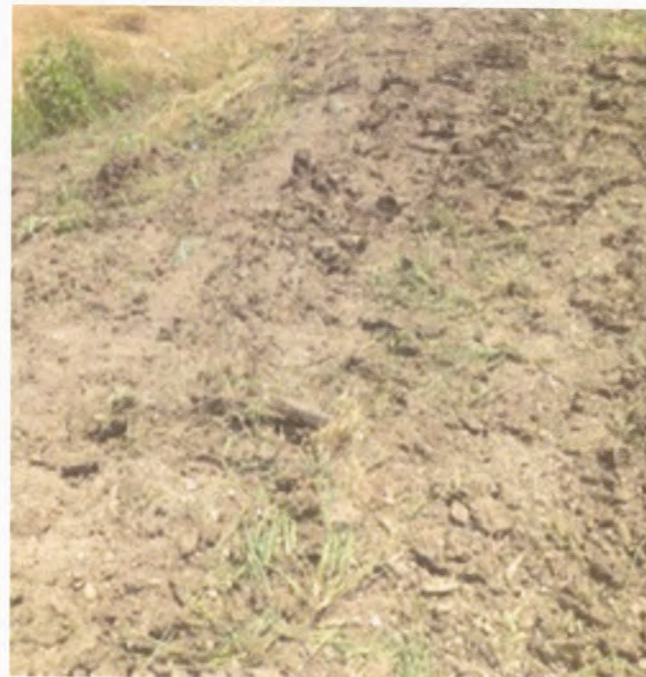
West Slope Area at North End Area Left Unprotected Ensuring Repaired

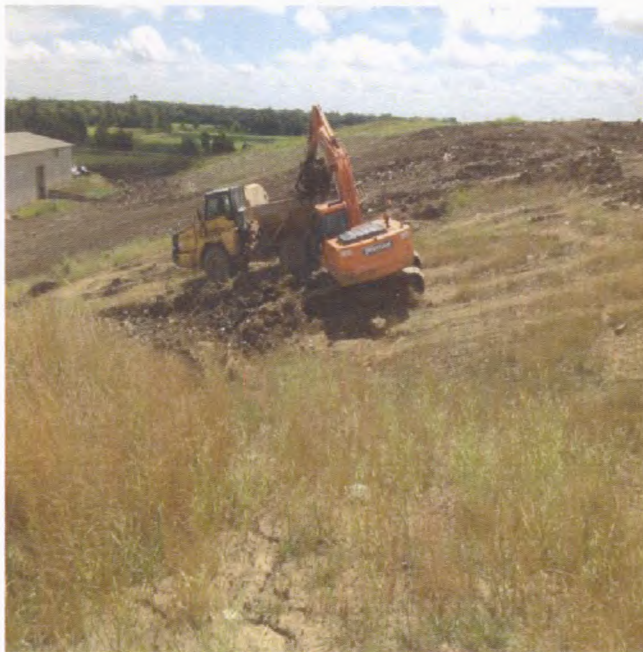
1 Regualtion 309C Overfill/Off line Area

Overfill Removal On Nort Side of South Slope @ Corner

Corrective Action: Overfill continues to be removed and remaining overfill, as of June 11th at 11:00 am

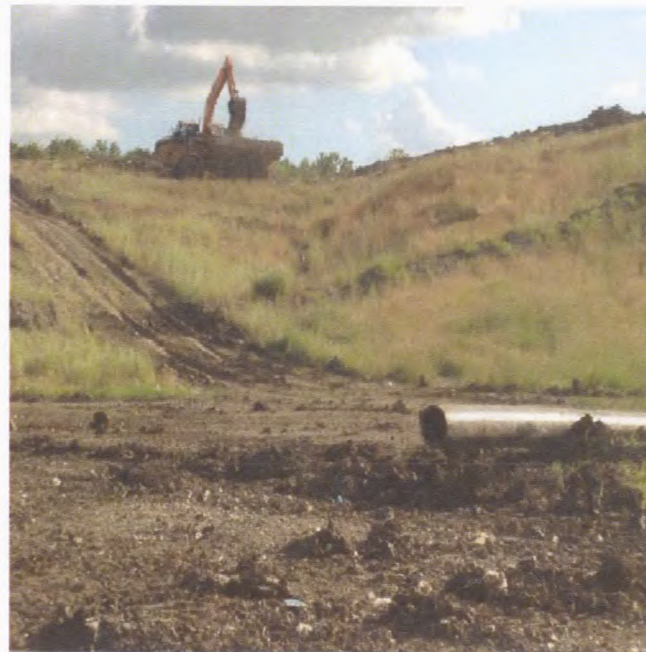
Completing Cut Noted during May 18, 2015 Inspection
