RE: Quarterly Inspection; AFIN 15-00001; Permit Number 0284-S3N

Class 3 Landfill Inspection

Site Name	Green Bay Packaging, Inc., Arkansas Kraft Division	County	Conway	AFIN	15-00001
Facility Address	Morrilton, Hwy 9 S. to Hwy 133 S. to the Facility	Phone Number	501-354-9289	Permit Number	0284-S3N
Permittee Address	PO Box 711, Morrilton, AR 72110	E-Mail Address		PDS #	085483
Date	7/23/2015	Entry Time	1310	Exit Time	1425

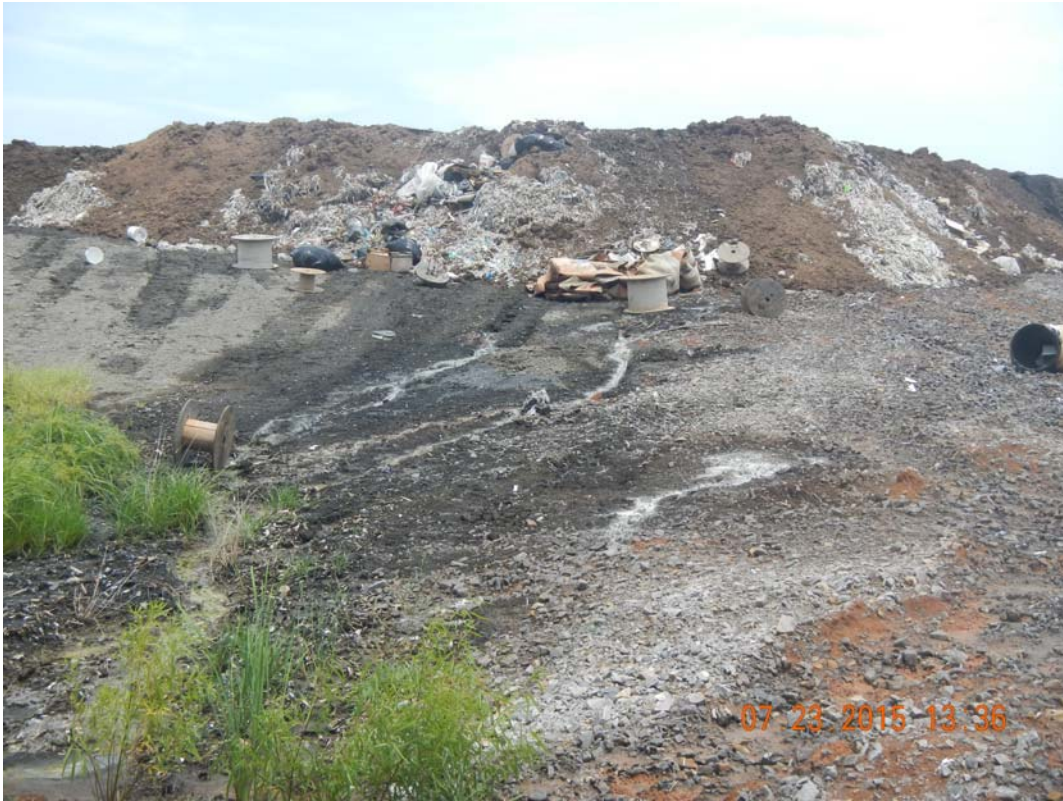
Photo 1

Comment: A leachate seep was noted near the southern end of the western slope of Area 4. Leachate was not leaving the cell and was routed to the leachate collection system. See photo 1.

As a corrective action, the facility immediately began working to cover the area where leachate seepage was noted. As of August 18th, the area was thoroughly covered.

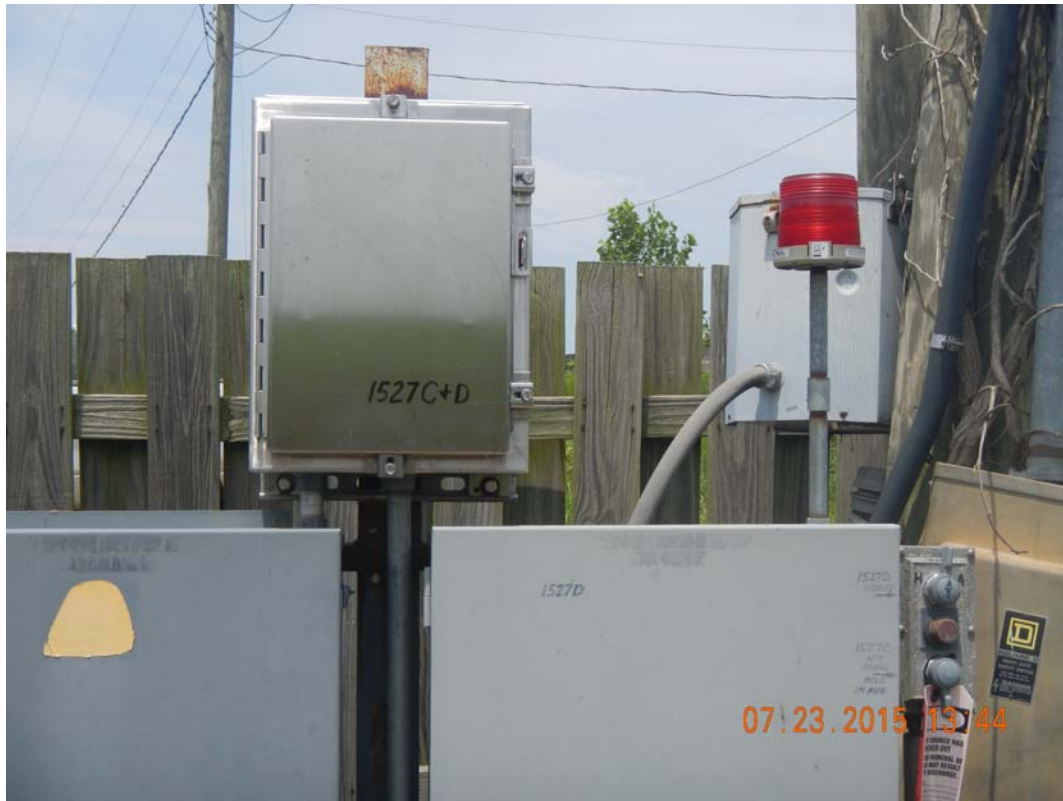
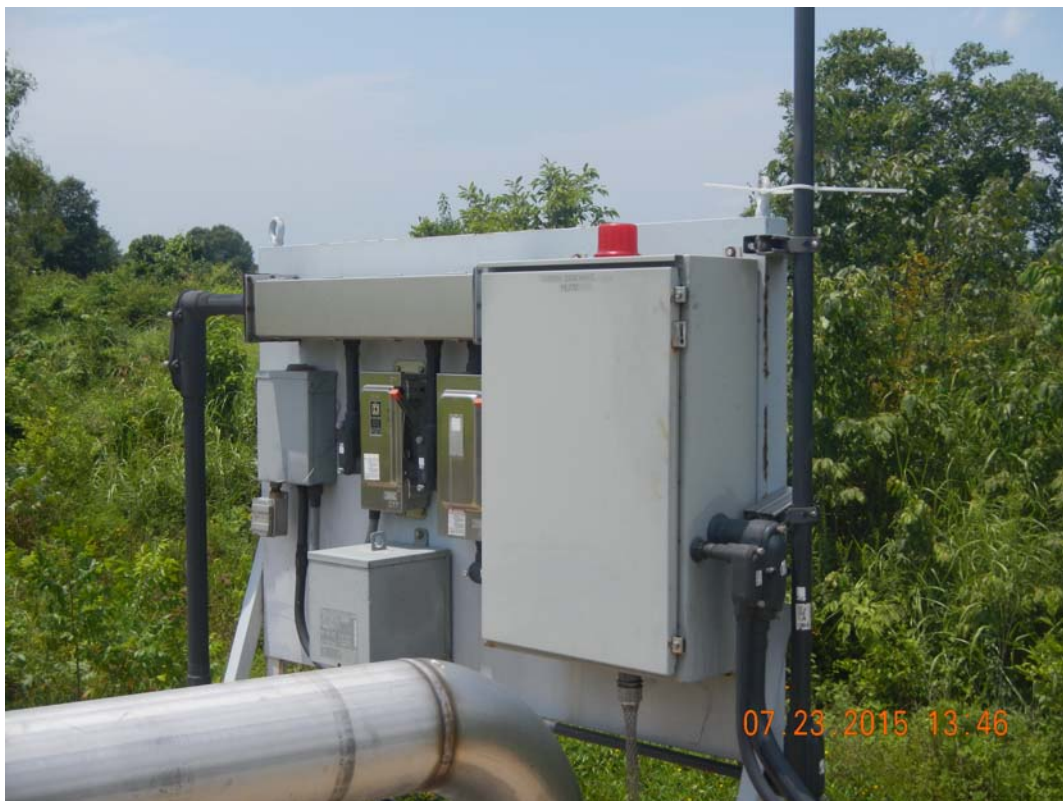
Photo 2 & 3

Comment: The alarm lights were flashing at the leachate collection sumps indicating that the leachate has risen above compliance levels. The facility had to shut-off the pumps in the leachate system in order to service and maintain the clarifier for the leachate treatment system. See photos 2 through 4

Arkansas Kraft was in the midst of a planned annual maintenance shutdown where equipment and systems are inspected and repaired as necessary. While this allows leachate levels to exceed 12 inches of head, it is necessary for properly maintaining both production and environmental equipment. While levels in the collection sumps may become high during this time, levels are observed to ensure leachate does not inadvertently escape the leachate collection system.
