ARKANSAS
Department of Environmental Quality

RE: Valley Ridge Subdivision Inspection
AFIN: 63-00820 Permit No.: ARR151435

A R K A N S A S Department of Environmental Quality		WATER DIVISION INSPECTION REPORT						
		AFIN: 63-00820		PERMIT #: ARR151435		DATE: 7/9/2015		
		COUNTY: 63 Saline			PDS #: 085802		MEDIA: WN	
		GPS LAT: 34.611232 LONG: -92.436733 LOCATION: General Area						
FACILITY INFORMATION				INSPECTION INFORMATION				
NAME: Valley Ridge Subdivision LOCATION: Valley Ridge Drive CITY: Alexander, AR				FACILITY TYPE: 1 - Municipal		INSPECTOR ID#: 107625 S - State		
				FACILITY EVALUATION RATING: ***		INSPECTION TYPE: Compliance Evaluation		
				DATE(S): 7/9/2015	ENTRY TIME: 09:45	EXIT TIME: 11:50	PERMIT EFFECTIVE DATE: 12/29/2011	
				PERMIT EXPIRATION DATE: 10/31/2016				
RESPONSIBLE OFFICIAL				FAYETTEVILLE SHALE RELATED: N FAYETTEVILLE SHALE VIOLATIONS: N INSPECTION PARTICIPANTS NAME/TITLE/PHONE/FAX/EMAIL/ETC.: Chris Naus/ADEQ District 9 Water Inspector/ 501-682-0658/naus@adeq.state.ar.us				
NAME / TITLE Greg Holman / Reg. Agents COMPANY: Boto AR Properties, LLC MAILING ADDRESS: 17901 Chenal Parkway CITY, STATE, ZIP: Little Rock AR 72223 PHONE & EXT: / FAX: 501-33

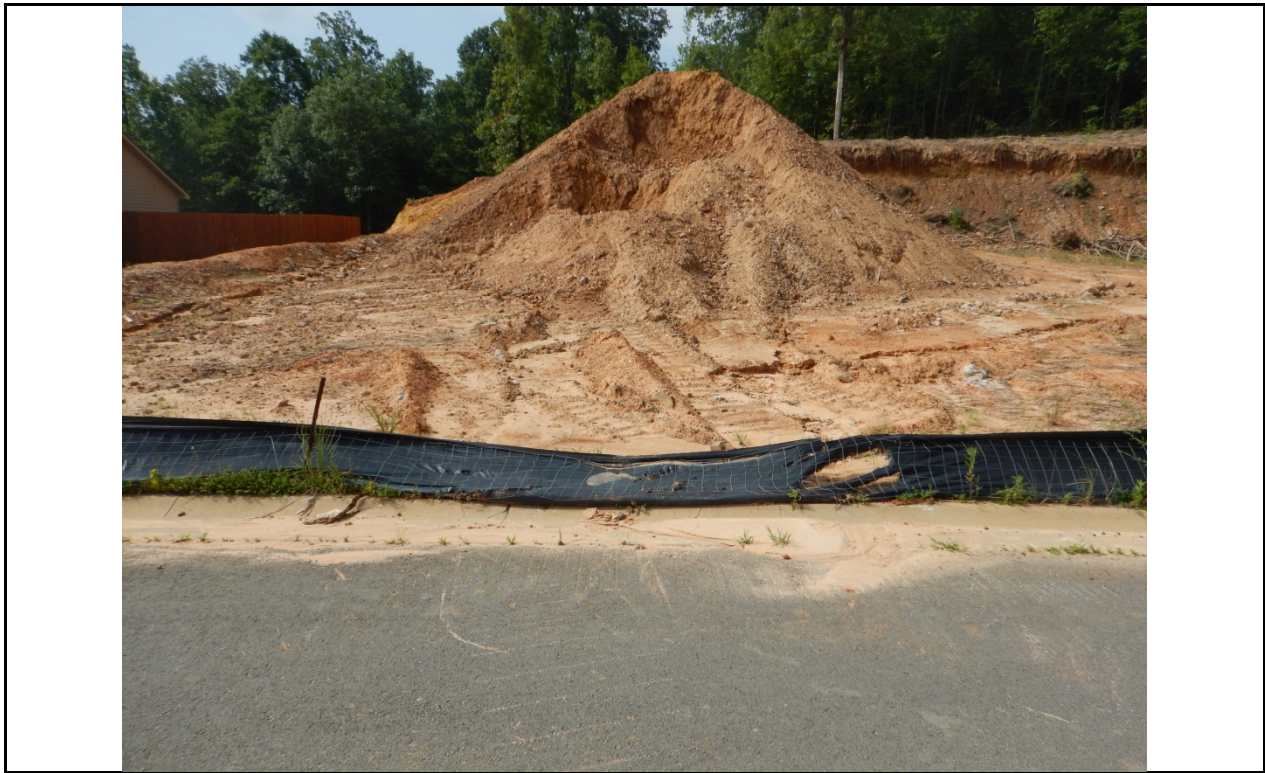
3. Part I, Section B, 12, A; The operator must design, install, and maintain effective erosion controls and sediment controls to minimize the discharge of pollutants. **Damaged silt fences were observed on lots 53/54, 64/65, and adjacent to Lot 75(Pictures 2-4); sediment traps were filled beyond capacity on 53 and 97 (Pictures 5 & 6), detention ponds/sediment basins were beyond capacity (Pictures 7-9) and check dam was filled beyond capacity (Picture10 & 11).**

Photographer:	Chris Naus	Date:	7/9/2015	Time:	9:49
Witness:				Photo #:	2
Description:	Silt fence down on Lot 53/54 and a large pile of sediment left exposed to stormwater.

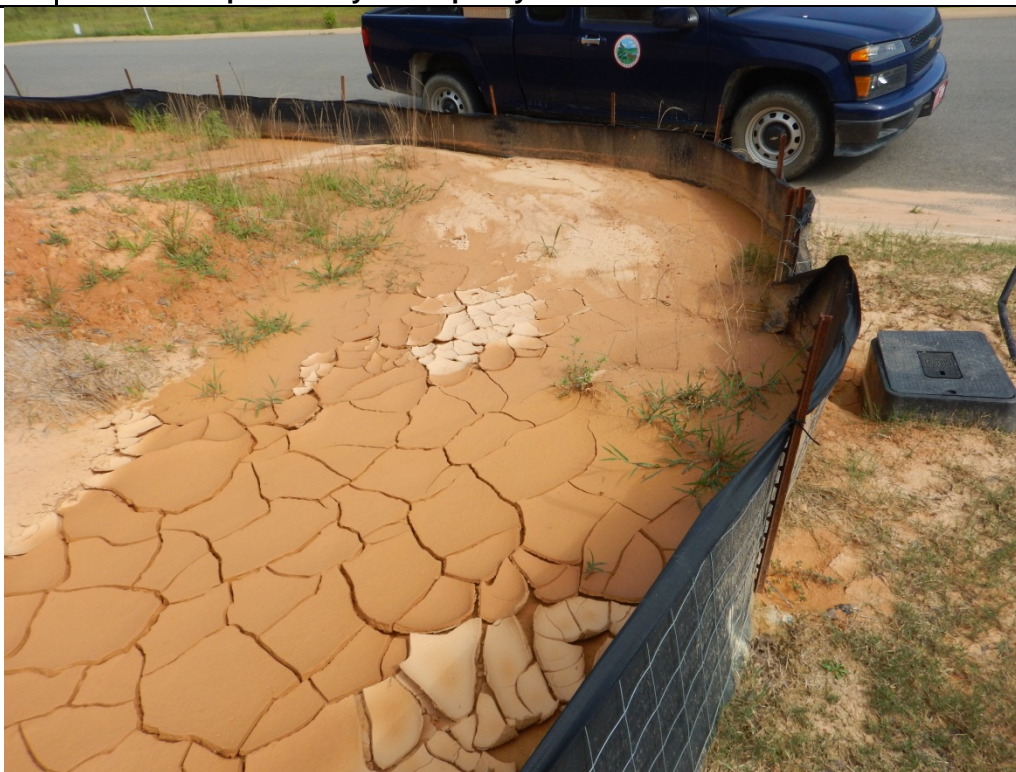
Water Division Photographic Evidence Sheet			
Location:	Valley Ridge Subdivision		
Photographer:	Chris Naus	Date:	7/9/2015
Time:	9:54		Photo #:
Witness:			5
Description:	Sediment trap filled beyond capacity on Lot 53.

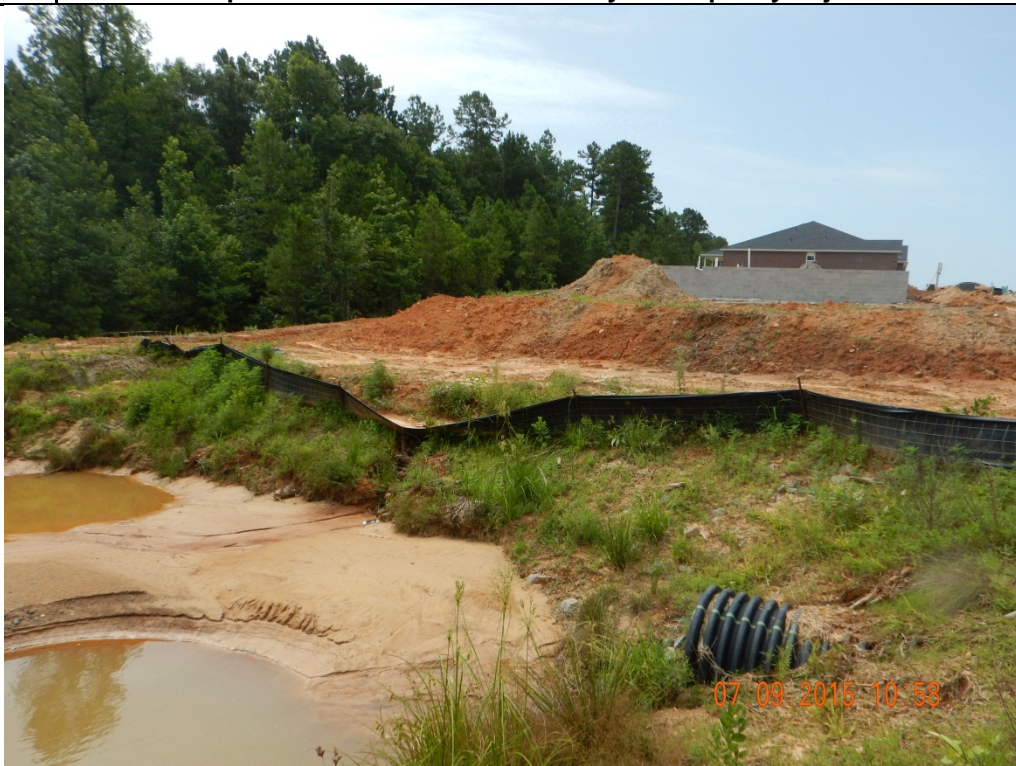
Photographer:	Chris Naus	Date:	7/9/2015	Time:	10:53
Witness:			Photo #:	6	
Description:	Sediment trap and sediment basin filled beyond capacity adjacent to Lot 97.

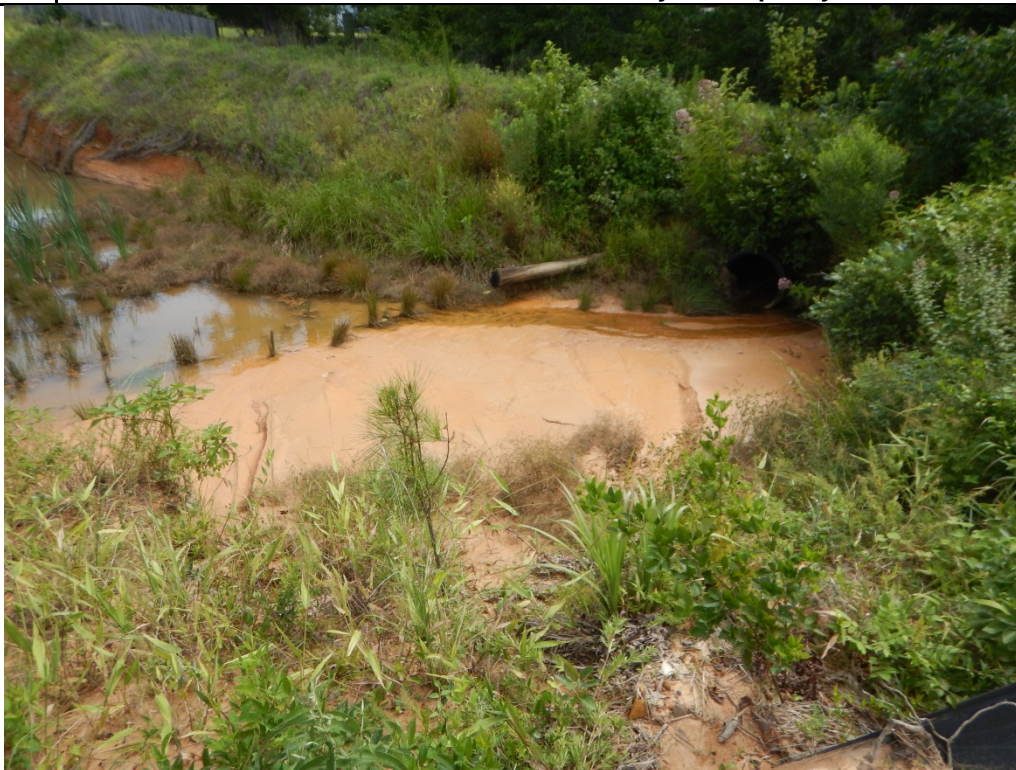
Water Division Photographic Evidence Sheet			
Location:	Valley Ridge Subdivision		
Photographer:	Chris Naus	Date:	7/9/2015
Time:	10:06		Photo #:
Witness:			7
Description:	Sediment basin near Lots 89/90 that is filled beyond capacity.

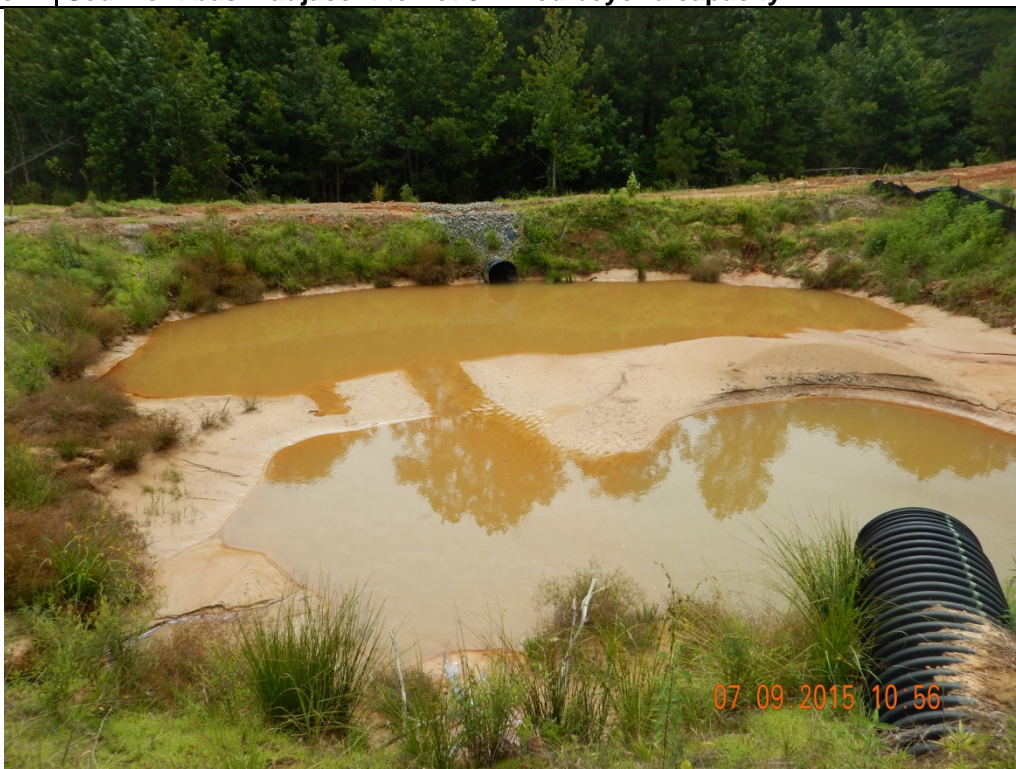
Photographer:	Chris Naus	Date:	7/9/2015	Time:	10:56
Witness:			Photo #:	8	
Description:	Sediment basin adjacent to Lot 97 filled beyond capacity.

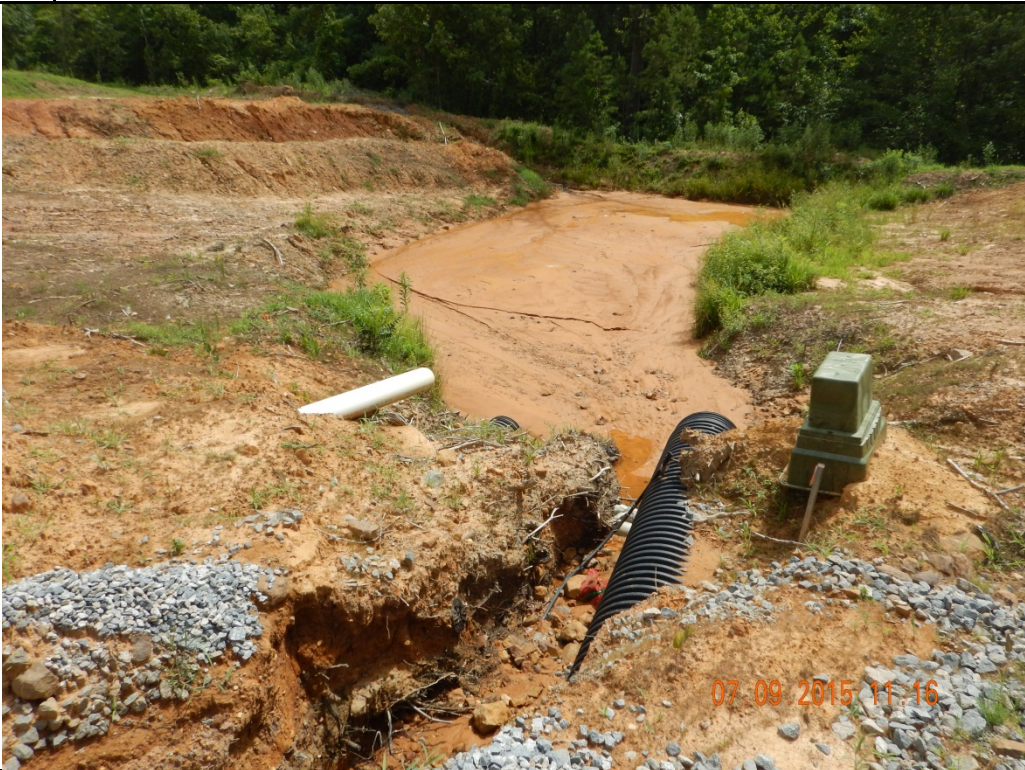
Water Division Photographic Evidence Sheet				
Location:	Valley Ridge Subdivision			
Photographer:	Chris Naus	Date:	7/9/2015	Time: 11:16
Witness:				Photo #: 9
Description:	Sediment basin on far southeast corner of unfinished development that has not been maintained.

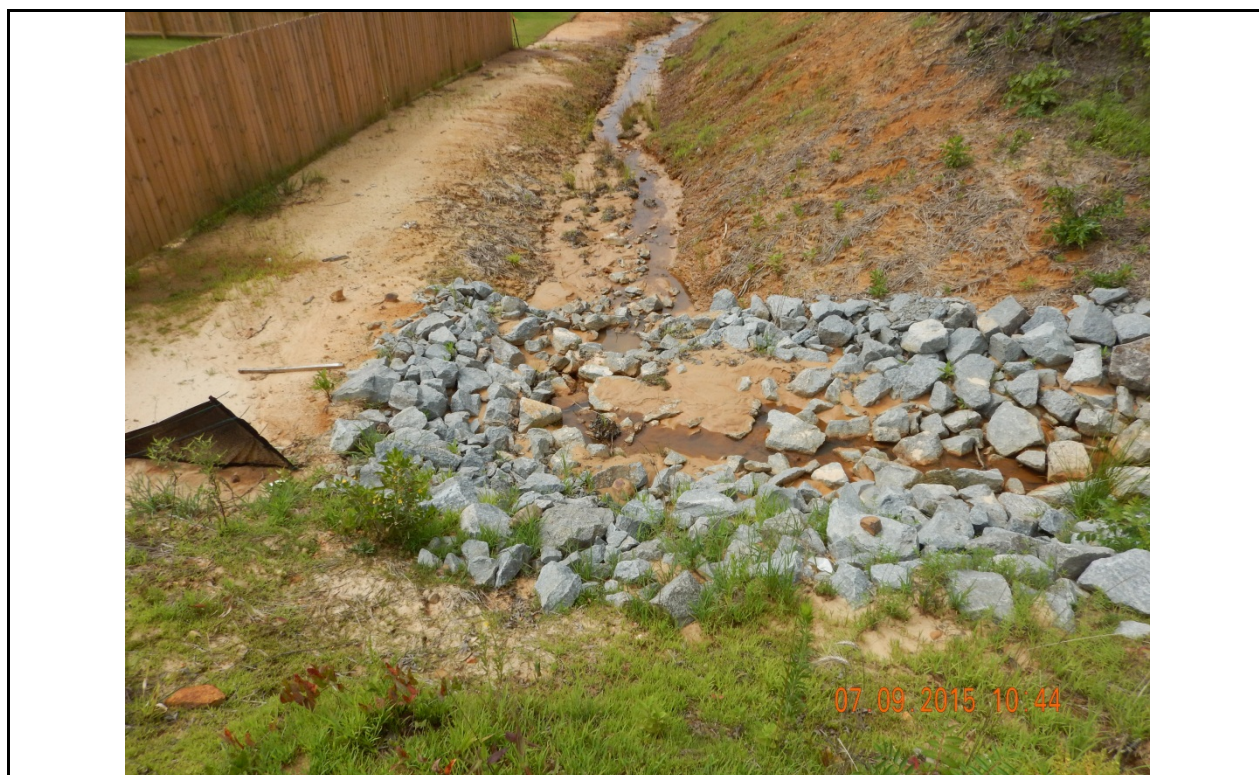
Photographer:	Chris Naus	Date:	7/9/2015	Time: 10:44
Witness:				Photo #: 10
Description:	Check dam located along western property line (Lots 69-75), that has not been maintained.

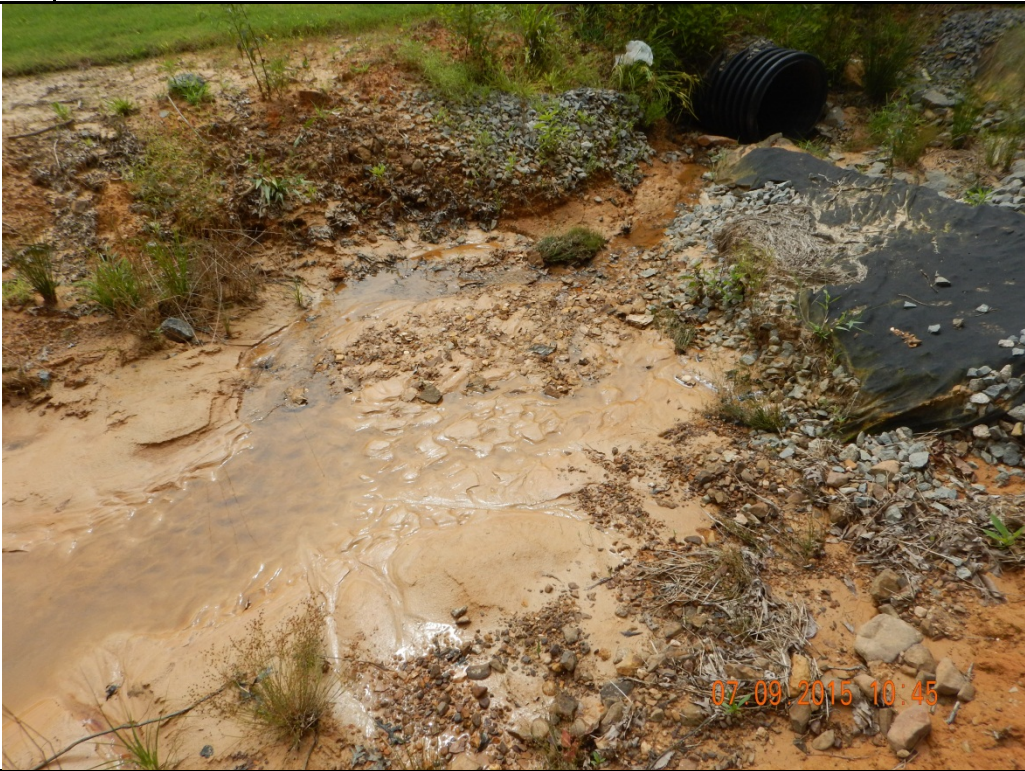
Water Division Photographic Evidence Sheet					
Location:	Valley Ridge Subdivision				
Photographer:	Chris Naus	Date:	7/9/2015	Time:	10:45
Witness:				Photo #:	11
Description:	End of check dam with evidence sediment had entered pipe leading to a storm drain.

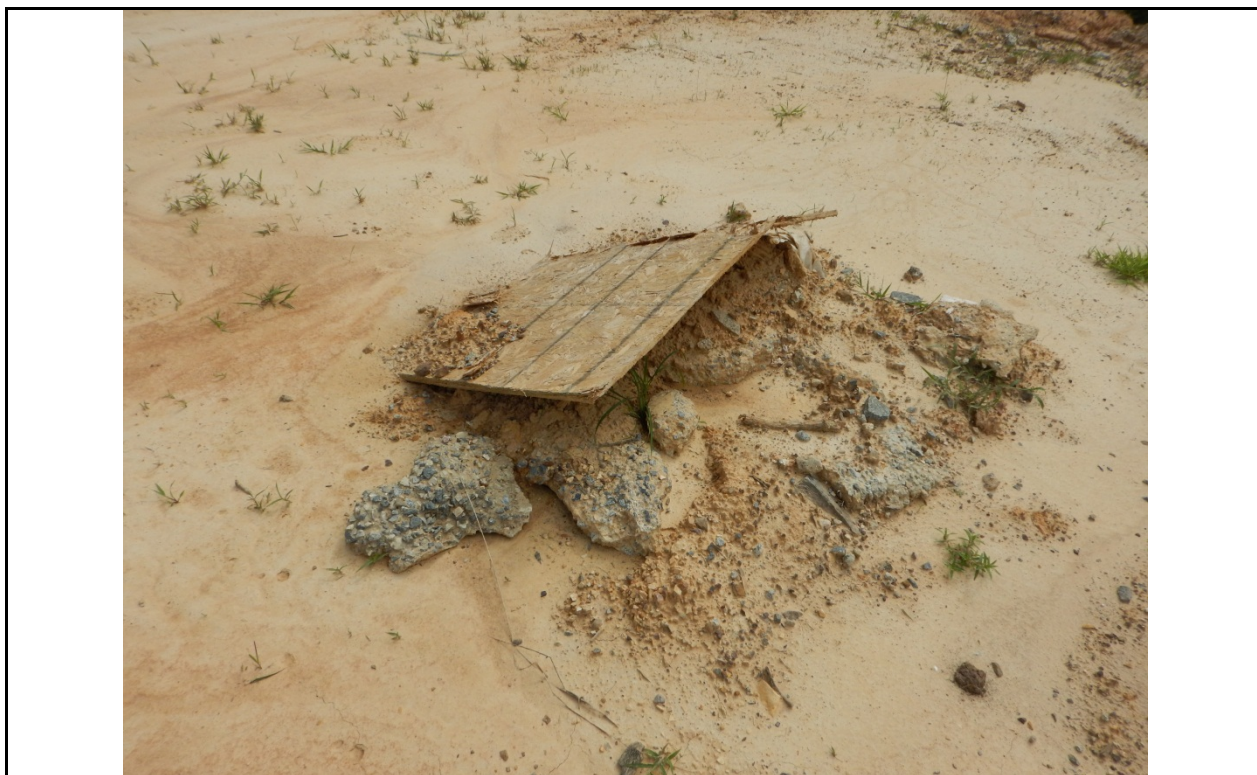
5. Part I, Section B, 12, D; Minimize the exposure of building materials, building products, construction wastes, trash, landscape materials, fertilizers, pesticides, detergents, sanitary waste, and other materials present on site to precipitation and to stormwater. **Piles of construction waste was present on lots 90, 64, and 65 (Pictures 3 & 12).**

Photographer:	Chris Naus	Date:	7/9/2015	Time:	10:11
Witness:				Photo #:	12
Description:	Construction waste left on Lot 90, which has also not been stabilized.

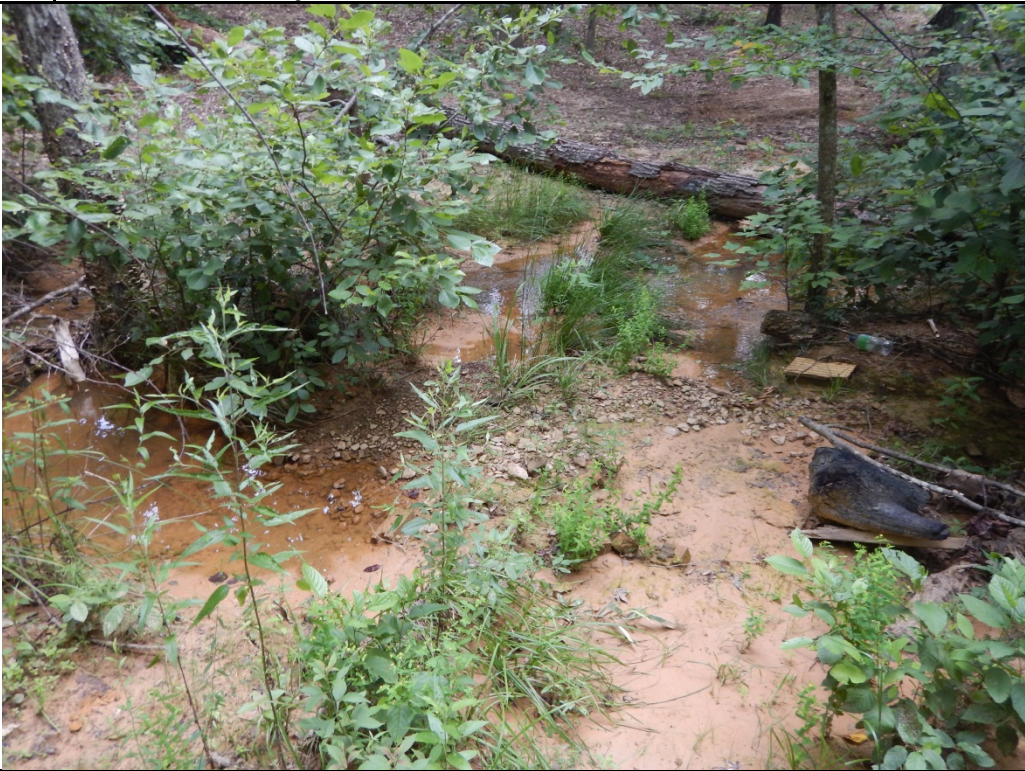
6. Part I, Section B, 12, E; Part I, Section B, 16, A; The operator is ultimately responsible for the runoff from the perimeter of the entire development. Regardless for the reason of the runoff, the operator is responsible for ensuring sufficient sediment controls of the development. **At the time of inspection, there was evidence that sediment had left lots and entered "Waters of the State" either directly or via storm drains (Pictures 13-17).**

Water Division Photographic Evidence Sheet					
Location:	Valley Ridge Subdivision				
Photographer:	Chris Naus	Date:	7/9/2015	Time:	10:07
Witness:				Photo #:	13
Description:	Sediment that has escaped the site and entered "Waters of the State," near sediment basin adjacent to Lot 89/90.

Your picture 13 is of the exit area behind the detention pond on Lot 97. A picture is provided that shown new slit fencing and additional rock checks to prevent this occurrence. Pictures are also provided showing the that the detention pond at lot 110 in the new area has been cleaned out and restored to a functional condition.

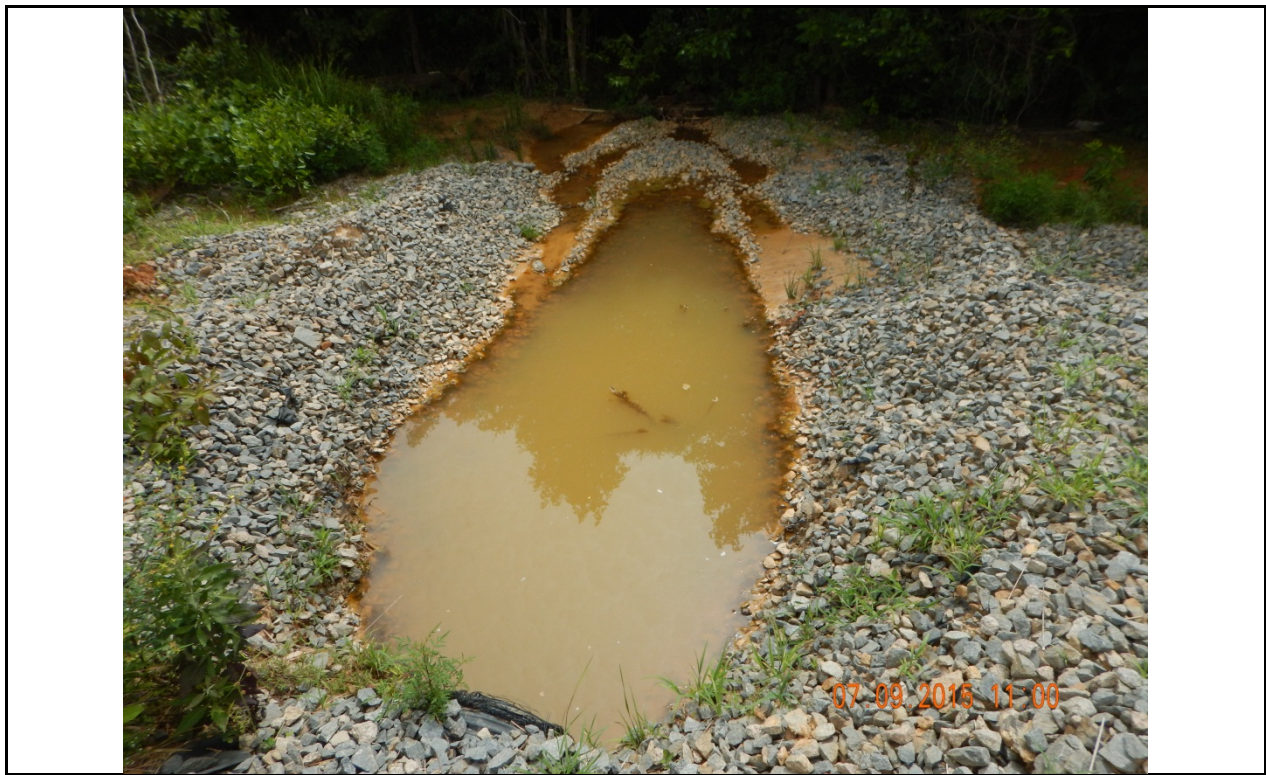
Photographer:	Chris Naus	Date:	7/9/2015	Time:	11:00
Witness:				Photo #:	14
Description:	Sediment leaving sediment basin adjacent to Lot 97.

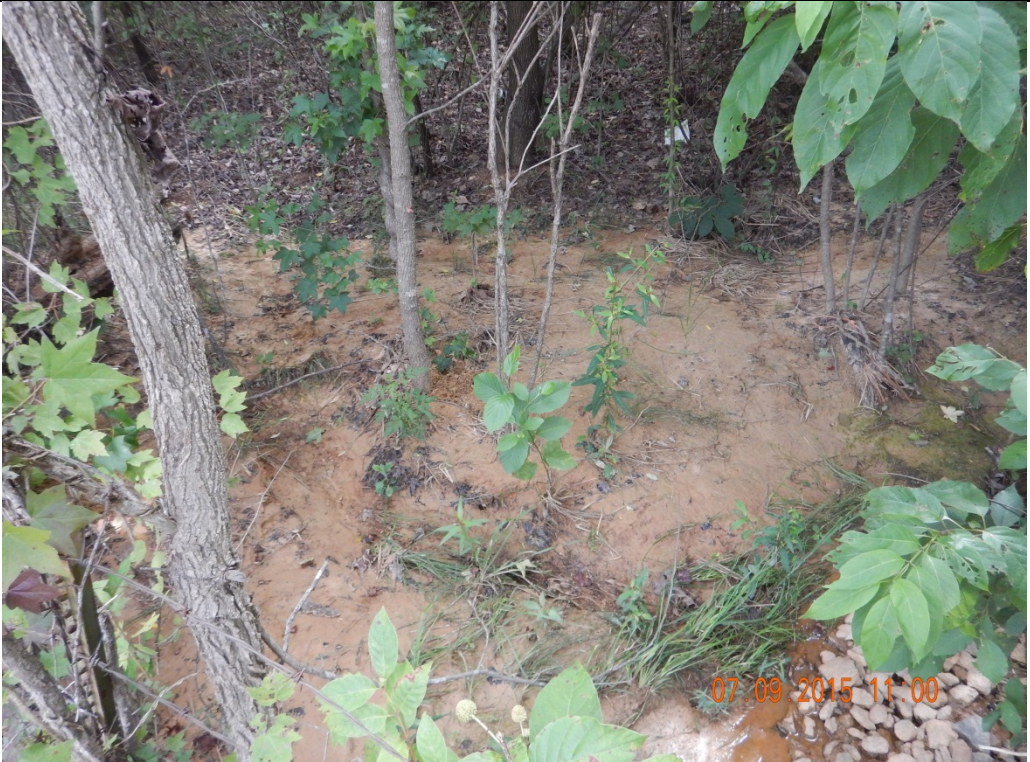
Water Division Photographic Evidence Sheet			
Location:	Valley Ridge Subdivision		
Photographer:	Chris Naus	Date:	7/9/2015
Time:	11:00		
Witness:			Photo #:
Description:		Sediment that has left the site near sediment basin adjacent to Lot 97.

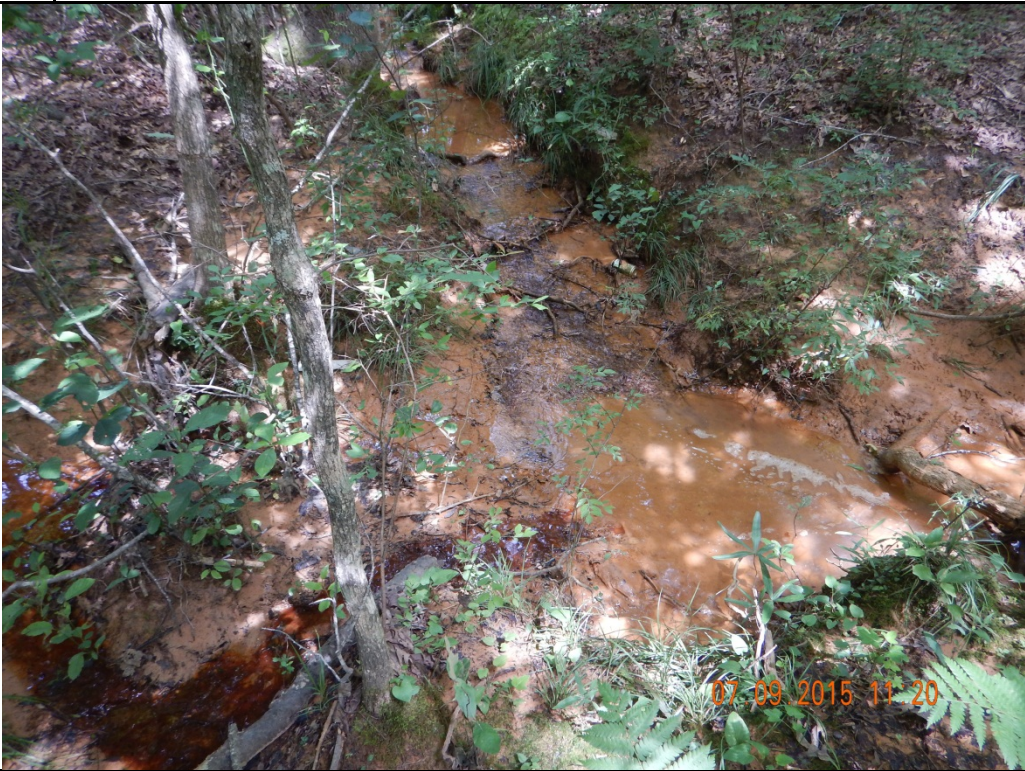
Water Division Photographic Evidence Sheet					
Location:	Valley Ridge Subdivision				
Photographer:	Chris Naus	Date:	7/9/2015	Time:	11:20
Witness:				Photo #:	17
Description:	Sediment that has left the site and entered "Waters of the State," near farthest southeast sediment basin.
