ARKANSAS
Department of Environmental Quality

RE: James Olive Salvage Yard Inspection
AFIN: 56-00000 Permit No.: ARR000000 - Unpermitted

WATER DIVISION INSPECTION REPORT				
	AFIN: 56-00000	PERMIT #: ARR000000	DATE: 10/20/2015		
	COUNTY: 56 Poinsett	PDS #: 088062	MEDIA: WN		
	GPS LAT: 35.484233 LONG: -90.338308 LOCATION: Entrance				
FACILITY INFORMATION		INSPECTION INFORMATION			
NAME: James Olive Salvage Yard LOCATION: Steel Bridge Rd. CITY: Tyronza		FACILITY TYPE: 2 - Industrial INSPECTOR ID#: 52138 S - State FACILITY EVALUATION RATING: N INSPECTION TYPE: Industrial Stormwater DATE(S): 10/20/2015 ENTRY TIME: EXIT TIME: PERMIT EFFECTIVE DATE: PERMIT EXPIRATION DATE:			
RESPONSIBLE OFFICIAL		INSPECTION PARTICIPANTS			
NAME / TITLE: James Olive / Owner COMPANY: James Olive Salvage Yard MAILING ADDRESS: 39143 Steel Bridge Rd. CITY, STATE, ZIP: Tyronza AR 72386 PHONE & EXT. / FAX: 901-359-0995 / EMAIL:		NAME/TITLE/PHONE/FAX/EMAIL/ETC.: None			
CONTACTED DURING INSPECTION: No					
AREA EVALUATIONS (S=Satisfactory, M=Marginal, U=Unsatisfactory, N=Not Applicable/Evaluated)

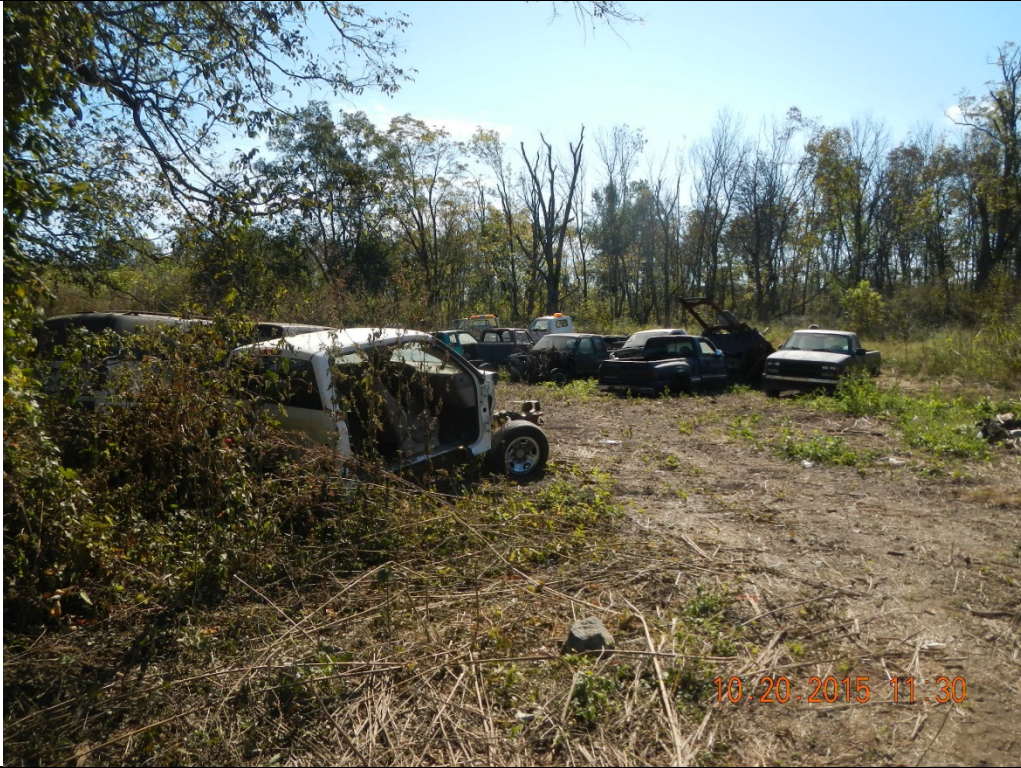
Location:	James Olive Salvage Yard, Steel Bridge Rd., Tyronza, AR				
Photographer:	Brent Walker	Date:	10/20/2015	Time:	1130
Witness:	Sarah Frasher	Photo #:	1		
Description:	Salvage vehicles stored adjacent to wetland area on south side of Steel Bridge Rd.

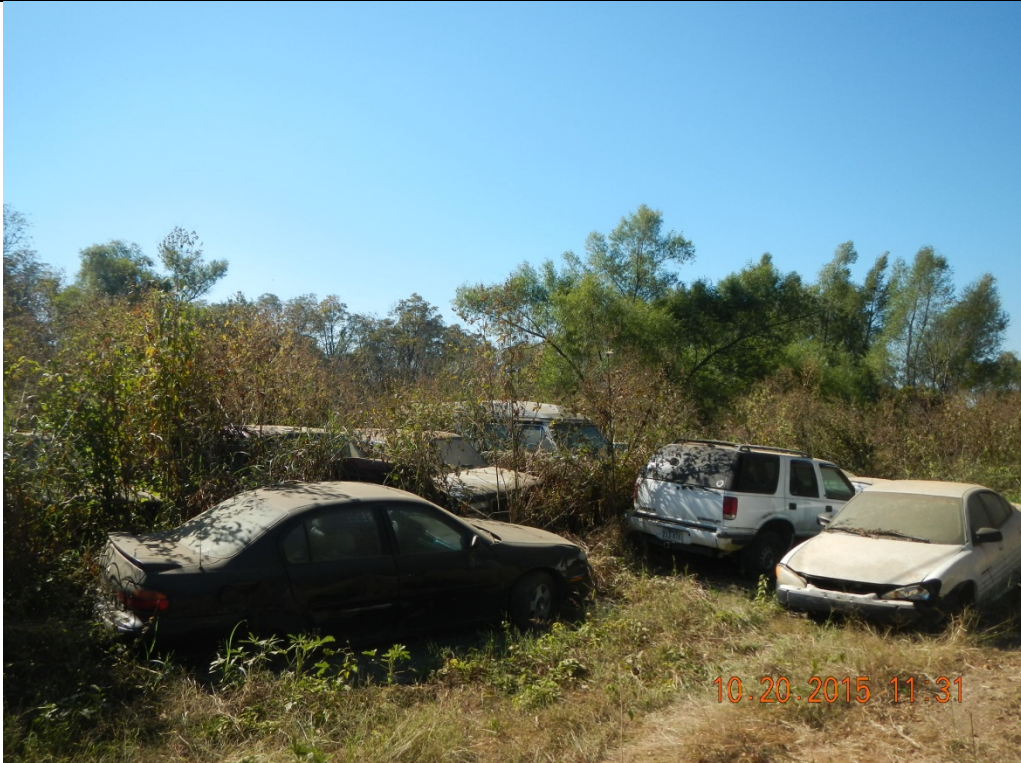
Photographer:	Brent Walker	Date:	10/20/2015	Time:	1131
Witness:	Sarah Frasher	Photo #:	2		
Description:	Salvage vehicles stored adjacent to wetland area on south side of Steel Bridge Rd.

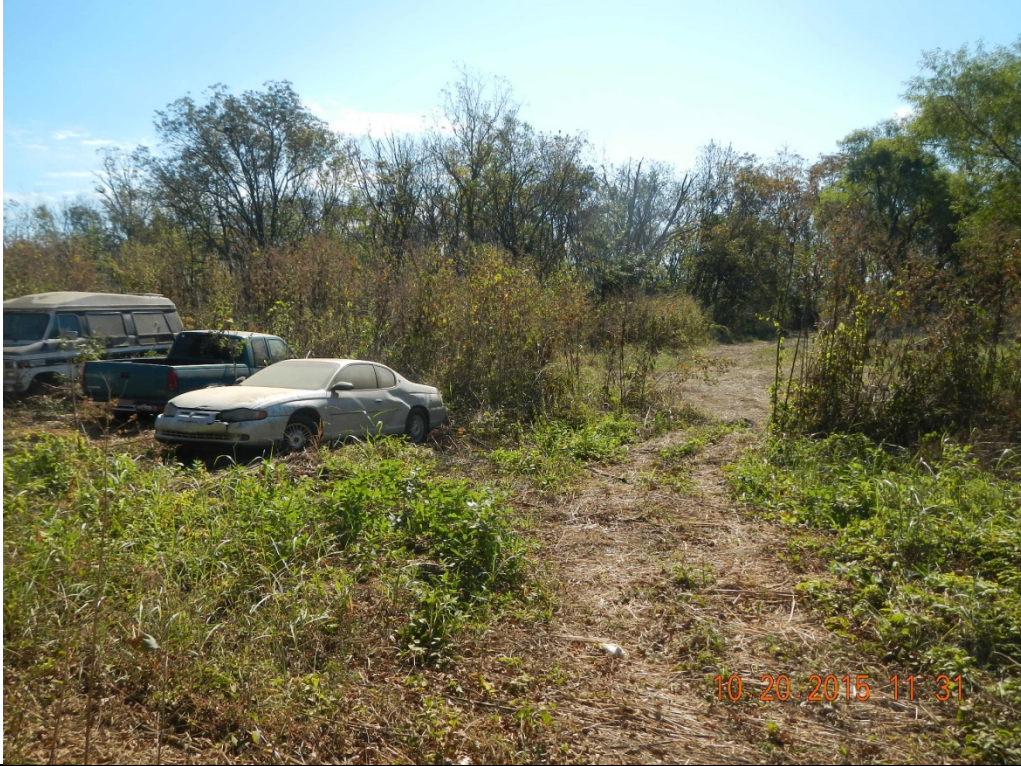
Location:	James Olive Salvage Yard, Steel Bridge Rd., Tyronza, AR				
Photographer:	Brent Walker	Date:	10/20/2015	Time:	1131
Witness:	Sarah Frasher	Photo #:	3		
Description:	Salvage vehicles stored adjacent to wetland area on south side of Steel Bridge Rd.

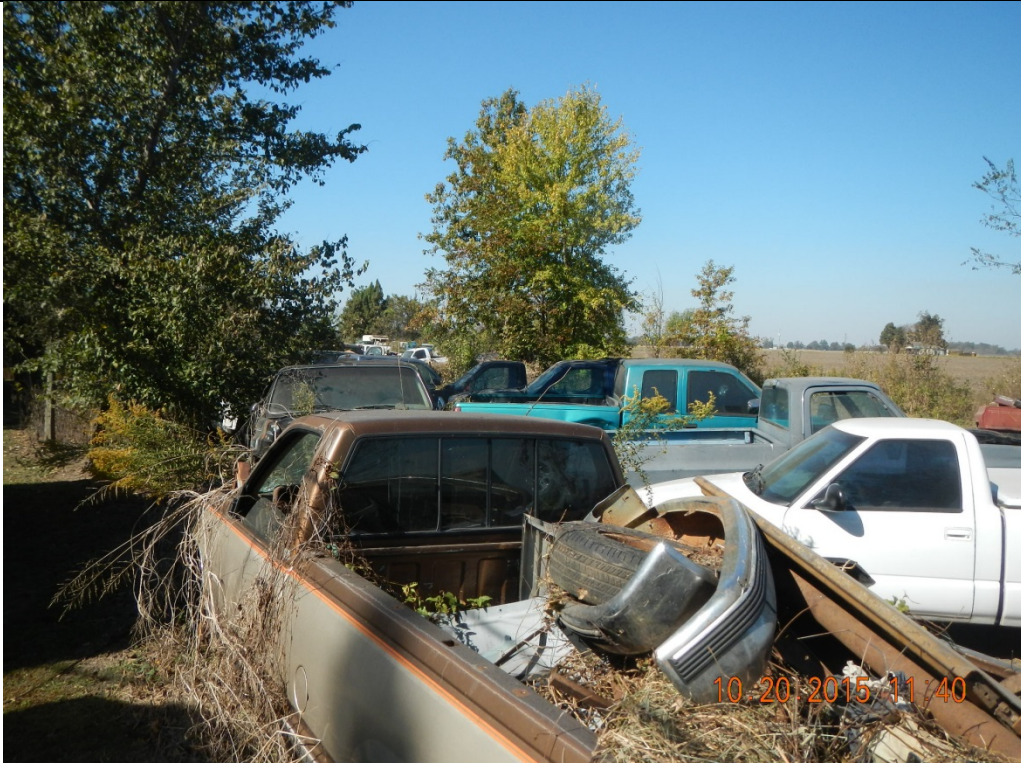
Photographer:	Brent Walker	Date:	10/20/2015	Time:	1140
Witness:	Sarah Frasher	Photo #:	4		
Description:	Salvage vehicles on north side of Steel Bridge Rd.

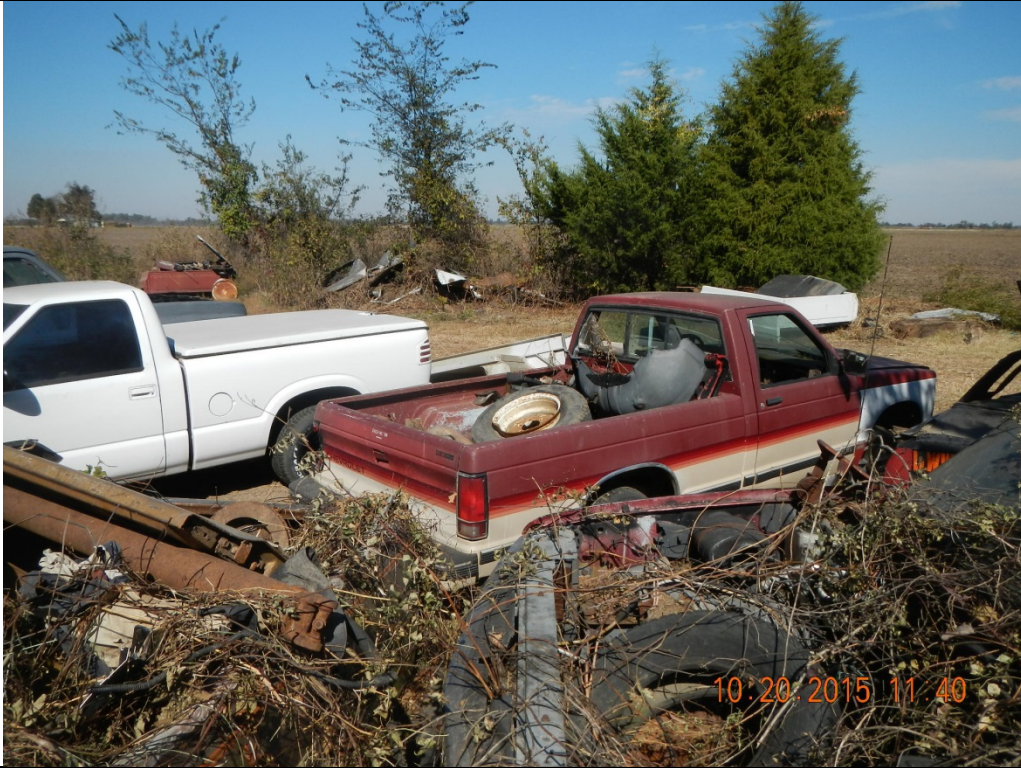
Location: James Olive Salvage Yard, Steel Bridge Rd., Tyronza, AR			
Photographer:	Brent Walker	Date:	10/20/2015
Witness:	Sarah Frasher	Time:	1140
		Photo #:	5
Description: Salvage vehicles on north side of Steel Bridge Rd.

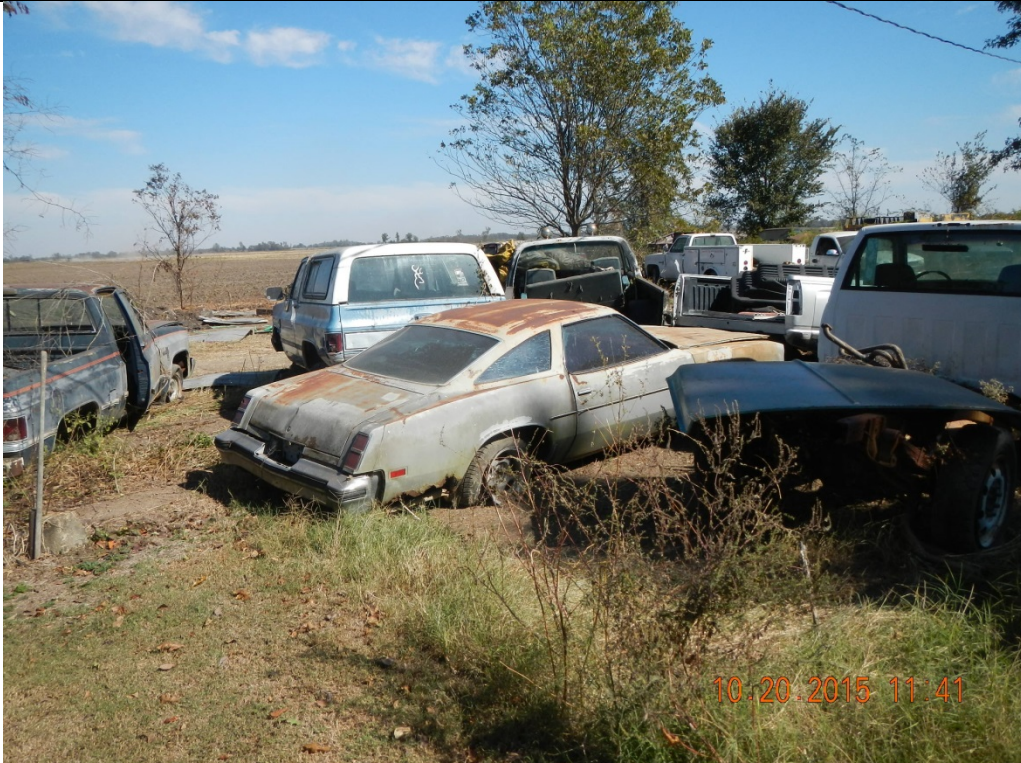
Photographer: Brent Walker			
		Date:	10/20/2015
Witness:	Sarah Frasher	Time:	1141
		Photo #:	6
Description: Salvage vehicles on north side of Steel Bridge Rd.

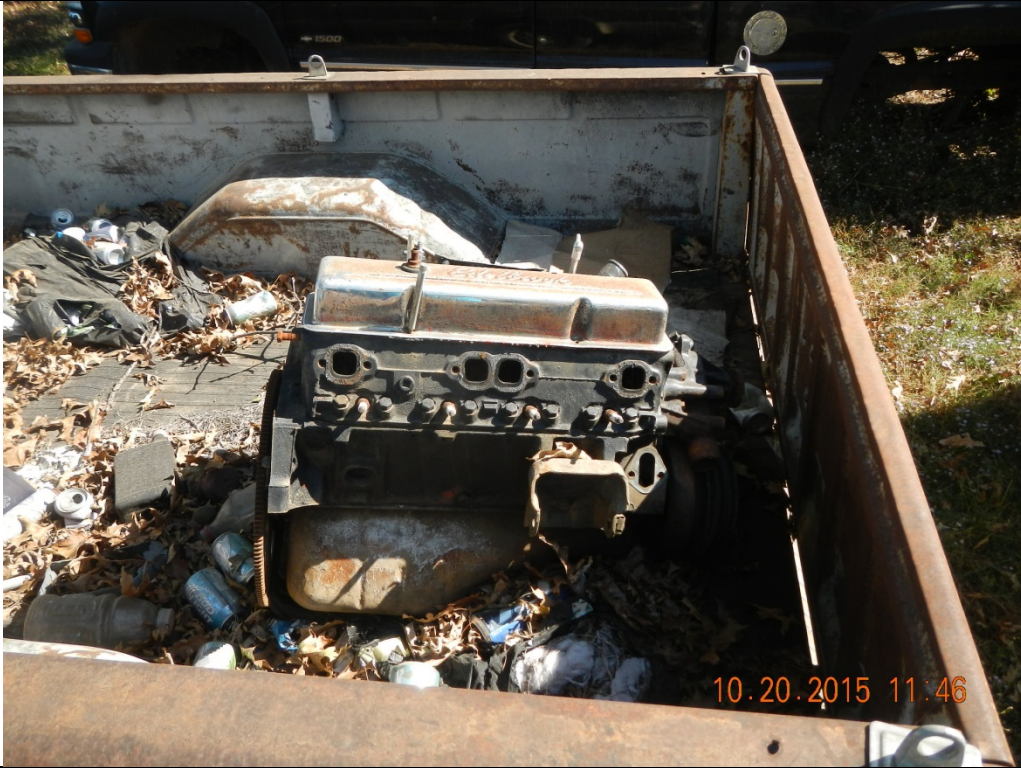
Location:	James Olive Salvage Yard, Steel Bridge Rd., Tyronza, AR				
Photographer:	Brent Walker	Date:	10/20/2015	Time:	1146
Witness:	Sarah Frasher			Photo #:	7
Description:	Engine in back of salvage pickup truck.

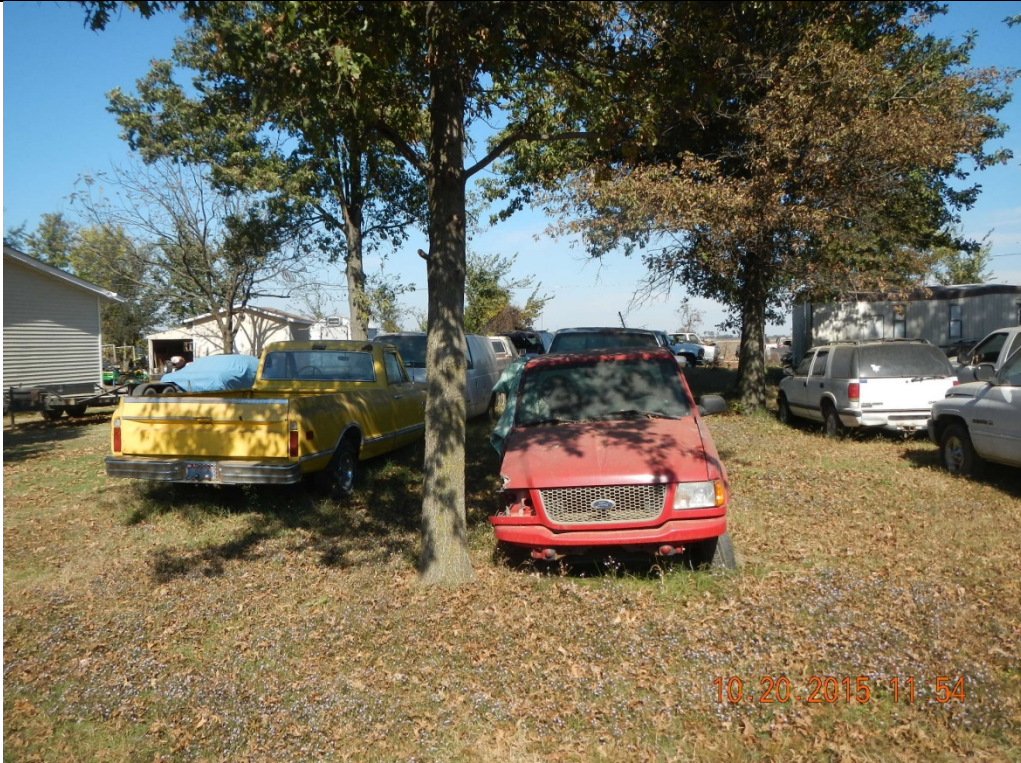
Photographer:	Brent Walker	Date:	10/20/2015	Time:	1154
Witness:	Sarah Frasher			Photo #:	8
Description:	Salvage vehicles on north side of Steel Bridge Rd.

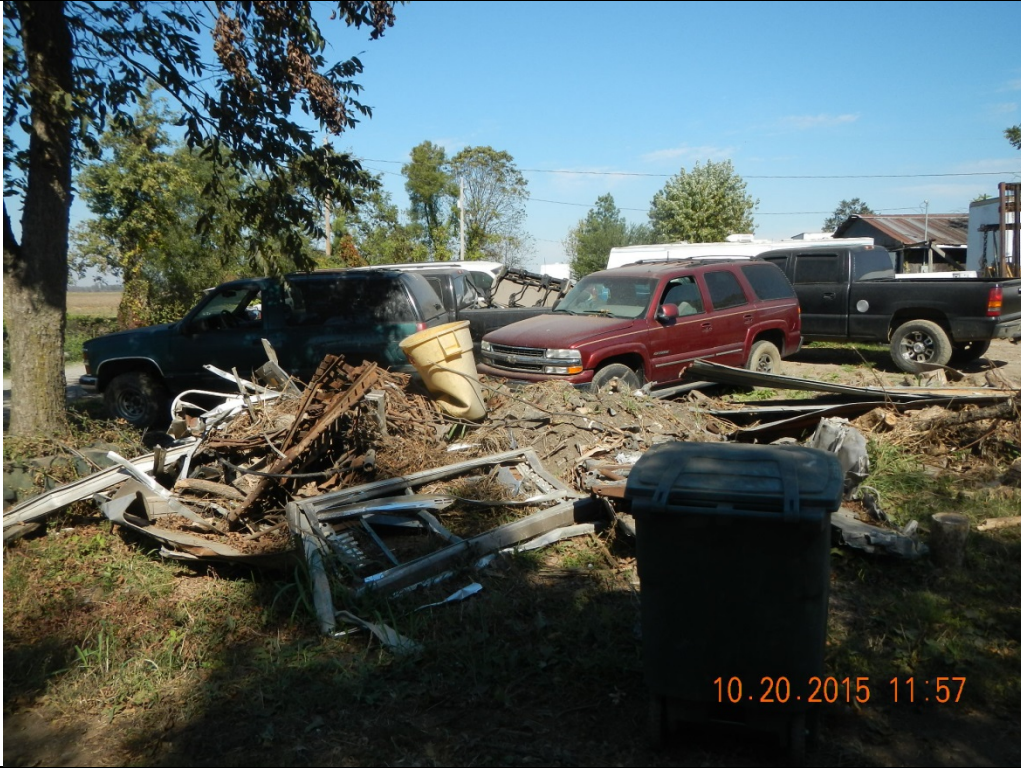
Location:	James Olive Salvage Yard, Steel Bridge Rd., Tyronza, AR				
Photographer:	Brent Walker	Date:	10/20/2015	Time:	1157
Witness:	Sarah Frasher	Photo #:	9		
Description:	Vehicles and miscellaneous solid wastes near facility entrance.

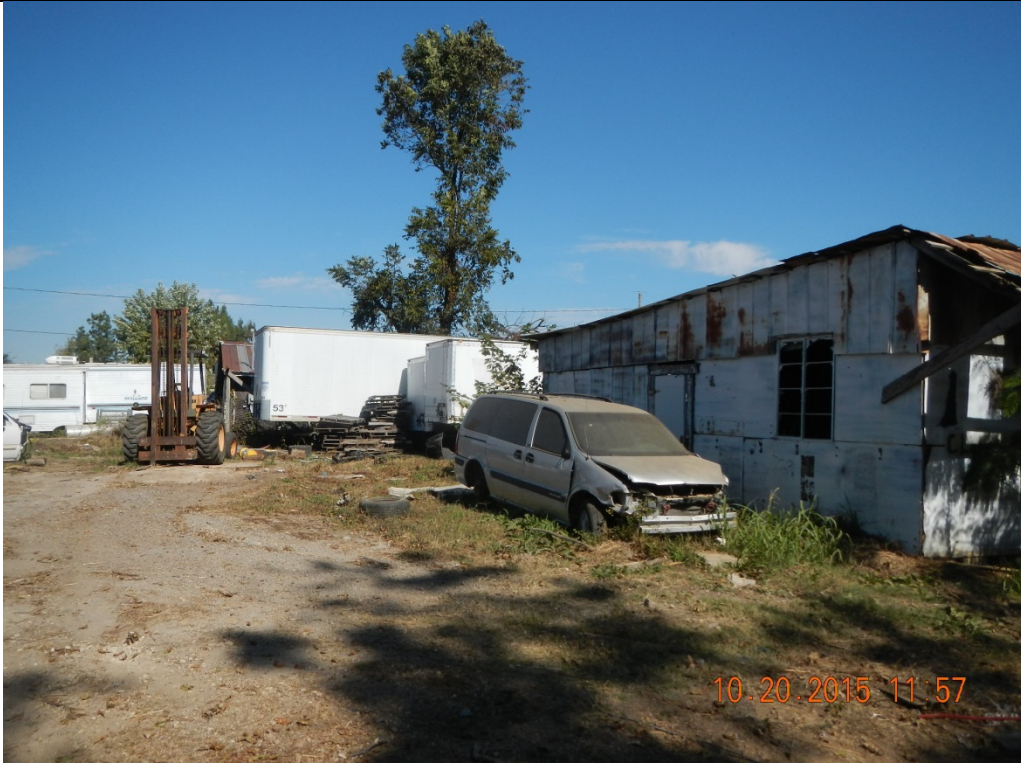
Photographer:	Brent Walker	Date:	10/20/2015	Time:	1157
Witness:	Sarah Frasher	Photo #:	10		
Description:	Salvage vehicle on north side of Steel Bridge Rd.
