ARKANSAS
Department of Environmental Quality

RE: Carman, Inc. Inspection (Sebastian Co)
AFIN: 66-00495 **NPDES Permit No.: ARR00A741**

ADEQ ARKANSAS Department of Environmental Quality		WATER DIVISION INSPECTION REPORT			
		AFIN: 66-00495	PERMIT #: ARR00A741	DATE: 1/20/2016	
		COUNTY: 66 Sebastian	PDS #: 089016	MEDIA: WN	
		GPS LAT: 35.319717 LONG: -94.423050 LOCATION: General Area			
FACILITY INFORMATION		INSPECTION INFORMATION			
NAME: Carman, Inc. LOCATION: 6705 Hwy 271 South CITY: Fort Smith		FACILITY TYPE: 2 - Industrial INSPECTOR ID#: 111784 S - State			
		FACILITY EVALUATION RATING: N INSPECTION TYPE: Industrial Stormwater			
		DATE(S): 1/20/2016 ENTRY TIME: 13:45 EXIT TIME: 14:20 PERMIT EFFECTIVE DATE: 7/1/2014 PERMIT EXPIRATION DATE: 6/30/2019			
RESPONSIBLE OFFICIAL		FAYETTEVILLE SHALE RELATED: N FAYETTEVILLE SHALE VIOLATIONS: N			
NAME: / TITLE Greg Carman / President COMPANY: Carman Inc. MAILING ADDRESS: PO Box 6424 CITY, STATE, ZIP: Fort Smith AR 72908 PHONE & EXT: / FAX: 479-646-8486 / EMAIL: greg@carmaninc.com		INSPECTION PARTICIPANTS

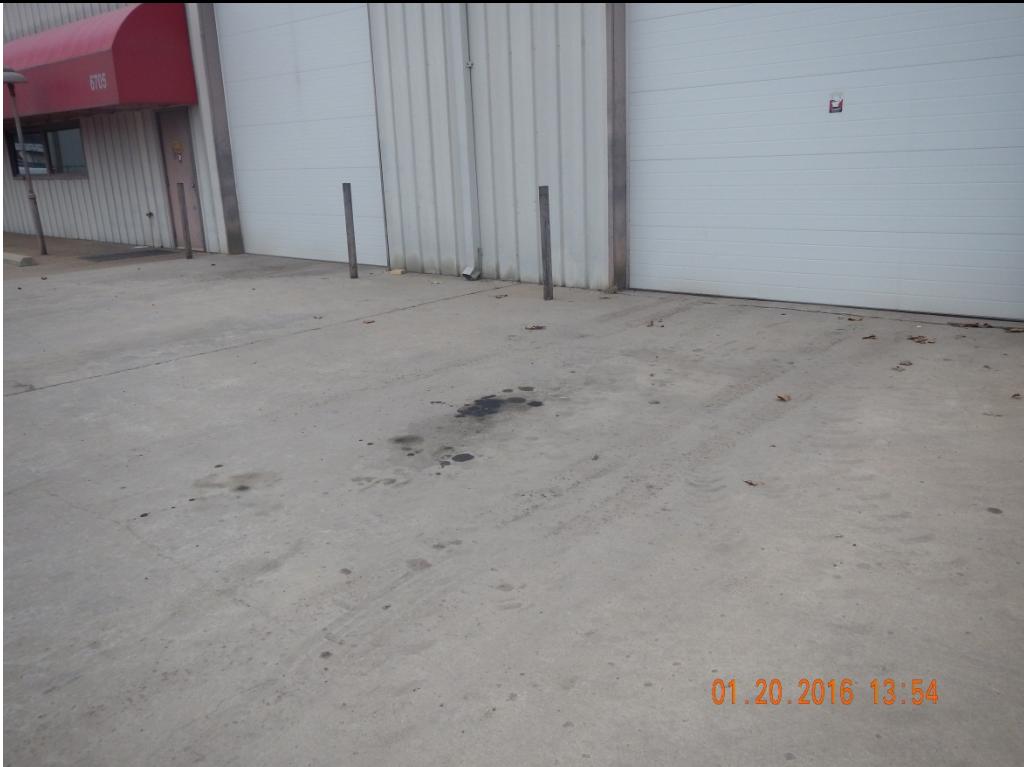
Residual from a spill/leak was noted at the entrance to the maintenance shop. Mr. Carman stated it would be cleaned up the day of the inspection. A fuel and DEF tank are located on the south-side of the building. The fuel tank is surrounded by a secondary containment berm. Mr. Carman reports no spills or leaks have occurred. There are several empty trailers being stored onsite.

Comments: Leak/spill at maintenance door entrance.

Location:	Carman, Inc.			
Photographer:	Alana Sullivan	Date:	1/20/2016	Time: 13:54
Witness:	Greg Carman			Photo #: 1
Description:	Residual from spill/leak.

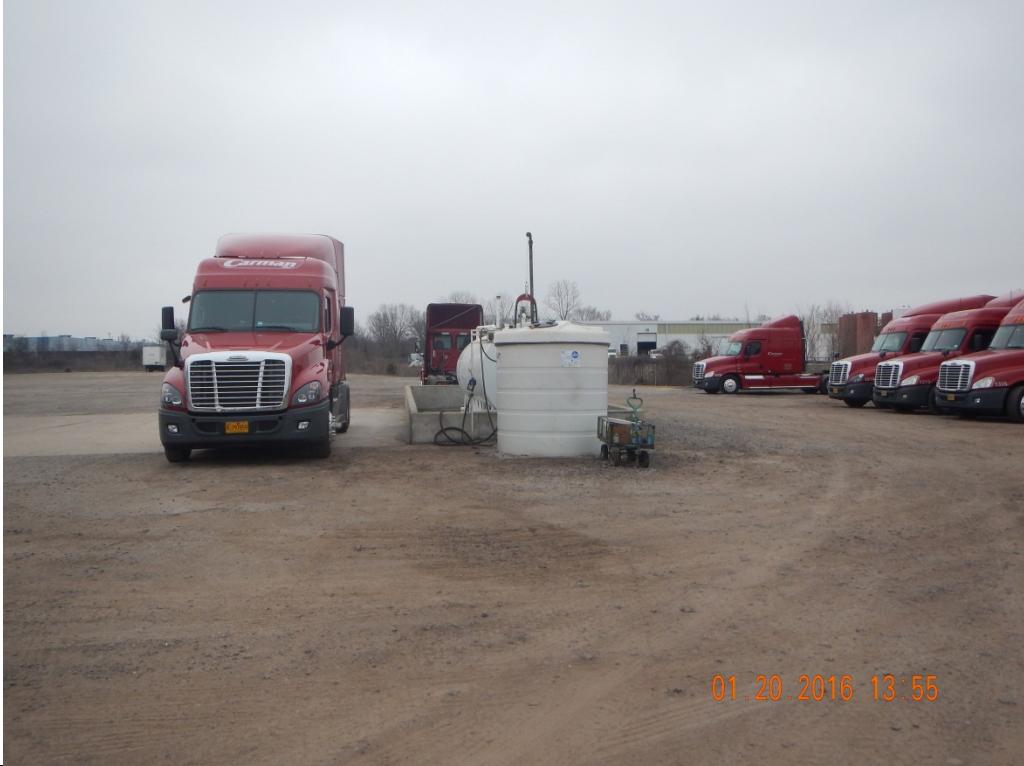
Photographer:	Alana Sullivan	Date:	1/20/2016	Time: 13:55
Witness:	Greg Carman			Photo #: 2
Description:	DEF tank; fuel tank with berm behind it.

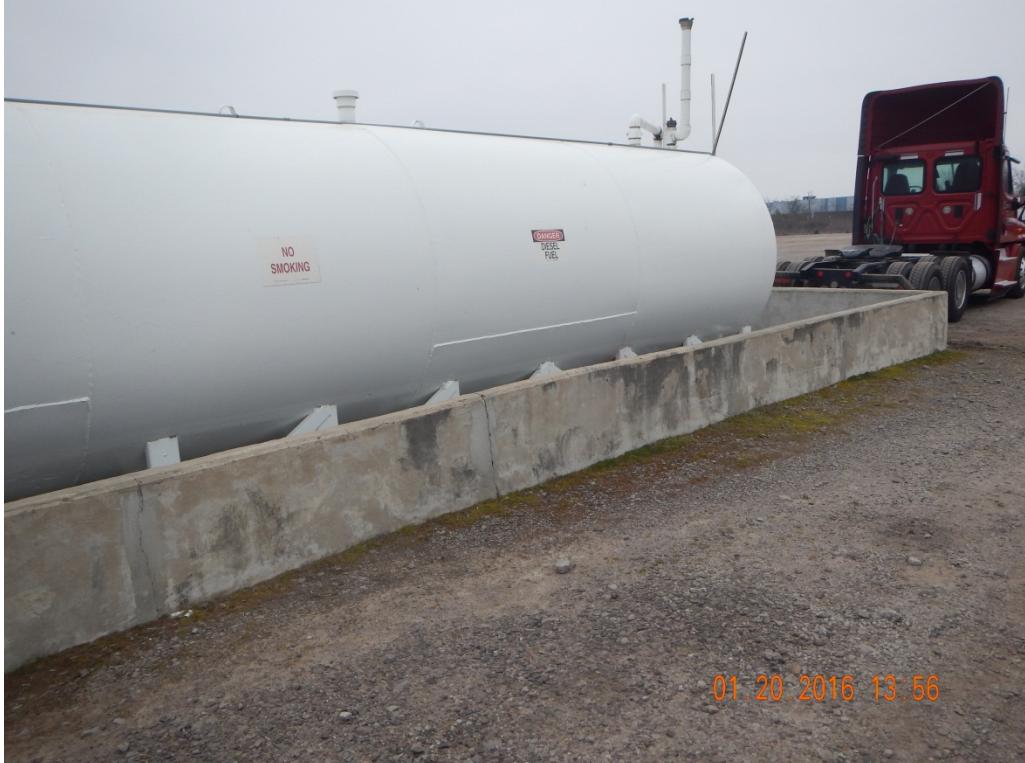
Water Division Photographic Evidence SheetLocation: **Carman, Inc.**Photographer: **Alana Sullivan**Date: **1/20/2016**Time: **13:56**Witness: **Greg Carman**Photo #: **3**Description: **Fuel tank with berm.**

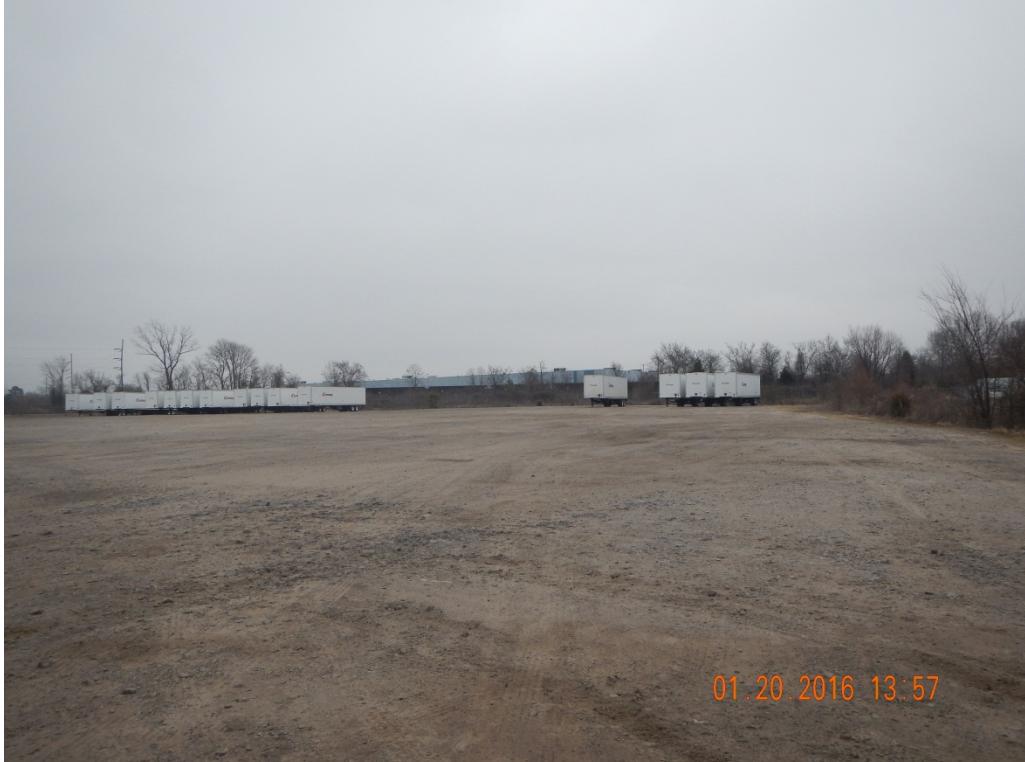
Photographer: **Alana Sullivan**Date: **1/20/2016**Time: **13:57**Witness: **Greg Carman**Photo #: **4**Description: **Empty trailers being stored onsite.**

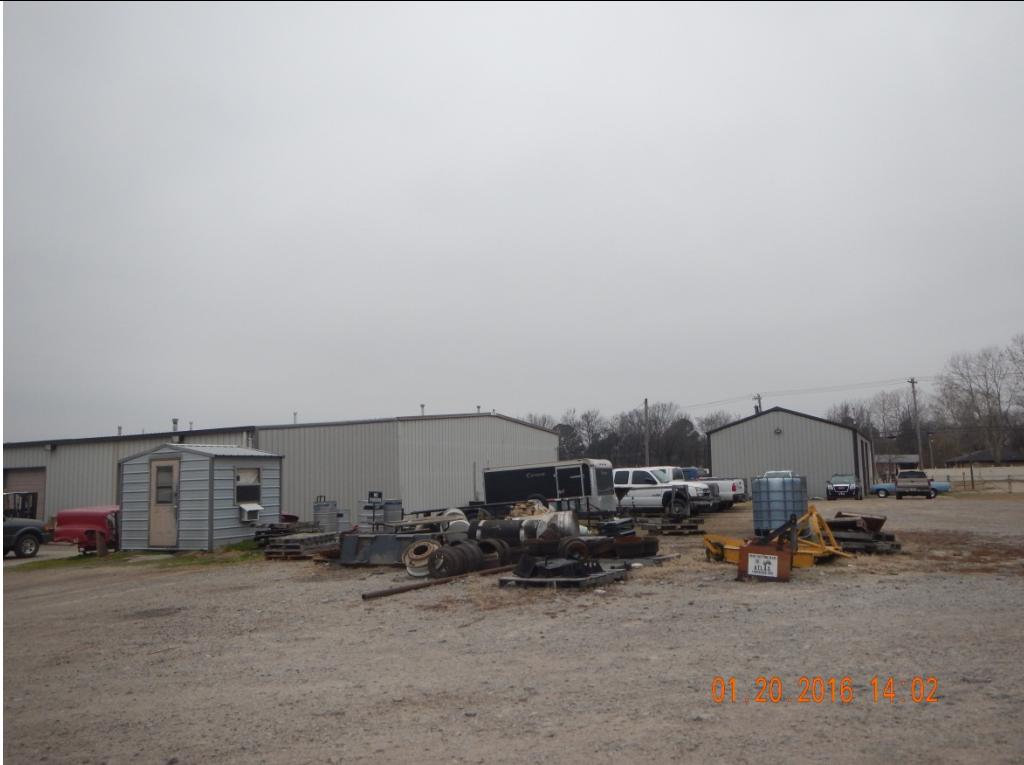
On the northwest-side of the building is a holding area for old vehicle parts, empty tanks, and used oil. These materials are all exposed to stormwater. The used oil container was not labeled. Mr. Carman had an employee label it while I was onsite.

Comments: Old vehicle parts waiting recycling.

Comments: Used metal parts and empty propane tanks in parking lot.

Location:	Carman, Inc.		
Photographer:	Alana Sullivan	Date:	1/20/2016
Witness:	Greg Carman	Time:	14:02
Description:	Old vehicle parts, metal, empty tanks, and used oil.

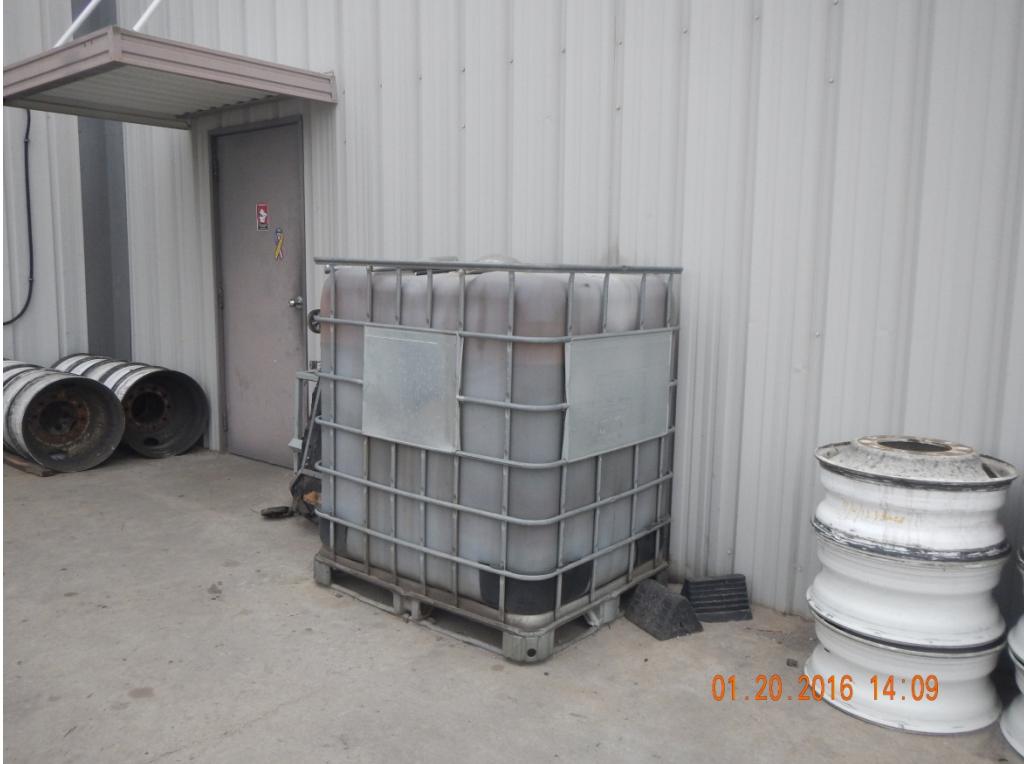
A used antifreeze container was noted on the south-side of the building and exposed to stormwater. It was also not labeled. An open dumpster was also located on this side. Mr. Carman was encouraged to keep the lid closed on the dumpster.

Comments: Used oil and antifreeze containers are uncovered and exposed to stormwater.

Photographer:	Alana Sullivan	Date:	1/20/2016	Time:	14:09
Witness:	Greg Carman			Photo #:	6
Description:	Used antifreeze; not labeled.

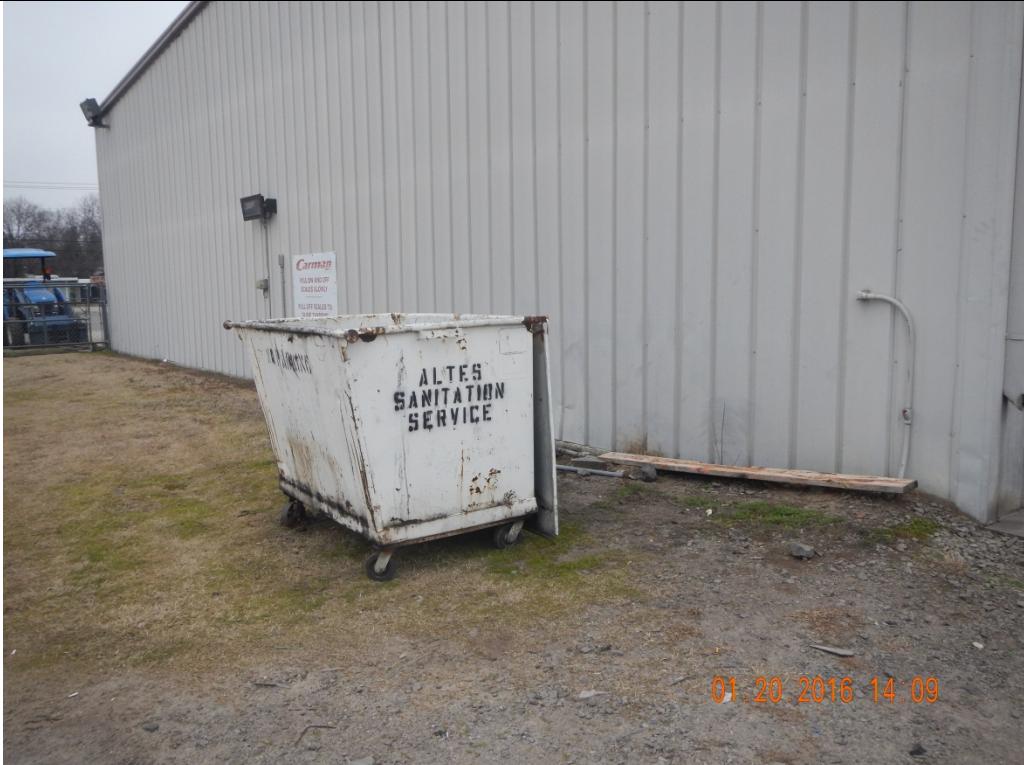
Location:	Carman, Inc.			
Photographer:	Alana Sullivan	Date:	1/20/2016	Time: 14:09
Witness:	Greg Carman			Photo #: 7
Description:	Open dumpster.

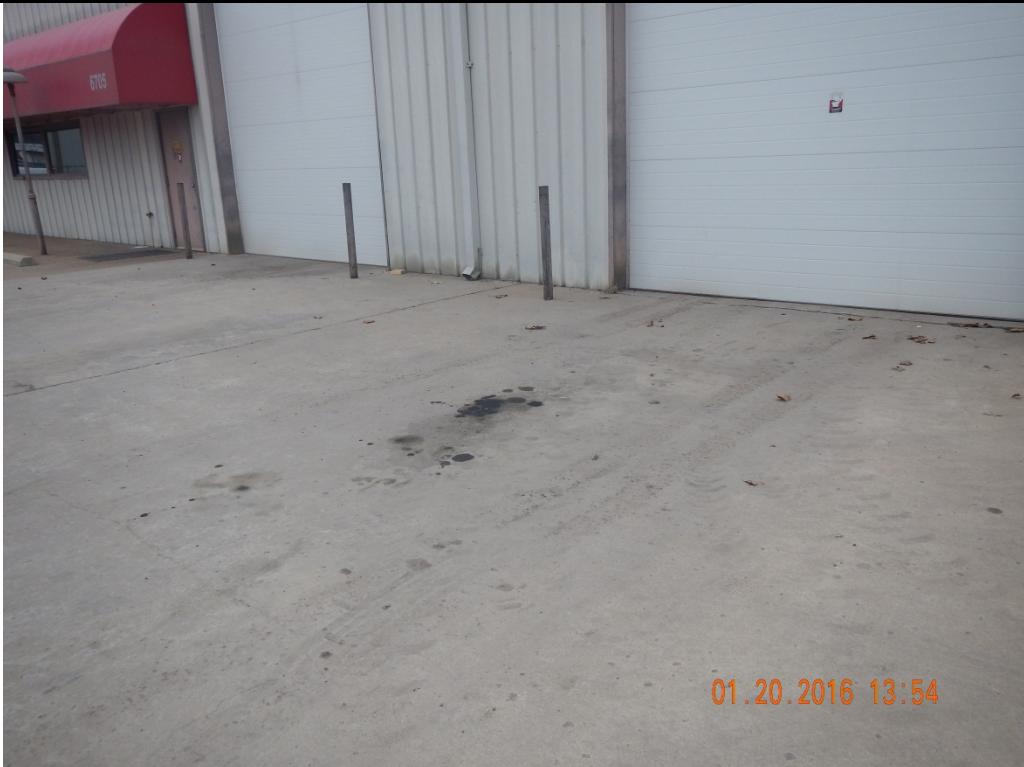
Location:	Carman, Inc.			
Photographer:	Alana Sullivan	Date:	1/20/2016	Time: 13:54
Witness:	Greg Carman			Photo #: 1
Description:	Residual from spill/leak.

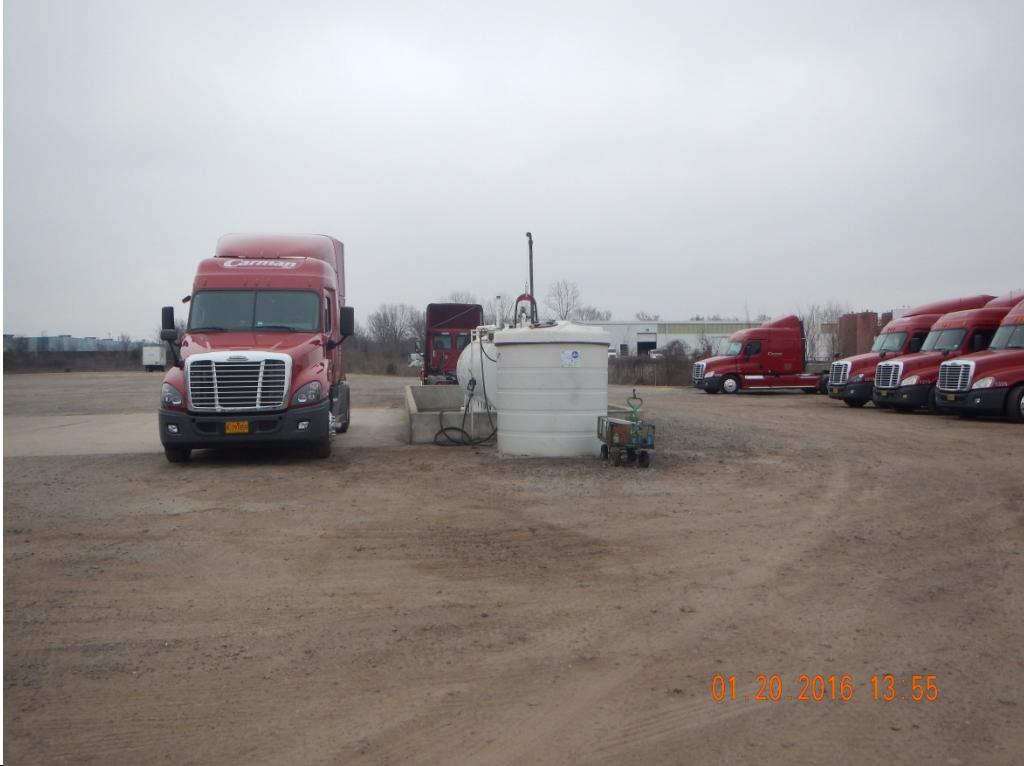
Photographer:	Alana Sullivan	Date:	1/20/2016	Time: 13:55
Witness:	Greg Carman			Photo #: 2
Description:	DEF tank; fuel tank with berm behind it.

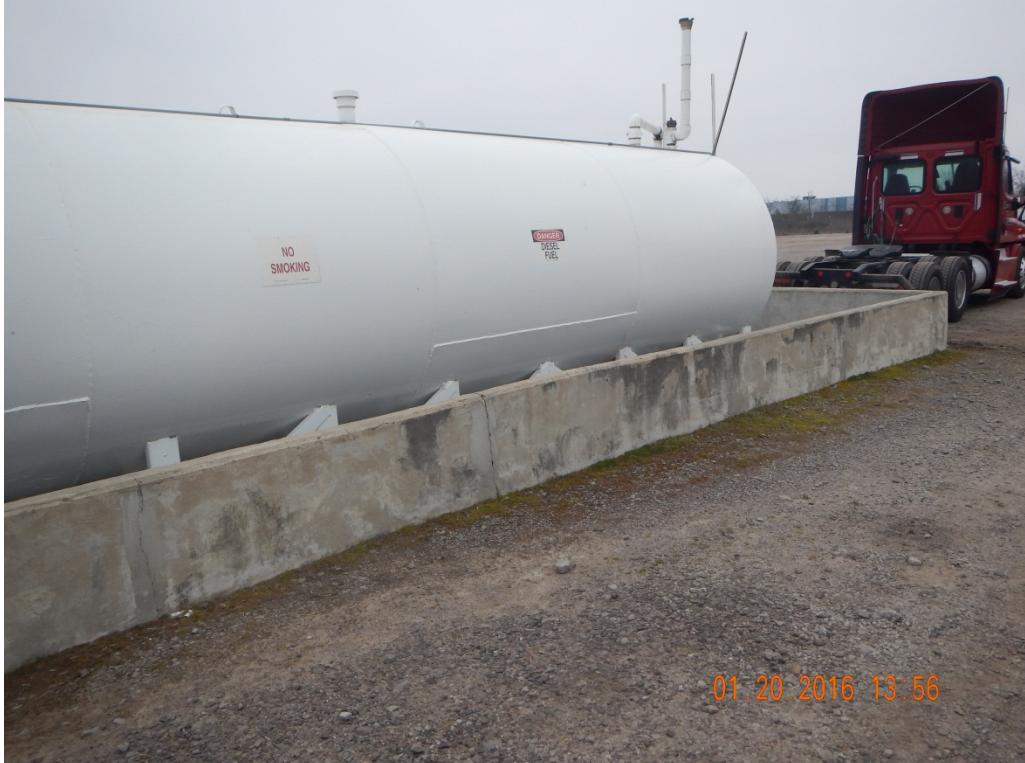
Water Division Photographic Evidence SheetLocation: **Carman, Inc.**Photographer: **Alana Sullivan**Date: **1/20/2016**Time: **13:56**Witness: **Greg Carman**Photo #: **3**Description: **Fuel tank with berm.**

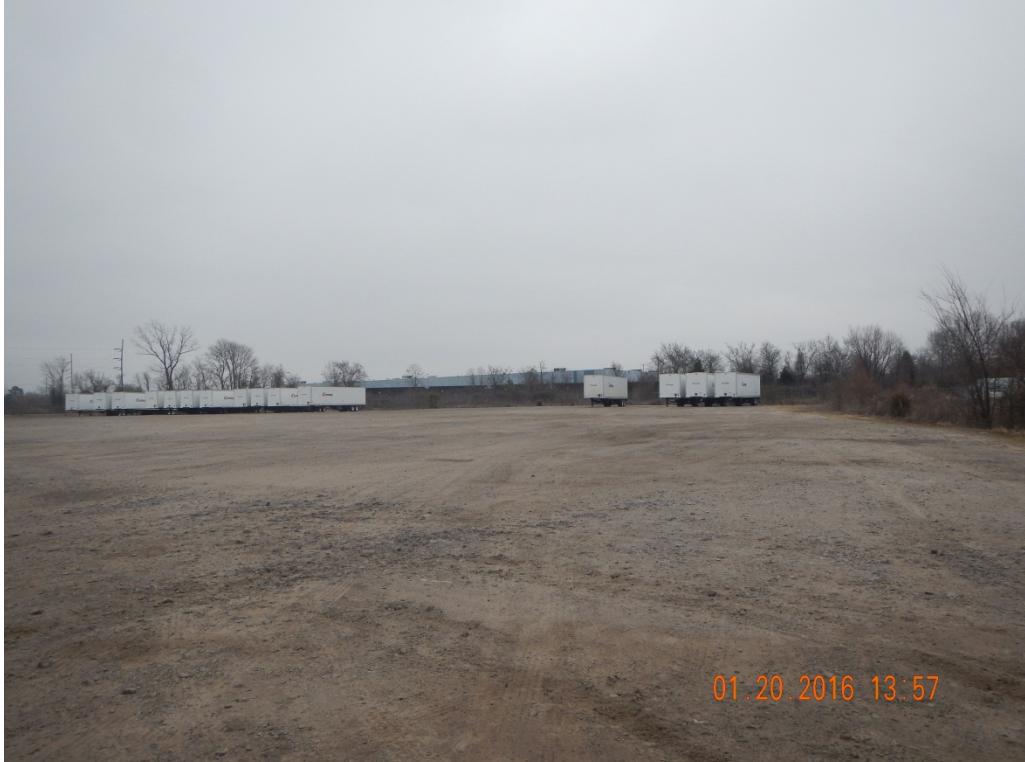
Photographer: **Alana Sullivan**Date: **1/20/2016**Time: **13:57**Witness: **Greg Carman**Photo #: **4**Description: **Empty trailers being stored onsite.**

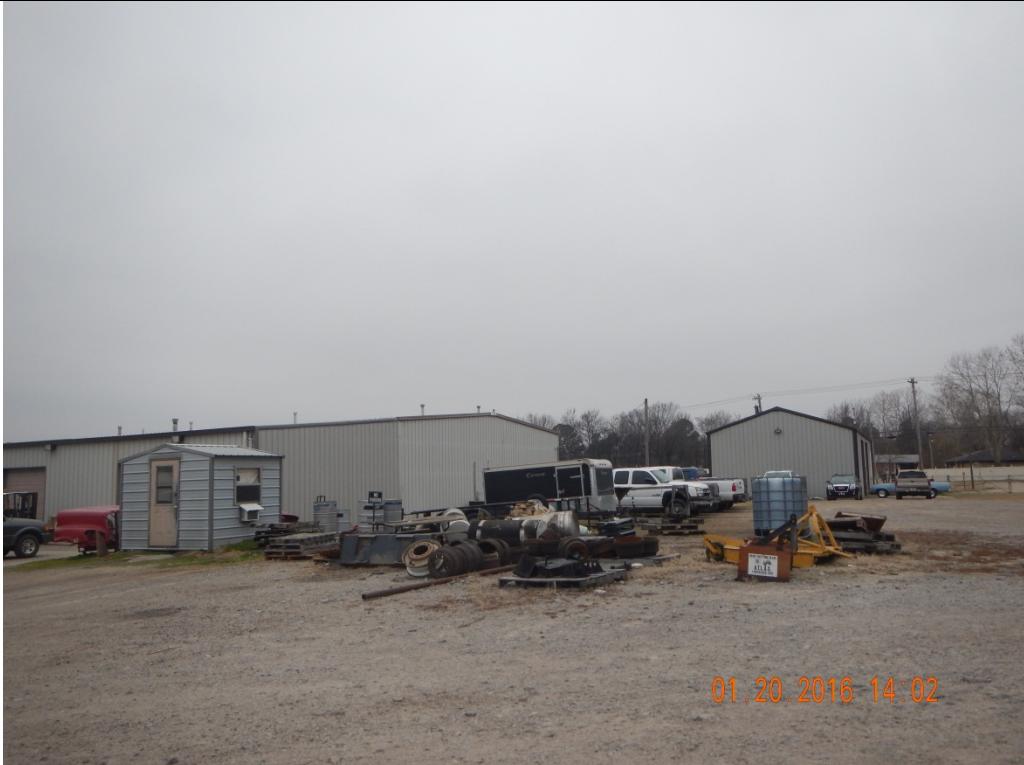
Location:	Carman, Inc.		
Photographer:	Alana Sullivan	Date:	1/20/2016
Witness:	Greg Carman	Time:	14:02
Description:	Old vehicle parts, metal, empty tanks, and used oil.

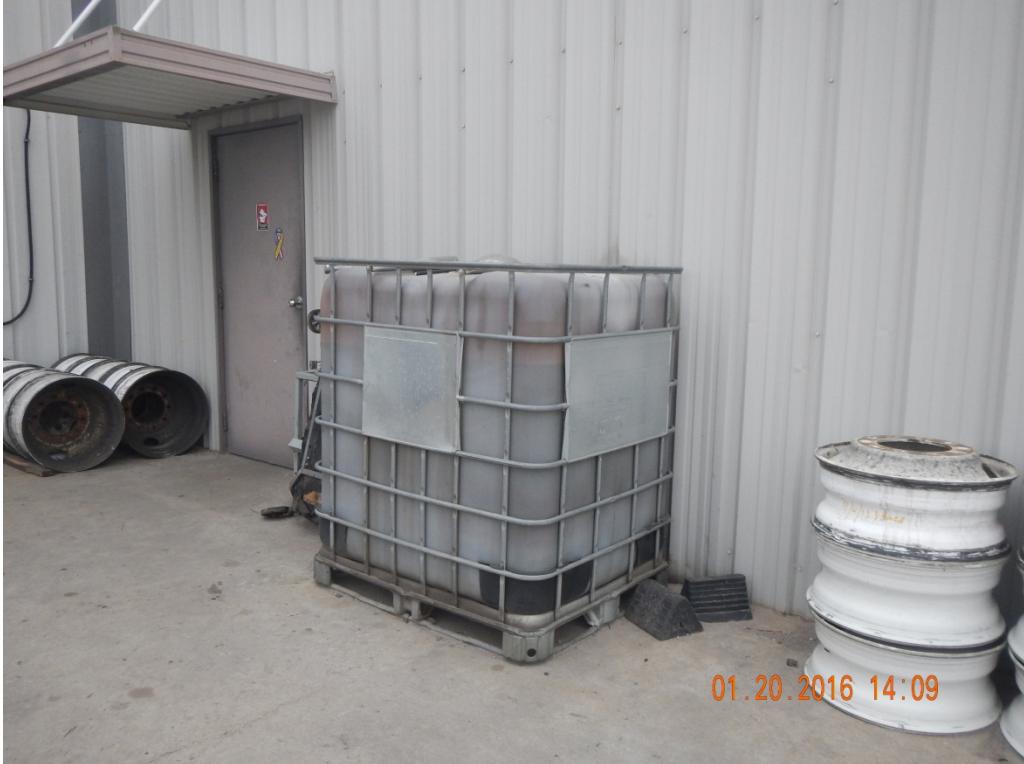
Photographer:	Alana Sullivan	Date:	1/20/2016	Time:	14:09
Witness:	Greg Carman				
Description:	Used antifreeze; not labeled.

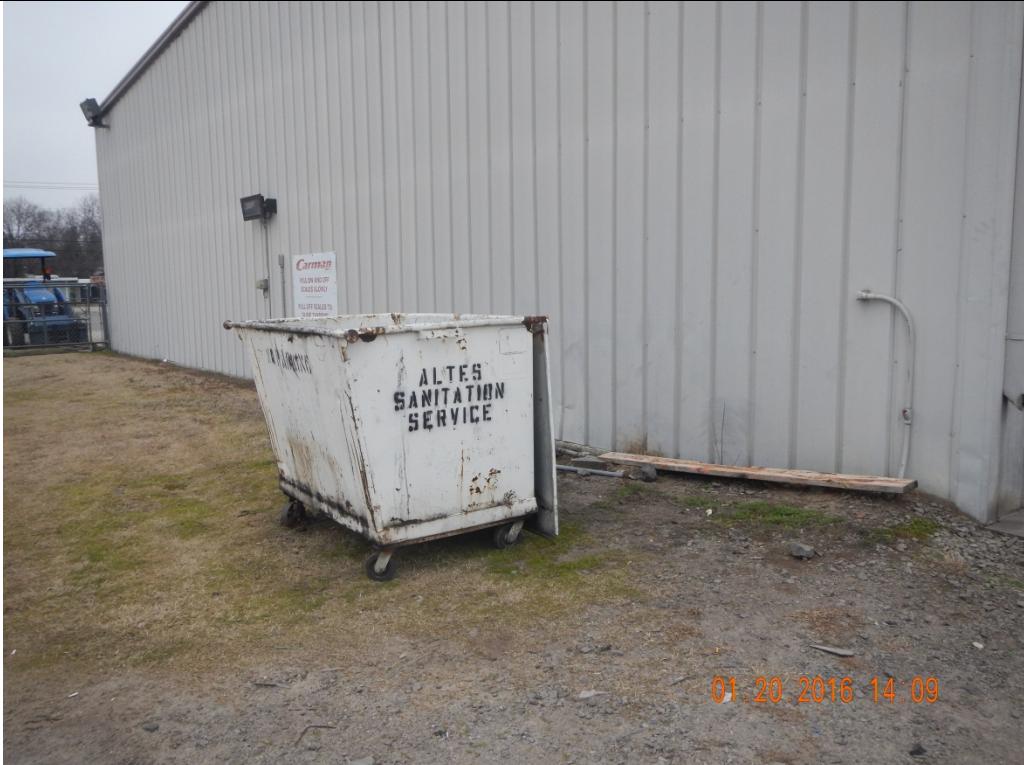
Location:	Carman, Inc.			
Photographer:	Alana Sullivan	Date:	1/20/2016	Time: 14:09
Witness:	Greg Carman			Photo #: 7
Description:	Open dumpster.

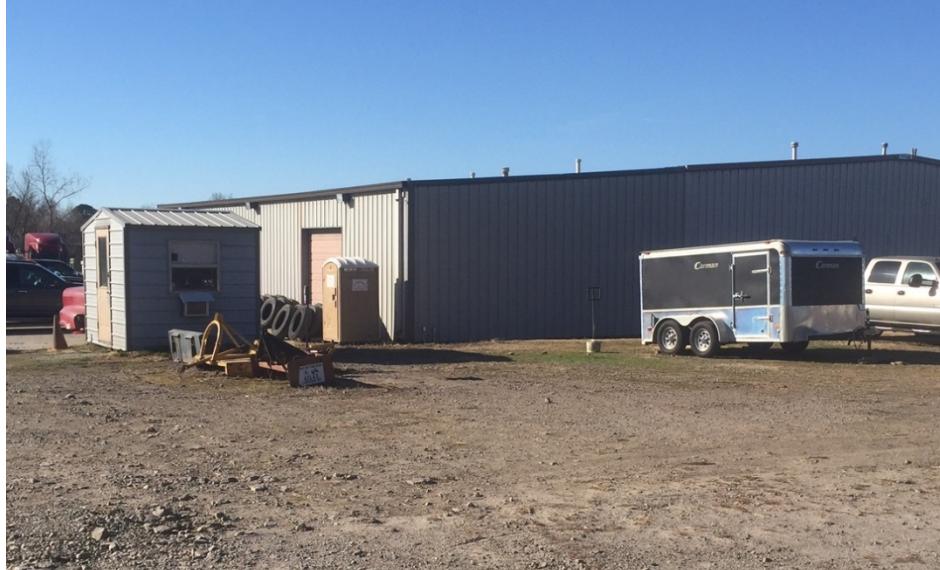
Comments: **Old vehicle parts waiting recycling.**

Corrective Action: **Salvage parts were gathered and conveyed to recycling center. Going forward, any parts will be taken to recycling often and strictly kept covered until that time. This procedure communicated to all personnel and management will insure future compliance. Image of area after correction:**

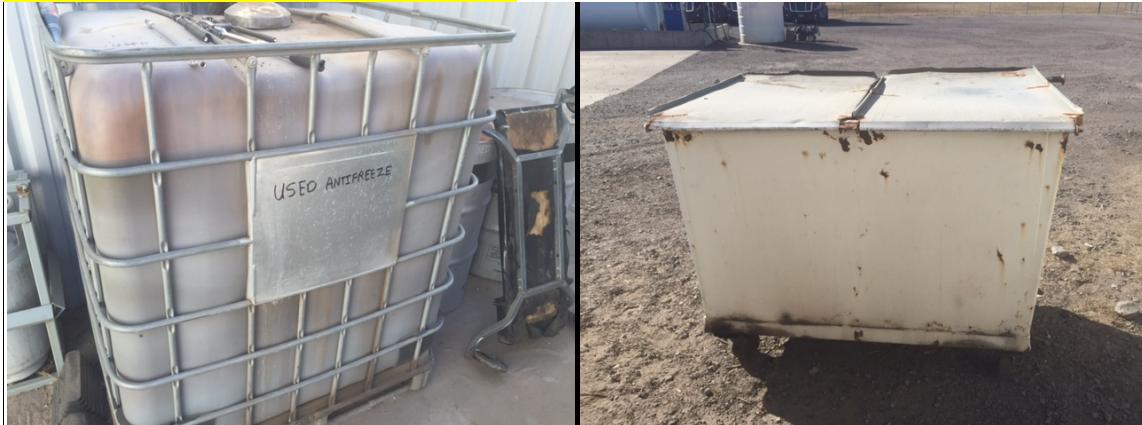
Comments: **Used oil and antifreeze containers are uncovered and exposed to stormwater.**

Corrective Action: **Used antifreeze tote was unlabeled by back door outside. The tote was labeled and moved inside away from potential exposure where it will remain. Dumpster covers will be closed at all times when not actively being used. Images during correction:**
