<u>VDEO</u>	AFIN: 33-000 COUNTY: 33 GPS LAT: FACILITY INFORMATION Melbourne Spur Irne, AR RESPONSIBLE OFFICIAL AHalbrook / Mayor Melbourne RESS: AVERAGE AND	WATER I	DIVISION INSPECTION REPORT				
	ADLQ	AF	IN: 33-00026 PE	ERMIT #: AR002 0	0036		DATE: 1	1/26/2016
Δ	RKANSAS	CC	UNTY: 33 Izard		PDS #	#: 089189		MEDIA: WN
Dep	partment of Environmental Quality	GP	S LAT: LO	ONG: LOC	ATION	l: ******		
	FACILITY INFORMAT	ION		IN	SPECT	TION INFO	RMATIO	N
Cit	y of Melbourne			FACILITY TYPE: 1 - Municipal		or id#: 162 S - Stat	е	
	y 9 Spur			FACILITY EVALUATION RATING 2 - Marginal	2 - Marginal SSO/Collection Sy		ion System	
Ме	lbourne, AR			(-)	1:32	EXIT TIME: 12:45		FECTIVE DATE:
	AME: / TITLE			172072010	1.02	12.40	11/1/2 PERMIT EX	(U15 (PIRATION DATE:
	IAME: / TITLE					10/31	/2020	
COM				FAYETTEVILLE SHALE RELATED: N				
Cit	y of Melbourne			FAYETTEVILLE SHALE VIOLATIONS: N				
MAILING ADDRESS:		INSPECTION PARTICIPANTS

SUMMARY OF FINDINGS

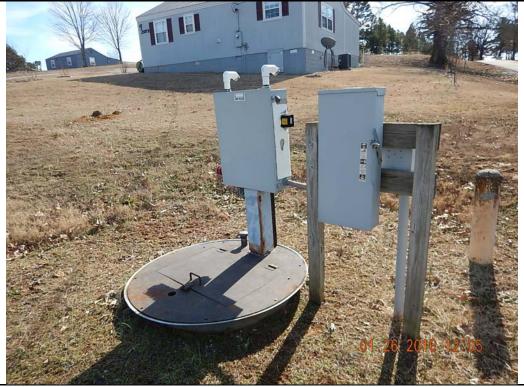
Water Division Photographic Evidence Sheet						
Location: City of Melbourne						
Photographer:	Cody Wallace	Date:	January 26, 2016	Time:	1205	
Witness: Dustin Payne, Kerri McCabe Photo #:				3

Description: Knob Creek Rd. Lift Station

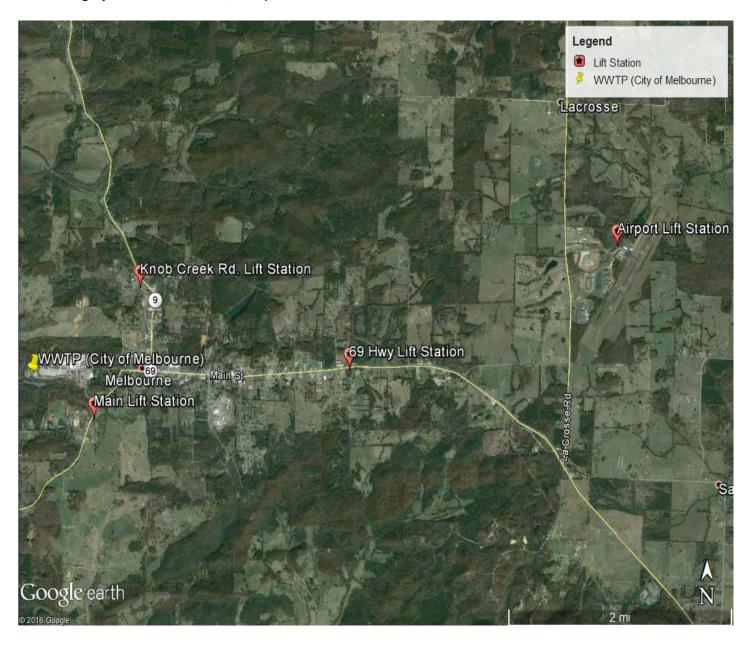
Figure 1. Aerial view of WWTP location and the four (4) lift stations associated with the collection system (Google Earth: imagery date November 16, 2012).
