WATER DIVISION INSPECTION REPORT

AFIN: **63-00820** | PERMIT #: **ARR151435** | DATE: **4/6/2016**

SUMMARY OF FINDINGS

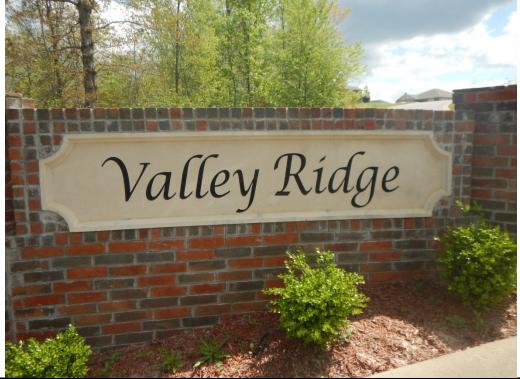
Water Division Photographic Evidence Sheet								
Location: Carrington Place/Emerald Mountain								
Photographer: Erica McAdoo, ADEQ Inspector Date: 4/6/2016 Time:				13:50				
Witness:				Photo #	: 1			
	Entrance to this Phase is confusing. Entrance signage indicates this is Valley

Ridge Subdivision, however the permit is for Carrington Place/Emerald Mountain

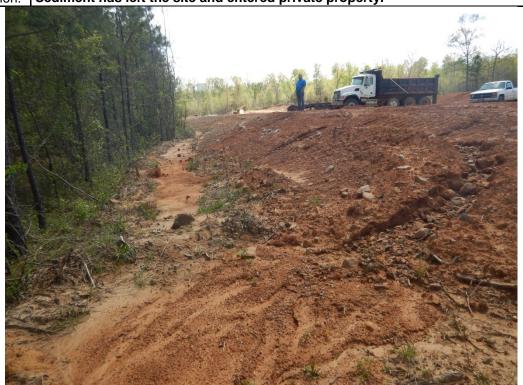
Photographer: Erica McAdoo, ADEQ Inspector Date: 4/6/2016 Time: 13:50 Witness: Photo #:

Silt/sediment was observed in unnamed tributaries to Otter Creek in the Carrington Place/Emerald Mountain, however it is indicated by signage as the Valley Ridge Subdivision (Photo 1). This is in violation of the Arkansas Water and Air Pollution Control Act [A.C.A. § 8-4-217(a)(2)] which states "It shall be unlawful for any person to place or cause to be placed any sewage, industrial waste, or other wastes in a location where it is likely to cause pollution of any waters of the state." (see photos 2-9). This is a repeat violation.

The operator is ultimately responsible for the runoff from the perimeter of the entire development. Regardless for the reason of the runoff, the operator is responsible for ensuring sufficient sediment controls of the development. At the time of inspection, there was evidence that sediment had left lots and entered "Waters of the State" either directly or via storm drains. This is a violation of Part I, Section B.12.E; Part I, Section B.16.A (see photos 2-9). This is a repeat violation.

The sediment that has gotten off-site has not been sufficiently removed as required by Part II, Section A.4.G.1.d of the permit (see photos 2-9). This is a Repeat Violation.

Sediment has left the site and entered private property. Description:

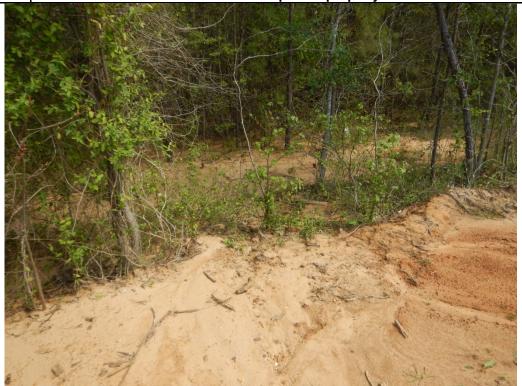
Water Division Photographic Evidence Sheet								
Location: C	Location: Carrington Place/Emerald Mountain							
Photographer: Erica McAdoo, ADEQ Inspector Date: 4/6/2016 Time: 13:50								
Witness:	Witness: Photo #: 3							
Description:	Description: Sediment has left the site and entered private property.

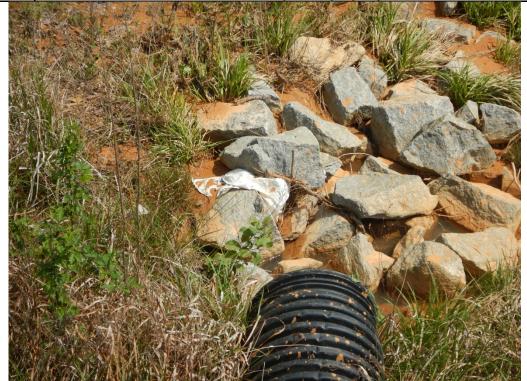
Water Division Photographic Evidence Sheet									
Location:	Location: Carrington Place/Emerald Mountain								
Photograph	ner:	Erica McAdoo, ADEQ Inspector	Date:	4/6/2016	Time:	13:50			
Witness:	•				Photo #:	5

Description: Sediment has left the site and entered private property.

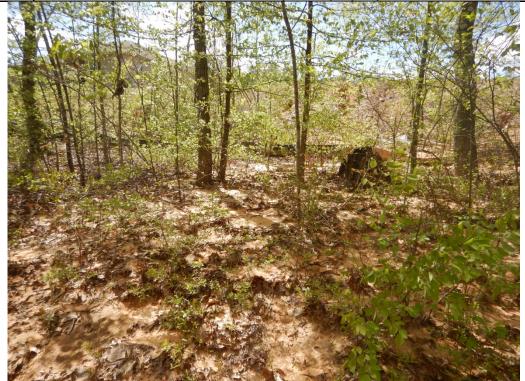
Water Division Photographic Evidence Sheet									
Location:	Location: Carrington Place/Emerald Mountain								
Photograph	ner:	Erica McAdoo, ADEQ Inspector	Date:	4/6/2016	Time:	13:50			
Witness:	•				Photo #:	7

Description: Sediment has left the site and entered private property.

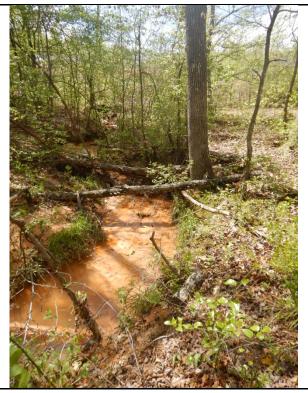
Photographer: Erica McAdoo, ADEQ Inspector Date: 4/6/2016 Time: 13:50
Witness: Photo #: 8

Description: Sediment has left the site and entered private property and into "waters of the state"

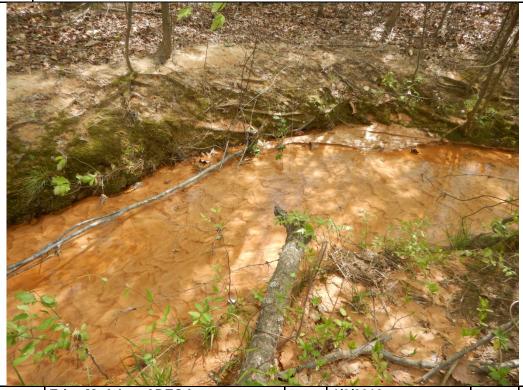
Water Division Photographic Evidence Sheet								
Location:	Car	rington Place/Emerald Mountain						
Photographer: Erica McAdoo, ADEQ Inspector Date: 4/6/2016 Time: 13					13:50			
Witness:					Photo #:	9		
Description	Description: Sediment has left the site and entered private property and into "waters of the state"

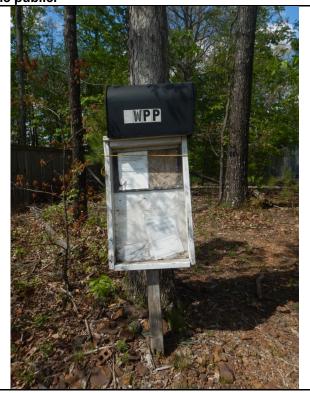
Photographer: Erica McAdoo, ADEQ Inspector Date: 4/6/2016 Time: 13:50
Witness: Photo #: 10

The stormwater pollution prevention plan (SWPPP) is not being maintained onsite from 8:00 am to 5:00 pm. The SWPPP was located within Phase 1 of the project and was not updated to include information pertaining to Phase 2. The SWPPP and inspection reports shall be signed by the operator in accordance with Part II, Section B.9 and be retained at the construction site during normal business hours. This is a violation of Part II, Section A.2.A (see photo 10). This is a Repeat Violation.

The site entrance was not posted with a visible Notice of Coverage (NOC). The NOC was located outside of the current project and in an obscured area. This is a violation of Part II, Section A.2.D of the permit (see photo 10).

Description: Empty SWPPP box in Phase 1, which was located in an obscured area and not visible to the public.

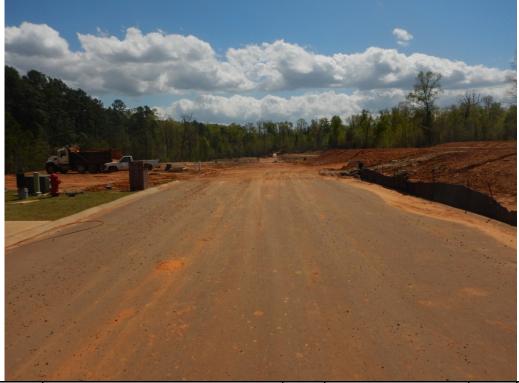
Water Division Photographic Evidence Sheet								
Location: Carrington Place/Emerald Mountain								
Photographer: Erica McAdoo, ADEQ Inspector	Date:	4/6/2016	Time:	13:50				
Witness:			Photo #:	11

The construction site entrance is not sufficiently stabilized to prevent offsite tracking. This is a violation of Part II, A.4.H.2 of the permit (see photos 11-12). This is a Repeat Violation.

Description: Construction site has not been stabilized to prevent off site tracking

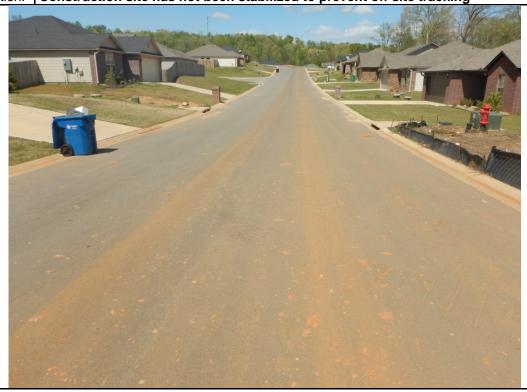
Photographer: Erica McAdoo, ADEQ Inspector Date: 4/6/2016 Time: 13:50
Witness: Photo #: 12

Description: Construction site has not been stabilized to prevent off site tracking

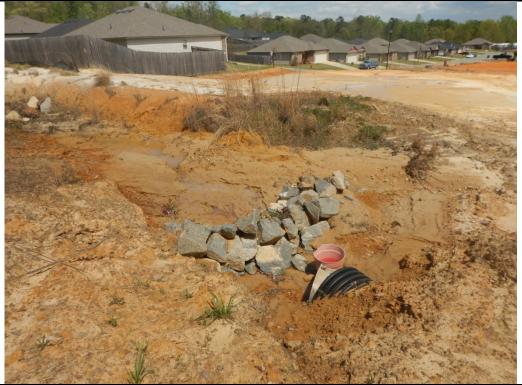
Water Division Photographic Evidence Sheet								
Location: Carrington Place/Emerald Mountain								
Photographer: Erica McAdoo, ADEQ Inspector	Date:	4/6/2016	Time:	13:50				
Witness:			Photo #:	13

Erosion control measures are not being properly installed, operated and/or maintained as required by Part II, Section B.17.A of the permit. Specifically, evidence of failure to control erosion on site, inappropriately installed or neglected erosion control structures, sediment traps passed capacity, failure to remove sediment that has left the site (see photos 13-19). This is a Repeat Violation.

Description: Check dam requires maintenance; allowing sediment to enter storm drain

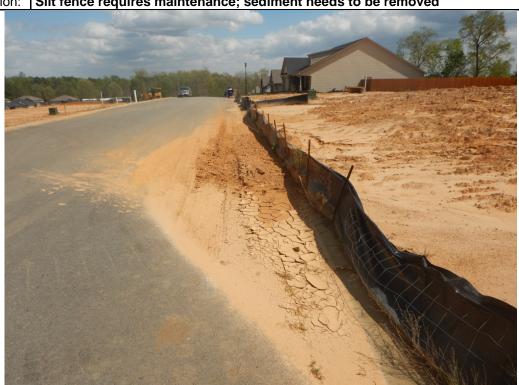
Photographer: Erica McAdoo, ADEQ Inspector Date: 4/6/2016 Time: 13:50
Witness: Photo #: 14

Description: Silt fence requires maintenance; sediment needs to be removed

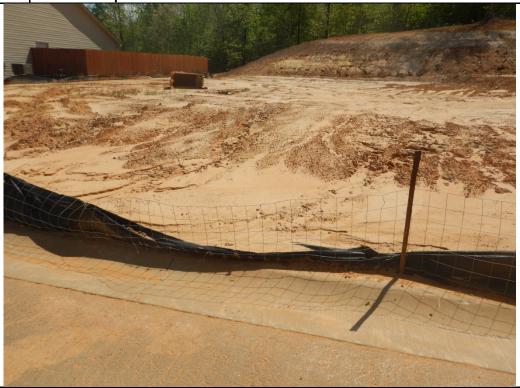
Water Division Photographic Evidence Sheet								
Location: Ca	rington Place/Emerald Mountain							
Photographer:	Erica McAdoo, ADEQ Inspector	Date:	4/6/2016	Time:	13:50			
Witness:				Photo #:	15

Description: Silt fence requires maintenance

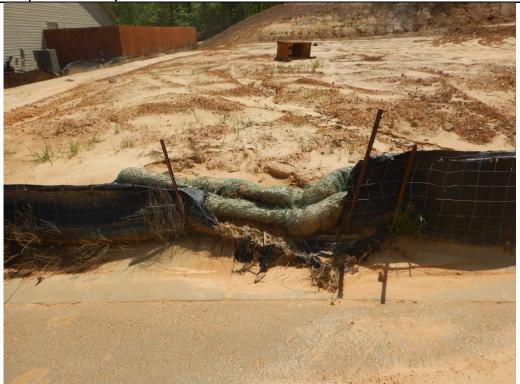
Photographer:Erica McAdoo, ADEQ InspectorDate:4/6/2016Time:13:50Witness:Photo #:16

Description: Silt fence requires maintenance

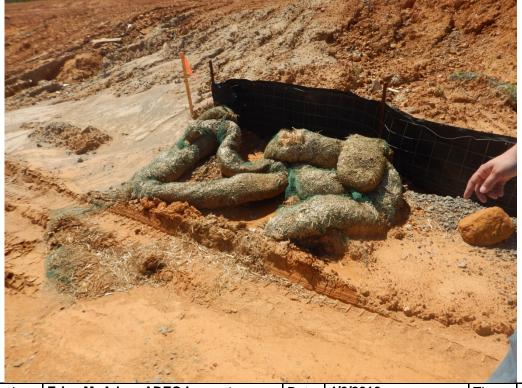
Water Division Photographic Evidence Sheet											
Location: Carrington Place/Emerald Mountain											
Photographer:		Erica McAdoo, ADEQ Inspector	Date:	4/6/2016	Time:	13:50					
Witness:					Photo #	: 17					
D. T. C.

Description: Silt fence requires maintenance

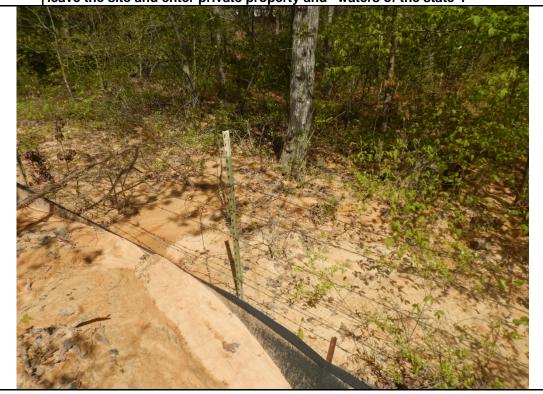
Photographer:Erica McAdoo, ADEQ InspectorDate:4/6/2016Time:13:50Witness:Photo #:18

Description: Silt fence requires maintenance. Lack of maintenance has allowed sediment to leave the site and enter private property and "waters of the state".
