# WATER DIVISION INSPECTION REPORT

AFIN: 63-00820	PERMIT #: ARR151435	DATE: 8/15/2016
COUNTY: 63 Saline	PDS #: 092486	MEDIA: WN
GPS LAT: 34.611232 LONG: -92.436733 LOCATION: General Area

NAME:  
**Emerald Mountain**

LOCATION:  
**Valley Ridge Drive**

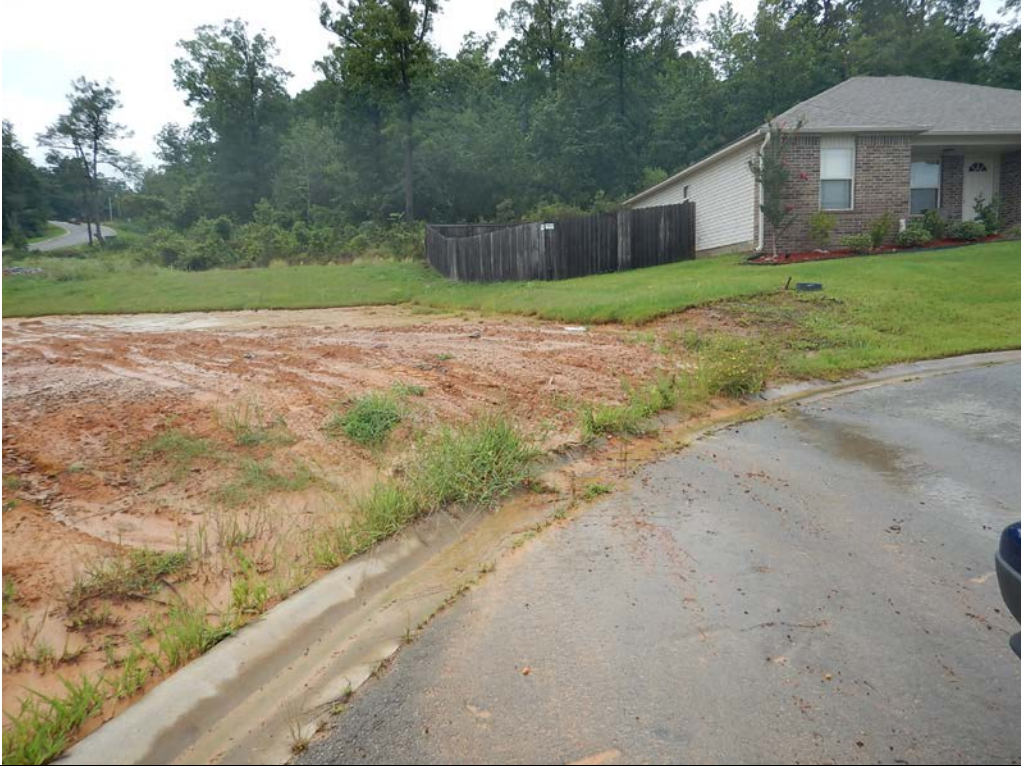
3. Silt fences, Check dams, and velocity dissipation devices are not properly installed or maintained as required by Part I, Section B.12.A and Part II, Section B.17.A of your permit (see photos 1-2, 7-8, 12-26, 27-30). **This is a repeat violation** noted in previous inspections on 9 July 2015 and 5 May 2016.

Location:	<b>Emerald Mountain</b>				
Photographer:	<b>Keith Waters</b>	Date:	<b>8/15/2016</b>	Time:	<b>1435</b>
Witness:	<b>Chris Naus</b>	Photo #:	<b>1</b>		
Description:	<b>Lot 13 with erosion and sediment being deposited on street.</b>

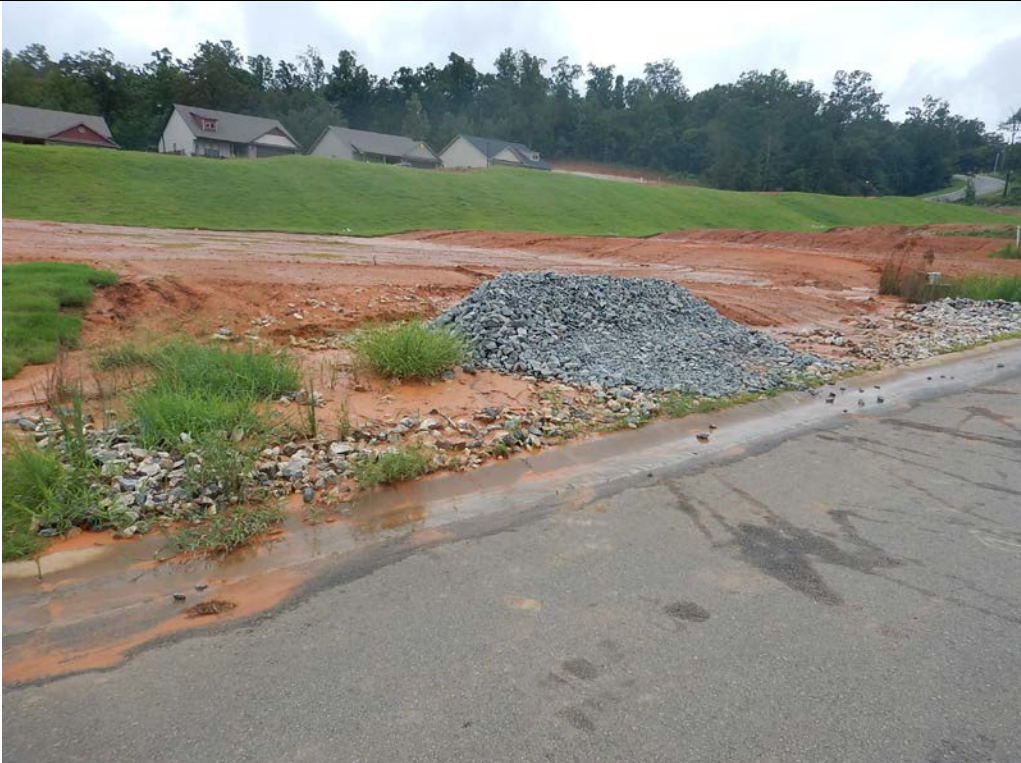
Photographer:	<b>Keith Waters</b>	Date:	<b>8/15/2016</b>	Time:	<b>1435</b>
Witness:	<b>Chris Naus</b>	Photo #:	<b>2</b>		
Description:	<b>Erosion on lots 9, 10, and 11 discharging into street at lot 9 and traveling to storm drain between lot 8 and 9.</b>

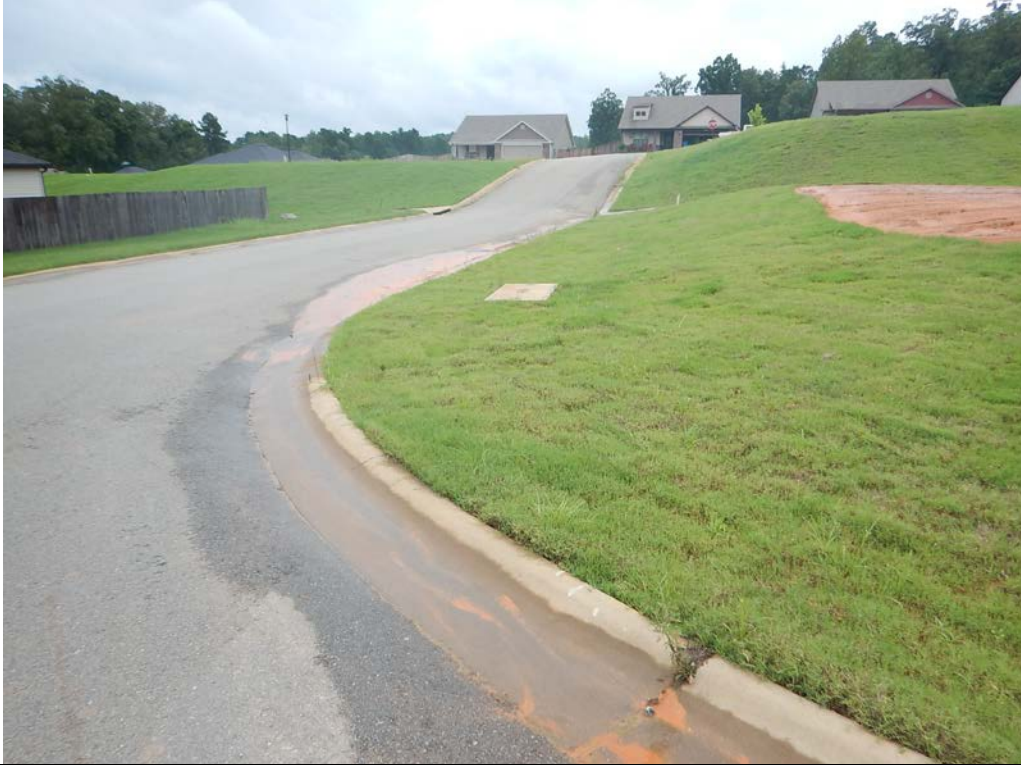
Location:	<b>Emerald Mountain</b>				
Photographer:	<b>Keith Waters</b>	Date:	<b>8/15/2016</b>	Time:	<b>1436</b>
Witness:	<b>Chris Naus</b>	Photo #:	<b>3</b>		
Description:	<b>Sediment leading to storm drain between lots 8 and 9.</b>

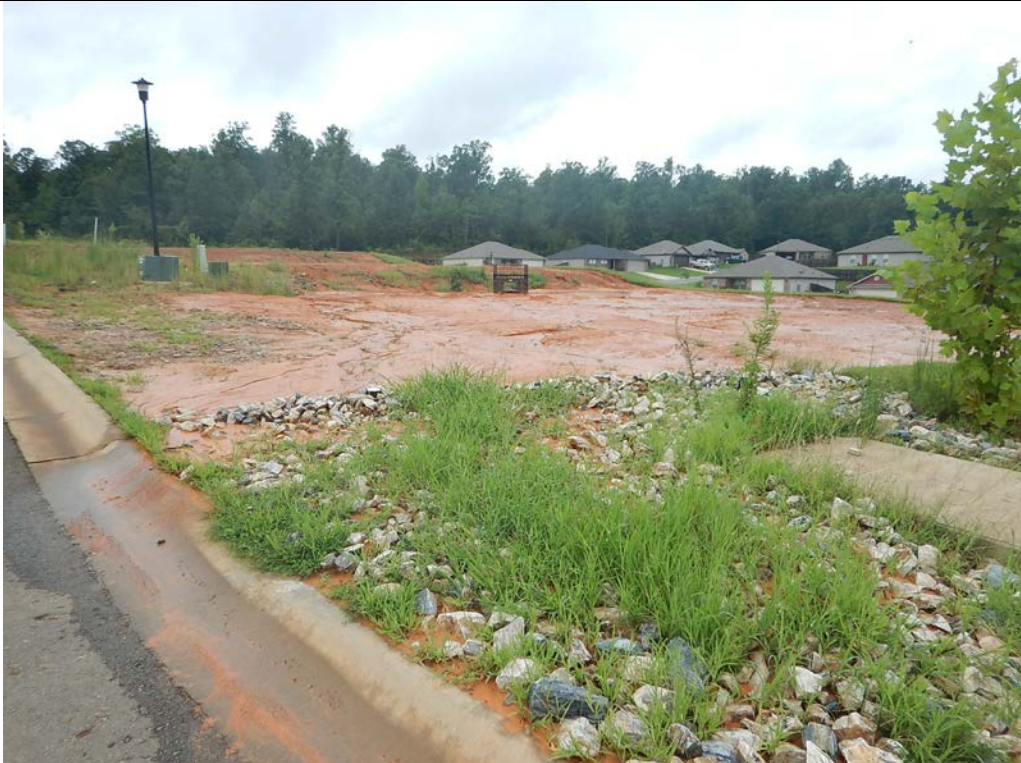
Photographer:	<b>Keith Waters</b>	Date:	<b>8/15/2016</b>	Time:	<b>1437</b>
Witness:	<b>Chris Naus</b>	Photo #:	<b>4</b>		
Description:	<b>Sediment from lots 4-8 discharging from lot 8 and leading into the storm drain and to lot 37.</b>

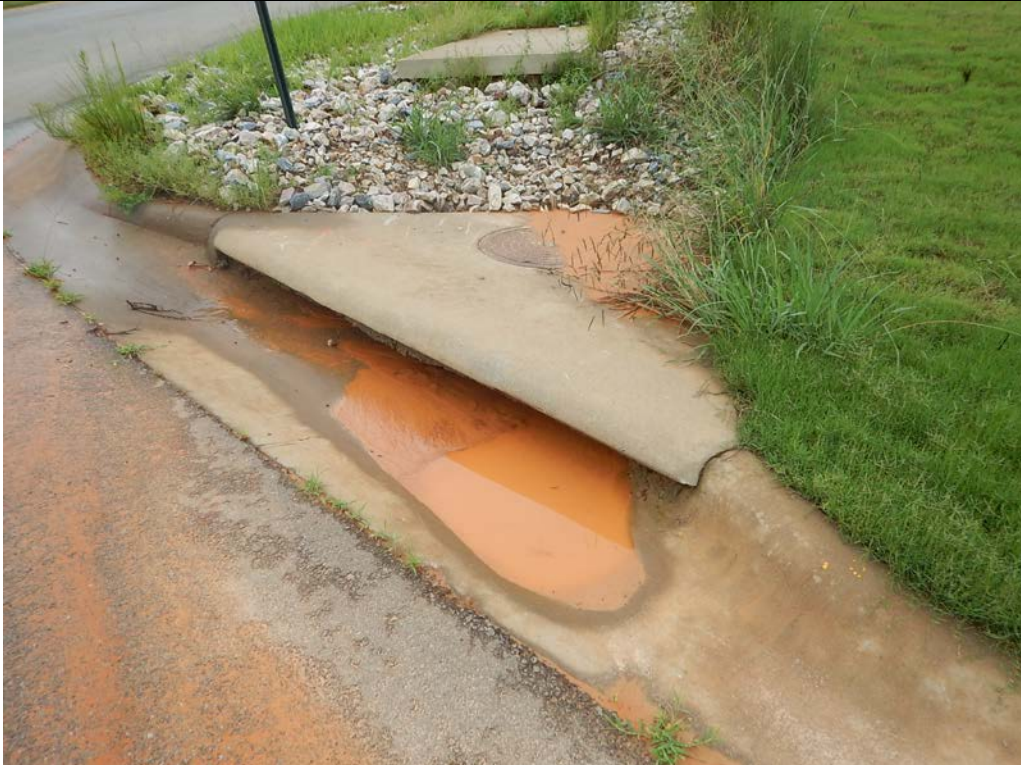
Location:	<b>Emerald Mountain</b>				
Photographer:	<b>Keith Waters</b>	Date:	<b>8/15/2016</b>	Time:	<b>1437</b>
Witness:	<b>Chris Naus</b>	Photo #:	<b>5</b>		
Description:	<b>Sediment from lots 4-8 leading in to storm drain.</b>

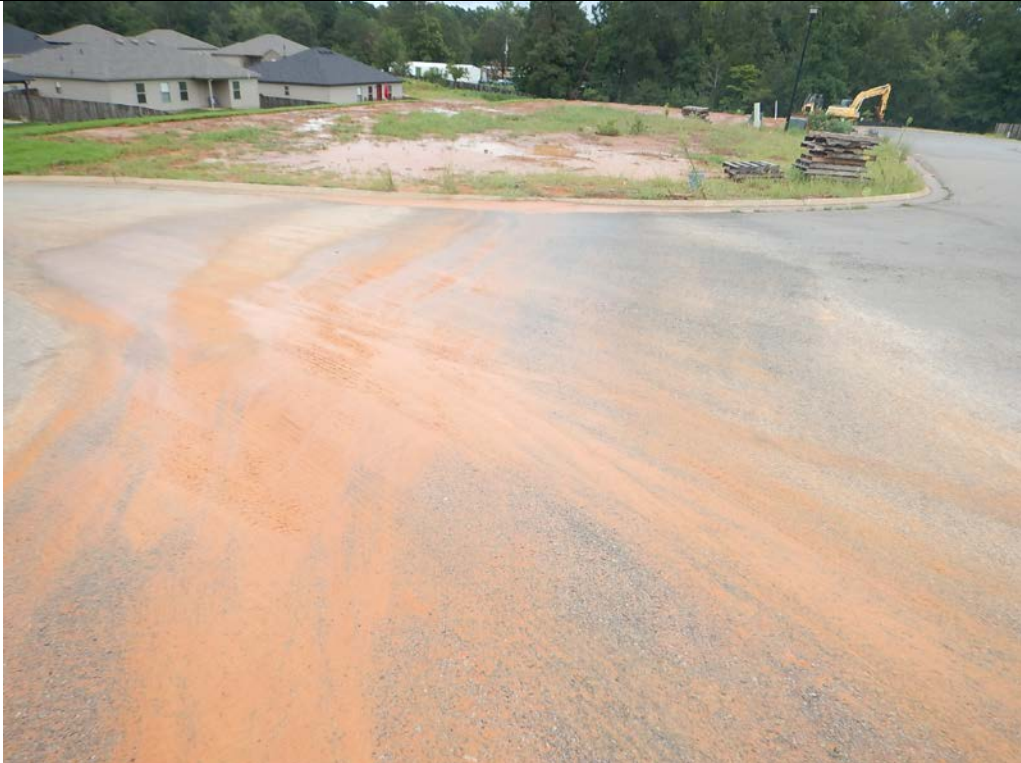
Photographer:	<b>Keith Waters</b>	Date:	<b>8/15/2016</b>	Time:	<b>1437</b>
Witness:	<b>Chris Naus</b>	Photo #:	<b>6</b>		
Description:	<b>Sediment from lots 4-8 leading to lot 37.</b>

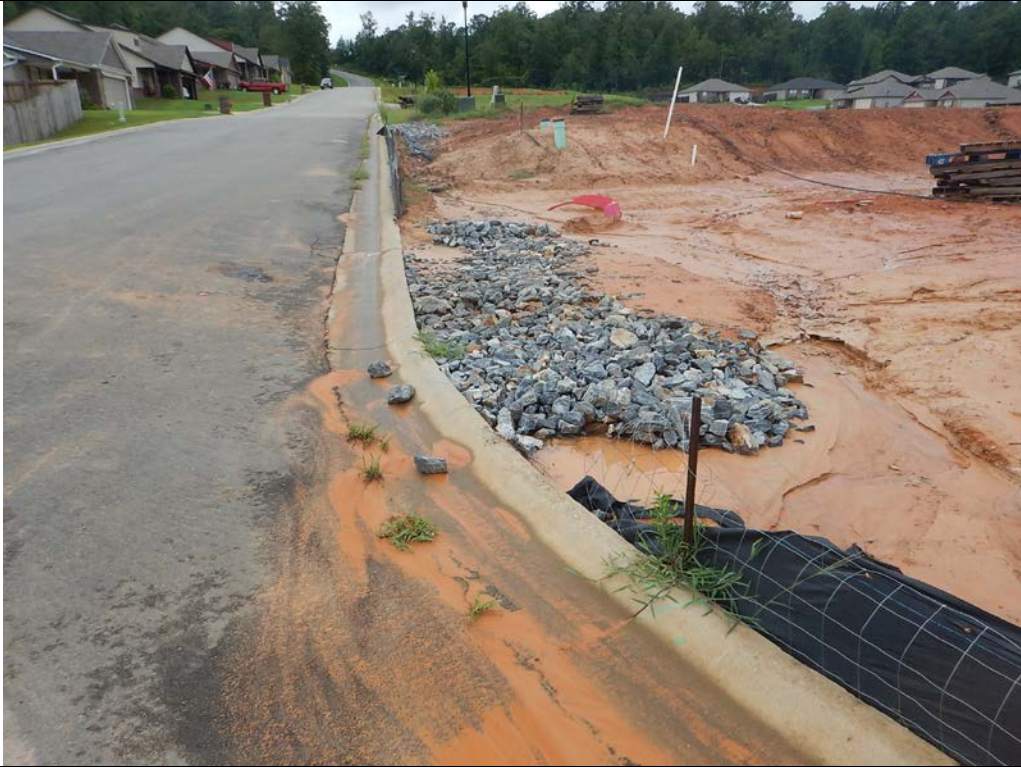
Location:	<b>Emerald Mountain</b>				
Photographer:	<b>Keith Waters</b>	Date:	<b>8/15/2016</b>	Time:	<b>1439</b>
Witness:	<b>Chris Naus</b>	Photo #:	<b>7</b>		
Description:	<b>Sediment from lots 37, 87, and 88 being tracked and discharging from lots into street.</b>

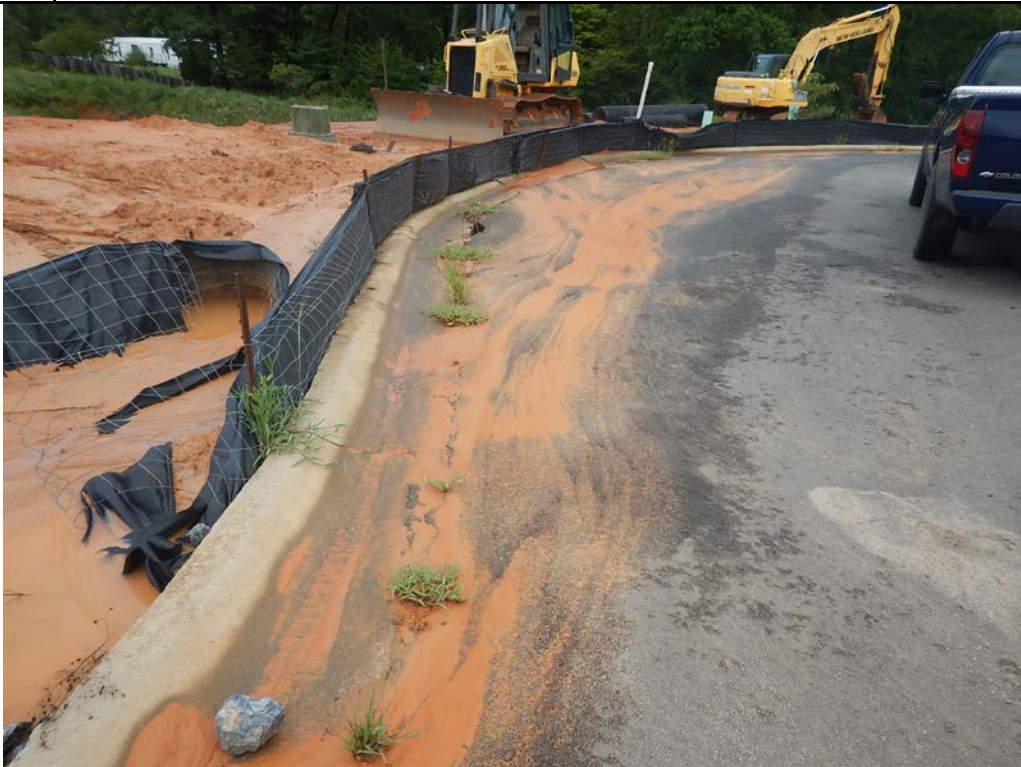
Photographer:	<b>Keith Waters</b>	Date:	<b>8/15/2016</b>	Time:	<b>1439</b>
Witness:	<b>Chris Naus</b>	Photo #:	<b>8</b>		
Description:	<b>Sediment from lots 37, 87, and 88 being tracked and discharging from lots into street.</b>

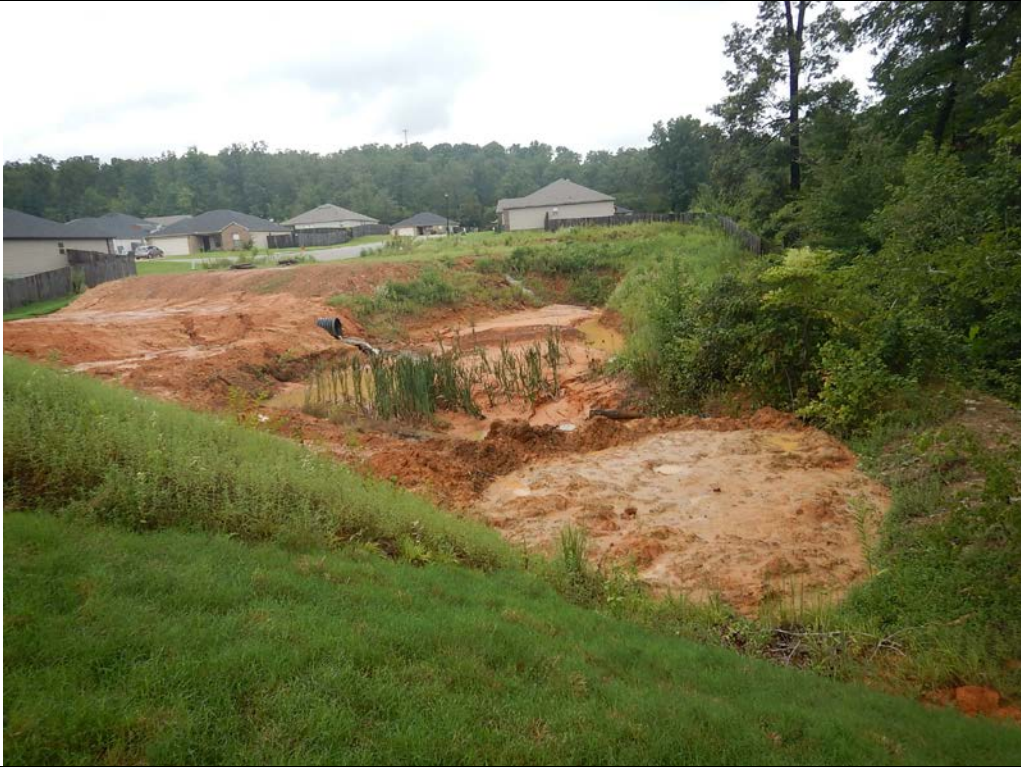
4. Sedimentation basins are not properly maintained as required by Part II, Section A.4.G.1.e and Part II, Section B.17.A of your permit (see photos 9, 13-14, 19-20). **This is a repeat violation** noted in previous inspections on 9 July 2015 and 5 May 2016.

Location:	<b>Emerald Mountain</b>				
Photographer:	<b>Keith Waters</b>	Date:	<b>8/15/2016</b>	Time:	<b>1440</b>
Witness:	<b>Chris Naus</b>	Photo #:	<b>9</b>		
Description:	<b>Sediment basin #1 between lots 33 and 89 still is full of sediment and needs maintenance.</b>

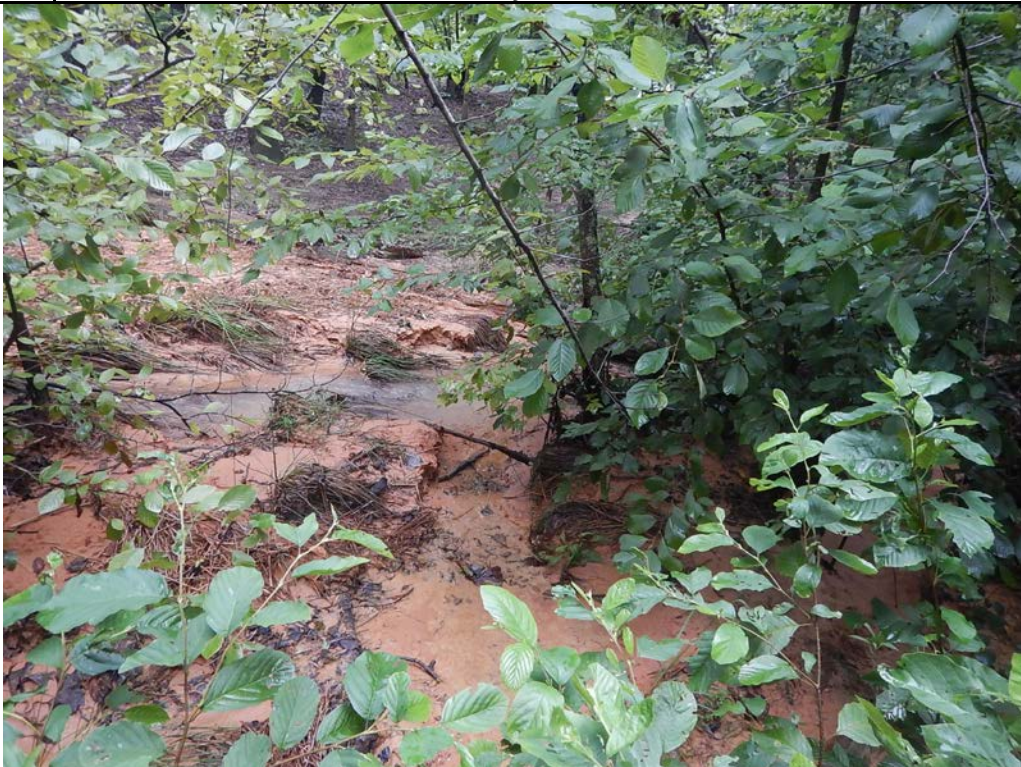
1. Sediment has gotten off site and discharged into waters of the State (see photos 10, 11, 12, 28, 29) in violation of Arkansas Water and Air Pollution Control Act § 8-4-217(a) (2) which states, "It shall be unlawful for any person to place or cause to be place any sewage, industrial waste, or other wastes in a location where it is likely to cause pollution of any waters of this state." **This is a repeat violation** noted in previous inspections on 9 July 2015 and 5 May 2016.

5. Sediment that has gotten off site and has not been removed as required by Part II, Section A.4.G.1.d of your permit (see photos 10, 11, 12, 28, 29). **This is a repeat violation** noted in previous inspections on 9 July 2015 and 5 May 2016.

Photographer:	<b>Keith Waters</b>	Date:	<b>8/15/2016</b>	Time:	<b>1442</b>
Witness:	<b>Chris Naus</b>	Photo #:	<b>10</b>		
Description:	<b>Sediment still downstream of sediment basin #1, no attempt to remove sediment from area or from unnamed tributary.</b>

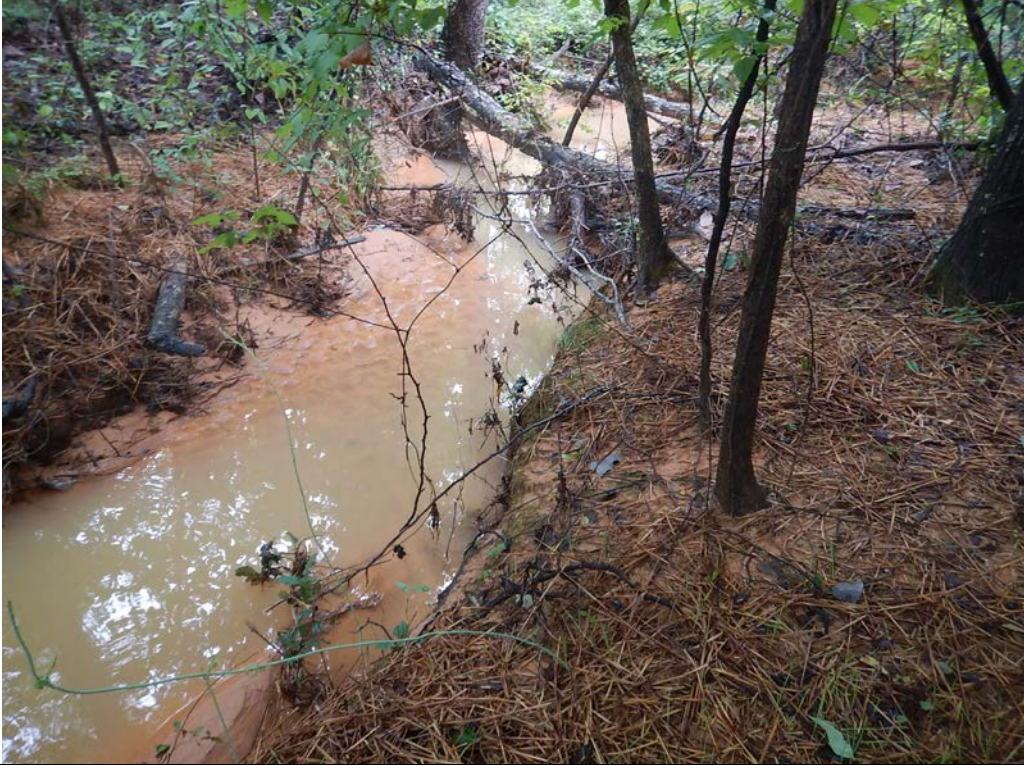
Location:	<b>Emerald Mountain</b>				
Photographer:	<b>Keith Waters</b>	Date:	<b>8/15/2016</b>	Time:	<b>1442</b>
Witness:	<b>Chris Naus</b>	Photo #:	<b>11</b>		
Description:	<b>Sediment in unnamed tributary down stream of sediment basin #1.</b>

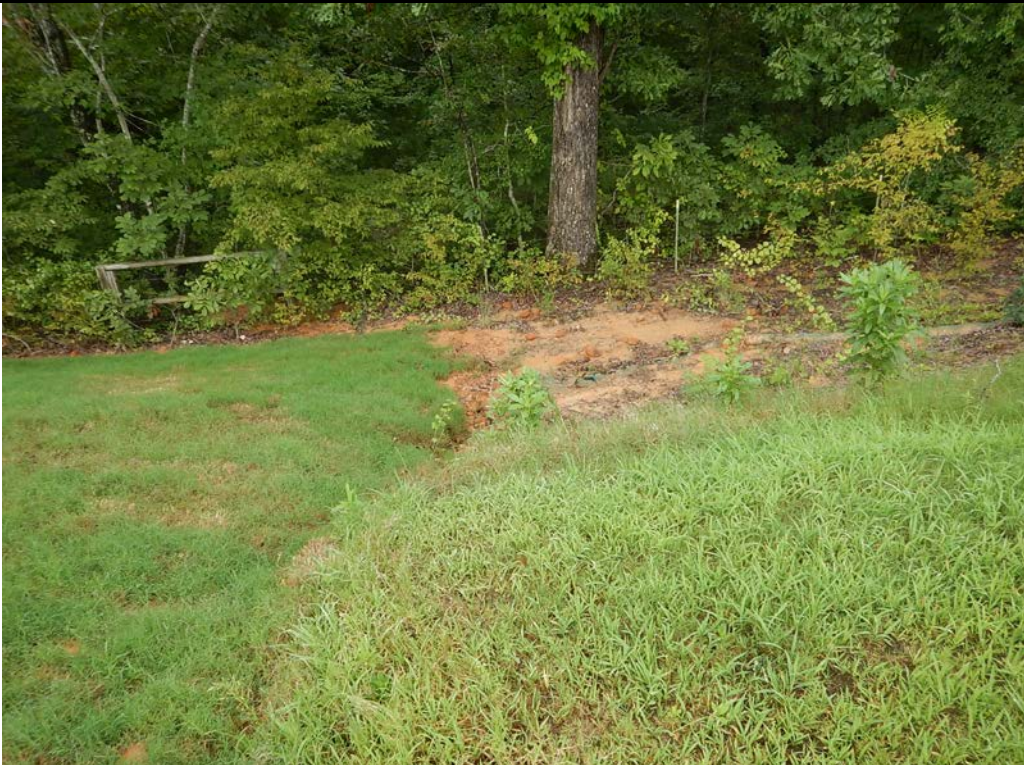
Photographer:	<b>Keith Waters</b>	Date:	<b>8/15/2016</b>	Time:	<b>1444</b>
Witness:	<b>Chris Naus</b>	Photo #:	<b>12</b>		
Description:	<b>Erosion gully forming between lots 90 and 91 causing sediment to be deposited off site.</b>

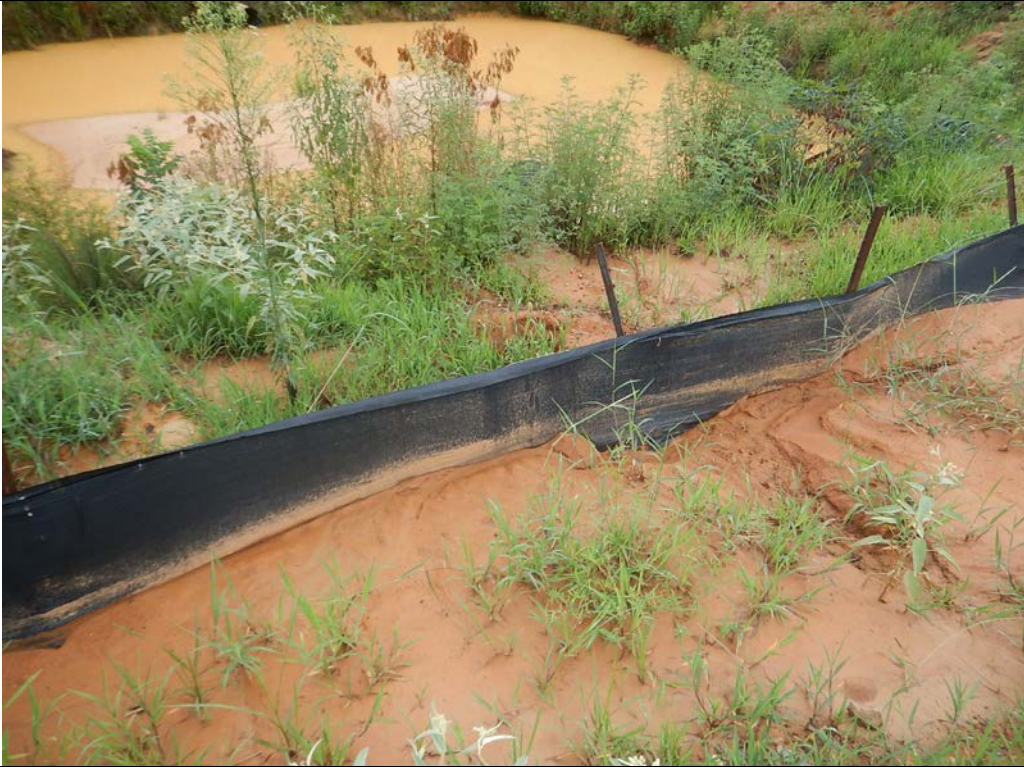
Location:	<b>Emerald Mountain</b>				
Photographer:	<b>Keith Waters</b>	Date:	<b>8/15/2016</b>	Time:	<b>1446</b>
Witness:	<b>Chris Naus</b>	Photo #:	<b>13</b>		
Description:	<b>Silt fence around sediment basin #2 failing, also note sediment basin #2 is still full of sediment and needs maintenance.</b>

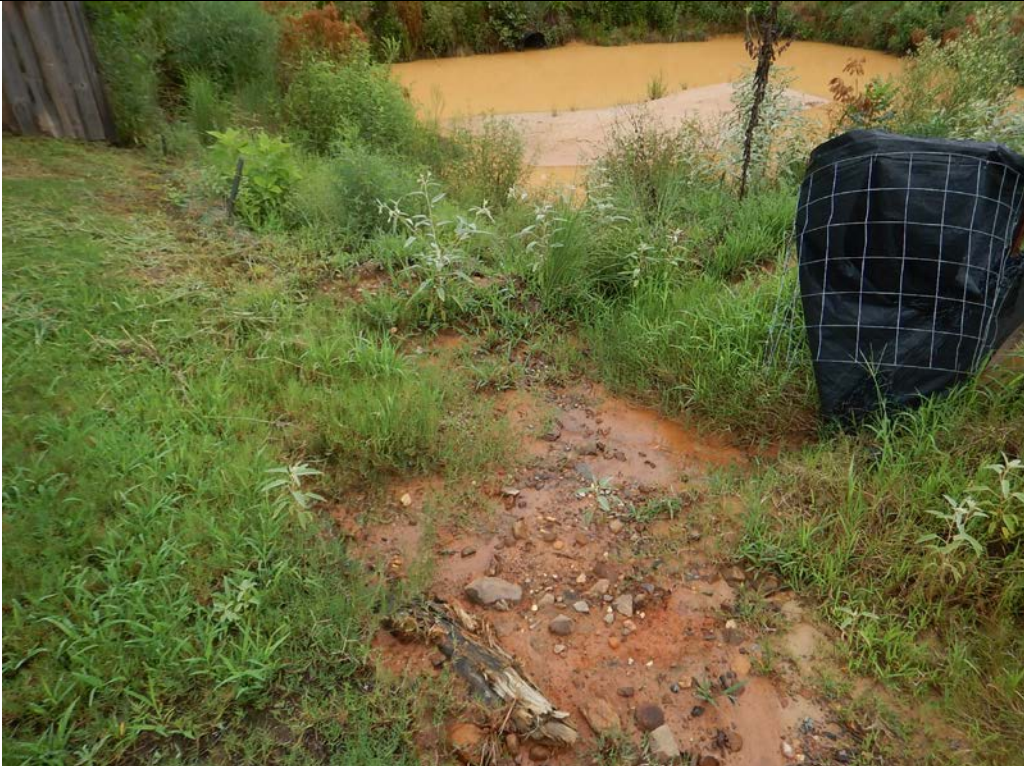
Photographer:	<b>Keith Waters</b>	Date:	<b>8/15/2016</b>	Time:	<b>1446</b>
Witness:	<b>Chris Naus</b>	Photo #:	<b>14</b>		
Description:	<b>Erosion gully forming on north side of silt fence by sediment basin #2 causing elevated levels of sediment to discharge into sediment basin.</b>

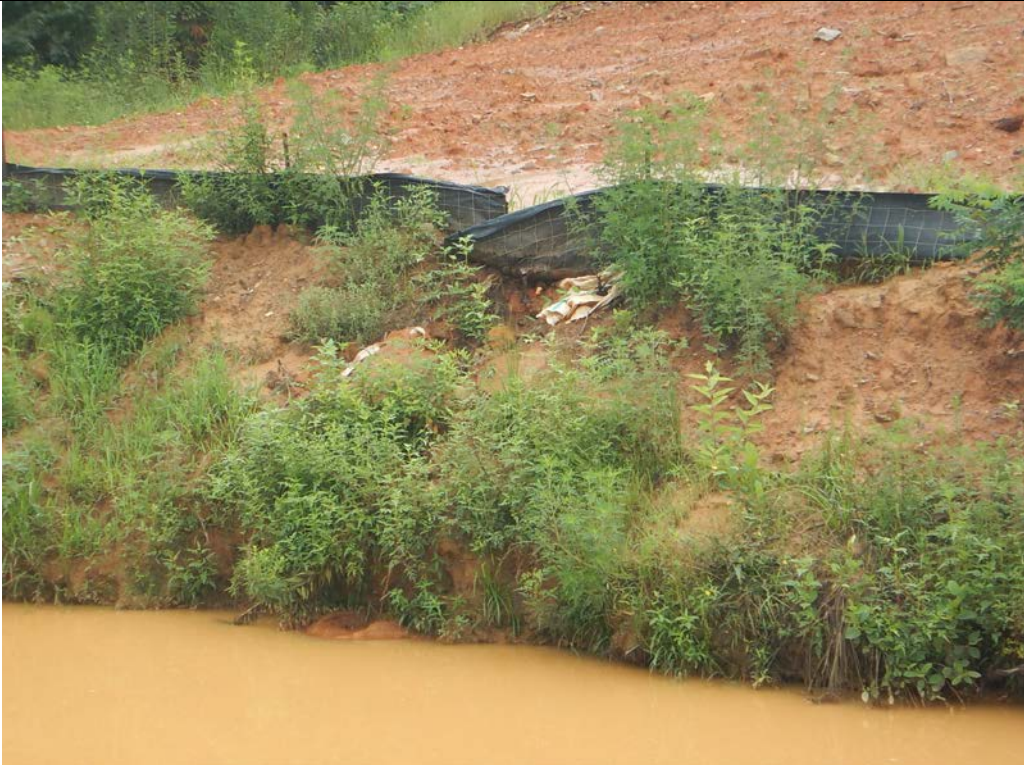
Location:	<b>Emerald Mountain</b>				
Photographer:	<b>Keith Waters</b>	Date:	<b>8/15/2016</b>	Time:	<b>1446</b>
Witness:	<b>Chris Naus</b>	Photo #:	<b>15</b>		
Description:	<b>Silt fence failing on south side of sediment basin #2.</b>

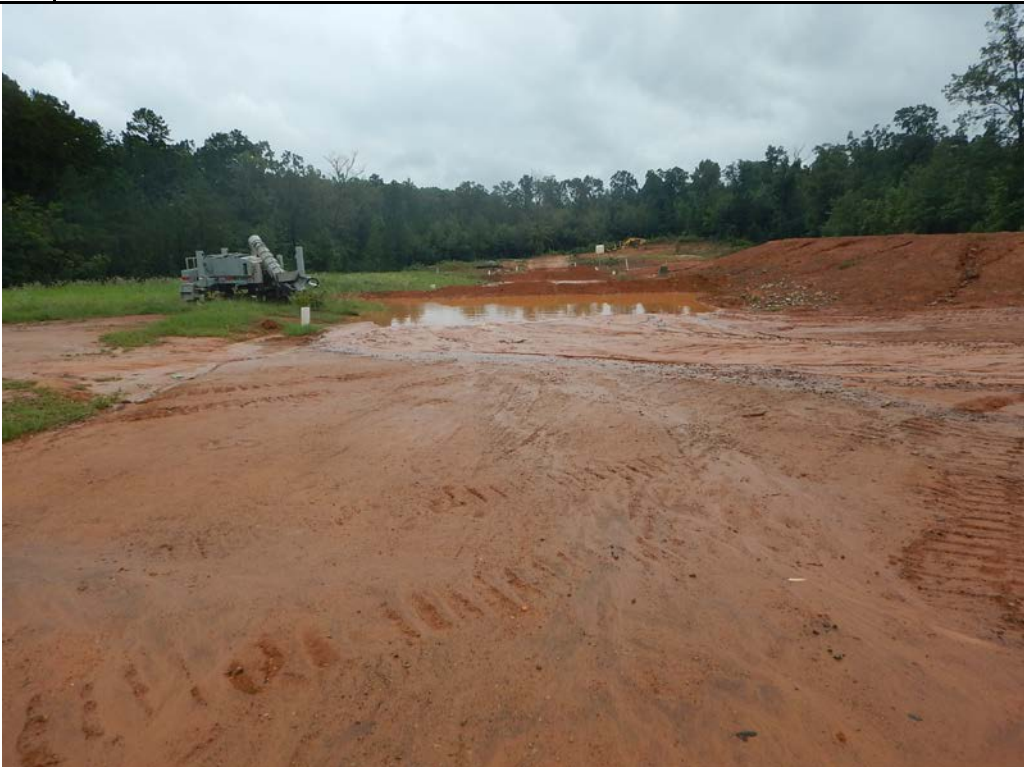
Photographer:	<b>Keith Waters</b>	Date:	<b>8/15/2016</b>	Time:	<b>1449</b>
Witness:	<b>Chris Naus</b>	Photo #:	<b>16</b>

Description:	<b>View of newly disturbed area at end of Pleasant Valley Drive. Note three earthen check dams were put in the potential road bed and partially around sediment basin #3 to slow the flow of storm water.</b>
--------------	---

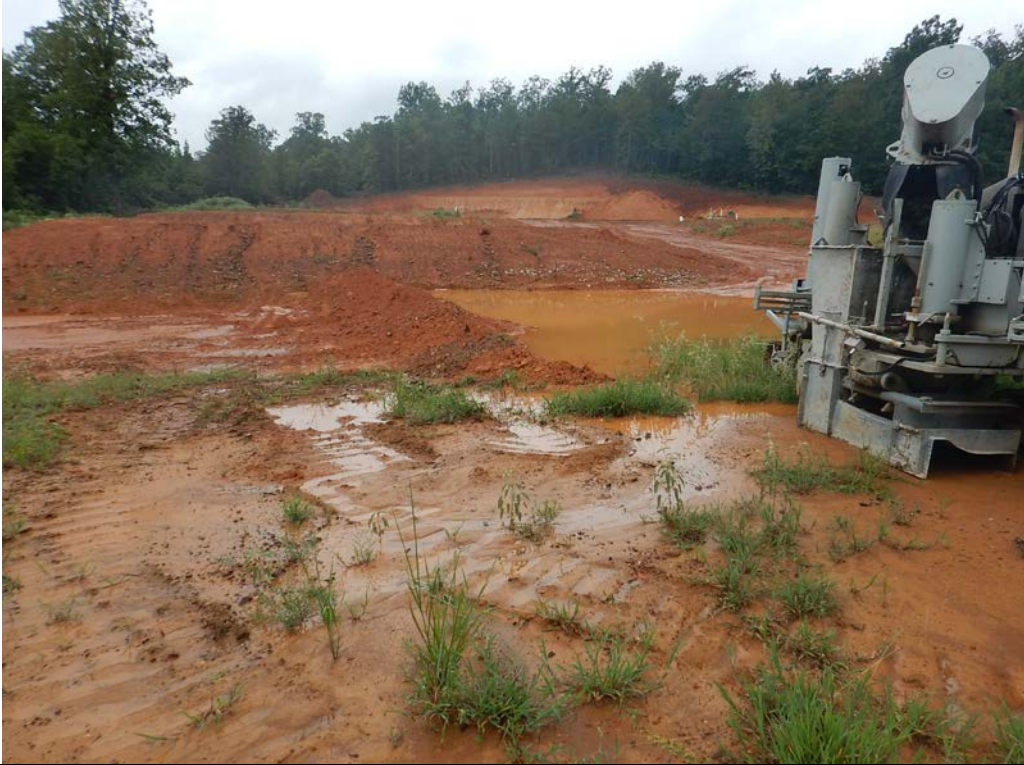
Location:	<b>Emerald Mountain</b>				
Photographer:	<b>Keith Waters</b>	Date:	<b>8/15/2016</b>	Time:	<b>1449</b>
Witness:	<b>Chris Naus</b>	Photo #:	<b>17</b>		
Description:	<b>View of first earthen check dam, stormwater is bypassing on east side of dam.</b>

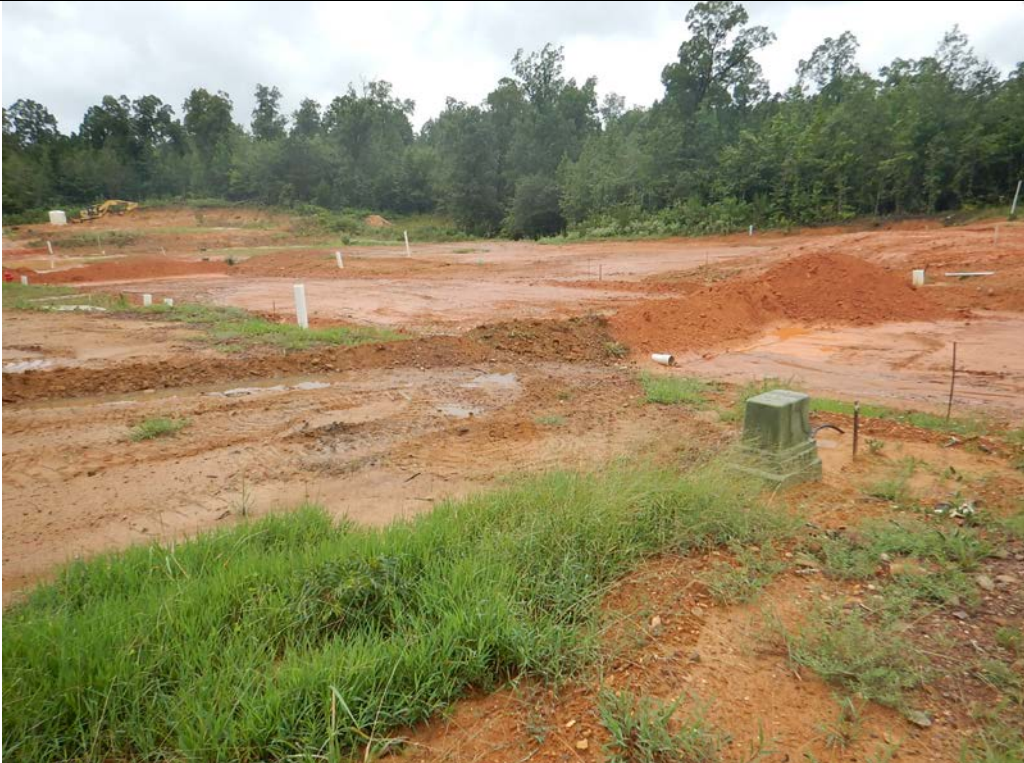
Photographer:	<b>Keith Waters</b>	Date:	<b>8/15/2016</b>	Time:	<b>1450</b>
Witness:	<b>Chris Naus</b>	Photo #:	<b>18</b>		
Description:	<b>View of earthen check dams 2 and 3 with pipe inserted on east side of check dams to allow storm water flow through.</b>

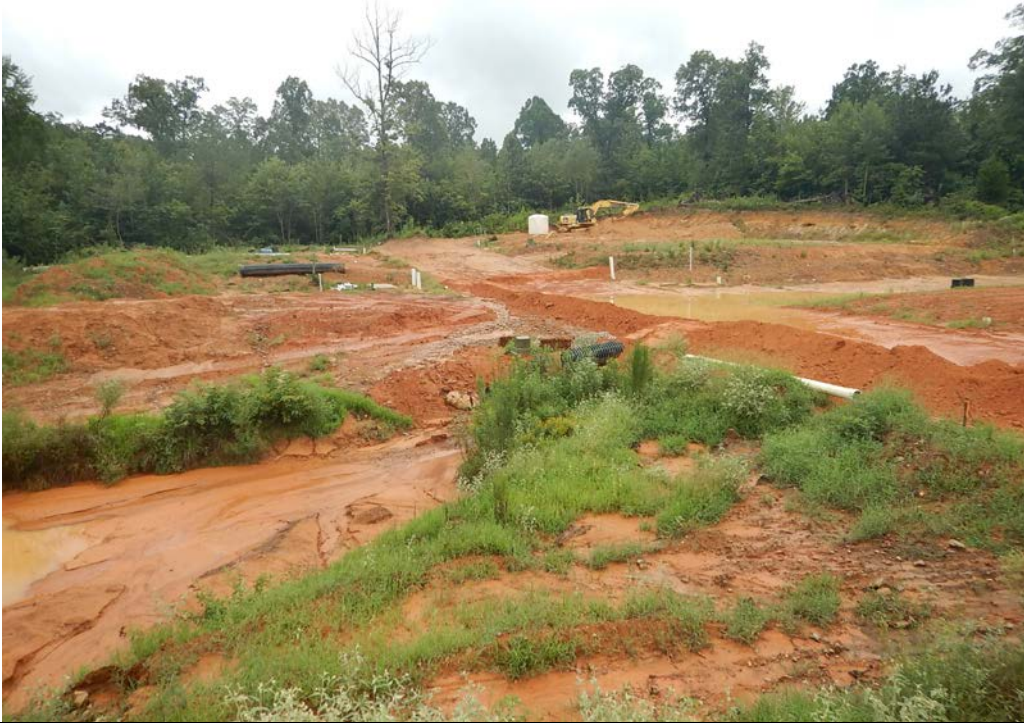
Location:	<b>Emerald Mountain</b>				
Photographer:	<b>Keith Waters</b>	Date:	<b>8/15/2016</b>	Time:	<b>1452</b>
Witness:	<b>Chris Naus</b>	Photo #:	<b>19</b>		
Description:	<b>View of sediment basin #3 and earthen dams to slow stormwater flow into basin. Note basin is still full of sediment and needs maintenance.</b>

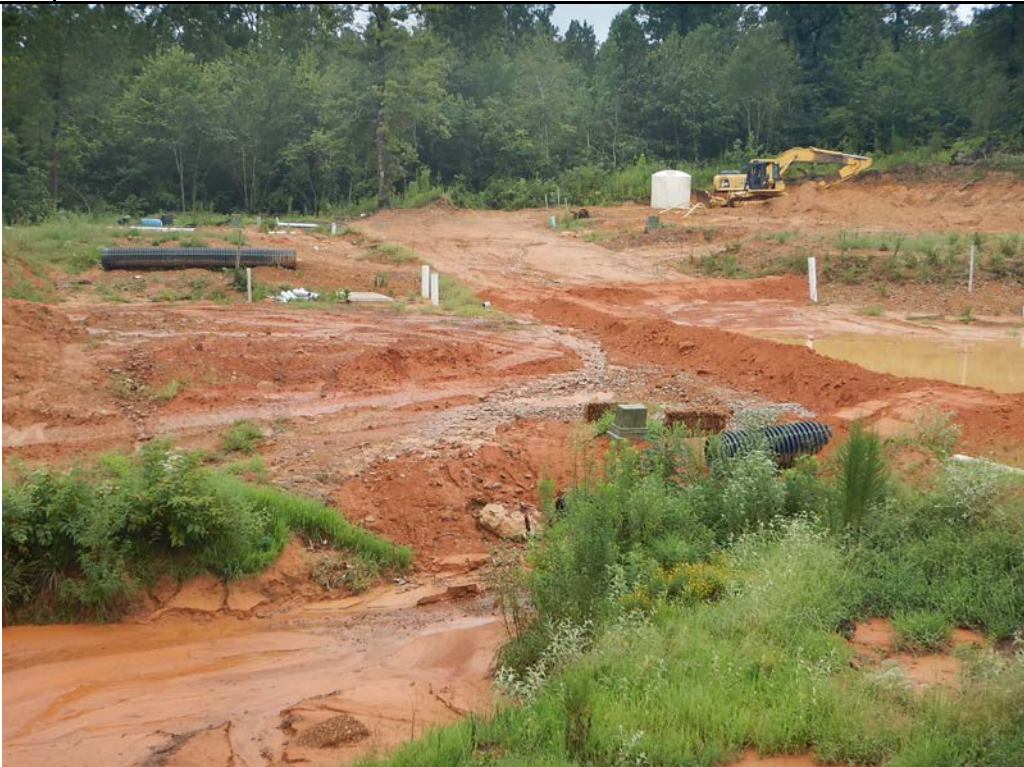
Photographer:	<b>Keith Waters</b>	Date:	<b>8/15/2016</b>	Time:	<b>1452</b>
Witness:	<b>Chris Naus</b>	Photo #:	<b>20</b>		
Description:	<b>Erosion gully coming from back of disturbed area around earthen dam and into sediment basin.</b>

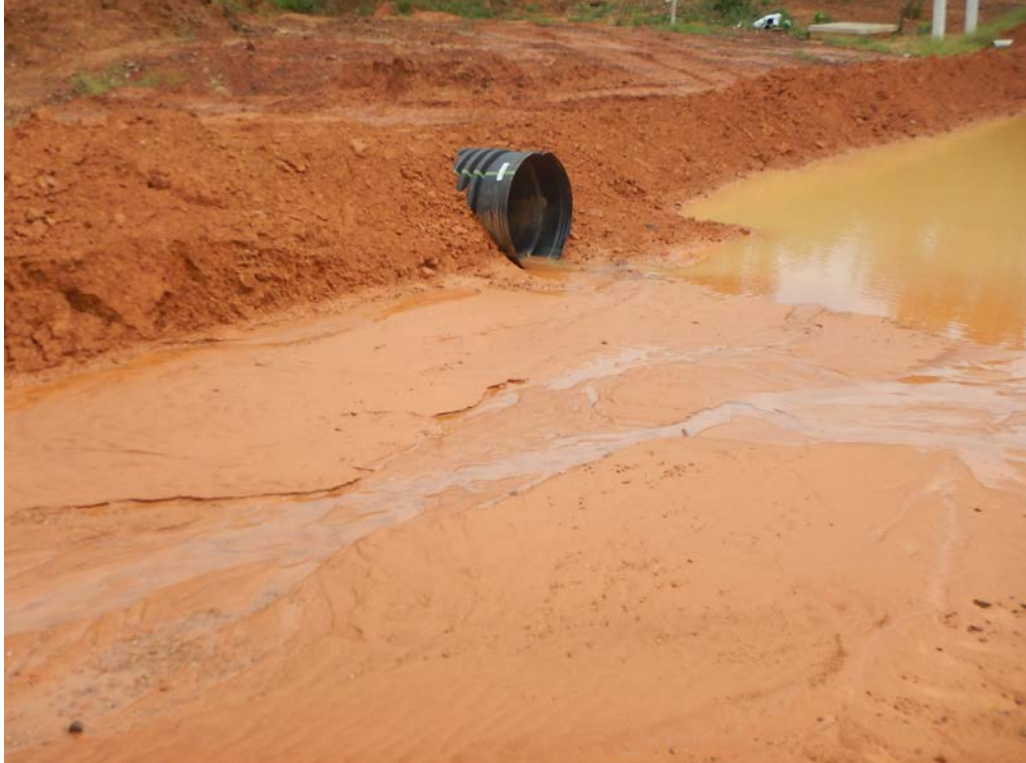
Location:	<b>Emerald Mountain</b>				
Photographer:	<b>Keith Waters</b>	Date:	<b>8/15/2016</b>	Time:	<b>1453</b>
Witness:	<b>Chris Naus</b>	Photo #:	<b>21</b>		
Description:	<b>Drainage pipe from behind earthen dam to sediment basin #3.</b>

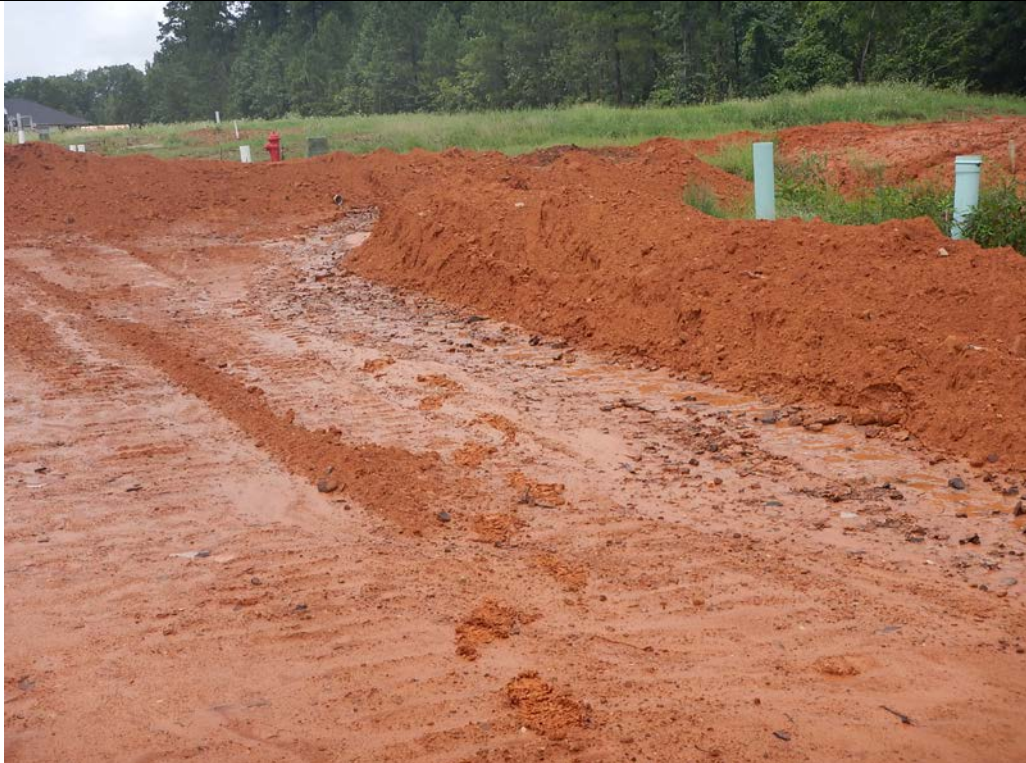
Photographer:	<b>Keith Waters</b>	Date:	<b>8/15/2016</b>	Time:	<b>1453</b>
Witness:	<b>Chris Naus</b>	Photo #:	<b>22</b>		
Description:	<b>Erosion gully from check dam 3 to drainage pipe to sediment basin #3.</b>

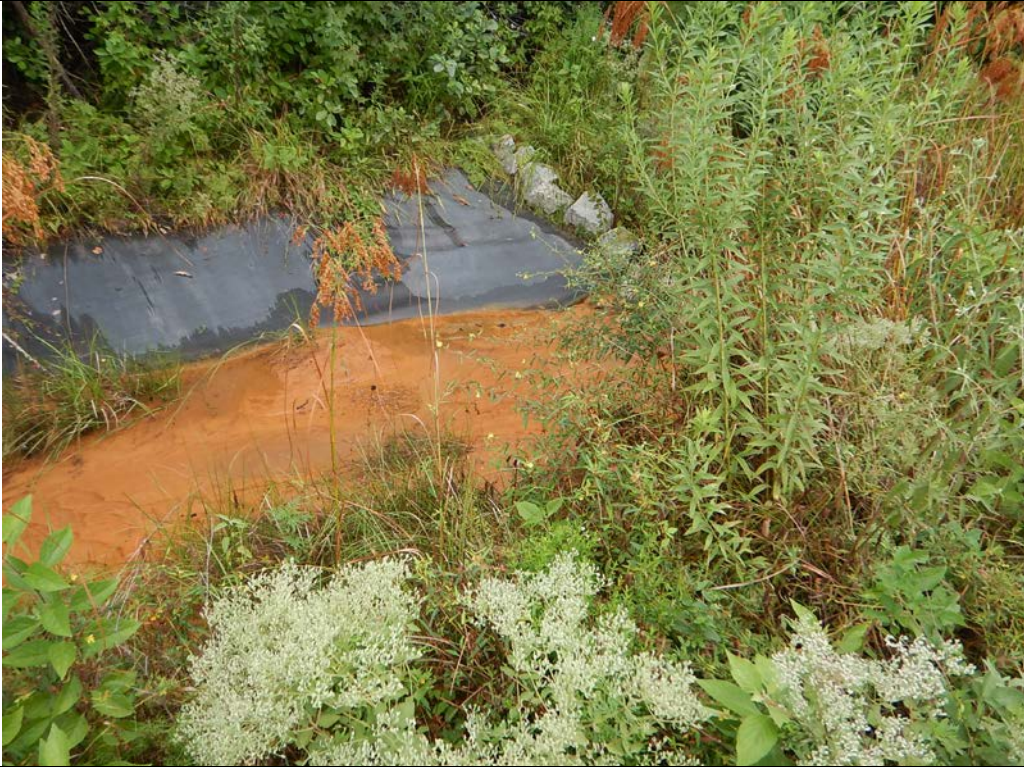
Location:	<b>Emerald Mountain</b>				
Photographer:	<b>Keith Waters</b>	Date:	<b>8/15/2016</b>	Time:	<b>1455</b>
Witness:	<b>Chris Naus</b>	Photo #:	<b>23</b>		
Description:	<b>Lined stormwater conveyance with rock check dams full of sediment and in need of maintenance.</b>

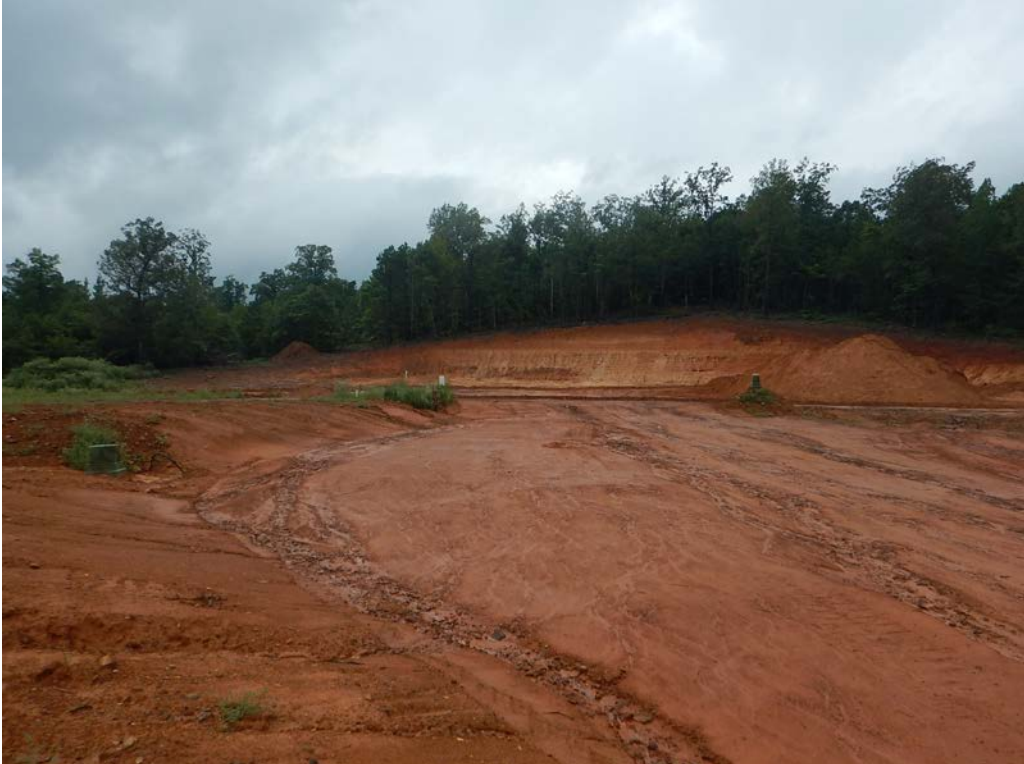
Photographer:	<b>Keith Waters</b>	Date:	<b>8/15/2016</b>	Time:	<b>1457</b>
Witness:	<b>Chris Naus</b>	Photo #:	<b>24</b>		
Description:	<b>Cul-De-Sac on west side of newly disturbed area with erosion gullies forming and leading to check dams and earthen dams that discharge into sediment basin #3.</b>

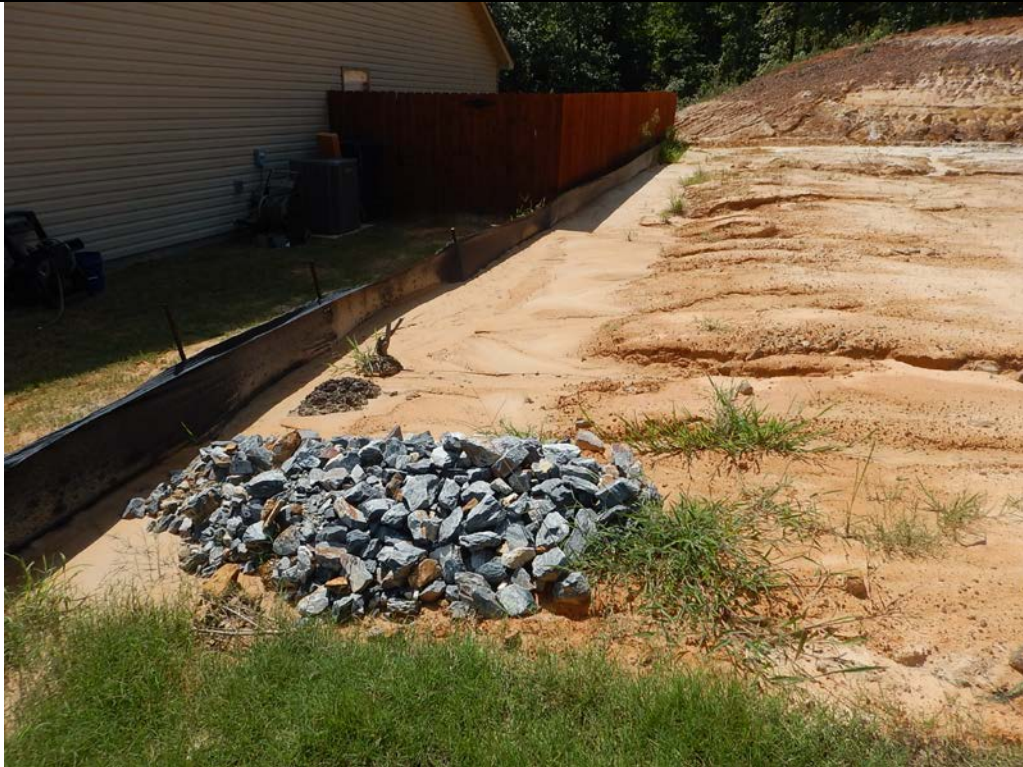
Location:	<b>Emerald Mountain</b>				
Photographer:	<b>Keith Waters</b>	Date:	<b>8/24/2016</b>	Time:	<b>1155</b>
Witness:	<b>Chris Naus</b>	Photo #:	<b>25</b>		
Description:	<b>Loaded silt fence at the edge of lot 53 in need of maintenance.</b>

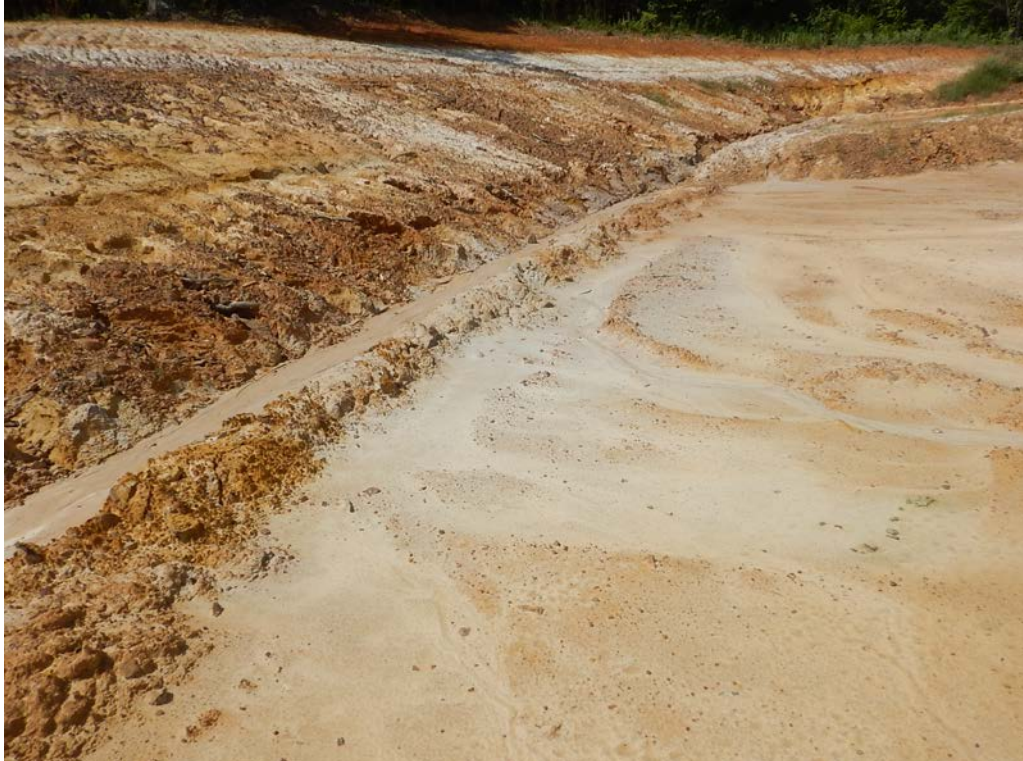
Photographer:	<b>Keith Waters</b>	Date:	<b>8/24/2016</b>	Time:	<b>1156</b>
Witness:	<b>Chris Naus</b>	Photo #:	<b>26</b>		
Description:	<b>Erosion gully at base of hill on south side of lots 52 and 53.</b>
