# WATER DIVISION INSPECTION REPORT

AFIN: 63-00820	PERMIT #: ARR151435	DATE: 8/15/2016
COUNTY: 63 Saline	PDS #: 092486	MEDIA: WN
GPS LAT: 34.611232 LONG: -92.436733 LOCATION: General Area

NAME:  
**Emerald Mountain**

LOCATION:  
**Valley Ridge Drive**

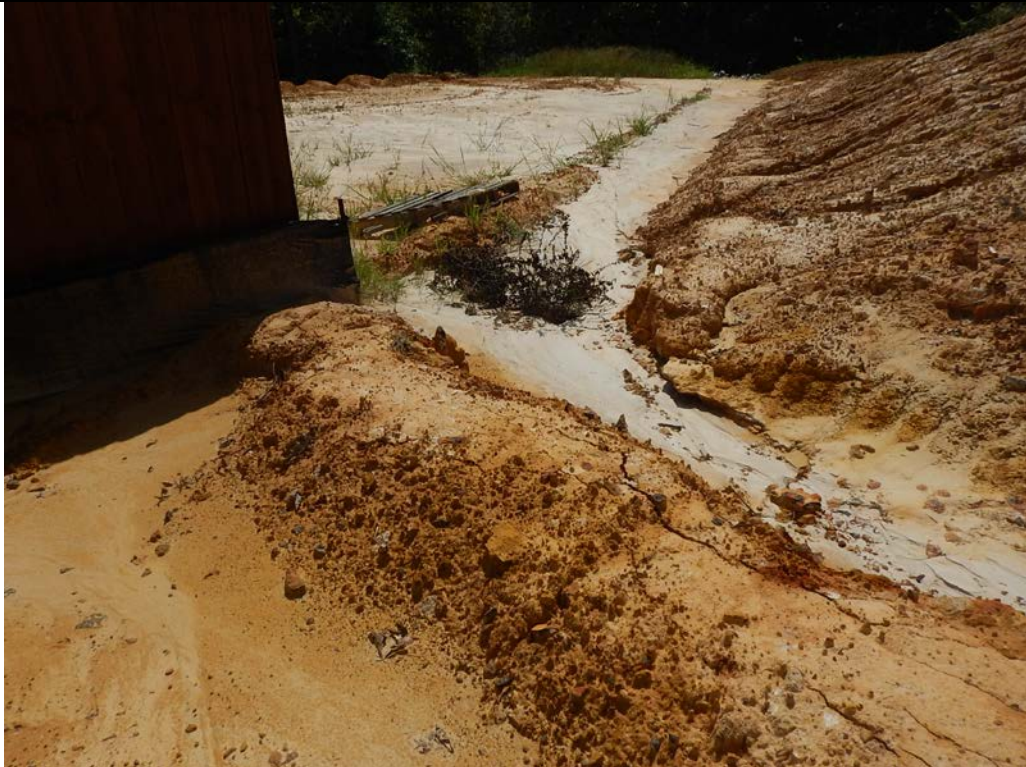
3. Silt fences, Check dams, and velocity dissipation devices are not properly installed or maintained as required by Part I, Section B.12.A and Part II, Section B.17.A of your permit (see photos 1-2, 7-8, 12-26, 27-30). **This is a repeat violation** noted in previous inspections on 9 July 2015 and 5 May 2016.

Location:	<b>Emerald Mountain</b>				
Photographer:	<b>Keith Waters</b>	Date:	<b>8/24/2016</b>	Time:	<b>1156</b>
Witness:	<b>Chris Naus</b>	Photo #:	<b>27</b>		
Description:	<b>Erosion gully leading to area behind lot 54.</b>

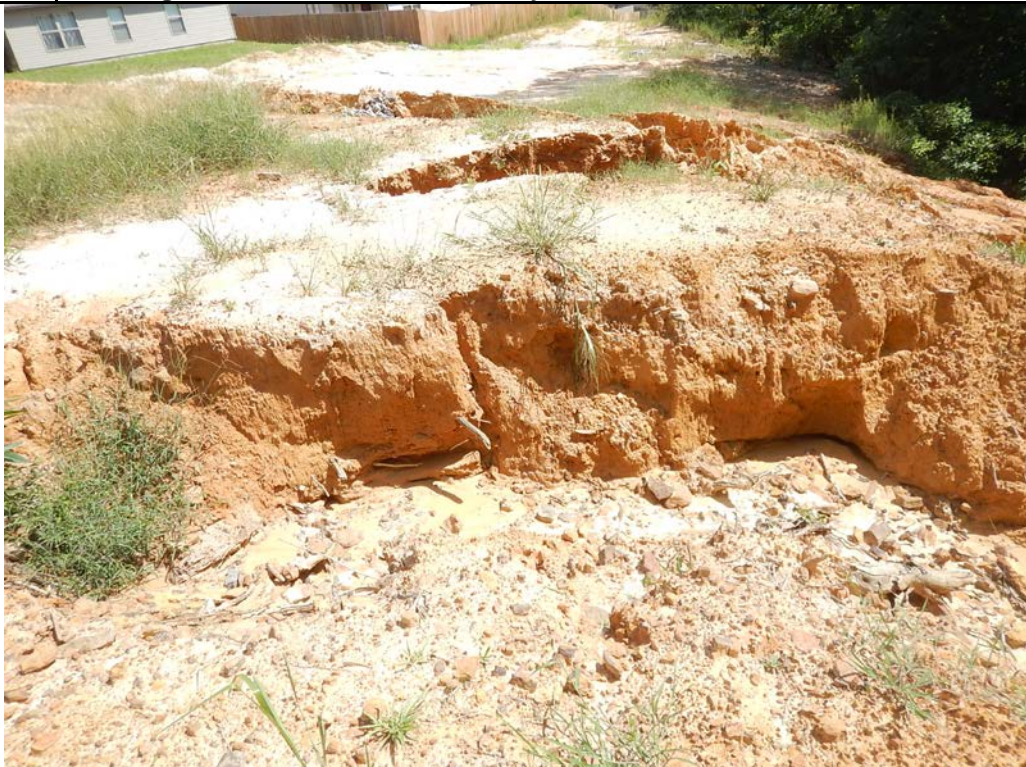
1. Sediment has gotten off site and discharged into waters of the State (see photos 10, 11, 12, 28, 29) in violation of Arkansas Water and Air Pollution Control Act § 8-4-217(a) (2) which states, "It shall be unlawful for any person to place or cause to be place any sewage, industrial waste, or other wastes in a location where it is likely to cause pollution of any waters of this state." **This is a repeat violation** noted in previous inspections on 9 July 2015 and 5 May 2016.

5. Sediment that has gotten off site and has not been removed as required by Part II, Section A.4.G.1.d of your permit (see photos 10, 11, 12, 28, 29). **This is a repeat violation** noted in previous inspections on 9 July 2015 and 5 May 2016.

Photographer:	<b>Keith Waters</b>	Date:	<b>8/24/2016</b>	Time:	<b>1157</b>
Witness:	<b>Chris Naus</b>	Photo #:	<b>28</b>		
Description:	<b>Area behind lot 54 and three erosion gullies formed causing sediment to be discharged off of site and into conveyance.</b>

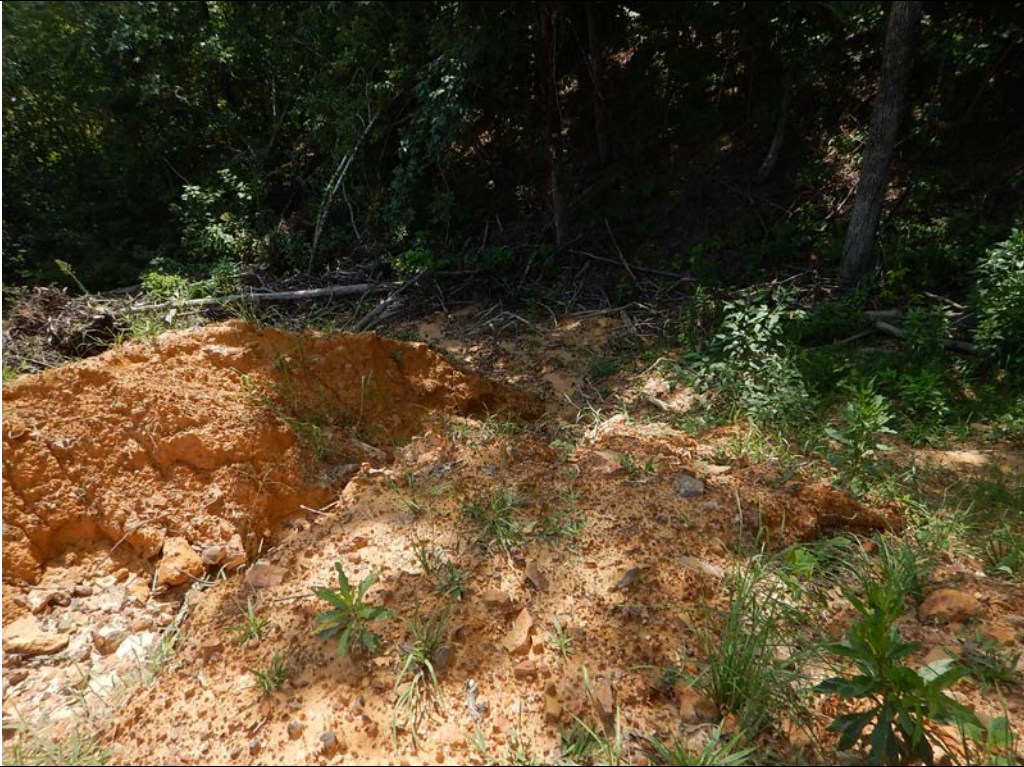
Location:	<b>Emerald Mountain</b>				
Photographer:	<b>Keith Waters</b>	Date:	<b>8/24/2016</b>	Time:	<b>1156</b>
Witness:	<b>Chris Naus</b>	Photo #:	<b>29</b>		
Description:	<b>Sediment being deposited off of site and into conveyance from erosion gullies from picture above.</b>

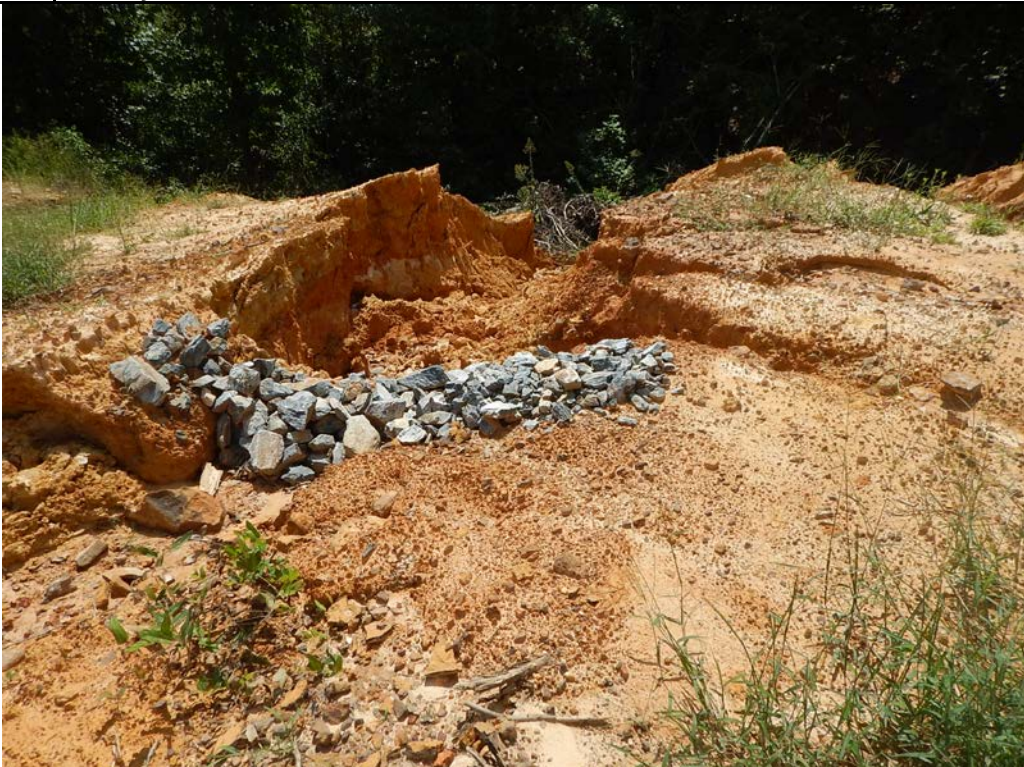
Photographer:	<b>Keith Waters</b>	Date:	<b>8/24/2016</b>	Time:	<b>1157</b>
Witness:	<b>Chris Naus</b>	Photo #:	<b>30</b>		
Description:	<b>Erosion gully behind lot 54 causing sediment to be discharged off of site and into conveyance.</b>
