ARKANSAS  
Department of Environmental Quality

RE: City of Fulton WWTP Inspection  
AFIN: 29-00054 Permit No.: AR0048810

## WATER DIVISION INSPECTION REPORT

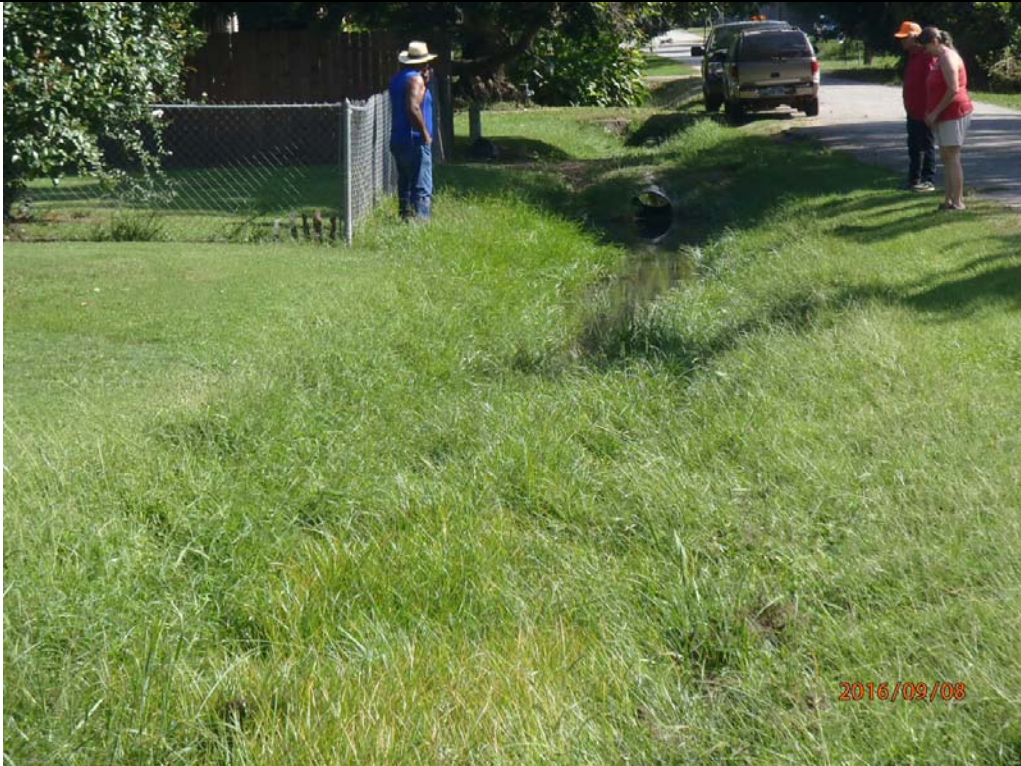
- Sanitary Sewer Overflows had occurred on Little River Street and also at 109 West Washington Street and were not immediately reported when your facility was notified. According to Departmental records, the City of Fulton has not reported any SSO's during the past several months. Refer to Part II, Condition 5.B of the permit for further details.

| Photo #: | <b>1</b> | Description: | Looking at standing sewerage in ditch on the north end of Little River Street. |

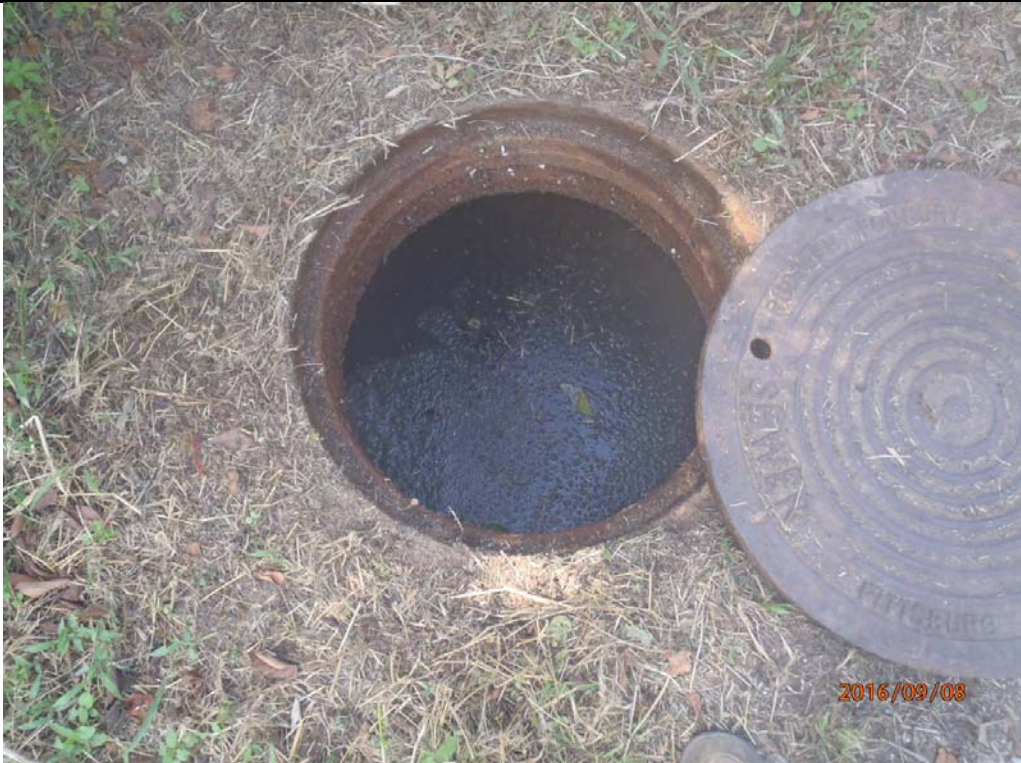
| Photo #: | <b>2</b> | Description: | Manhole at corner of Little River Street & Columbus street showing collection line is full. |

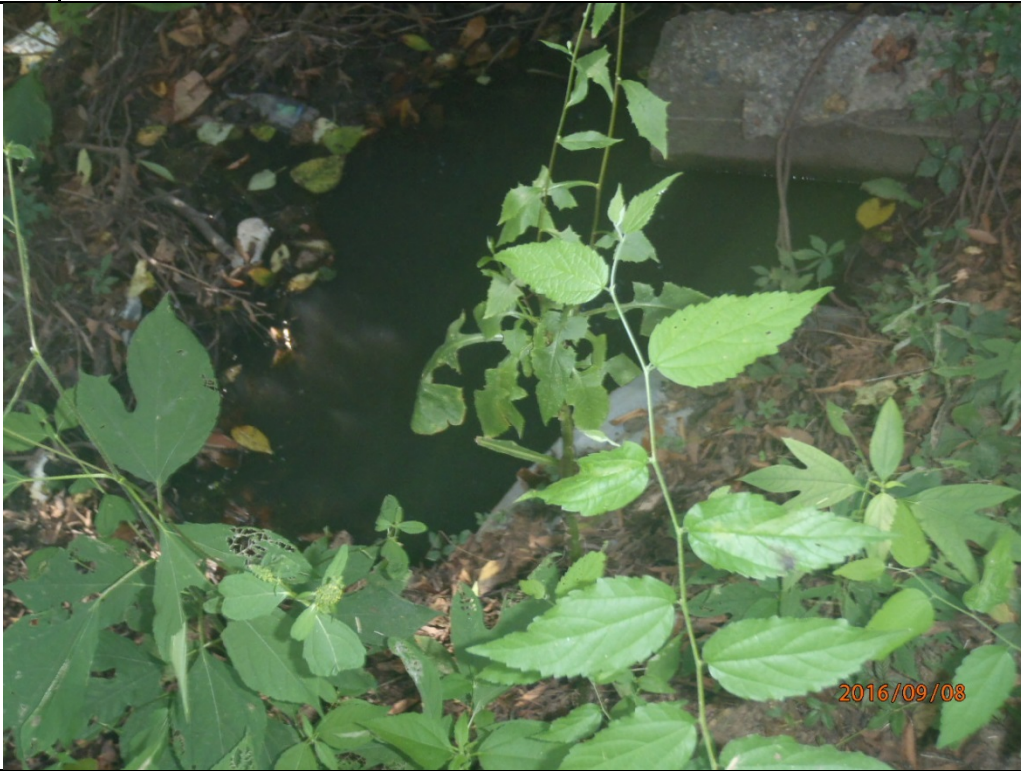
| | | Photo #: | <b>3</b> |

- As the Sanitary Sewer Overflow occurred, filled the ditch up to the point that sewerage backed up and flowed through a culvert under Little River Street into a ditch that flows to the Red River, The City of Fulton has placed waste in a manner that could be detrimental to the Waters of the State in violation of Arkansas Water and Air Pollution Control Act § 8-4-217(a)(2).

| Description: | East end of culvert at corner of Little River & Columbus running under Little River into ditch that drains toward the Red River. | | |

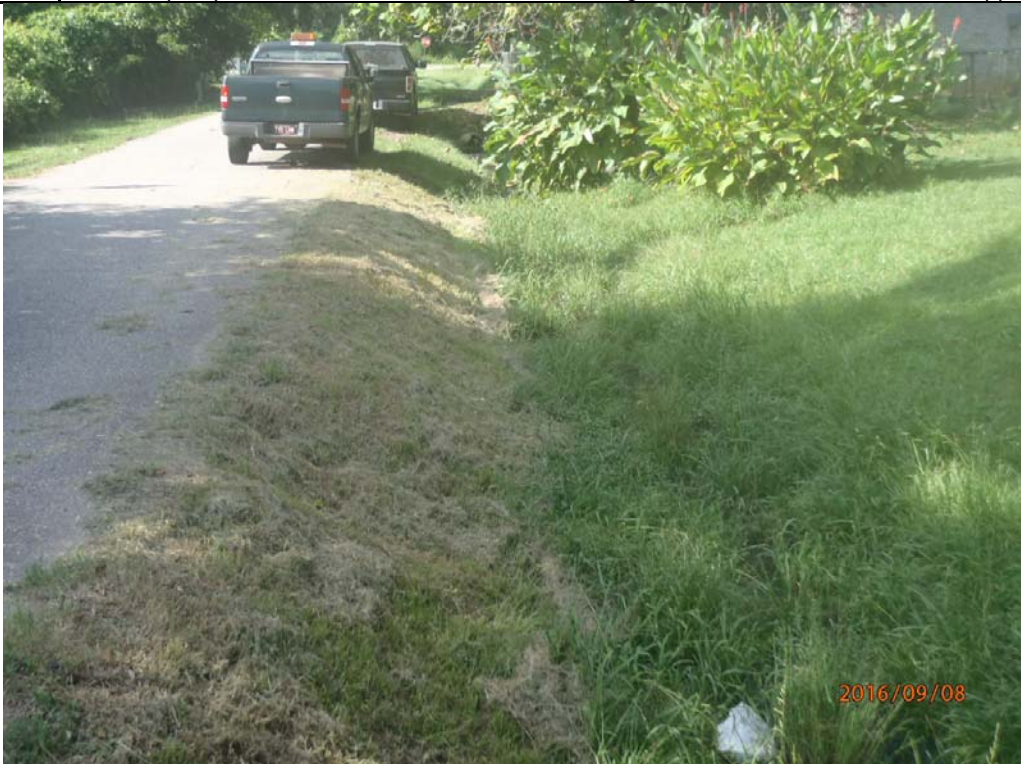
| | | Photo #: | <b>4</b> |

| Description: | Ditch with sewage in the grass just below Columbus Street and culvert in picture 3. Should drain toward top of picture but culverts at end of ditch that go under West Jefferson were stopped up. | | |

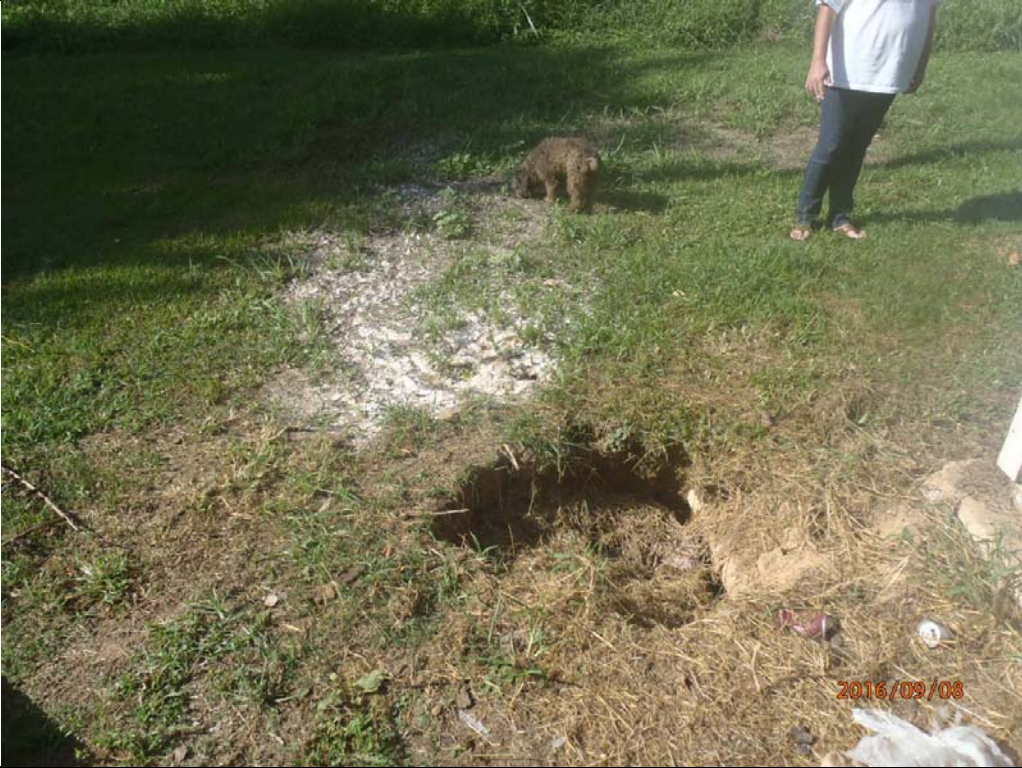
| Water Division Photographic Evidence Sheet | | | |
|---|---|---|---|
| | | Photo #: | <b>5</b> |

| Water Division Photographic Evidence Sheet | | | |
|---|---|---|---|
| Description: | Clean-out at the complainant's (John Pettit) home showing that it had overflowed. | | |

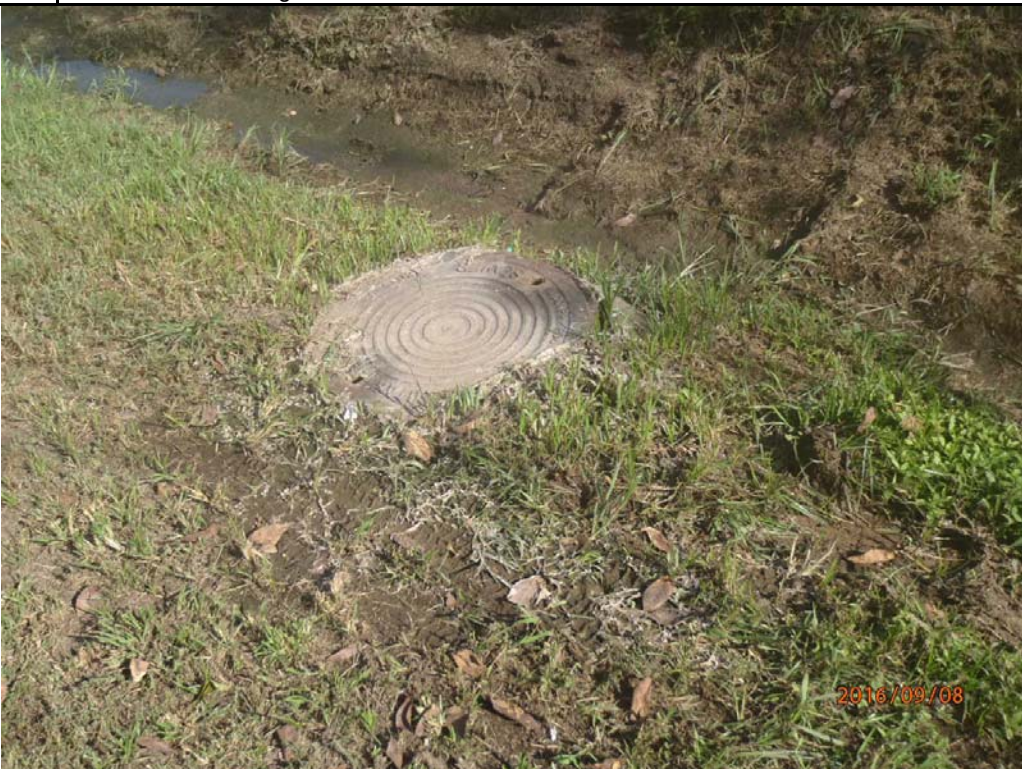
| Water Division Photographic Evidence Sheet | | | |
|---|---|---|---|
| | | Photo #: | <b>6</b> |

| Water Division Photographic Evidence Sheet | | | |
|---|---|---|---|
| Description: | Manhole on Washington Street. Notice evidence of overflow, solids and water in ditch. | | |

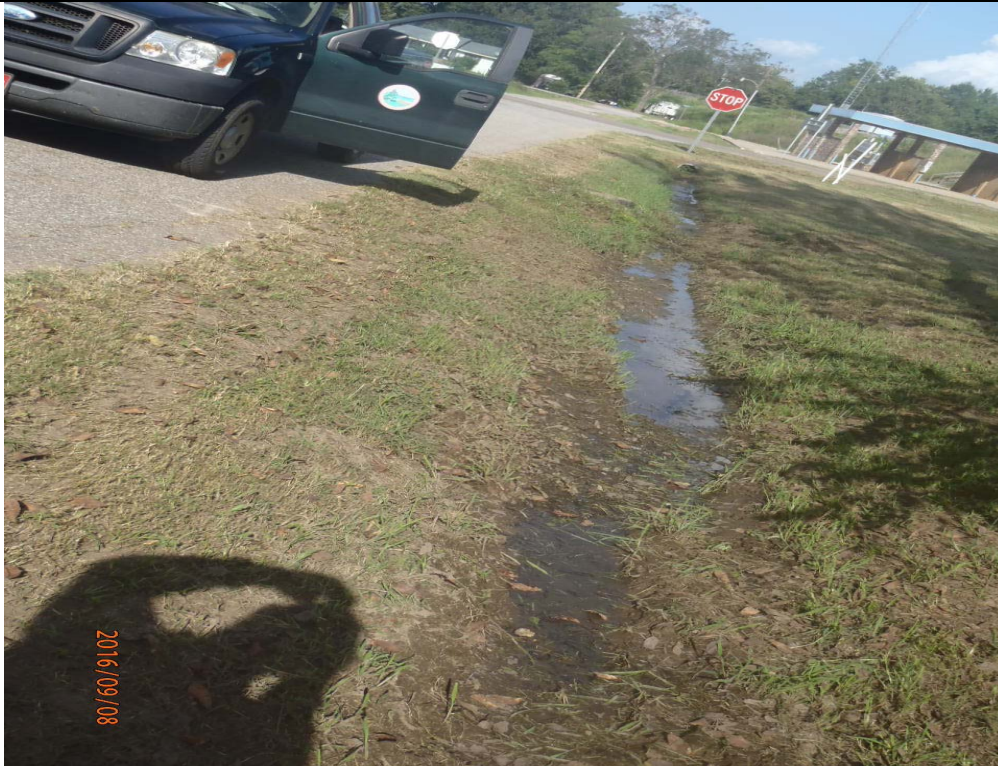
| | | Photo #: | <b>7</b> |

| Description: | <b>Another view of same area as in picture 6.</b> | | |

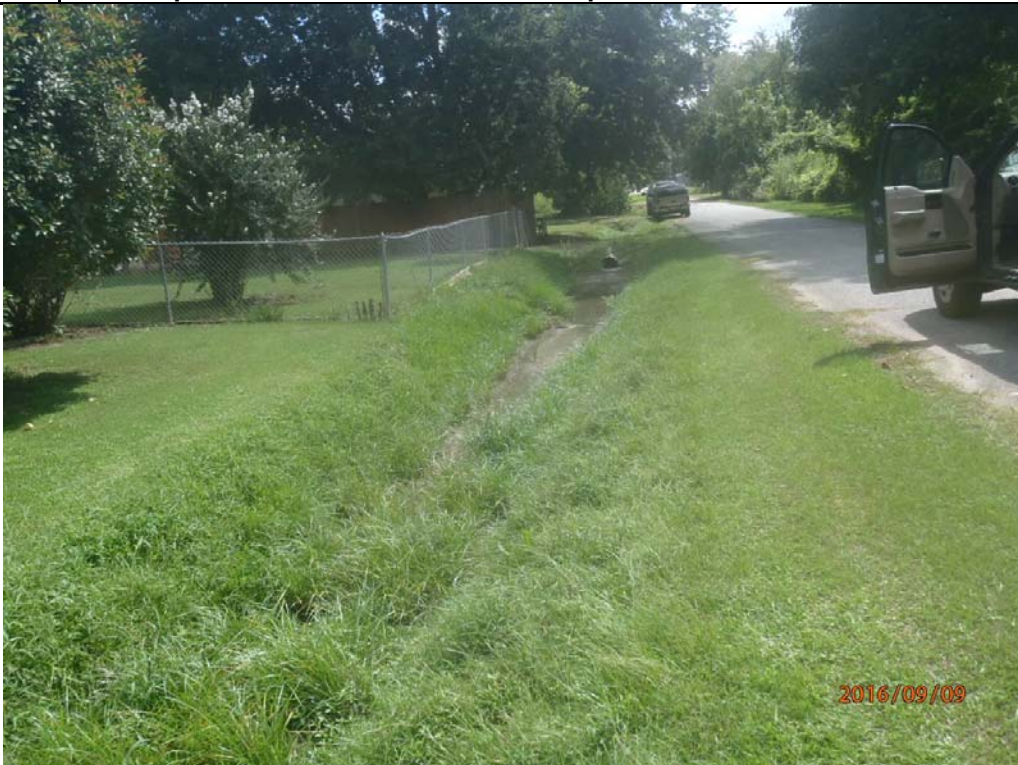
| | | Photo #: | <b>8</b> |

- The City of Fulton failed to follow through in a timely manner with a corrective action plan to clean up the sites. It was revealed on a follow up visit at 2:00 p.m. on September 9, 2016, that the ditch on Little River Street, 109 W Washington Street, still had standing sewerage in them and no disinfection conducted on the areas. The cleanout behind Mr. John Pettit's house at 407 Little River Street and the manhole at 109 W Washington still had solids present with no clean-up or disinfection conducted. Refer to Part II, Condition 5, C, 11 of the permit for further details.

| Description: | <b>Ditch in picture 1 on 9/9/2016. No clean-up conducted.</b> | | |

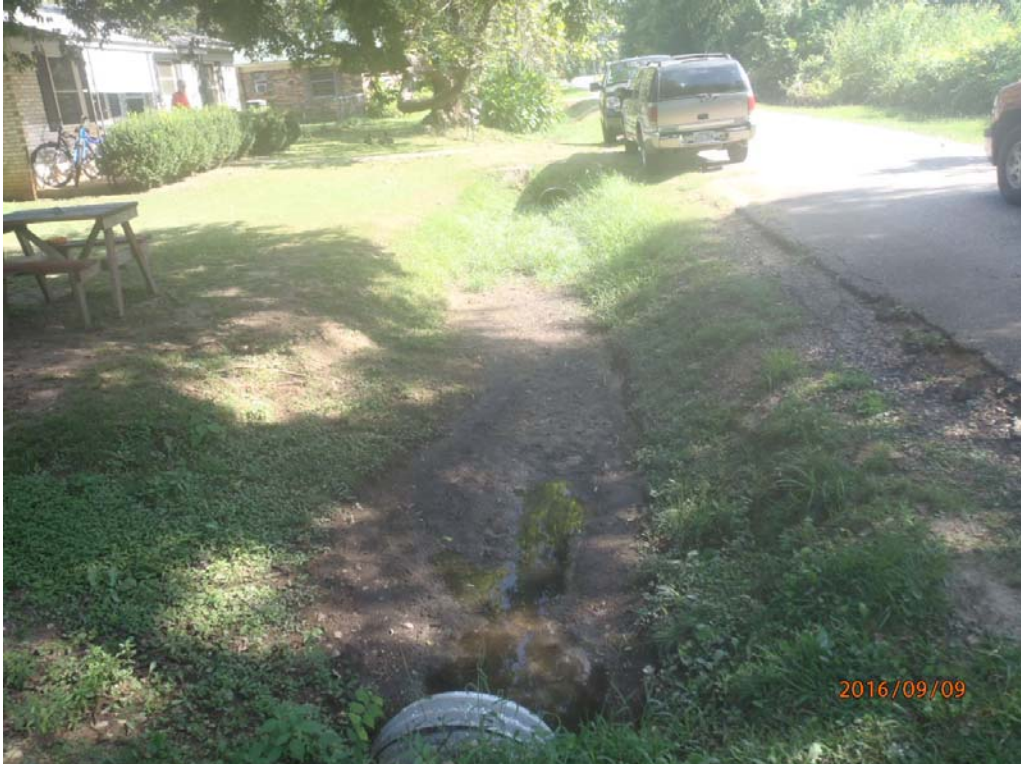
| | | Photo #: | <b>9</b> |

| Description: | <b>Same ditch as in picture 8 one yard up. Again, no clean-up or disinfection.</b> | | |

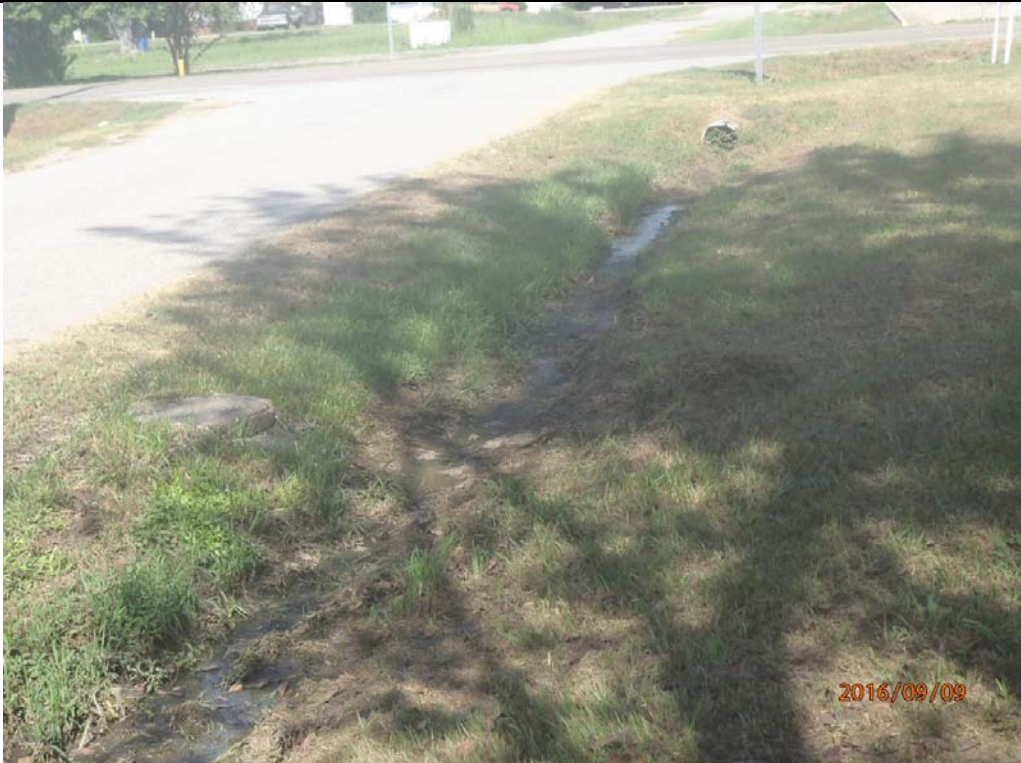
| | | Photo #: | <b>10</b> |

| Description: | <b>Ditch on Washington Street on 9/9/2016. No clean-up or disinfection.</b> | | |

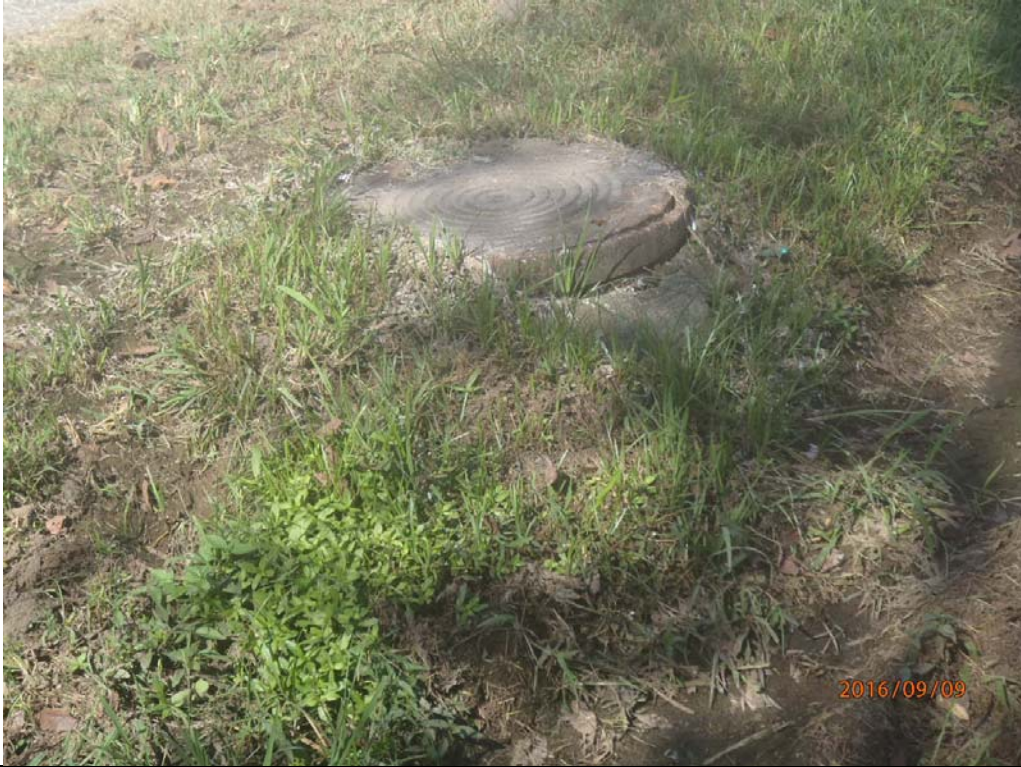
| | | Photo #: | <b>11</b> |

| Description: | <b>Manhole for the location on Washington street on 9/9/2016.</b> | | |

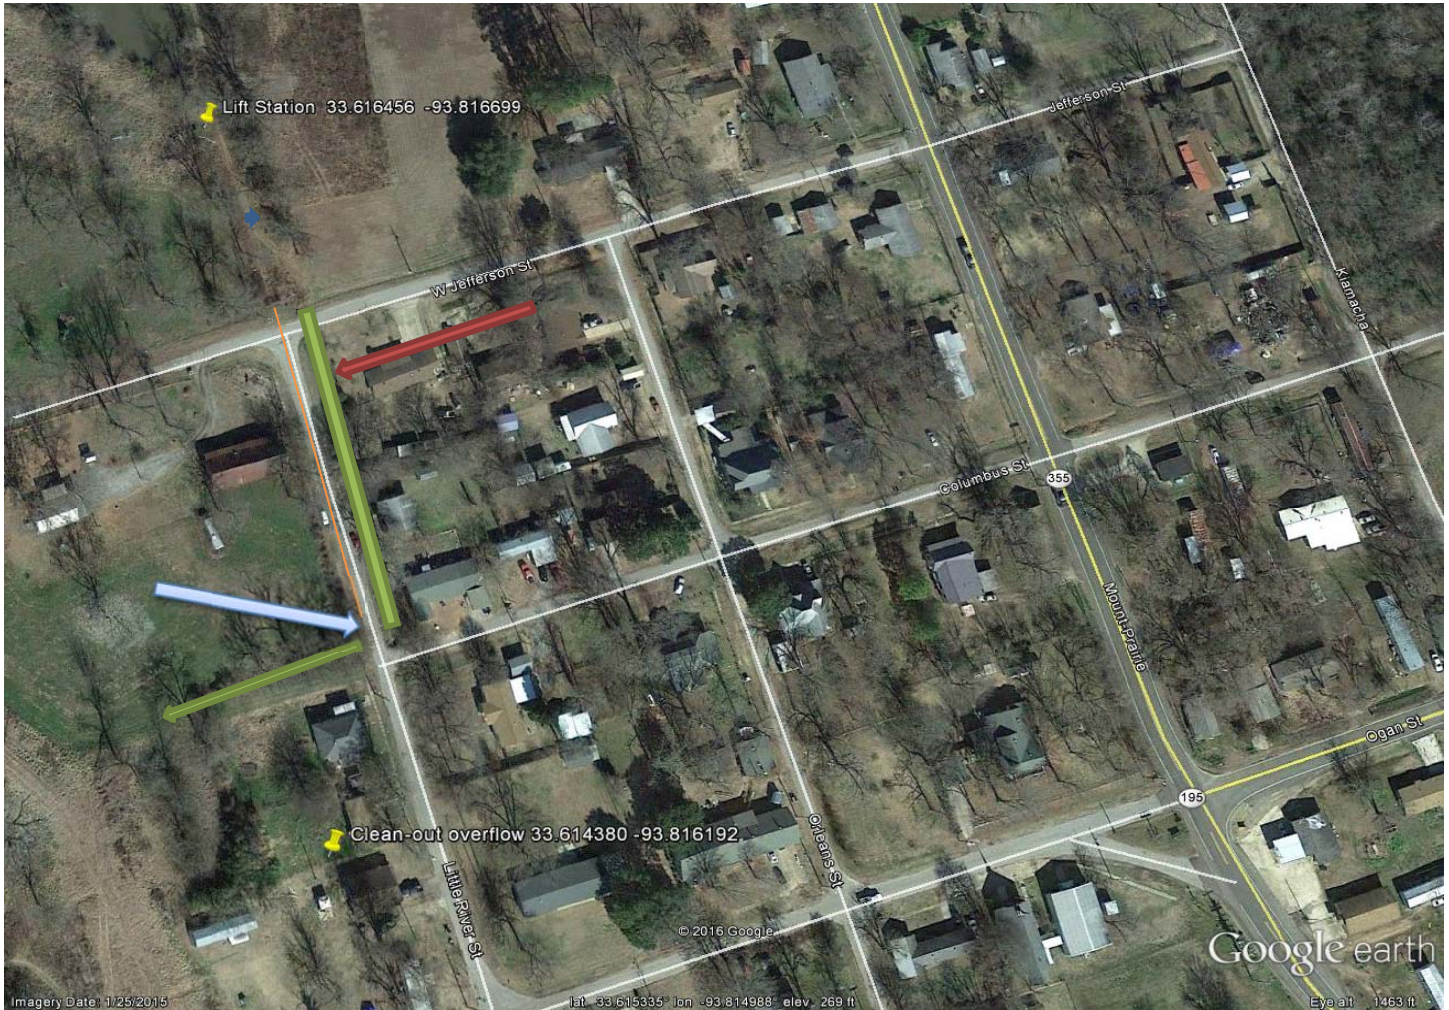
Picture 13

Green line is area of overflow east side of street, 1 city block long and ran under Little River Street at Columbus Street toward river

Orange line is main collection line, west side of street.

Red arrow is point (33.615570 -93.816235) in ditch where sewerage ran back into ground when pump finally kicked on.

Lite blue arrow is manhole in picture 2.A culvert is located under Little River Street at this point and sewerage from ditch across street was backed through culvert an able to flow towards the Red River.
