-1	,		,	, -				
	ADEO	WATER	DIVISION INSPECTION REPORT						
AULU			AFIN: 67-00023 PERMIT #: AR002173		733		DATE: 1/4/2017		
Α	RKANSAS	CC	DUNTY: 67 Sevie	r	PDS #	#: 094792	MEDIA: WN		
	partment of Environmental Quality	GF	PS LAT: 34.02608	1 LONG: -94.3473	354 L	OCATION:	ntrance		
FACILITY INFORMATION			INS	SPEC1	TION INFOR	MATION			
City of DeQueen WWTP				FACILITY TYPE: INSPECTOR ID#: 26294 S - State					
LOCATION: 670 South 9 th Street				FACILITY EVALUATION RATING: INSPECTION TYPE: 2 - Marginal SSO/Collection System					
De	Queen			DATE(S): ENT	RY TIME:	EXIT TIME:	PERMIT EFFECTIVE DATE:		
	RESPONSIBLE OFFIC	CIAI			:00	16:00	11/1/2013		
	ET TITLE Chael Sims / WW Superintendent			1/5/2017 13:00 16:30 PERMIT EXPIRATION DATE: 10/31/2018					
COMI	PANY:	-		FAYETTEVILLE SHALE RELATED: N					
	y of DeQueen ng address:			FAYETTEVILLE S	SHALI	E VIOLATIO	NS: N		
_	Box 730					ION PARTI	CIPANTS		
	STATE, ZIP: Queen AR 71832			Mike Sims, WW		intendent

RE: City of DeQueen SSO Inspection

Subject: De Queen WWTP inspection response AR0021733, ARR00C398

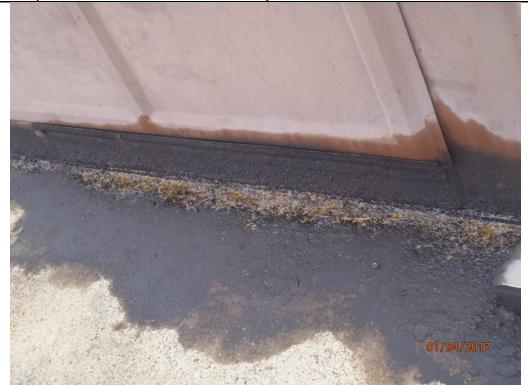
Water Division Photographic Evidence Sheet							
Location:	City	of DeQueen WWTP					
Photographer: Red Smith Date: 1/4/2017 Time: 1514							
Witness: Mike Sims / WW Superintendent					Photo #:	3	
Descriptio	_n . L	Looking at the inside of north side of Hwy 71 West Station. Appears that seals are					
Describing	· · · L	leaking or fluid reservoirs are being overfilled

On January 4 & 5 2017 a compliance evaluation inspection was performed at the City of De Queen Wastewater Plant. In the summary of findings Collection System, it was reported that the Hwy 70 West Lift Station had an oily leak and needed to be cleaned and repaired. In the attach pictures you will see that the inside and outside has been cleaned, also in watching the pumps operate no leaking was seen, in talking to the maintenance staff it was found out that when the oil has been changed some will leak out into floor and not cleaned up properly. In the future all excess oil will be captured for disposal and I will keep a better watch on the situation.
