RE: Emerald Mountain Inspection AFIN: 63-00820 Permit No.: ARR151435

1 1									
	WATER DIVISION INSPECTION REPORT							PORT		
ADLU		AFIN: 63-00820 PERMIT #: ARR151		14	1435			DATE: 1/23/2017		
ARKANSAS		COUNTY: 63 Saline		Ρ	DS #:	09511	4		MEDIA: WN	
Department of Environmental Quality			GPS LAT: 34.611232 LONG: -92.43		3733 LOCATION: General Area					
	FACILITY INFORMAT	ION		IN			ION IN	FORM	IATIO	N
Emerald Mountain				FACILITY TYPE: 1 - Municipal		INSPECTOR ID#: 97072 S - State				
LOCATION:				FACILITY EVALUATION RATING: INSPECTION TYPE:						
Valley Ridge Drive			1 - Unsatisfactory Construction Stormwater DATE(S): ENTRY TIME: EXIT TIME:							
Alexander, AR				3:0		13:40		PERMIT EI	FFECTIVE DATE:	
	RESPONSIBLE OFFIC	CIAL	-							XPIRATION DATE:
	eg Holman / Reg. Agents								10/31	/2021
COM	PANY:			FAYETTEVILLE SHALE RELATED: N						
	DTO- AR Properties, LLC			FAYETTEVILLE SHALE VIOLATIONS: N						
	901 Chenal Parkway			INSPECTION PARTICIPANTS						
	state, zip: tle Rock AR 72223			NAME/TITLE/PHONE/FAX/EMAIL/ETC.: Keith Waters/ ADEQ Water Inspector/ 501-683-6629

SECTION I: SITE POSTING AND SITE INFORMATION					
SITE NAME: Emerald Mountain TOTAL ACREAGE: 668 acres ACREAGE D

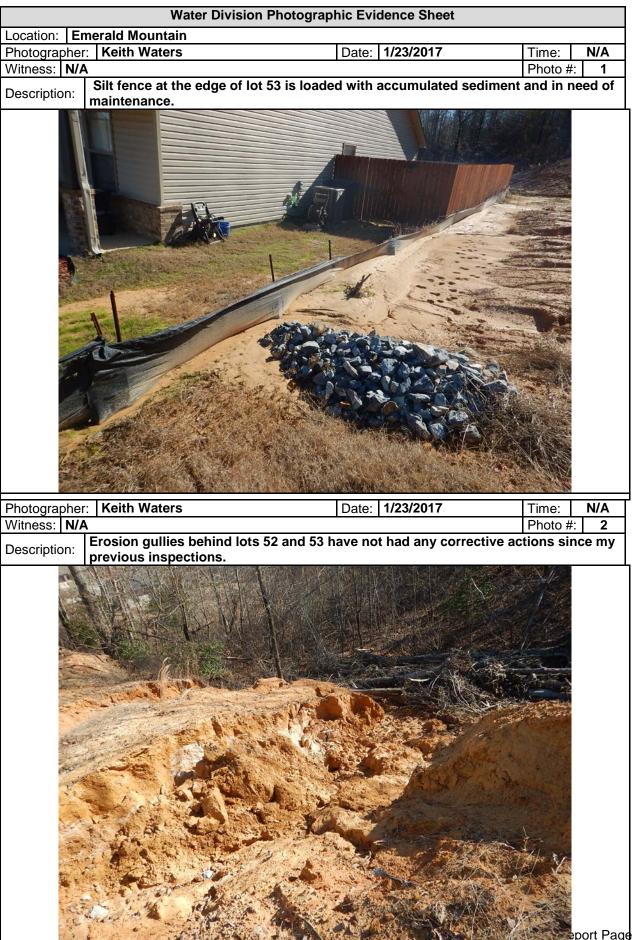
4. Silt fences, Check dams, and velocity dissipation devices are not properly installed or maintained as required by Part I, Section B.12.A and Part II, Section B.17.A of your permit (see photos 1-5 and 9-12).

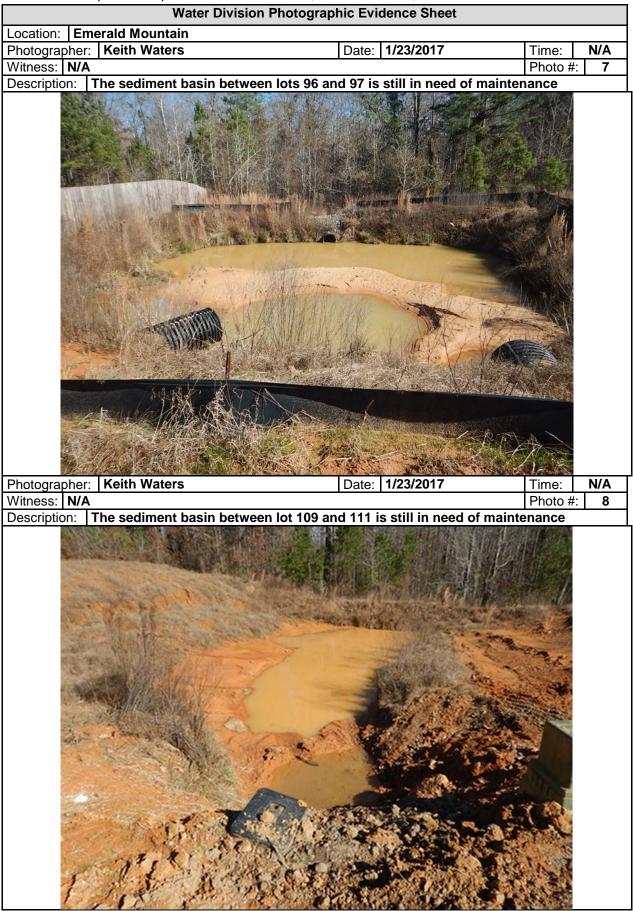
5. Sedimentation basins are not properly maintained as required by Part II Section A.4.G.1.e and Part II Section B.17.A of your permit (see photos 6-8).
