RE: Quarterly Inspection conducted on June 23, 2017  
AFIN 15-00001  
Permit Number 0284-S3N

**Arkansas Department of Environmental Quality**  
**Office of Land Resources - Solid Waste Management**  
**Class 3 Landfill Inspection**

Response to ADEQ Landfill inspection conducted on June 23, 2017

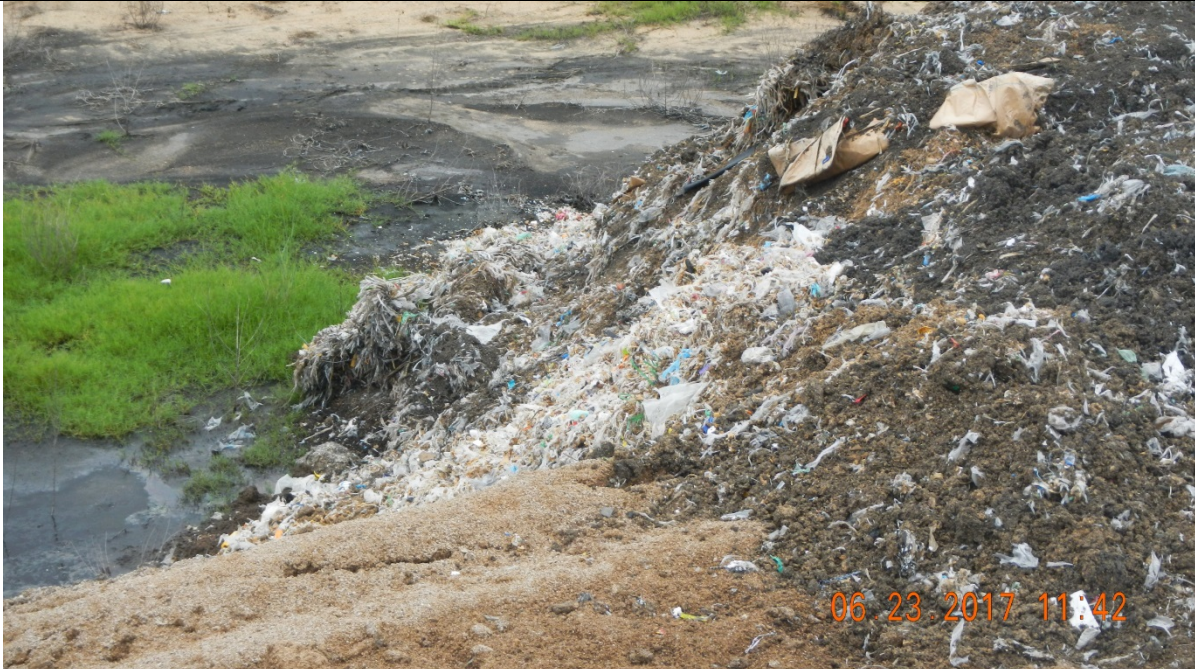
<b>Witness</b>	NA		
<b>Photo #</b>	1	<b>Of</b>	8	<b>Date</b>	6/23/2017	<b>Time</b>	1142
<b>Description</b>	Cell 5 current working face

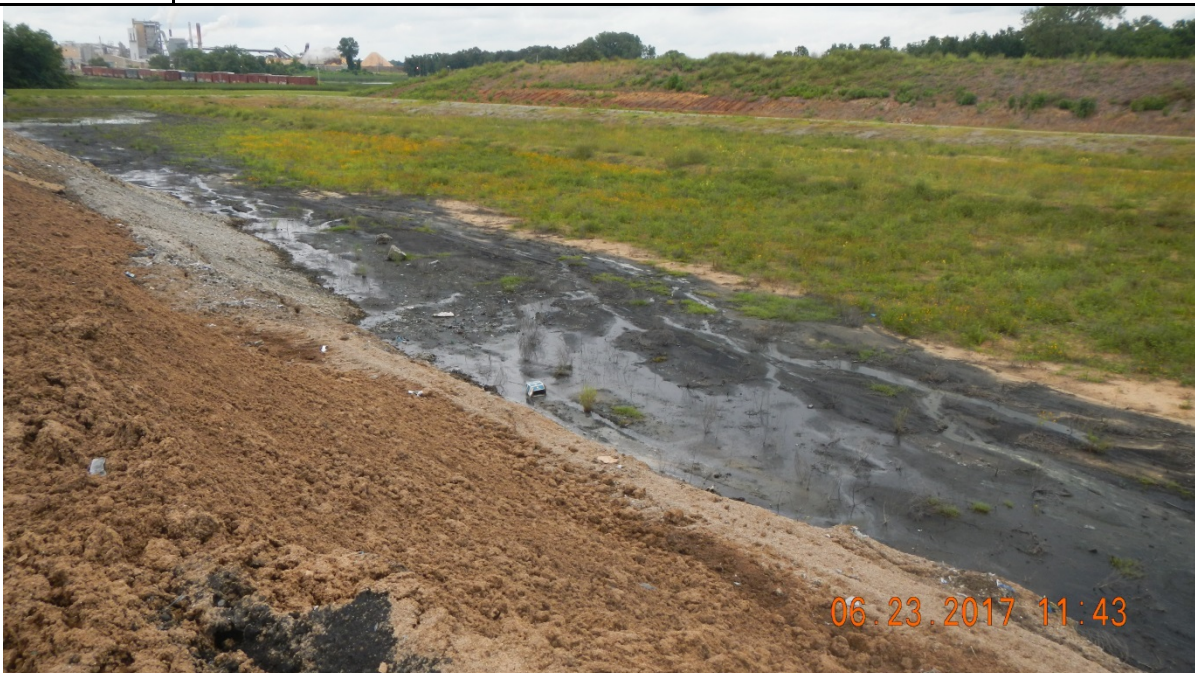
<b>Witness</b>	NA		
<b>Photo #</b>	2	<b>Of</b>	8	<b>Date</b>	6/23/2017	<b>Time</b>	1143
<b>Description</b>	Comingled storm water and leachate which is drained to water treatment basin.

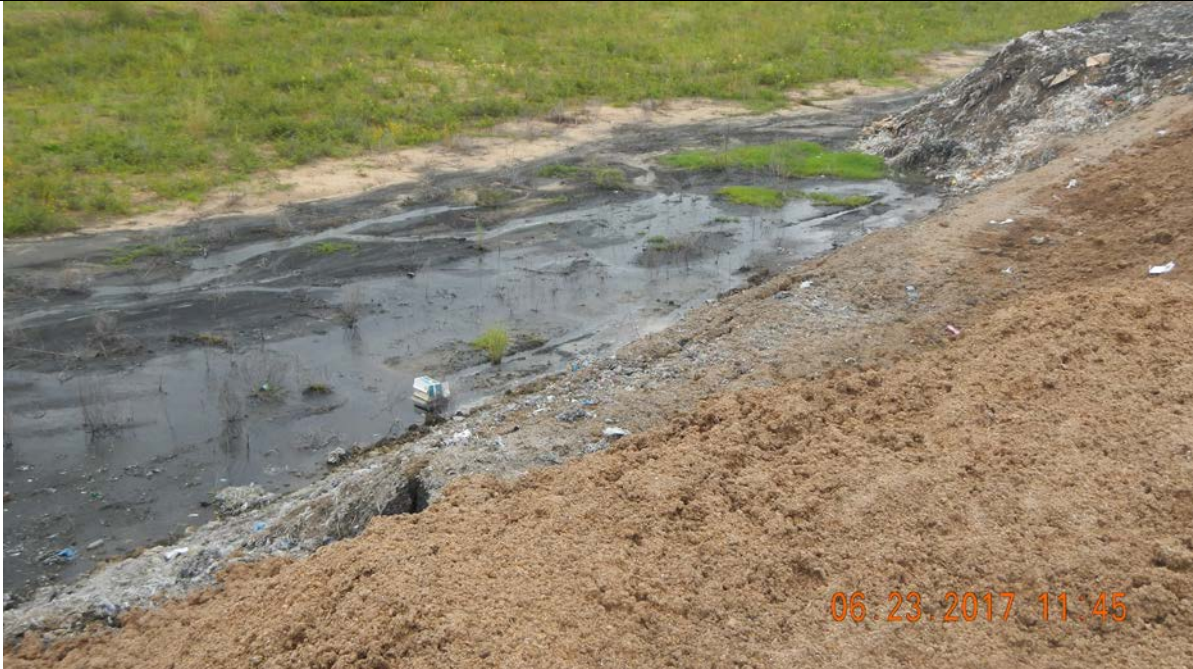
<b>Witness</b>	NA		
<b>Photo #</b>	3	<b>Of</b>	8	<b>Date</b>	6/23/2017	<b>Time</b>	1145
<b>Description</b>	Leachate on Western portion of cell 5 and exposed waste on East slope of cell 4

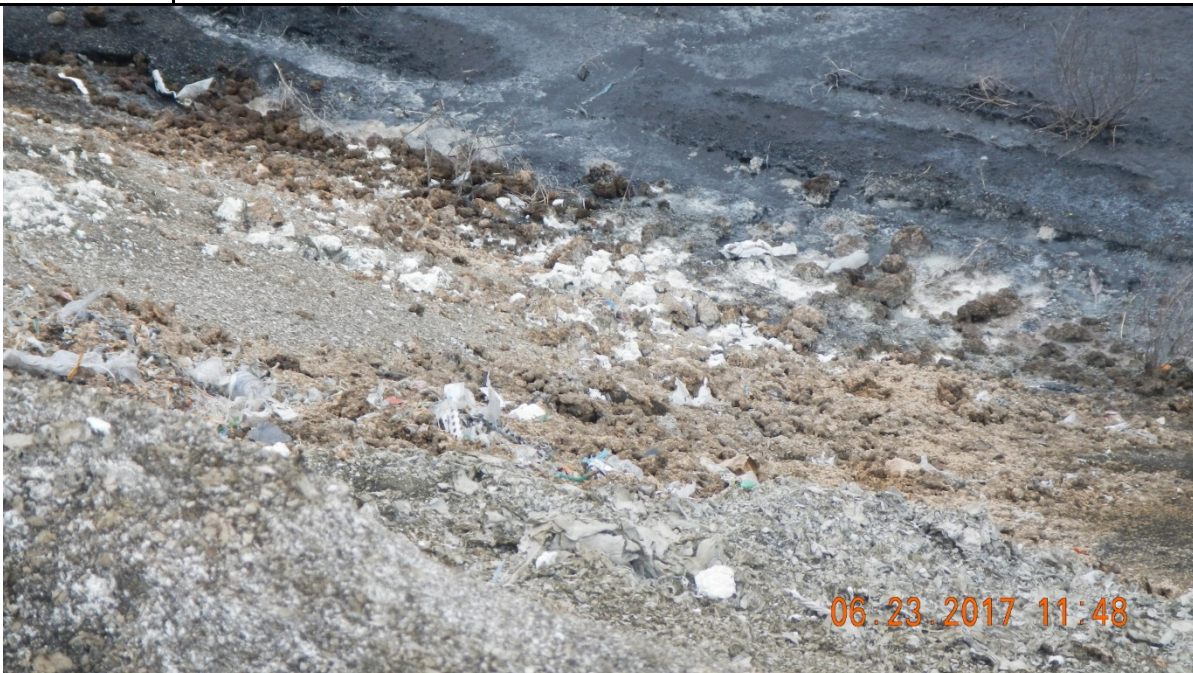
<b>Witness</b>	NA		
<b>Photo #</b>	4	<b>Of</b>	8	<b>Date</b>	6/23/2017	<b>Time</b>	1148
<b>Description</b>	Exposed waste and leachate on East slope of cell 4

**Item #2:** *Areas of erosion with exposed waste were notes on the East slope of cell4 during the inspection.*

**Corrective Action:** The erosion on cell 4 has been addressed. The area was regraded, sloped correctly and the areas that were washing have been filled in. The area in question is shown in the picture below.

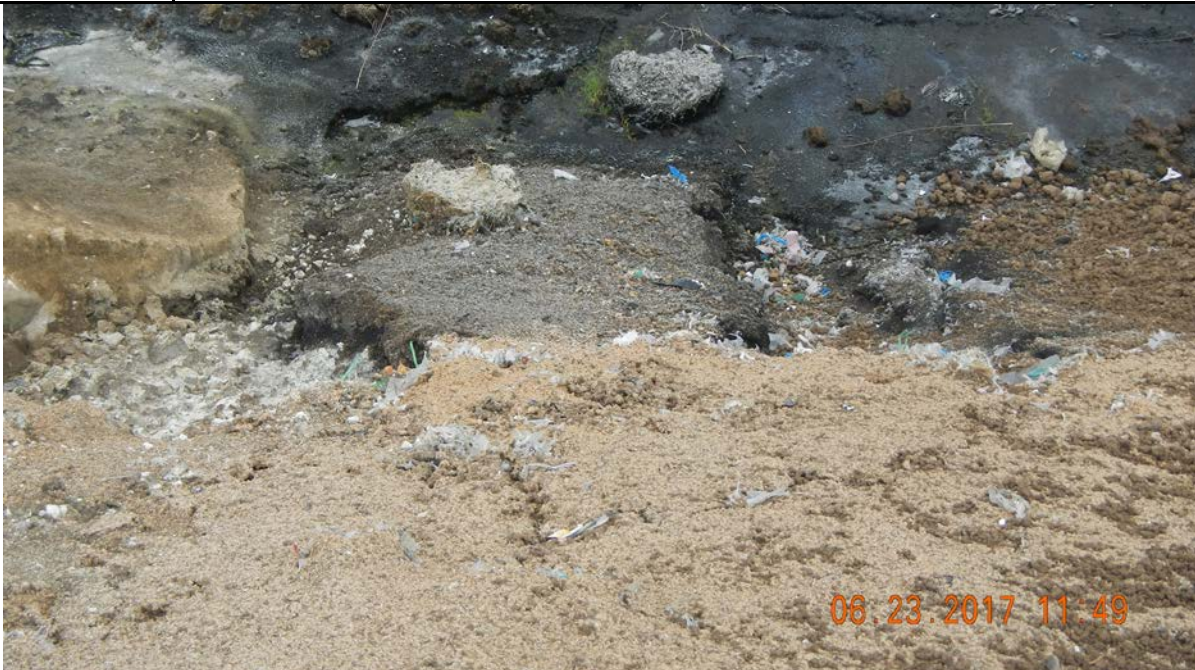
<b>Witness</b>	NA		
<b>Photo #</b>	5	<b>Of</b>	8	<b>Date</b>	6/23/2017	<b>Time</b>	1149
<b>Description</b>	Erosion with exposed waste and leachate on East slope of cell 4

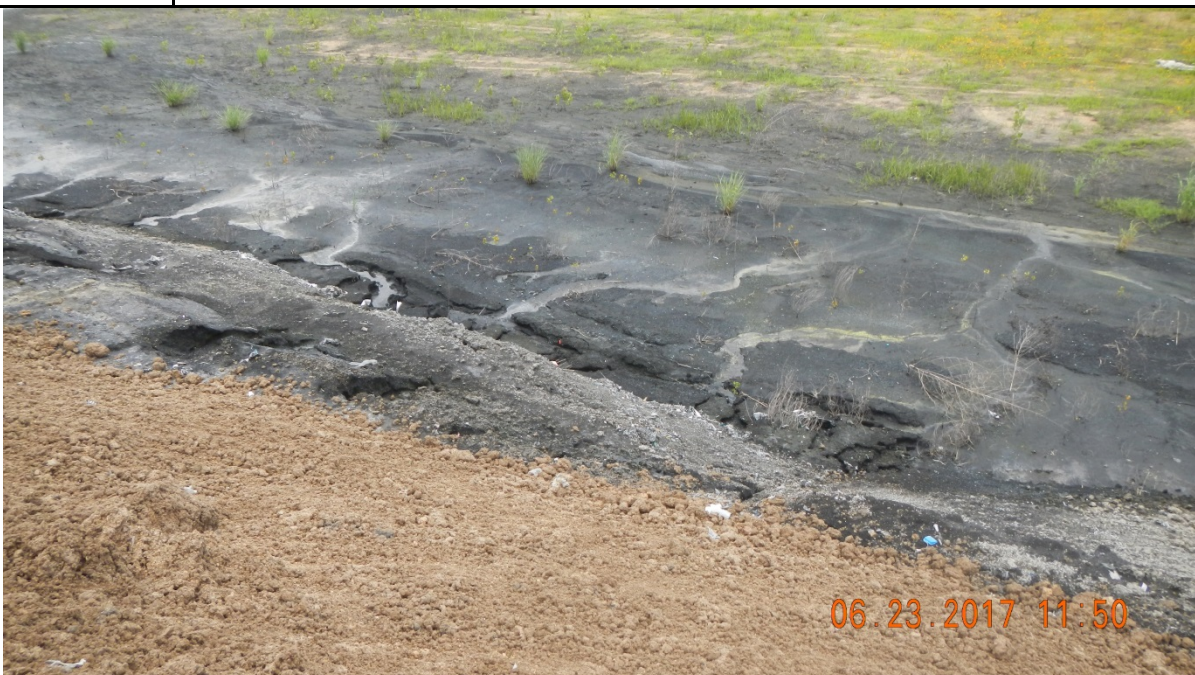
<b>Witness</b>	NA		
<b>Photo #</b>	6	<b>Of</b>	8	<b>Date</b>	6/23/2017	<b>Time</b>	1150
<b>Description</b>	Erosion and leachate on East slope of cell 4 and Western portion of cell 5

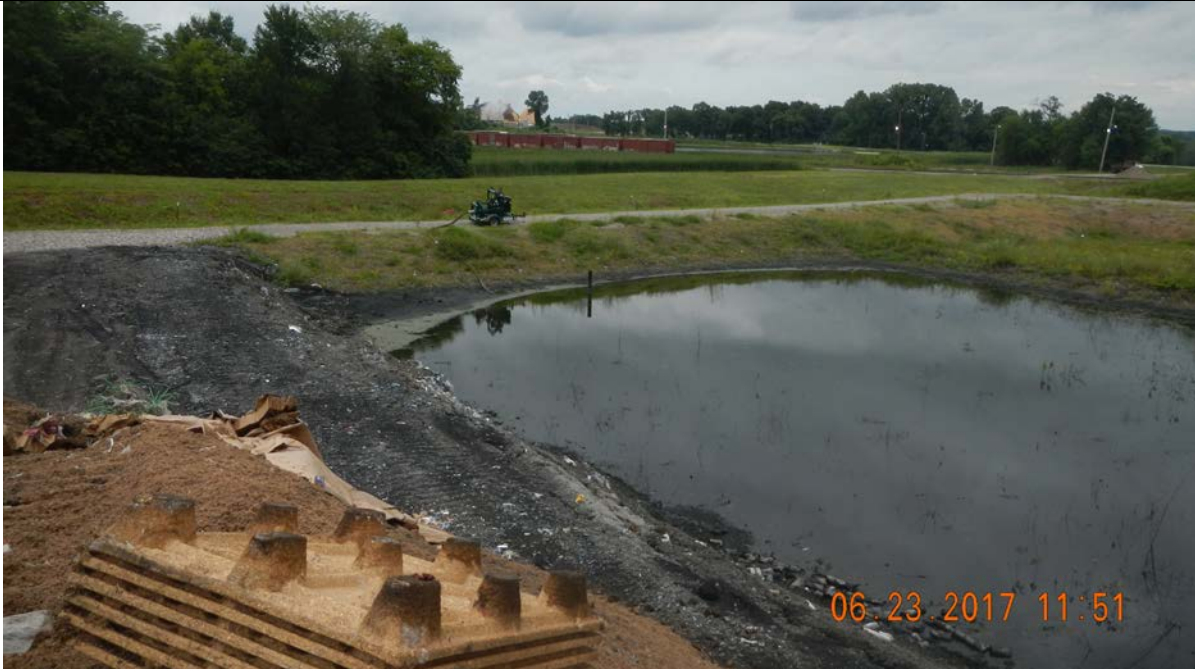
<b>Witness</b>	NA		
<b>Photo #</b>	7	<b>Of</b>	8	<b>Date</b>	6/23/2017	<b>Time</b>	1151
<b>Description</b>	Leachate ponding due to pump malfunction at Northwest section of cell 5.

**Item #1:** *During the inspection, leachate was noted ponding in the Northwest section of cell 5. Operator confirmed this was due to an un-identified pump malfunction.*

**Corrective Action:** After further investigation of the leachate system, it was determined that it was not a malfunctioning pipe, but an incorrectly installed leachate line draining the area. The line was corrected and cleaned out, and the area began draining as expected. The images below show the area as it was draining after the repair and what it looks like as of today 8/18/2017, after receiving 5-6" of rain this week.

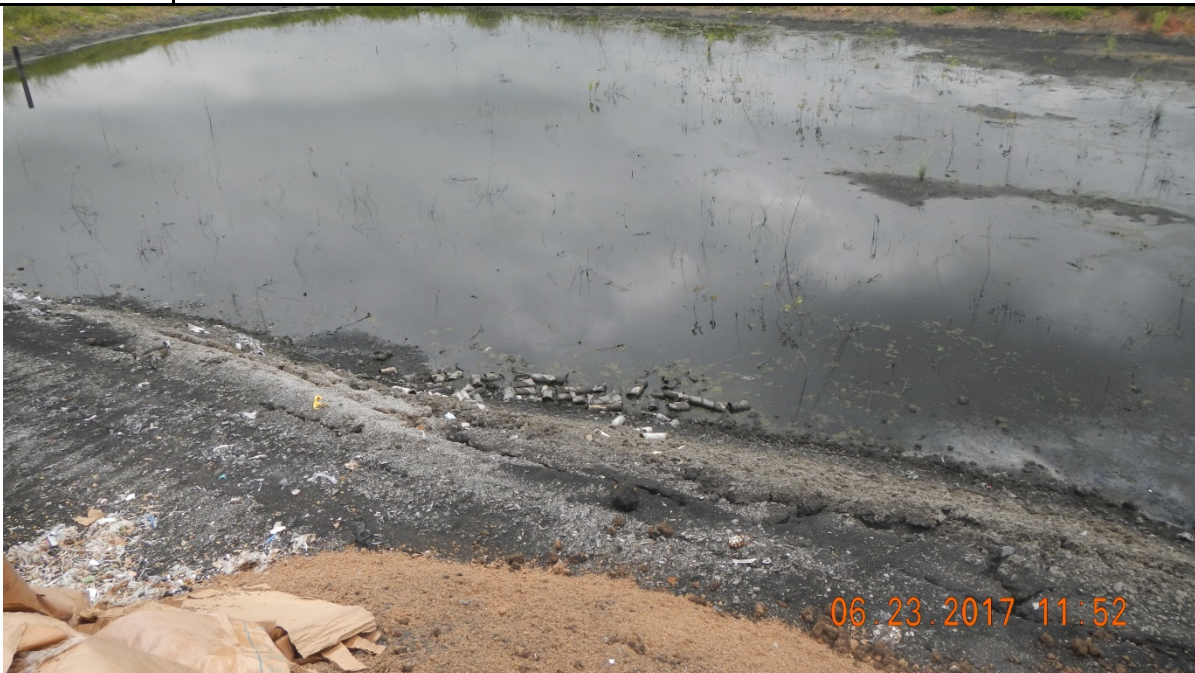
<b>Witness</b>	NA		
<b>Photo #</b>	8	<b>Of</b>	8	<b>Date</b>	6/23/2017	<b>Time</b>	1152
<b>Description</b>	Ponding of leachate and exposed waste Northwest portion of cell 5.

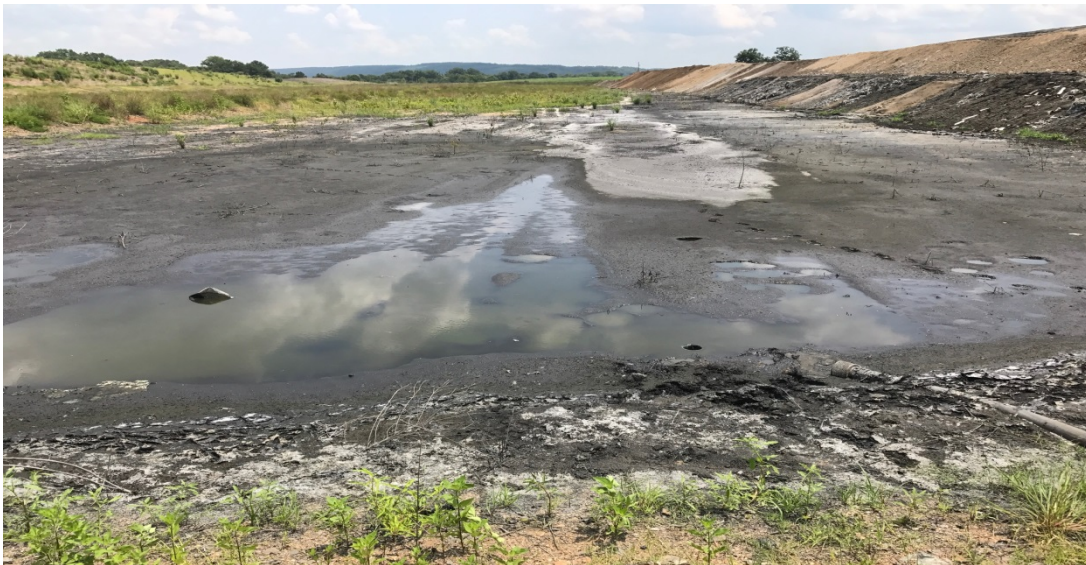
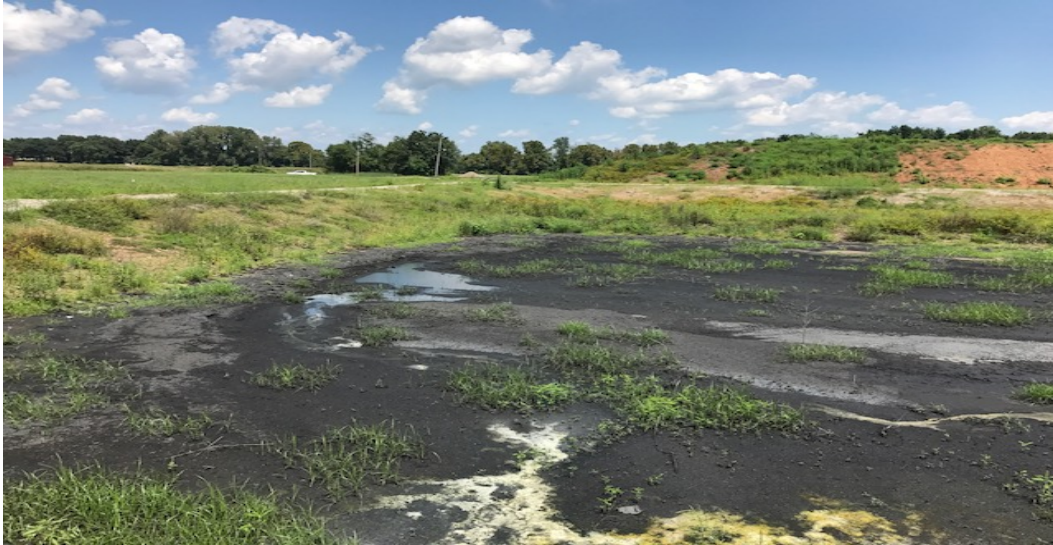
Draining after leachate line was corrected.

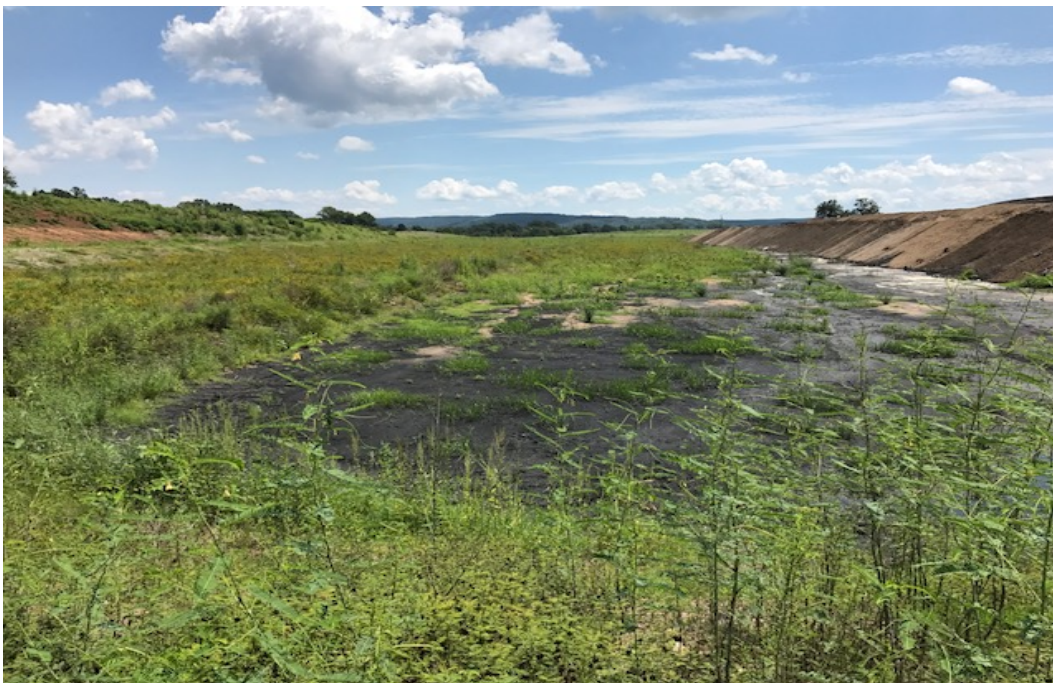
Pictures taken 8-18-2017 after heavy rains this week.
