October 25, 2017

RE: Reconnaissance Inspection (Newton County) AFIN: 51-00000 NPDES Permit No.:

ADEO			OFFICE OF WATER QUALITY INSPECTION REPORT						
ADEQ		AFIN: 51-00000 PERMIT #:			[DATE: 8/17/2017			
A R K A N S A S		COUNTY: 51 Newto		on	PDS #: 099746			MEDIA: W	
Department of Environmental Quality			GPS LAT: 36.10192 LONG: -93.01016 LOCATION: General Area						
	FACILITY INFORMAT	INSPECTION INFORMATION							
NAME: Pat Sanders LOCATION:				FACILITY TYPE:	104111 5 - State				
Pat Sanders Farm, Newton County Rd 50				FACILITY EVALUATION RATING: INSPECTION TYPE: *** Reconnaissance					
CITY:									
Western Grove, AR					11:14	12:30	PERMIT EF	FECTIVE DATE:	
RESPONSIBLE OFFICIAL				10/04/2017 1	6:40	16:50	PERMIT EX	PIRATION DATE:	
NAME: / TITLE Ret Sandara / Branarty Owner									
Pat Sanders / Property Owner COMPANY:				FAYETTEVILLE SHALE RELATED: N					
				FAYETTEVILLE SHALE VIOLATIONS: N					
Mailing address: Route 1 Box 238				INSPECTION PARTICIPANTS					
CITY, STATE, ZIP:				NAME/TITLE/PHONE/FAX/EMAIL/ETC.:

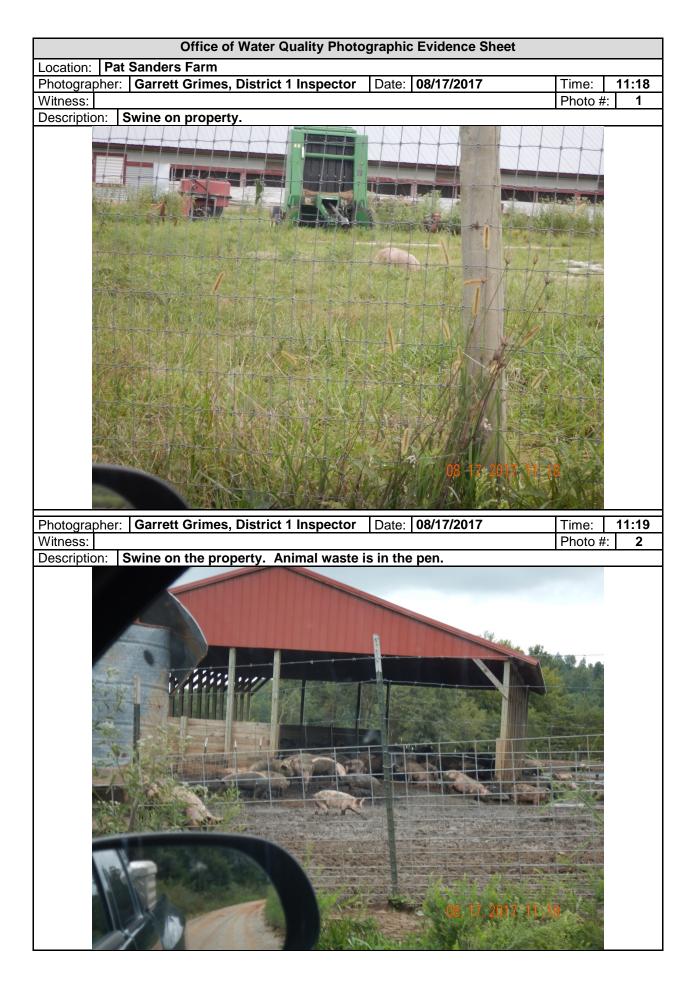
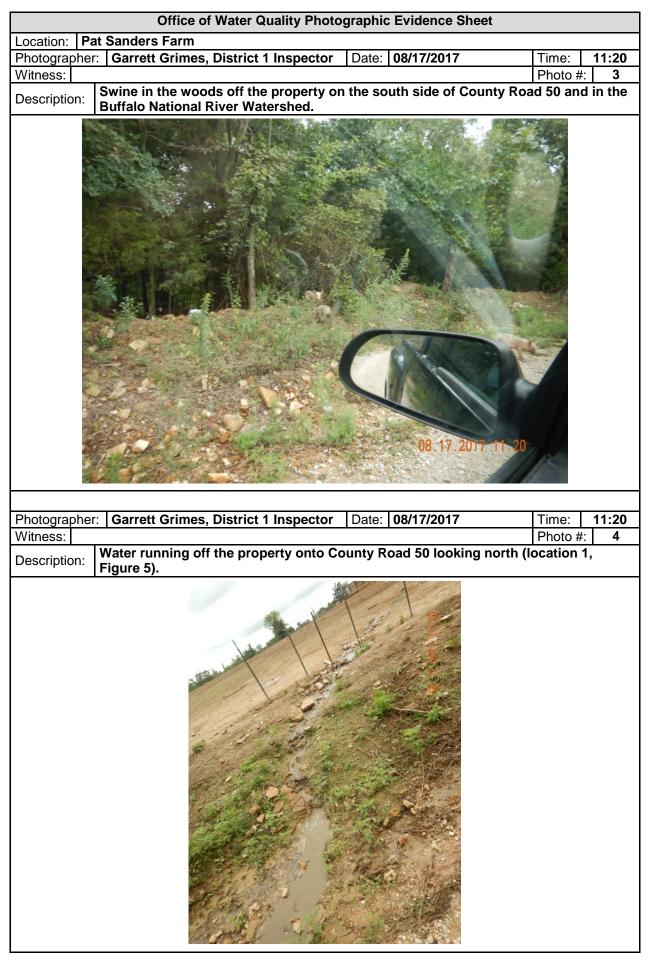
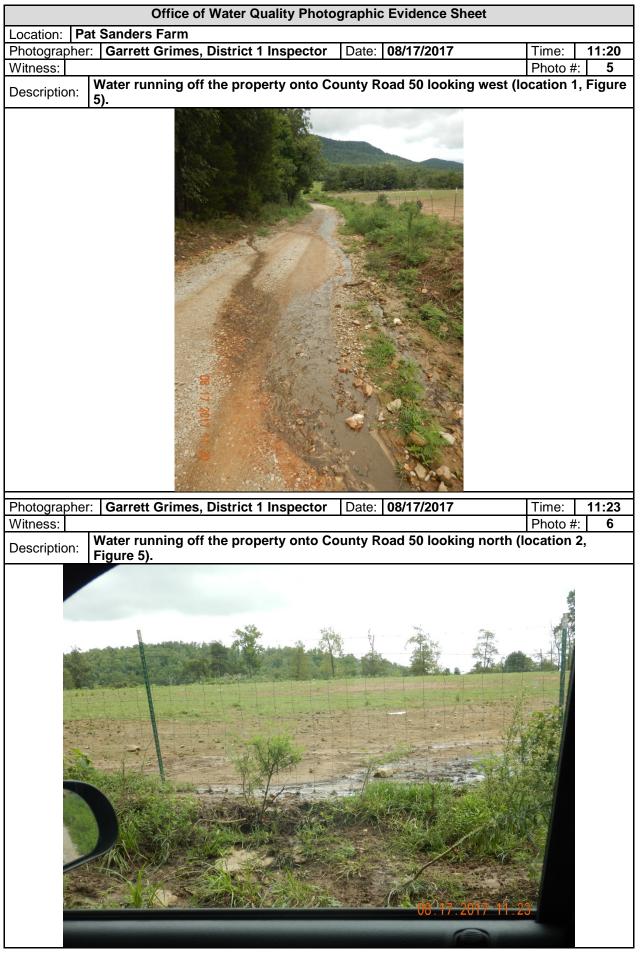
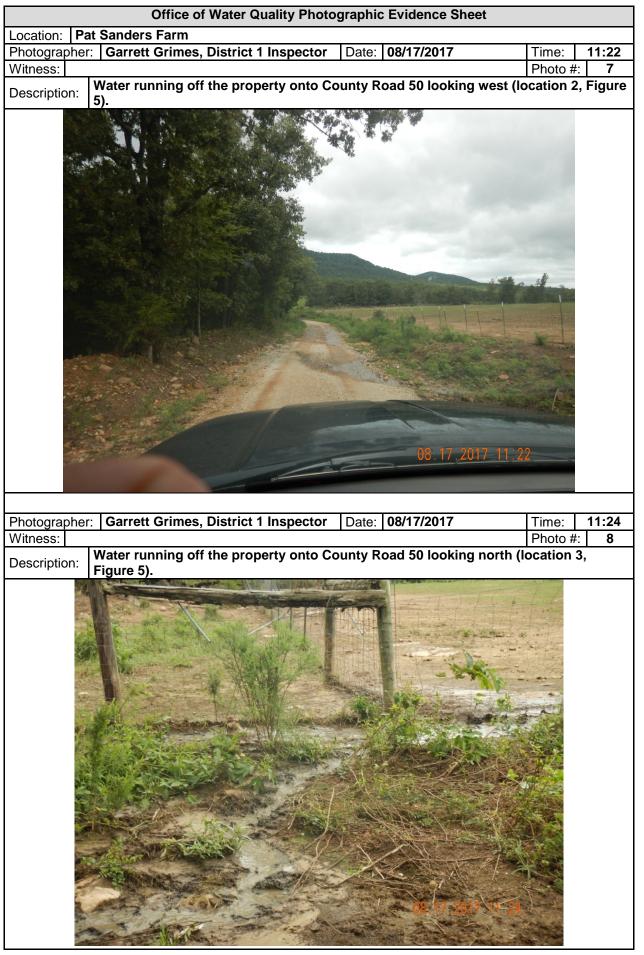
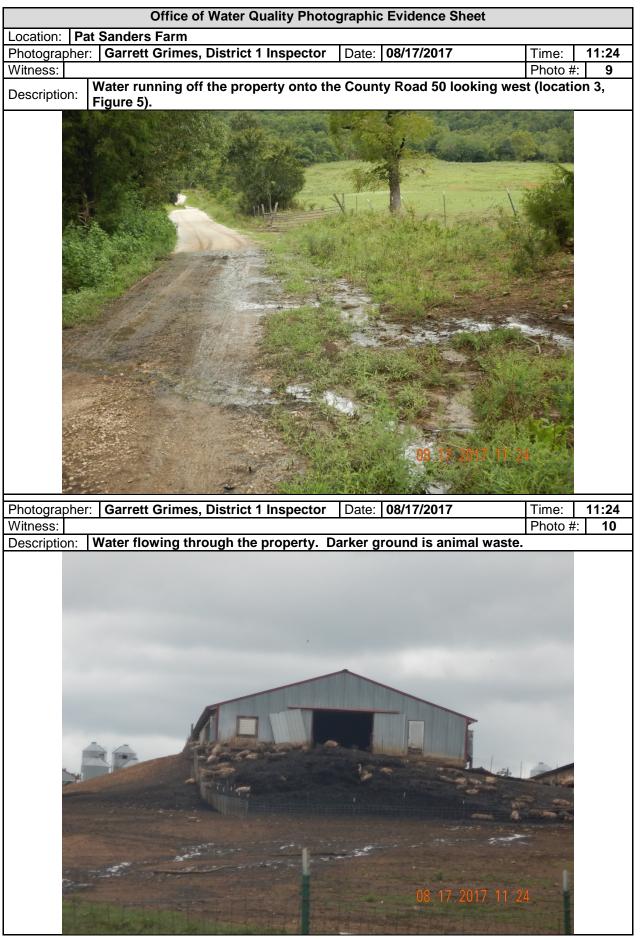
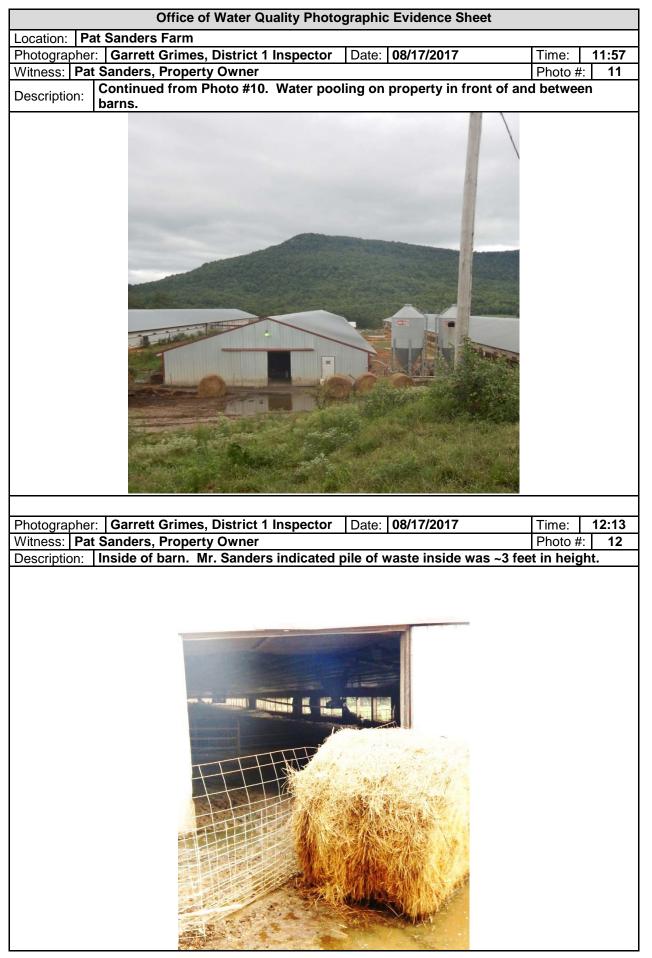
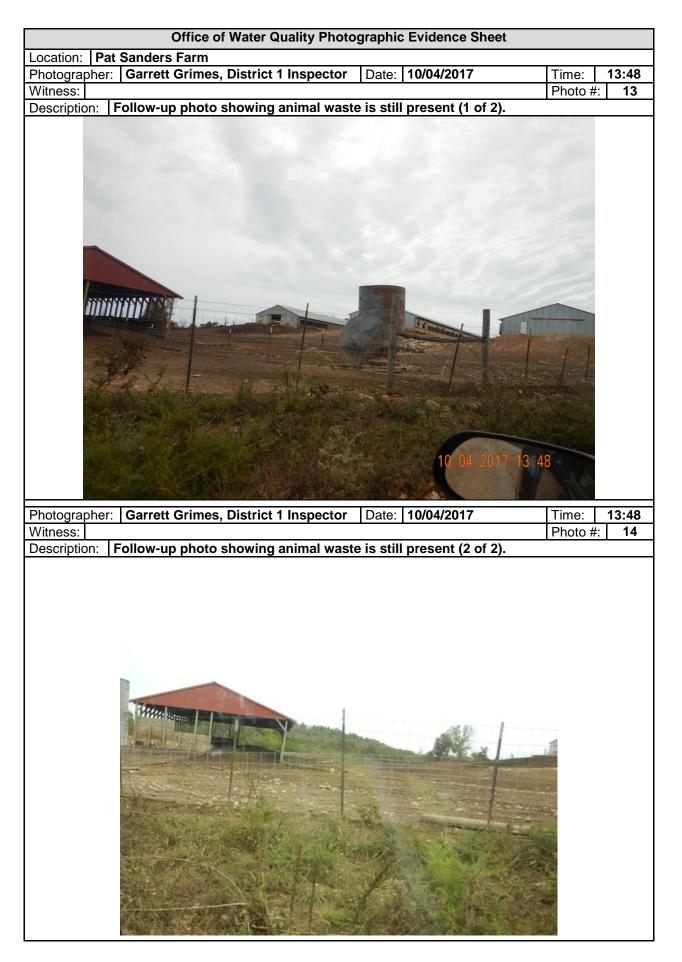
**	SAMPLING	**	SLUDGE HANDLING/DISPOSAL ** PRETREATMENT						
**	** OTHER:								
SUMMARY OF FINDINGS									
ADEQ arrived on-site on August 17, 2017. Upon arrival swine were observed on the County Road 50 and

throughout the property (Photos #1 - #3). Water was observed flowing across the property, onto County Road 50, and south towards Cedar Creek (Photos #4 - #9, Figure 1). Water accumulated on the property was observed running off through an area where swine as well as piles of animal waste were located (Photos #2 #10 & #11).

Mr. Sanders stated that he had a Nutrient Management Plan (NMP) through the Arkansas Natural Resource Commission (ANRC). However, ANRC confirmed the NMP was for the previous turkey operation. According to Mr. Sanders, he had been pushing waste out of the barns onto the surrounding ground because there was not enough room in the barns and verified that the previous observations were of animal waste. Mr. Sanders also stated that there was approximately three feet of manure piled in one of the barns (Photo #12).

I returned to the property on October 4, 2017. Swine were still observed throughout the property and animal waste was still present, but no water was observed running off the property at the time of the inspection (Photos #13 - #15).

Due to the runoff and inability to manage waste generated from your operation, you may be in violation of Arkansas Water and Air Pollution Control Act § 8-4-217(a)(2) which states, "It shall be unlawful for any person to place or cause to be placed any sewage, industrial waste, or other wastes in a location where it is likely to cause pollution of any waters of this state."

Please refer to the "Summary of Findings" section of this report and provide a written response for each violation noted. This case has been referred directly to the Enforcement Branch of the Office of Water Quality for further review. Please immediately initiate all actions necessary to resolve and correct the violations cited.
